Mosca - KCK-131-22 Service Inspection report

Hayes Packaging Service Ltd

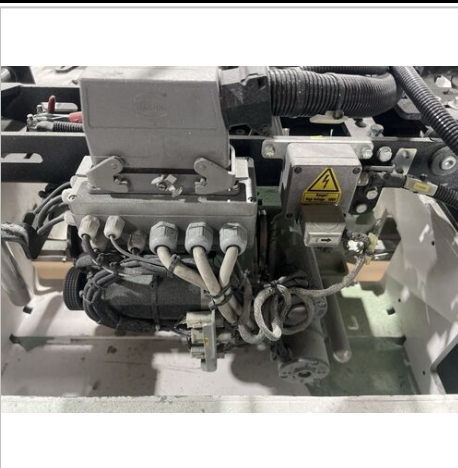
Strap dust build up

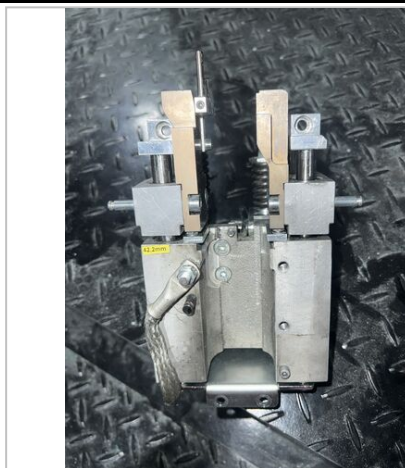
Brass shoe minimal wear

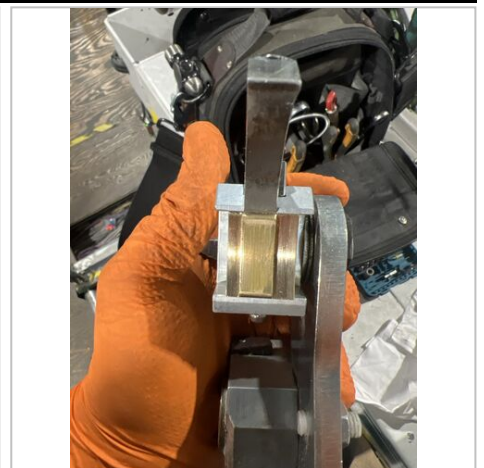
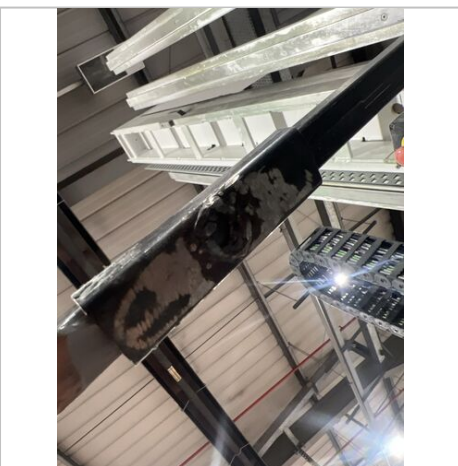
Damage to strap infeed joint

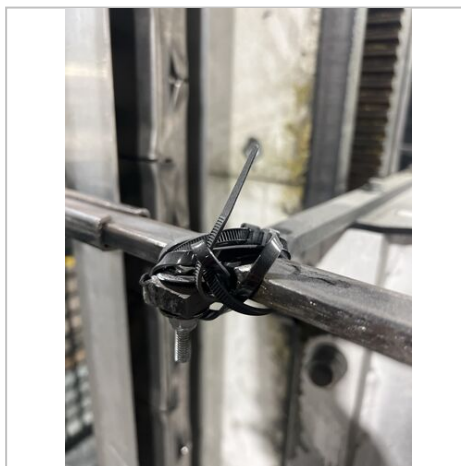
Operators fix for bad joint

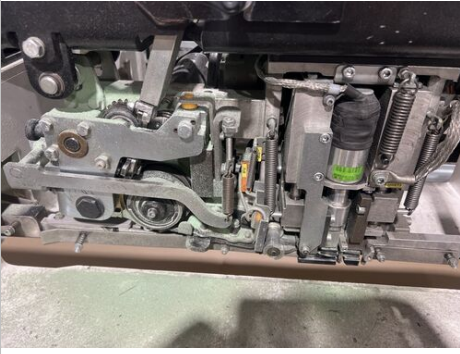
Heads require regular blowing of the strap dust

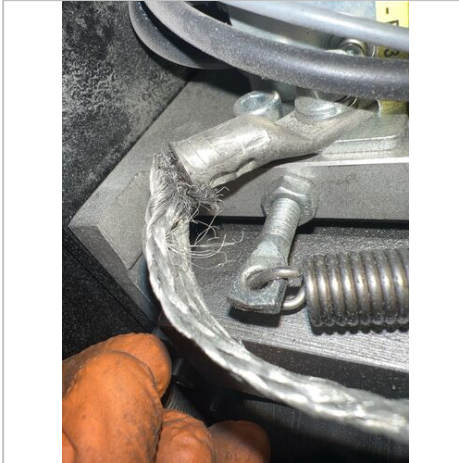
Reformed entry chute flap to assist in alignment. Adjusted re entry chute guide for alignment. Cutter also required, occasional split during strap cut whilst infer tension. Earth connection for sonic weld frayed also, this will need replacing soon to stop welds from deteriorating. Ran and tested all okay

Earthing belt damaged

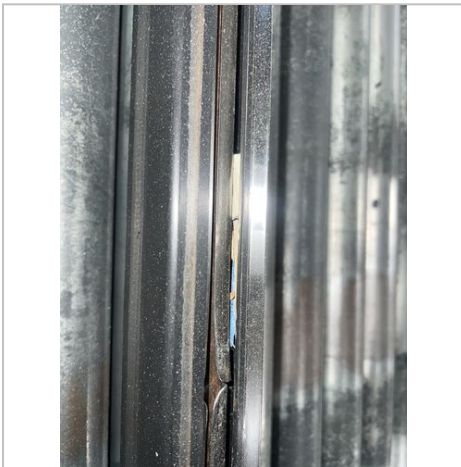
Entry Bayonet/Lance

Pallet wood must be removed from bayonet where possible

Blocks of pallet wood are getting stuck in bayonet chute flaps, this will prevent the chute flaps from opening during the tensioning stage of the machine. This will reduce the service life of the chute flaps and cause mis-feeds.

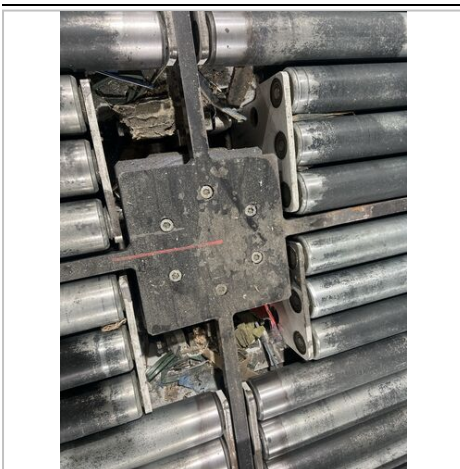
Wood build up on turncross

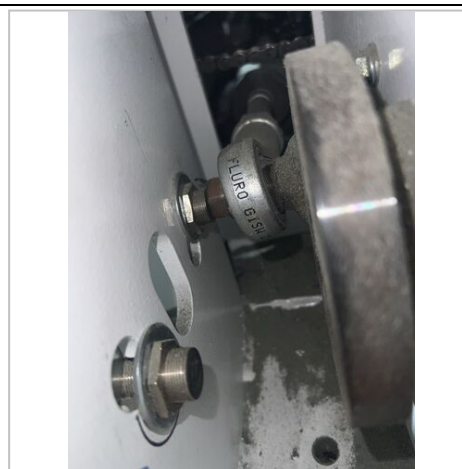
Turncross proximity switch damaged, this will need changing before it loses sensitivity.

Proximity sensor end damaged. Still sensitive enough to read

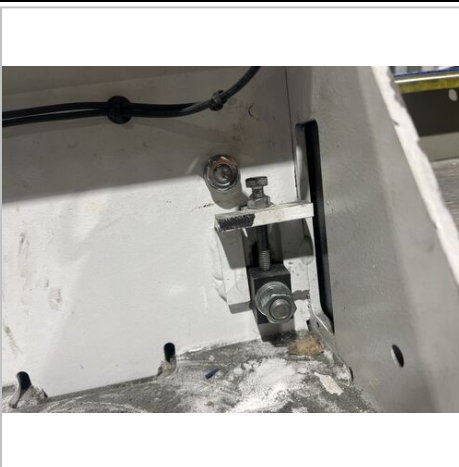
Entry conveyor bearing damaged, unable to determine if roller shaft has snapped, Bearing unseated from roller on left hand side. Tension set to max on left hand side. The chain may have jumped an idler. The conveyors will need to be worked on ASAP.

Chain tensioner set at max, requires new chains left hand side

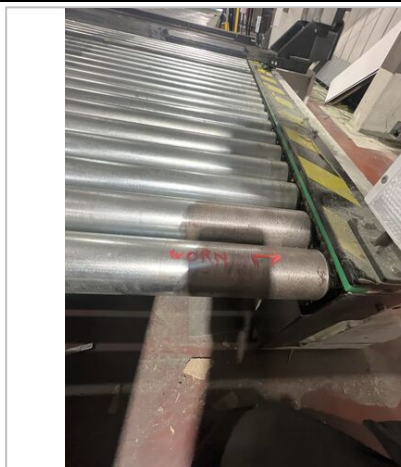
Bearing unseated, requires replacing

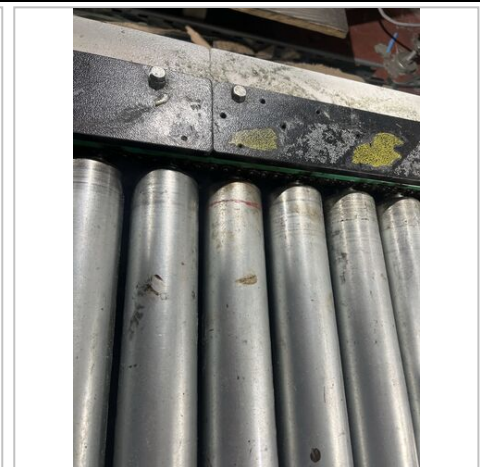
Red marked roller not seated in bearing housing. Sprocket likely damaged, have listed for replacement.
