Check Out

Property inspected by A. Clerk

123 Preview Street
Sample City
London
AB1 2CD

May
29th 2026
09:00

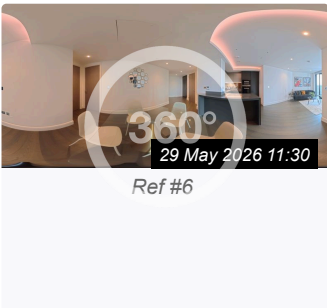
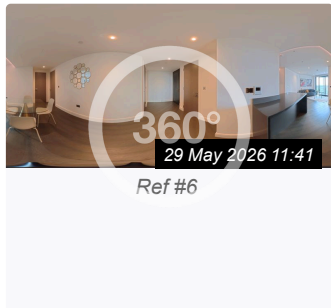
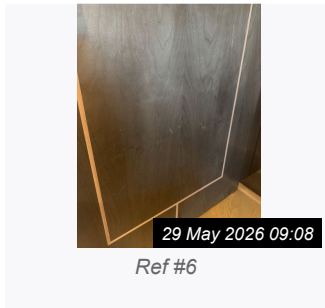
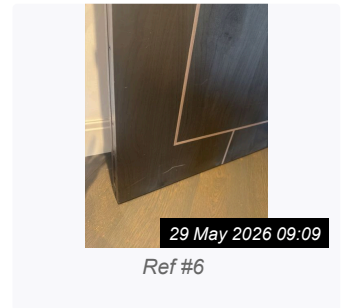
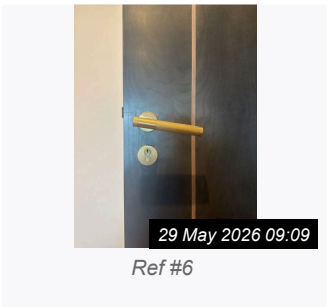
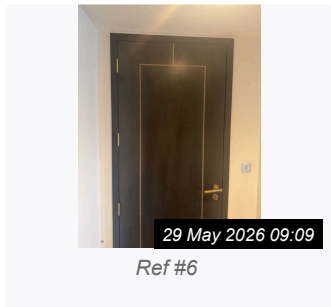
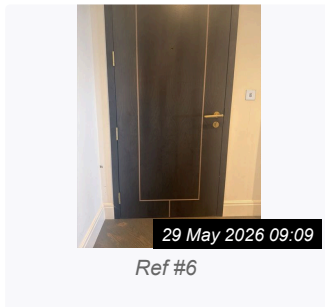
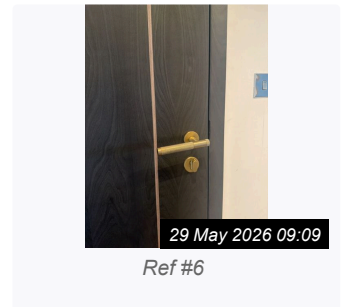
6. ENTRANCE / HALLWAY (CONT.)				
6.12.1	-	1x white sprinkler unit		Appears in good condition.
6.12.2	-	1x digital thermostat	- Light is seen	As Inventory & Check In
6.12.3	-	1x black doorstop, skirting mounted		In good condition.
6.12.4	-	1x wall mounted mirror		Appears in good condition.
6.12.5	-	A range of glass panes	- Intact	As Inventory & Check In
6.13	Dining Table	Glass top dining table	- Light surface scratching seen	As Inventory & Check In + Chip near centre; glass has minor scratches in places.
6.14	Dining Chairs	4x cream leather dining chairs 4x matching legs	- Very light usage marks seen to the base - Some additional staining seen to the base, cleaning required, 1x is torn and hole seen at the bottom, please see the photograph.	As Inventory & Check In

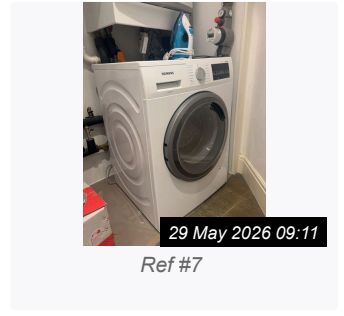
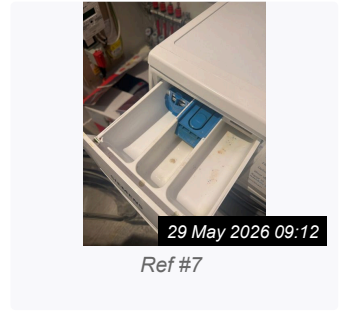
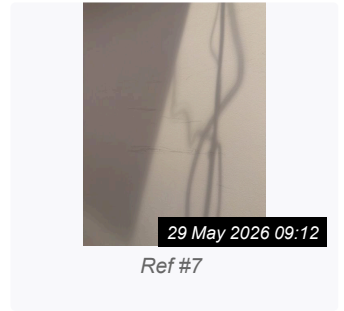
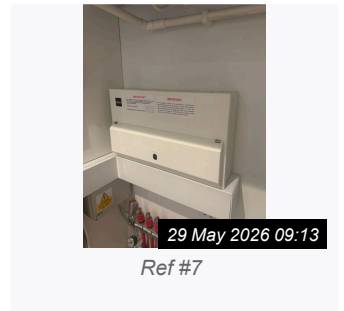
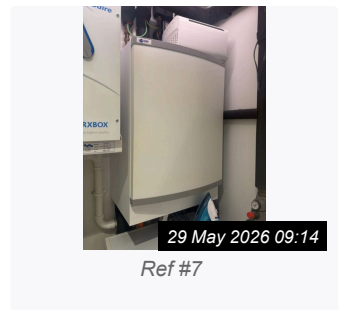
29 May 2026 09:11
Ref #7

7. UTILITY ROOM / AREA (CONT.)				
7.15.10	-	1x grey bin		Not seen. Note: Bedroom 1 contains a grey bin; no check-in photo available, so unable to confirm if this is the same item. Needs Replacing - Investigate
7.15.11	-	1x Russell Hobbs iron		This is present.
7.15.12	-	1x further grey mop		Not seen. Missing Item/s - Tenant
7.16	Fixtures & Fittings	1x small green brush		Not seen. Missing Item/s - Tenant
7.16.1	-	1x white vent, ceiling mounted		Appears in good condition - open.
7.16.2	-	1 x Danfoss heat meter unit with an associated pipework		Appears in good condition.
7.16.3	-	1x water meter with an associated pipework		Appears in good condition.

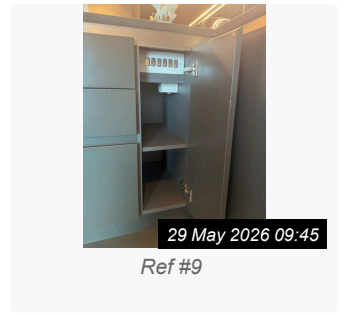
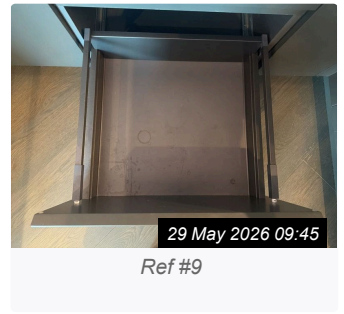
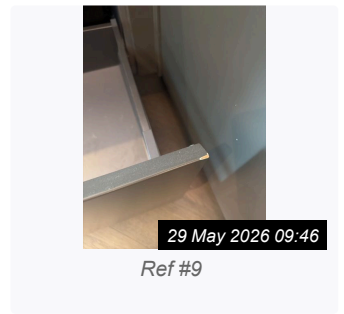
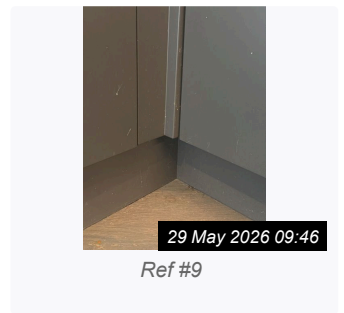
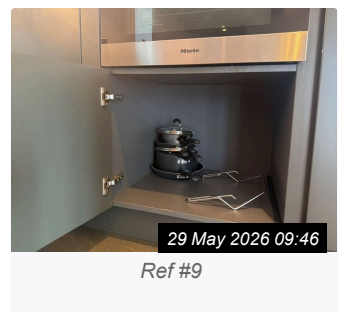
Ref #9

9.19.19	-	1x small iron	<i>Item added after Check In</i>	This is present.
9.19.20	-	1x white bag containing miscellaneous items	<i>Item added after Check In</i>	Appliance manuals and a few small items found inside.

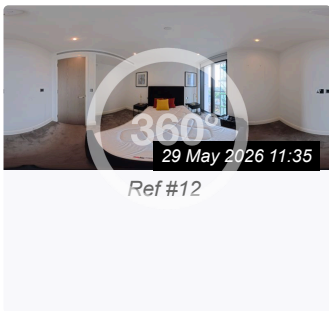
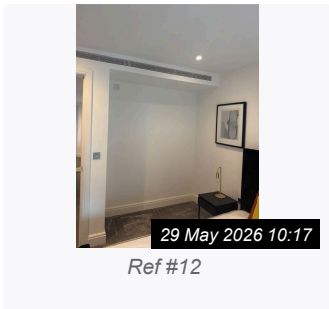
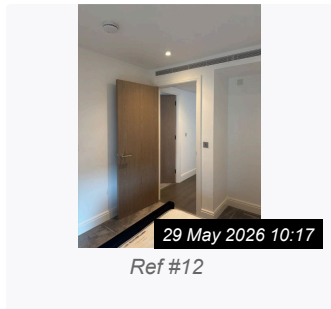
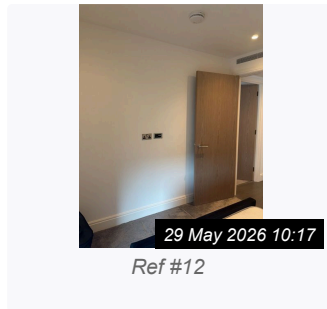
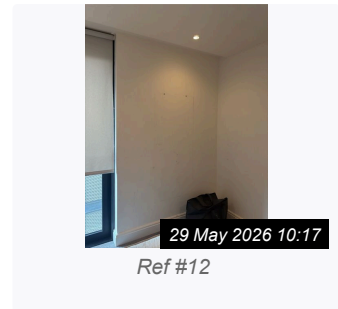
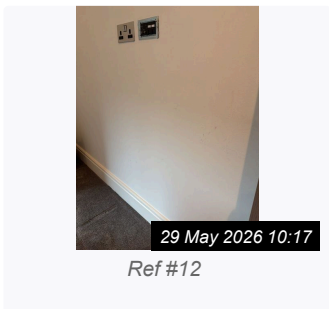
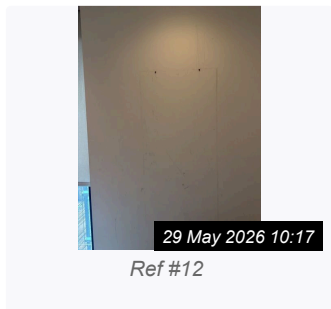
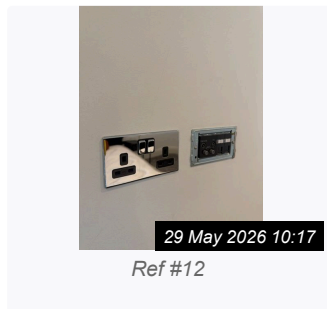
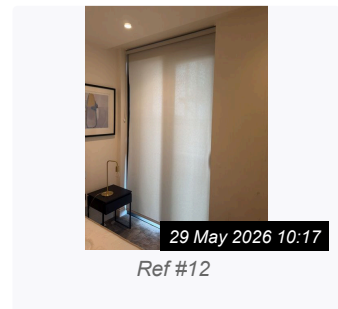
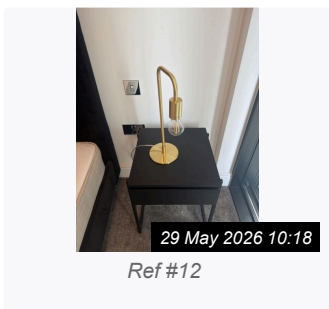
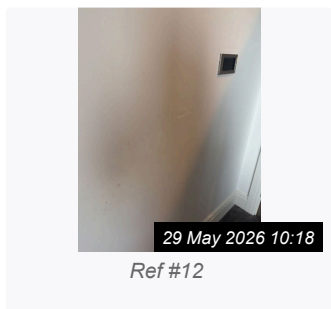
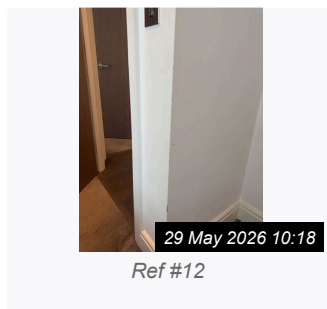
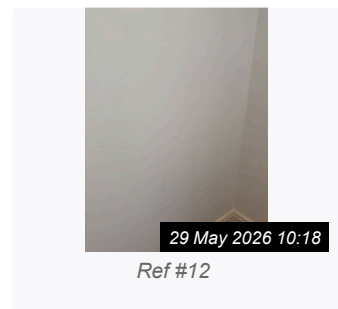
12.16	Armchair	1x orange accent fabric chair	<ul style="list-style-type: none"> - Light stained area seen to the base - Further stained area seen to the left hand side edge - Slightly wobbly - One of the legs is loose - Left hand side leg is wobbly, needs attention 	<p>Not seen.</p> <p>Missing Item/s - Tenant</p>
12.16.1	-	Duvet stored in black bag	<i>Item added after Check In</i>	<p>Requires Disposal - Tenant</p>
12.16.2	-	2x orange pillows 1x yellow pillow	<i>Item added after Check In</i>	In good condition.

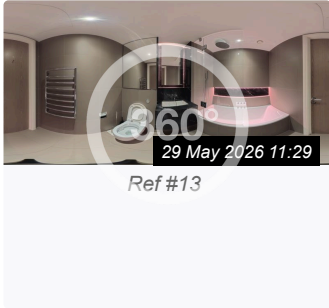
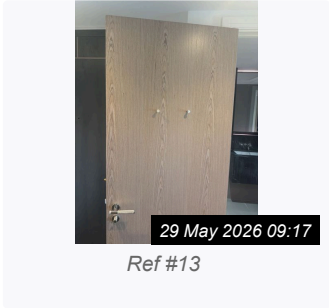
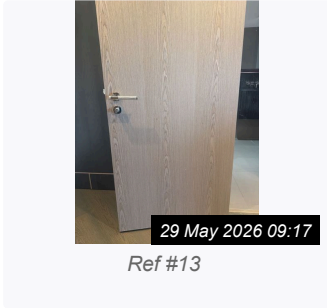
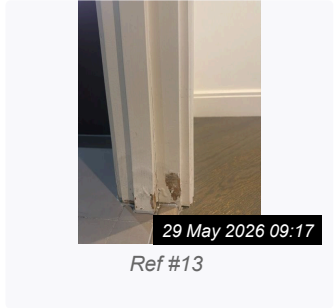
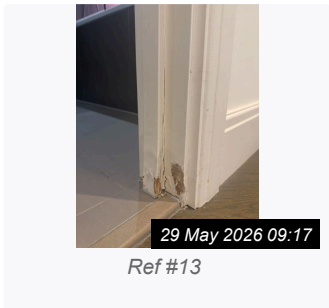
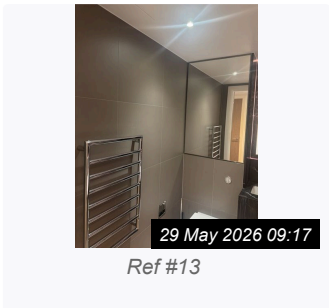
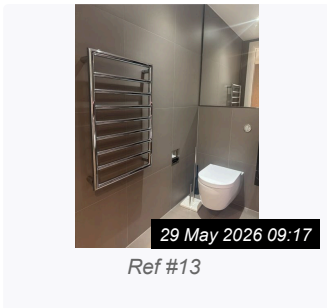
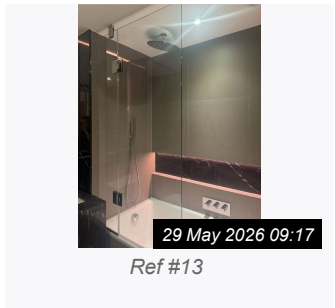
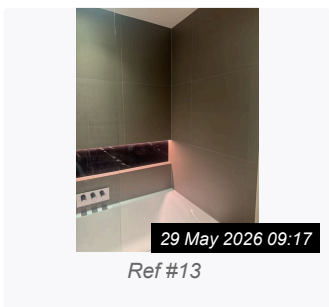
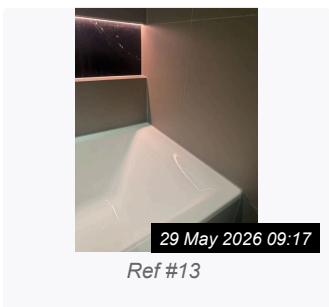
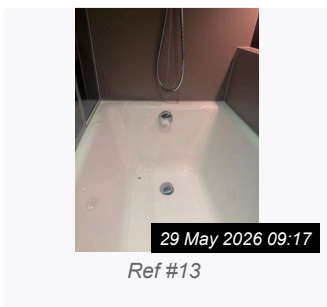
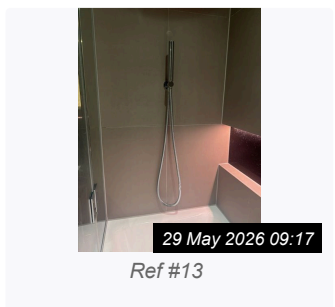
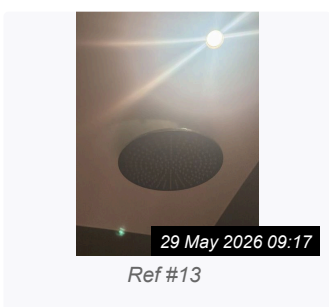
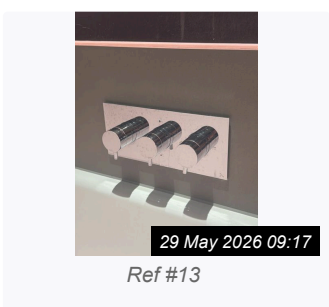
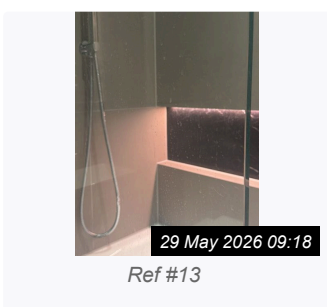
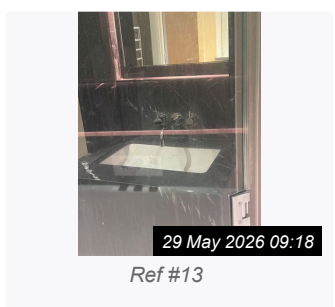
13.16	Additional Items / Information			
13.16.1	-	1x plunger		This is present.
13.16.2	-	Toilet roll holder with marble effect base	<i>Item added after Check In</i>	In good condition.
