Check Out

Property inspected by A. Clerk

123 Preview Street
Sample City
London
AB1 2CD

June
5th 2026
10:00

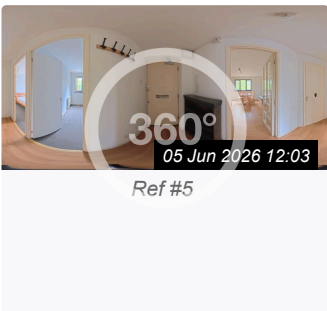
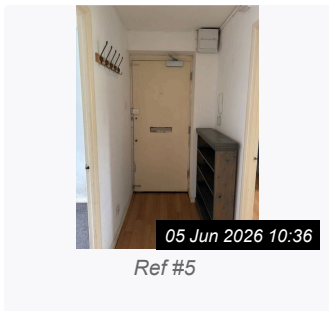
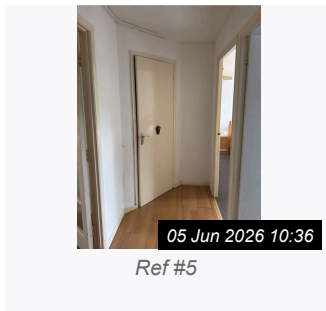
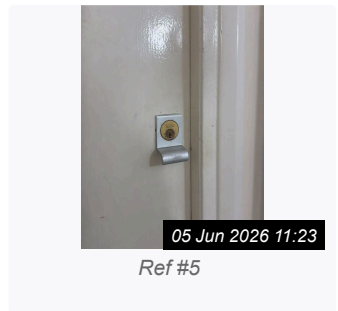
5. ENTRANCE/HALLWAY (CONT.)				
5.10.1	-	Open Shelving Unit.	<i>Item added after Check In</i>	<p>Constructed from timber with a grey-washed finish; colour is uneven and faded in areas, with natural grain showing through.</p> <p>General scuffs, wear marks and minor chips present along edges and corners from regular use; surface shows visible signs of age and handling.</p> <p>Sturdy and stable, stands level and securely; no damage or instability noted.</p> <p>Functionally sound, but cosmetically worn with clear marks of use throughout.</p>
5.10.2	-	Coat Rack.	<i>Item added after Check In</i>	<p>Wooden base with five black hooks; securely fixed to the wall, firm and stable.</p> <p>Minor surface marks and light wear visible on the wood; hooks intact, undamaged and securely attached.</p> <p>In good order, clean and fully functional; only very slight cosmetic signs of use.</p>

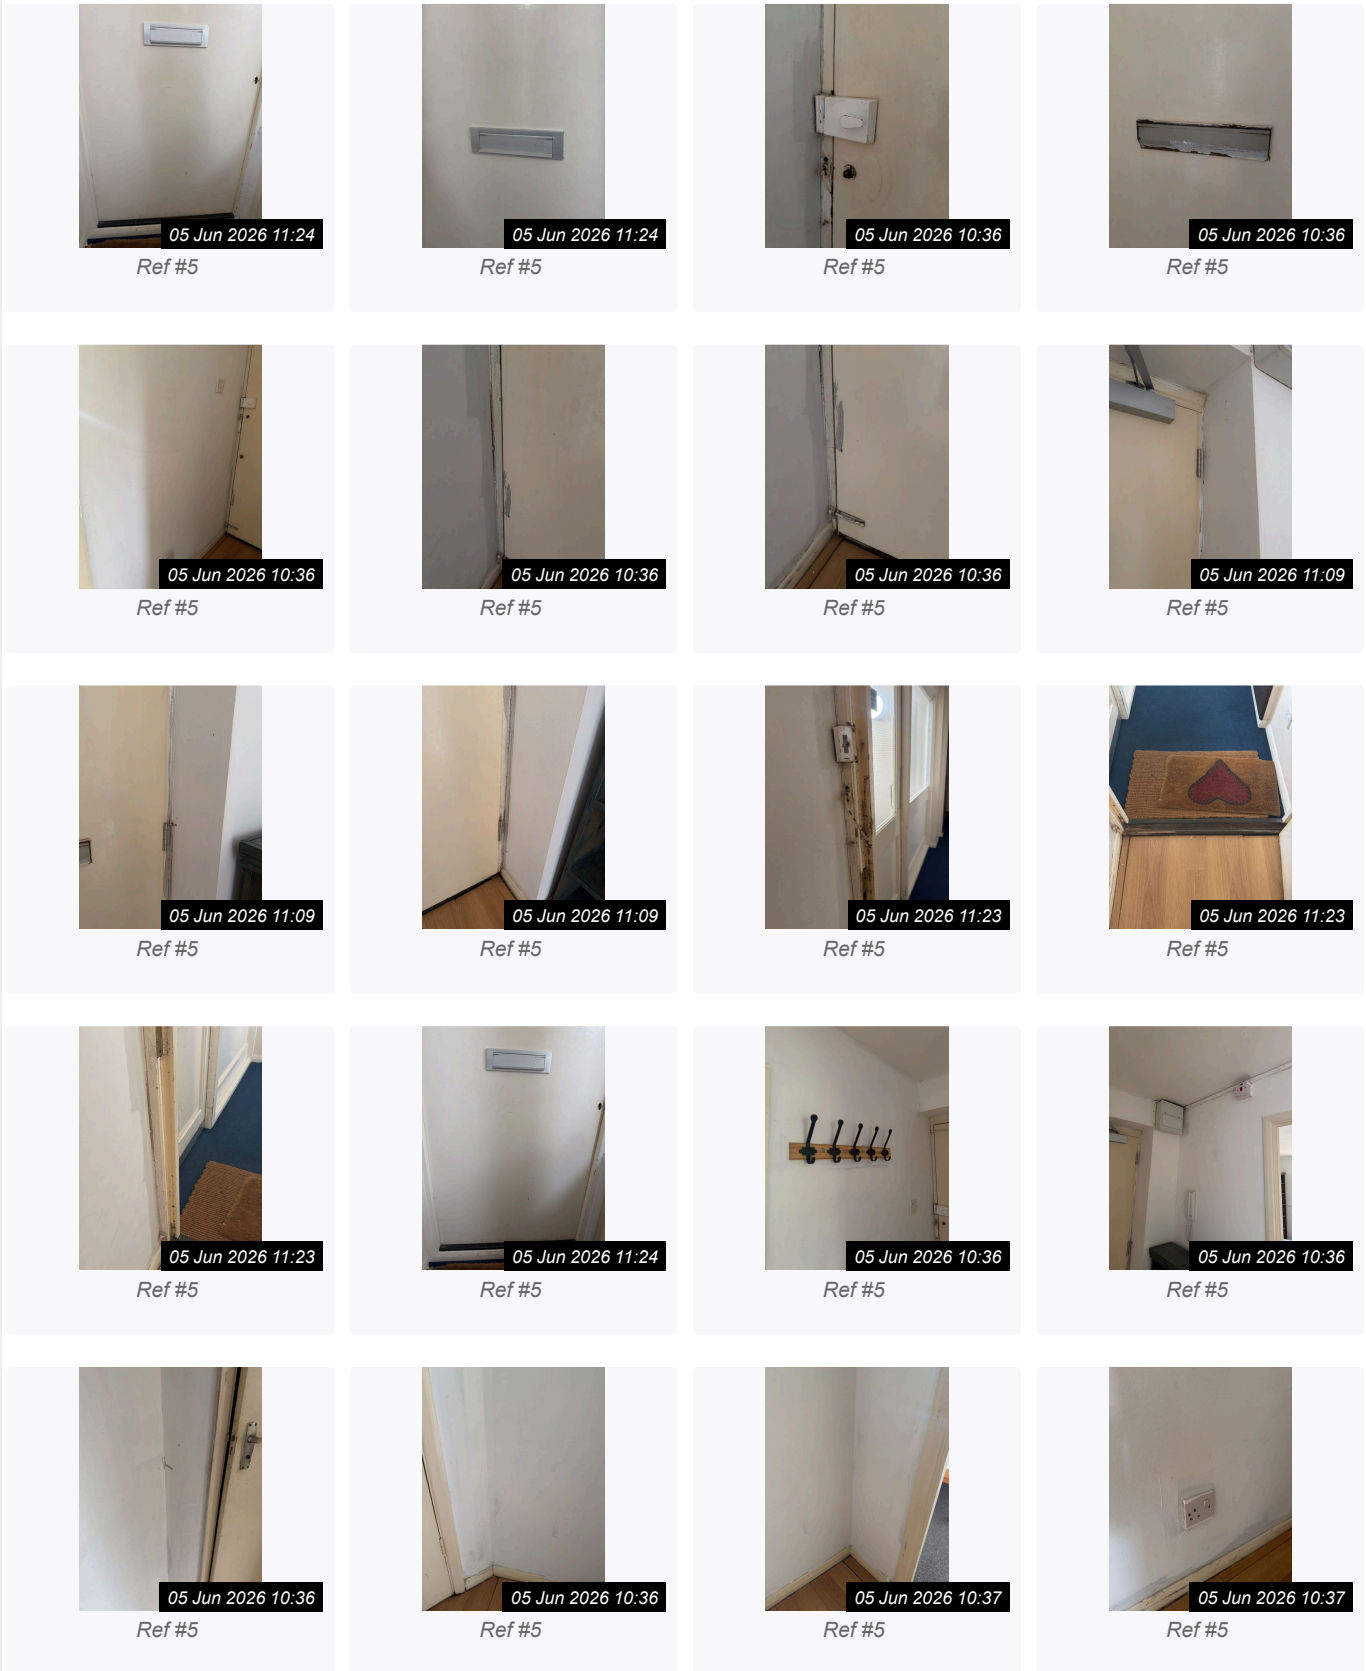
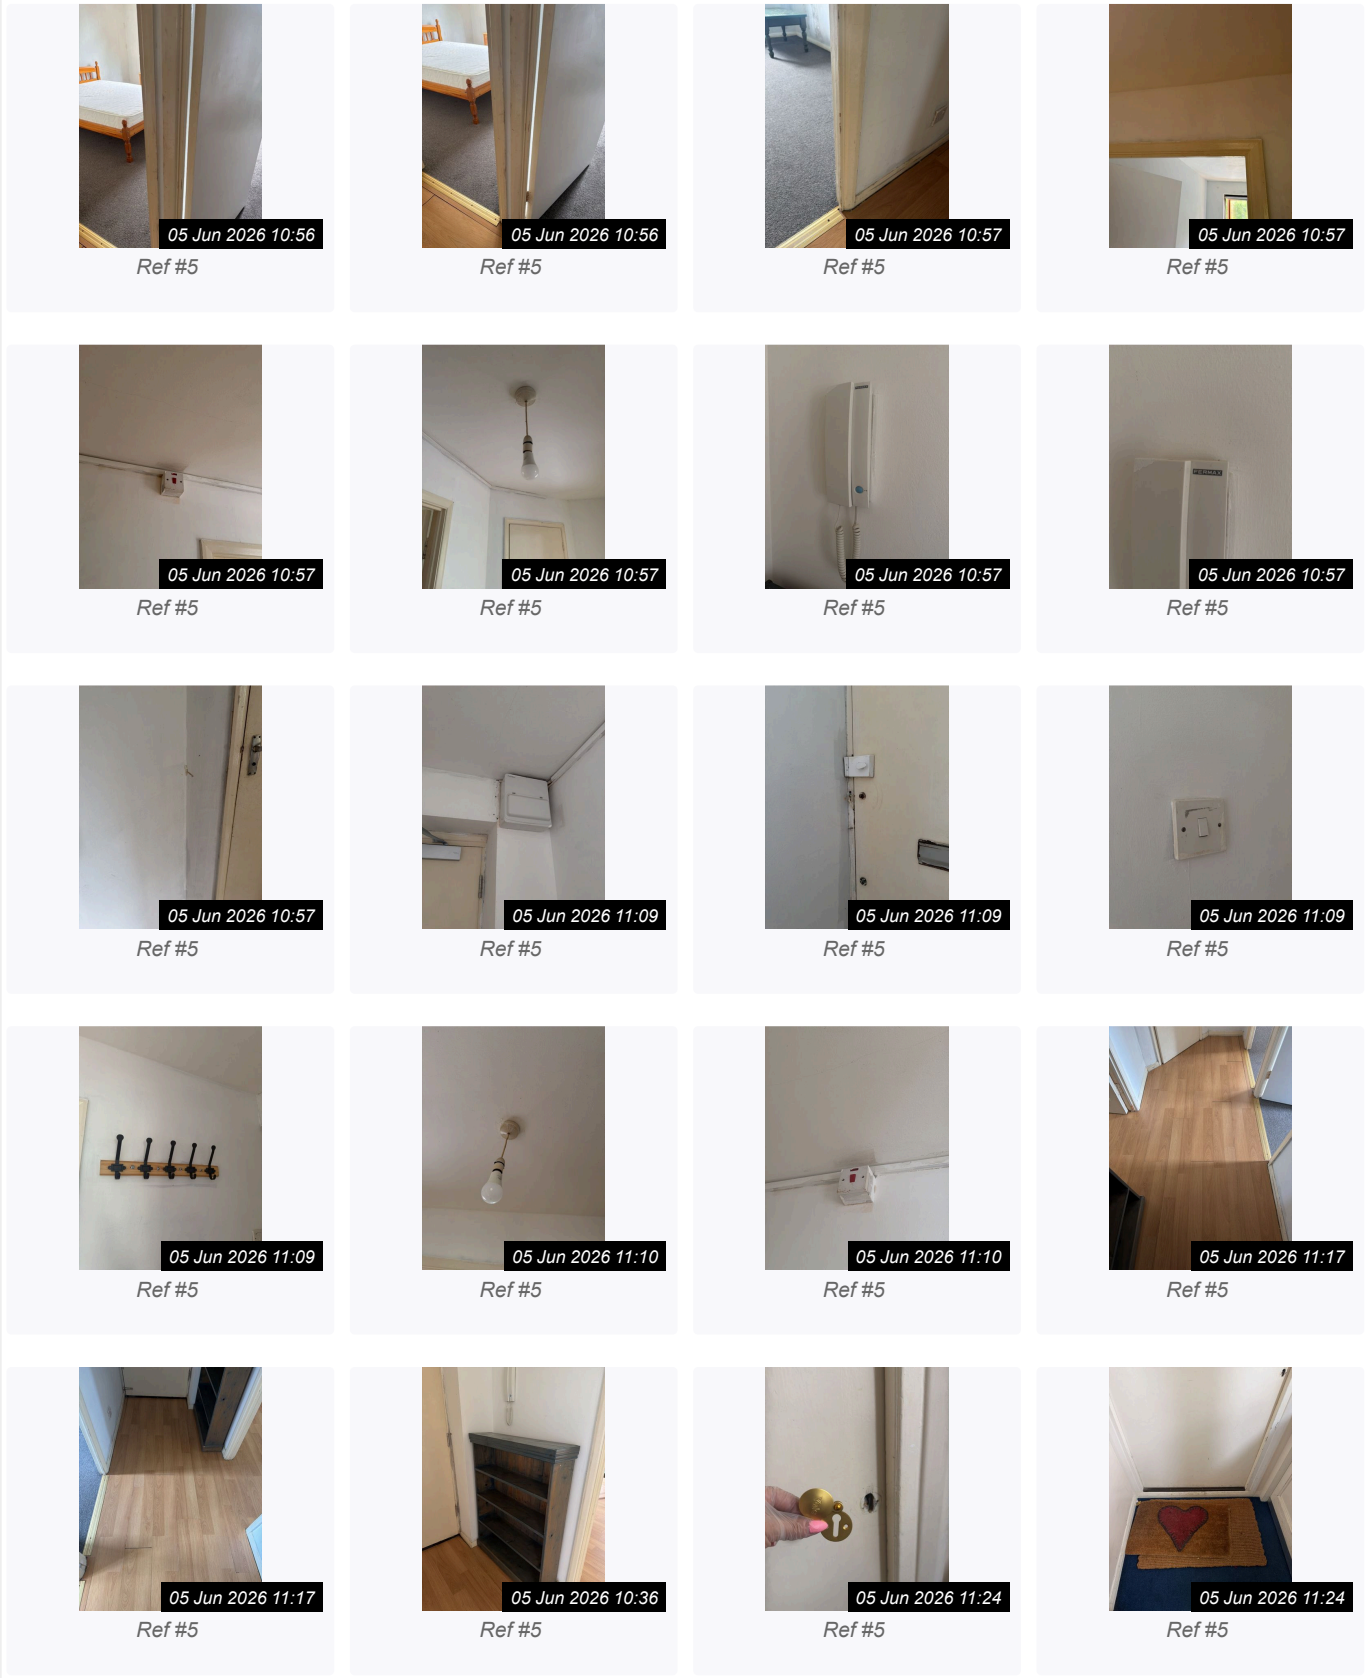
5. ENTRANCE/HALLWAY				
Ref	Name	Description	Condition at Inventory & Check In	Condition at Check Out
5.1	Front Door	Wood Flat-Panelled; White; Yale Lock; Mortice Lock; Bolt; Chrome Letterbox; Spyhole	In Good Condition; Smudges & Paint Marks Visible; Chipped to Outer Edge	<p>Cream painted finish, showing clear signs of age and use including widespread scuffs, surface marks and general discoloration across the whole surface. A small, distinct hole is present in the middle of the main panel; the door is missing its main handle and has no keyhole fitted.</p> <p>Lock: Surface-mounted box type; paint is chipped, worn and uneven. The lower lock unit shows significant rust and corrosion, with loose, exposed wiring visible.</p> <p>Hinges: Three in total; all have surface rust, heavy paint overspray and are slightly misaligned, causing small gaps between door and frame.</p> <p>Door closer: Fitted and operational; only minor marks and wear to the surrounding plate.</p> <p>Letterbox: Open slot only; no cover, flap or trim fitted.</p> <p>Door opens and closes as intended, but overall cosmetic state is poor. There is extensive wear, rusting on metal parts, multiple paint defects and uneven fit with noticeable gaps around edges.</p>

5. ENTRANCE/HALLWAY (CONT.)				
5.2	Door Frame	Wood Painted White	In Good Condition; Chipped & Marked in Places	<p>Frame: Painted; paint flaking, cracks, gaps, staining, dirt build-up; uneven joints and scuffs (including blue paint marks).</p> <p>Base & lower sections: Trim is damaged, worn and loose where it meets the floor, with gaps, movement and broken edges visible; paint is chipped, flaked and heavily marked.</p> <p>Head & upper sections: Paintwork is patchy, uneven and discoloured, with inconsistent coverage and worn areas; fine cracks are present in the plaster and paint directly above the frame, alongside minor surface damage and uneven finishing.</p> <p>Overall condition is poor; trim is ill-fitting in places, finish is uneven and aged, with visible defects and damage at both top and bottom.</p>

5.3	Ceiling	Plaster Painted White	In Good Condition	<p>White painted overall, showing general marks, widespread discolouration and faint stains across the area. Fine minor cracks are visible, and the paint finish is uneven, patchy and worn in many places.</p> <p>Trunking: Surface-mounted trunking runs along the edges; paintwork is worn and discoloured, with minor damage, scuffs and chipping to the casing and surrounding paint.</p> <p>There are multiple cosmetic defects, uneven paint coverage, general marking and signs of long-term wear throughout.</p>

5. ENTRANCE/HALLWAY (CONT.)				
5.4	Light Fixtures	White Plastic Pendant	No Bulbs Working; Base Cover Loose	<p><i>As Inventory & Check In +</i></p> <p>Simple pendant fitting, suspended from the ceiling.</p> <p>Made of plastic, noticeably yellowed, discoloured and worn with age; surface marked and dull.</p> <p>Fabric-covered flex, showing signs of wear and slight discolouration; insulation intact but aged in appearance.</p> <p>Bulb is fitted and present; no lamp shade or cover installed.</p> <p>Confirmed not in working order; fitting itself remains securely mounted.</p>

5. ENTRANCE/HALLWAY (CONT.)				
5.5	Walls	Plaster Painted Grey	In Good Condition	<p>White painted throughout; covered in general scuffs, surface marks and faint stains from regular use. There are multiple minor chips along edges and corners, plus an uneven, patchy paint finish in many areas, with visible brush marks and inconsistent coverage.</p> <p>Clear signs of age and wear, including sections where paint is peeling or flaking away, and small bare patches where the coating has worn thin or come away completely. Slight yellowing and discolouration are noticeable, particularly near the floor and around door frames, where there is also localised damage, heavier scuffing and rubbing from contact and movement.</p> <p>Aged appearance with widespread cosmetic defects; paintwork is uneven, marked and worn, with no consistent finish.</p>

5.6	Telephone Entry System	Wall Mounted	Not Tested	<p><i>As Inventory & Check In</i> +</p> <p>Make/Model: FERMAX branded unit, wall-mounted.</p> <p>White plastic enclosure; paint chipped and peeling at top edge, surface marks, scuffs and slight discolouration visible; finish uneven and worn.</p> <p>Gaps around edges where set into wall; surrounding paintwork marked and uneven.</p> <p>Not tested; operational status unknown.</p>

5. ENTRANCE/HALLWAY (CONT.)				
5.7	Sockets and Switches	As Pictured; Plastic; Fuse Box Present	In Good Condition; Marked; 1 x Loose Socket	<p><i>As Inventory & Check In +</i></p> <p>White plastic faceplate showing significant discolouration, with patches of paint overspray and splashes from previous decorating work. Edges and corners are worn, slightly rounded and marked from contact and cleaning. The fitting remains secure and operational, with no signs of damage to internal components, but the external appearance is tired and uneven.</p> <p>White plastic casing with scattered surface marks, scuffs and faint scratches. There is slight, uneven discolouration across the surface, particularly around the edges and fixing points. Visible paint splashes and drips are present on and around the unit, left from past work, and the overall finish is worn and aged rather than clean or uniform.</p>

5. ENTRANCE/HALLWAY (CONT.)				
5.8	Skirting Board	Wood Painted White	In Good Condition; Chipped & Marked in Places	<p><i>As Inventory & Check In +</i></p> <p>Painted finish is heavily worn in places, with numerous chips, scuffs and areas where the coating has flaked away, resulting in an uneven, patchy appearance along the full length.</p> <p>There are visible gaps at joints, corners and where it meets the wall or floor, with accumulated dirt, dust and grime trapped within these spaces. The paintwork is discoloured and faded in sections, and the overall fit is imperfect, with slight misalignments and signs of age and wear throughout.</p>

5.9	Flooring	Laminate Wood;	In Good Condition; Paint Splashed Area(s); Gaps Visible to Boards; Loose Debris Present	<p><i>As Inventory & Check In +</i></p> <p>Light wood-effect laminate flooring, generally appearing intact and in reasonable order overall. Small gaps and separations are visible between planks, along joins and near doorways, with some slight unevenness in alignment.</p> <p>The surface is dirty and dusty throughout, with accumulated grime, marks and general soiling noticeable across the whole area, particularly in corners and along edges.</p> <p>No major damage, deep scratches or wear-through is evident, but it is in need of a thorough clean and minor adjustments to close gaps.</p>

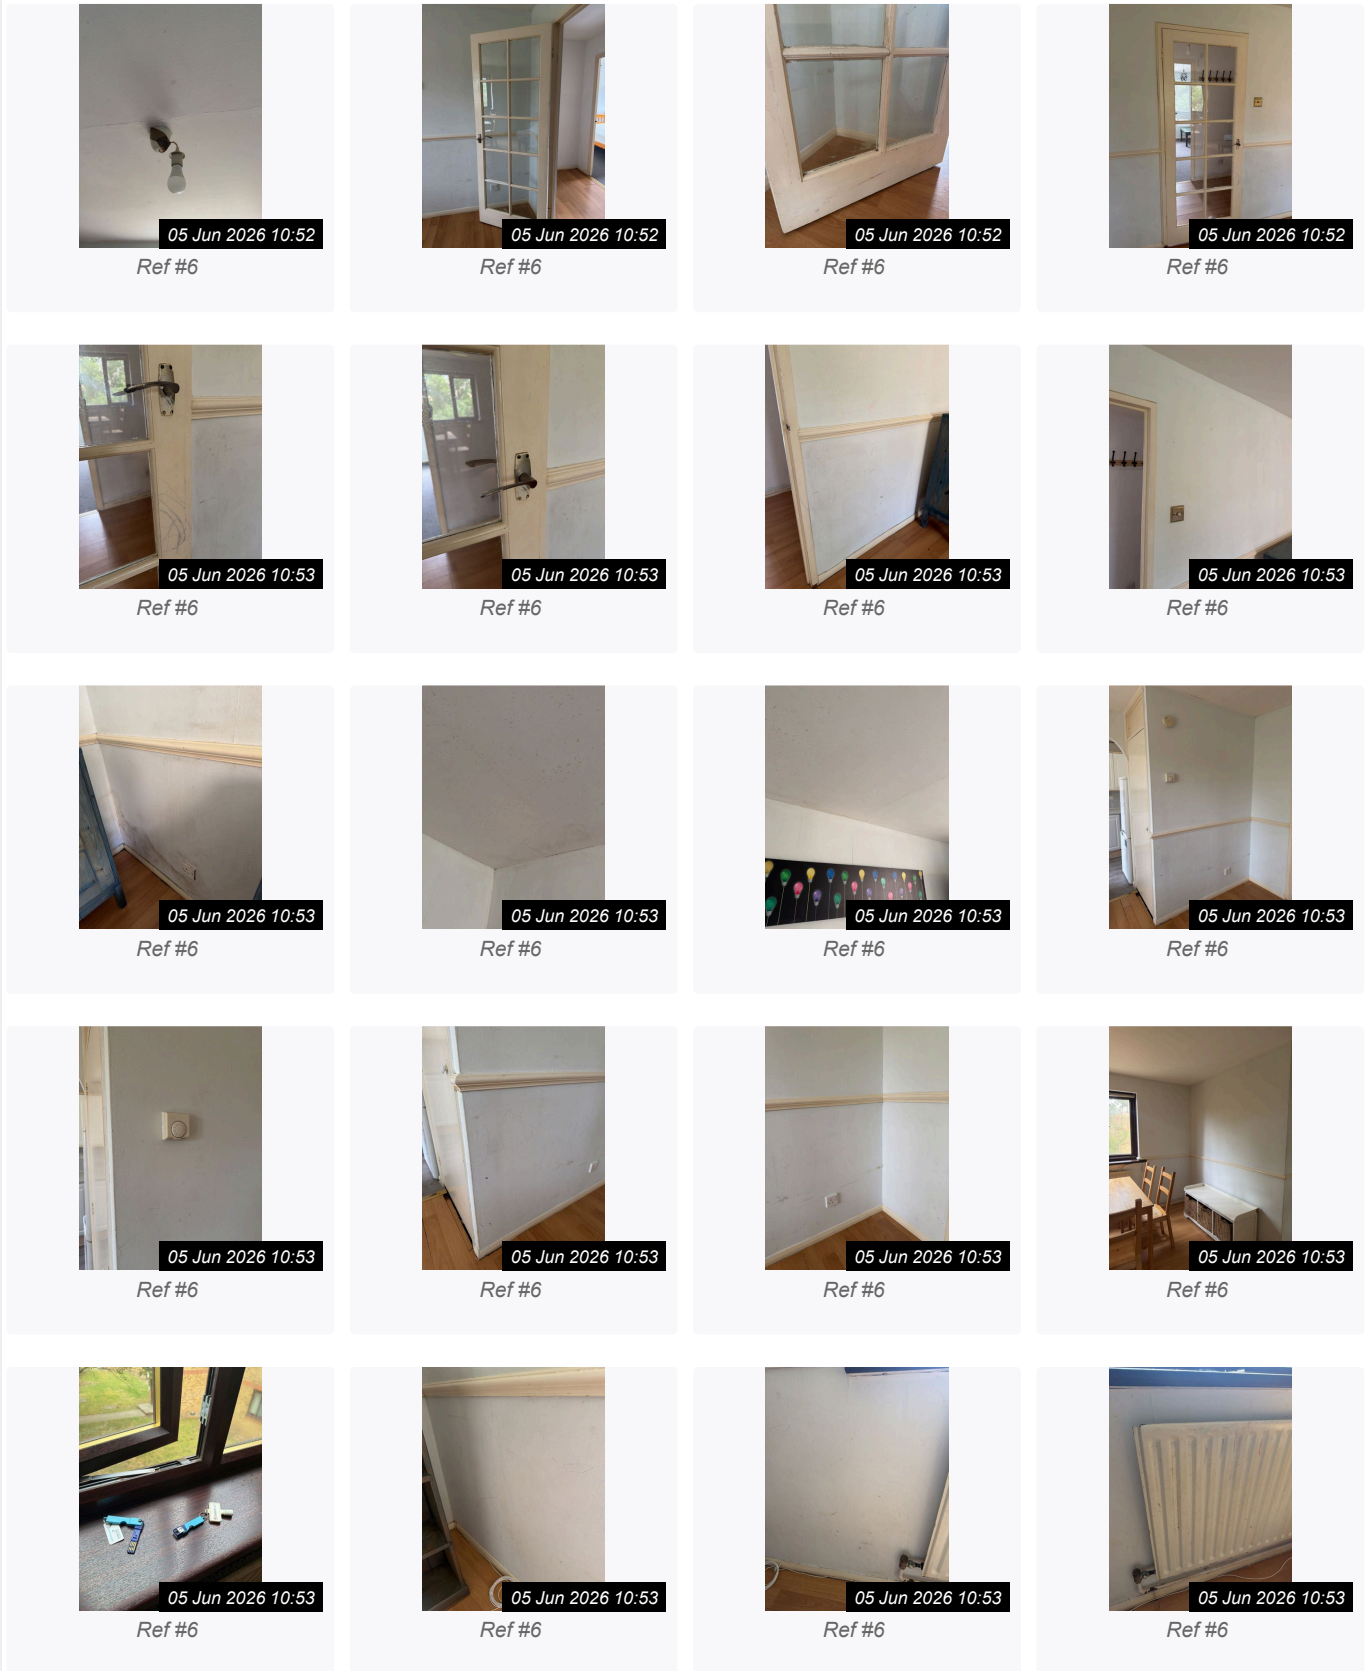
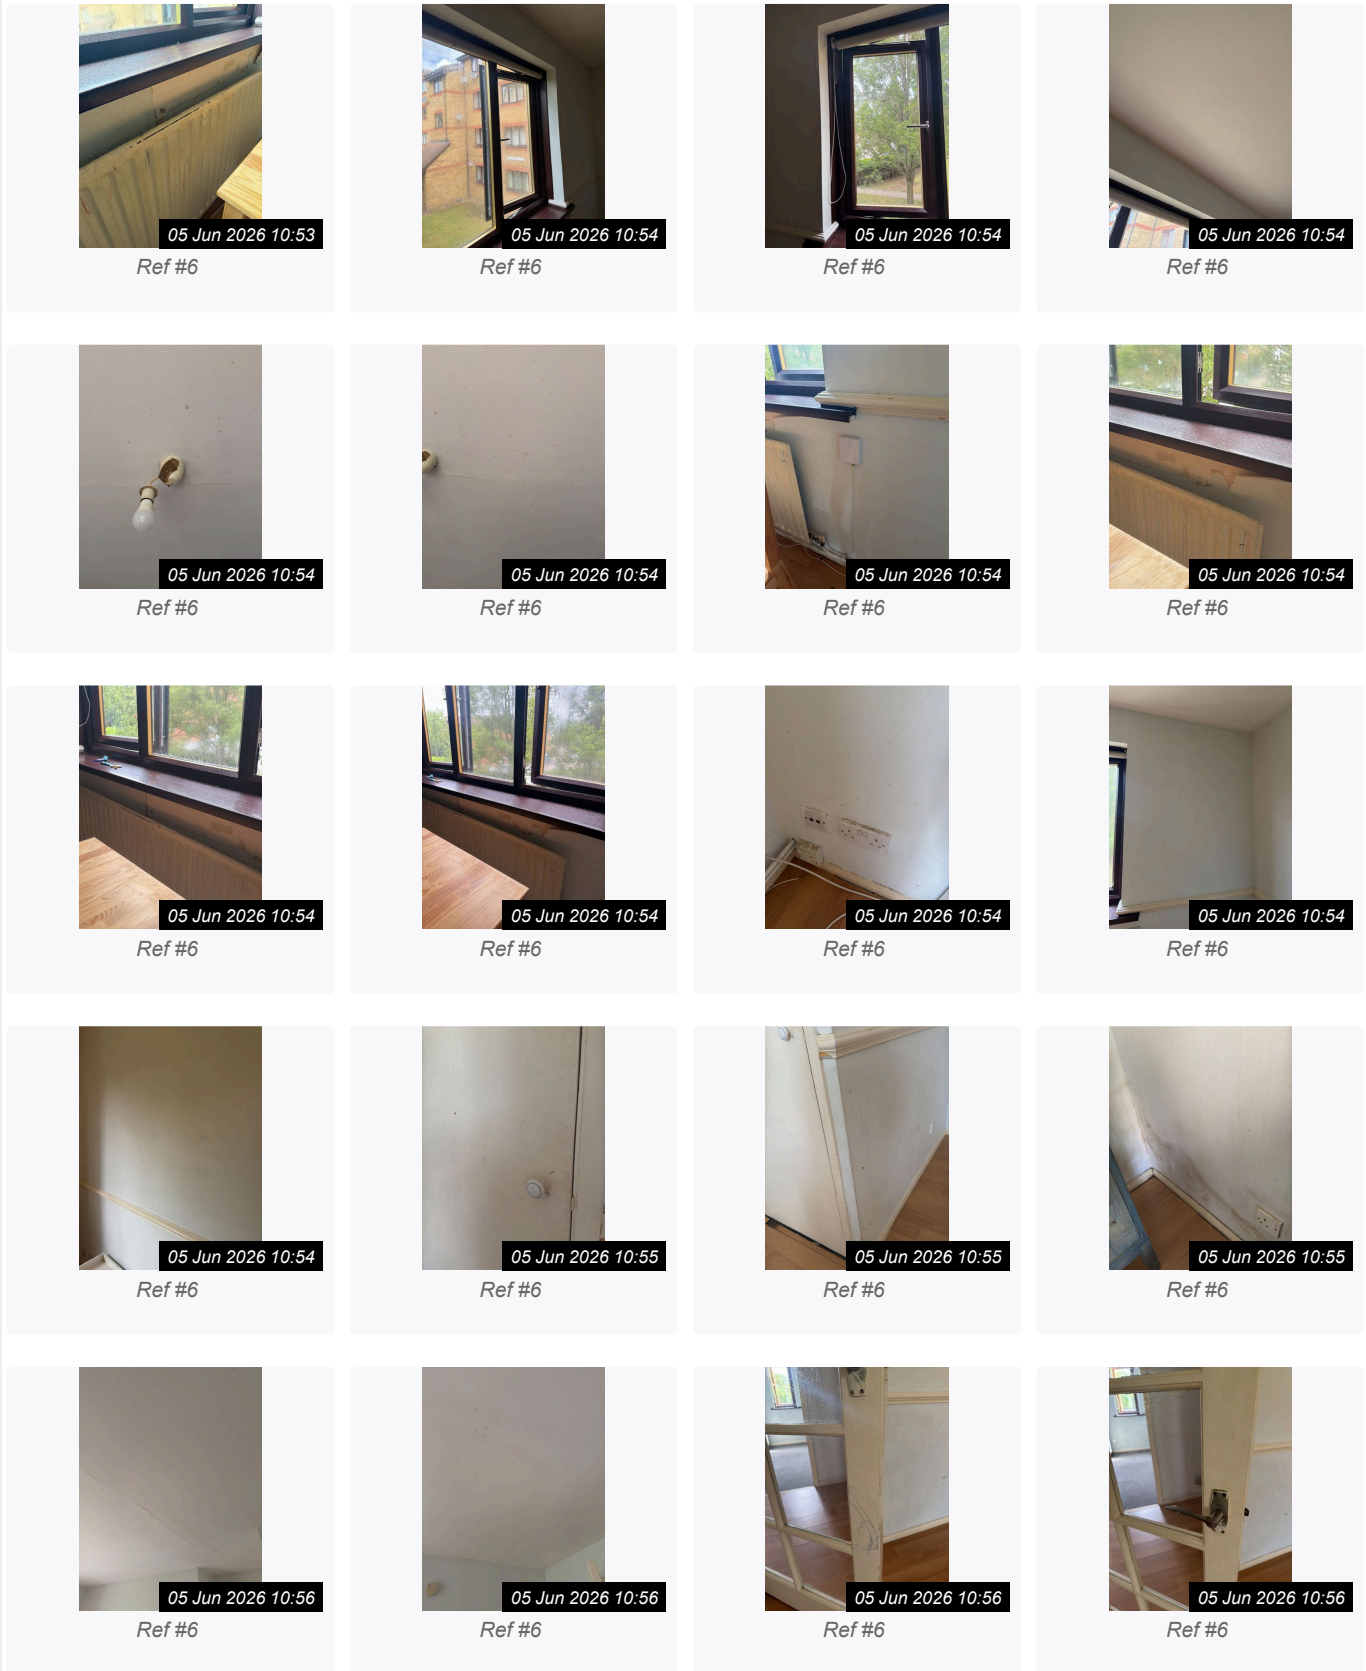
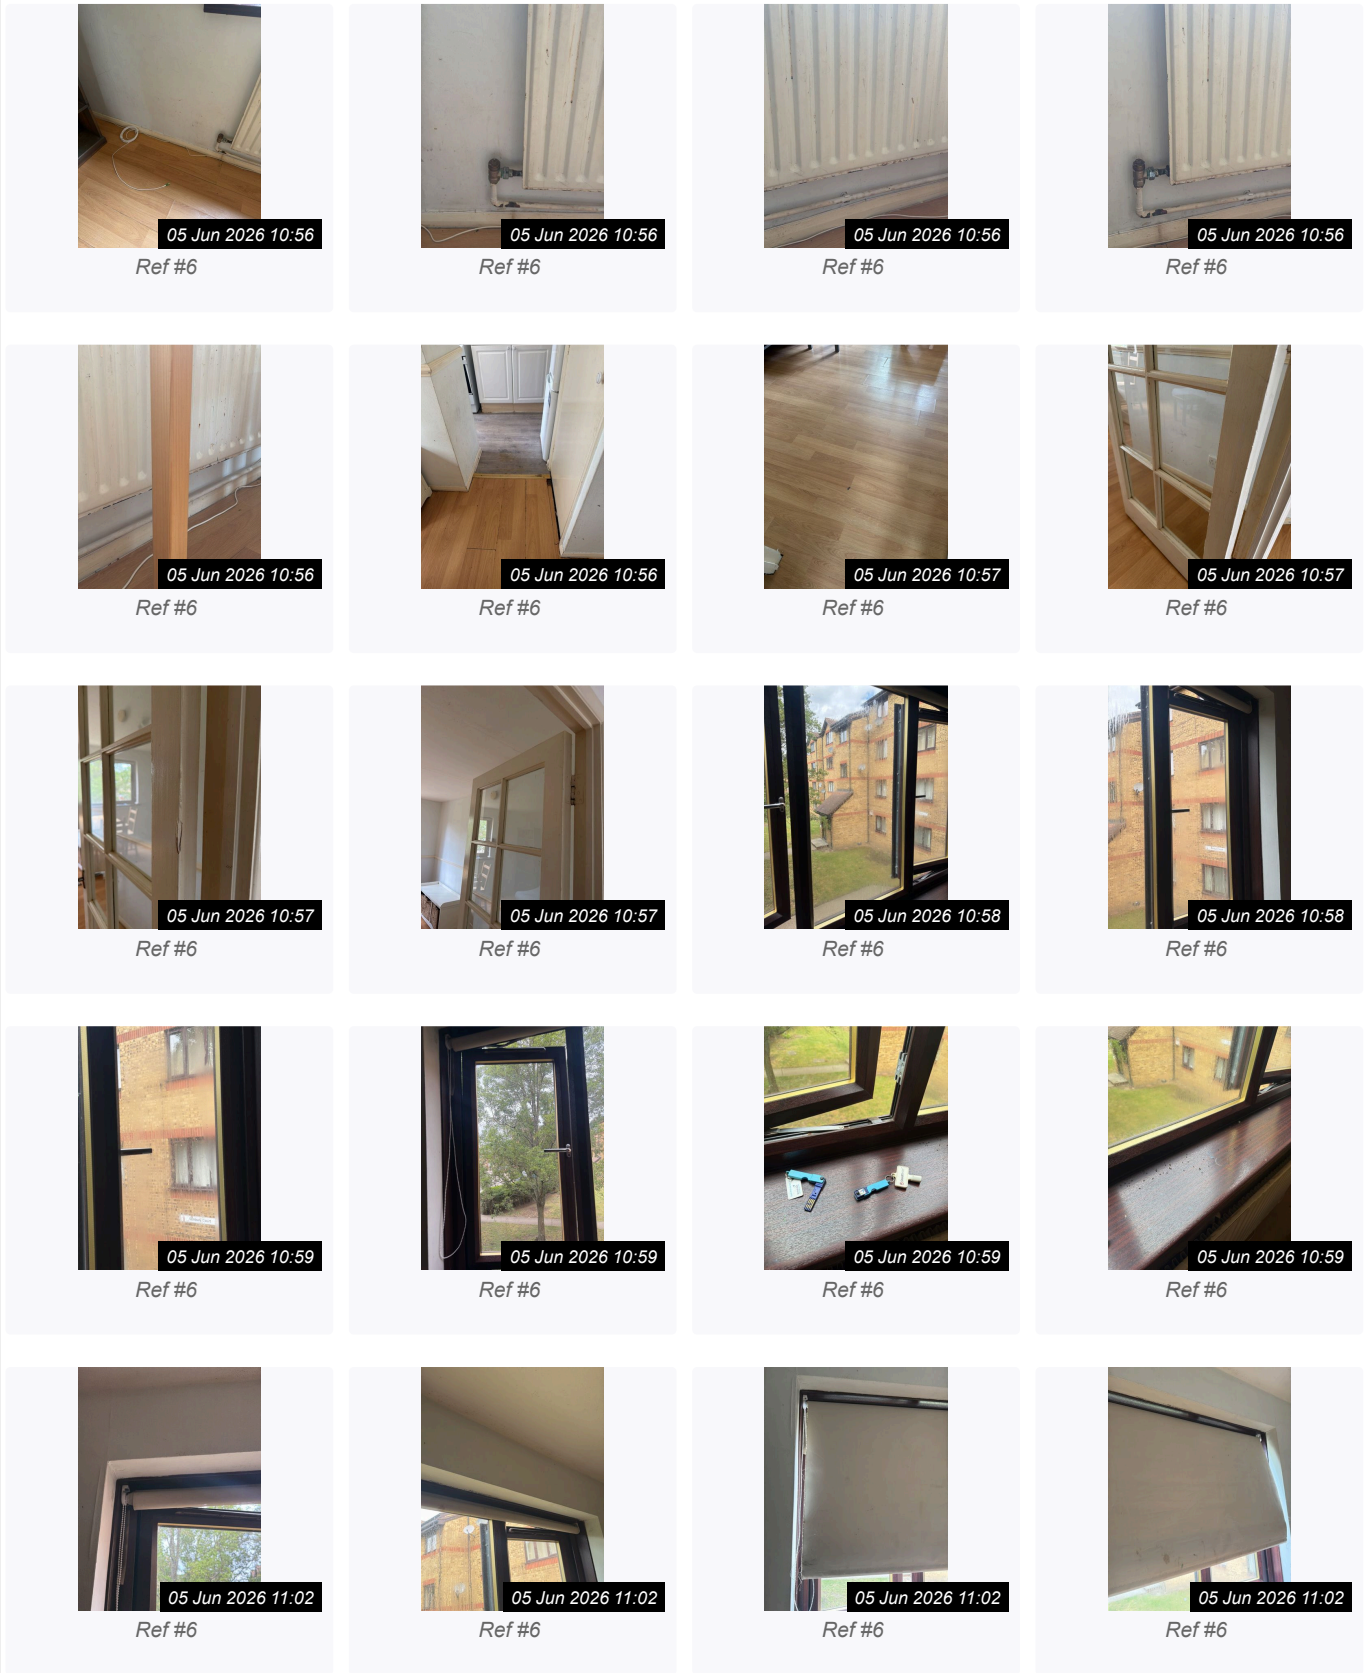
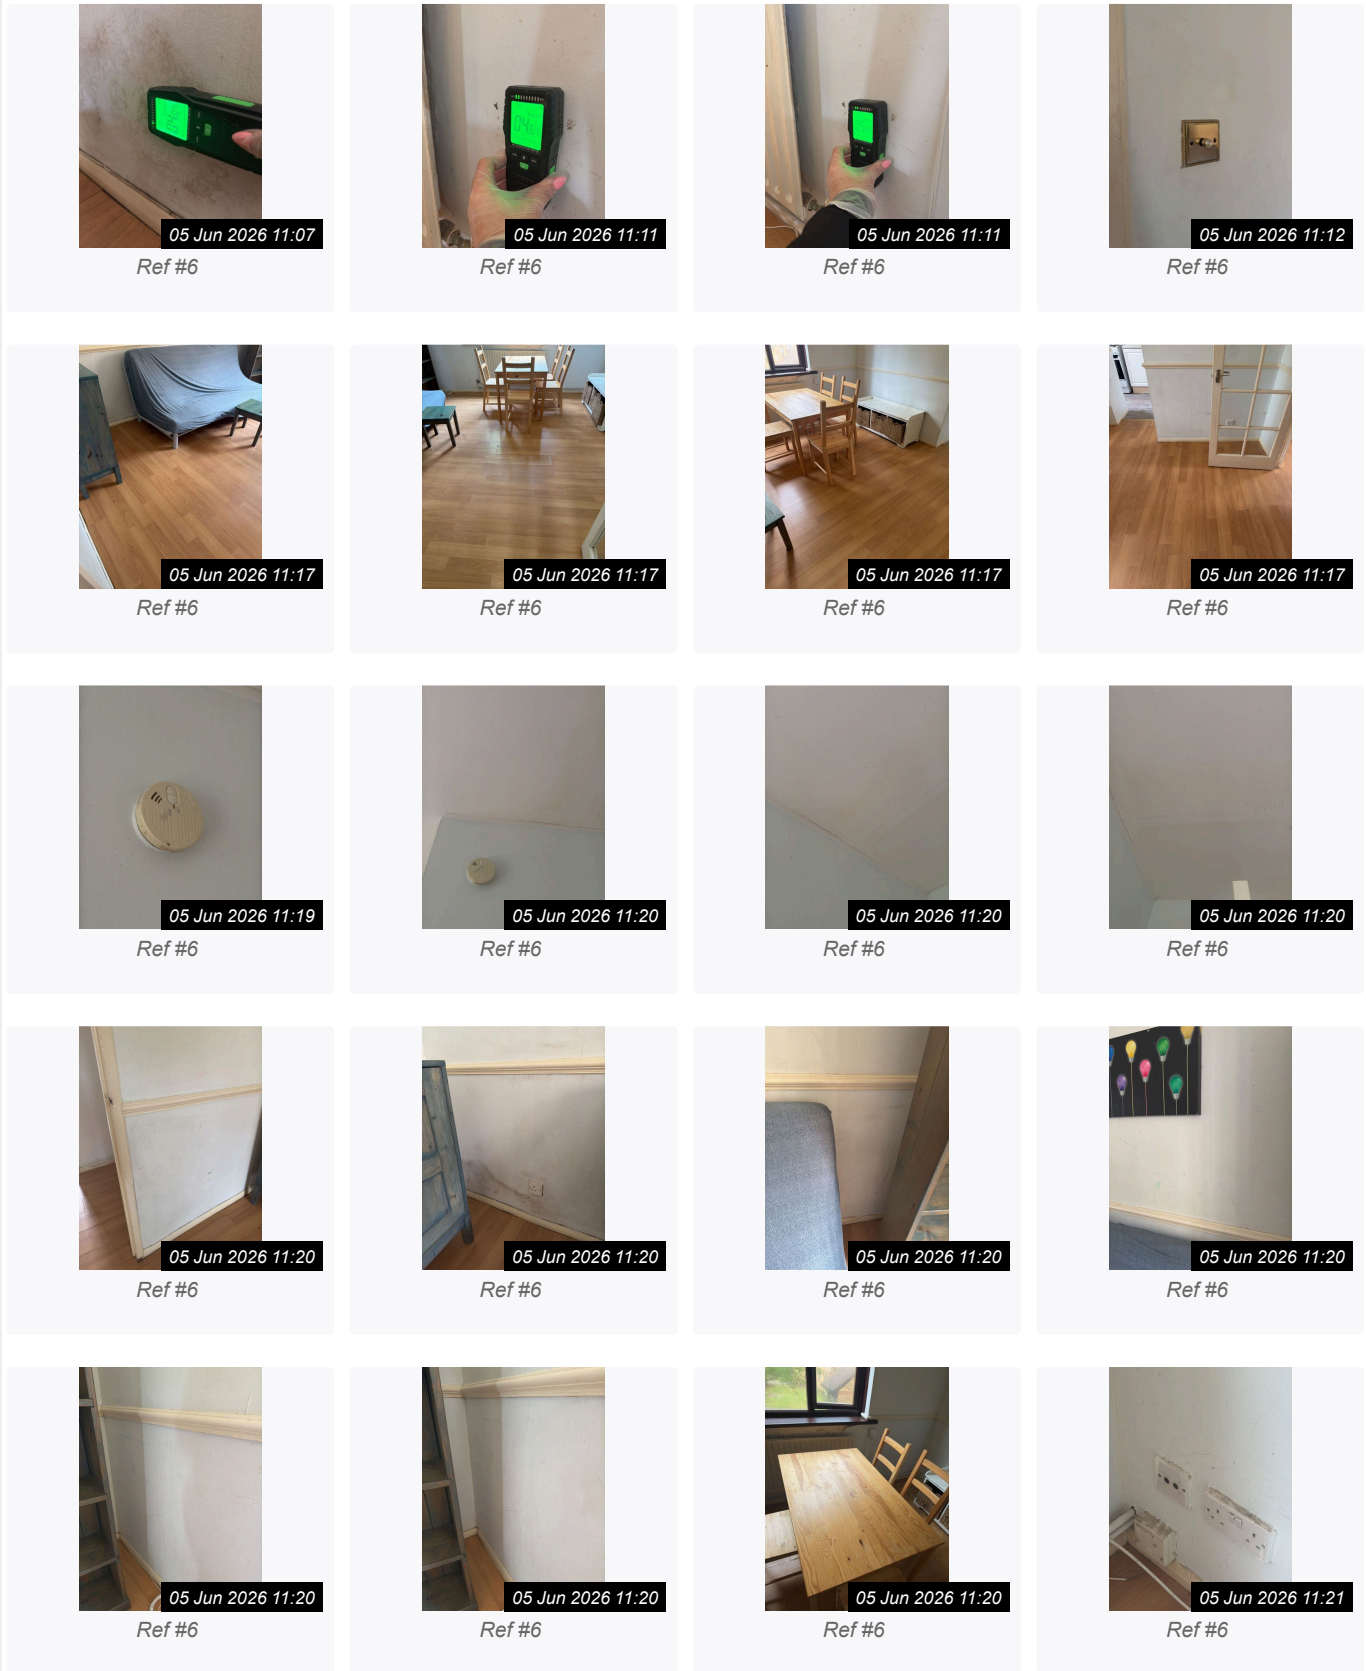
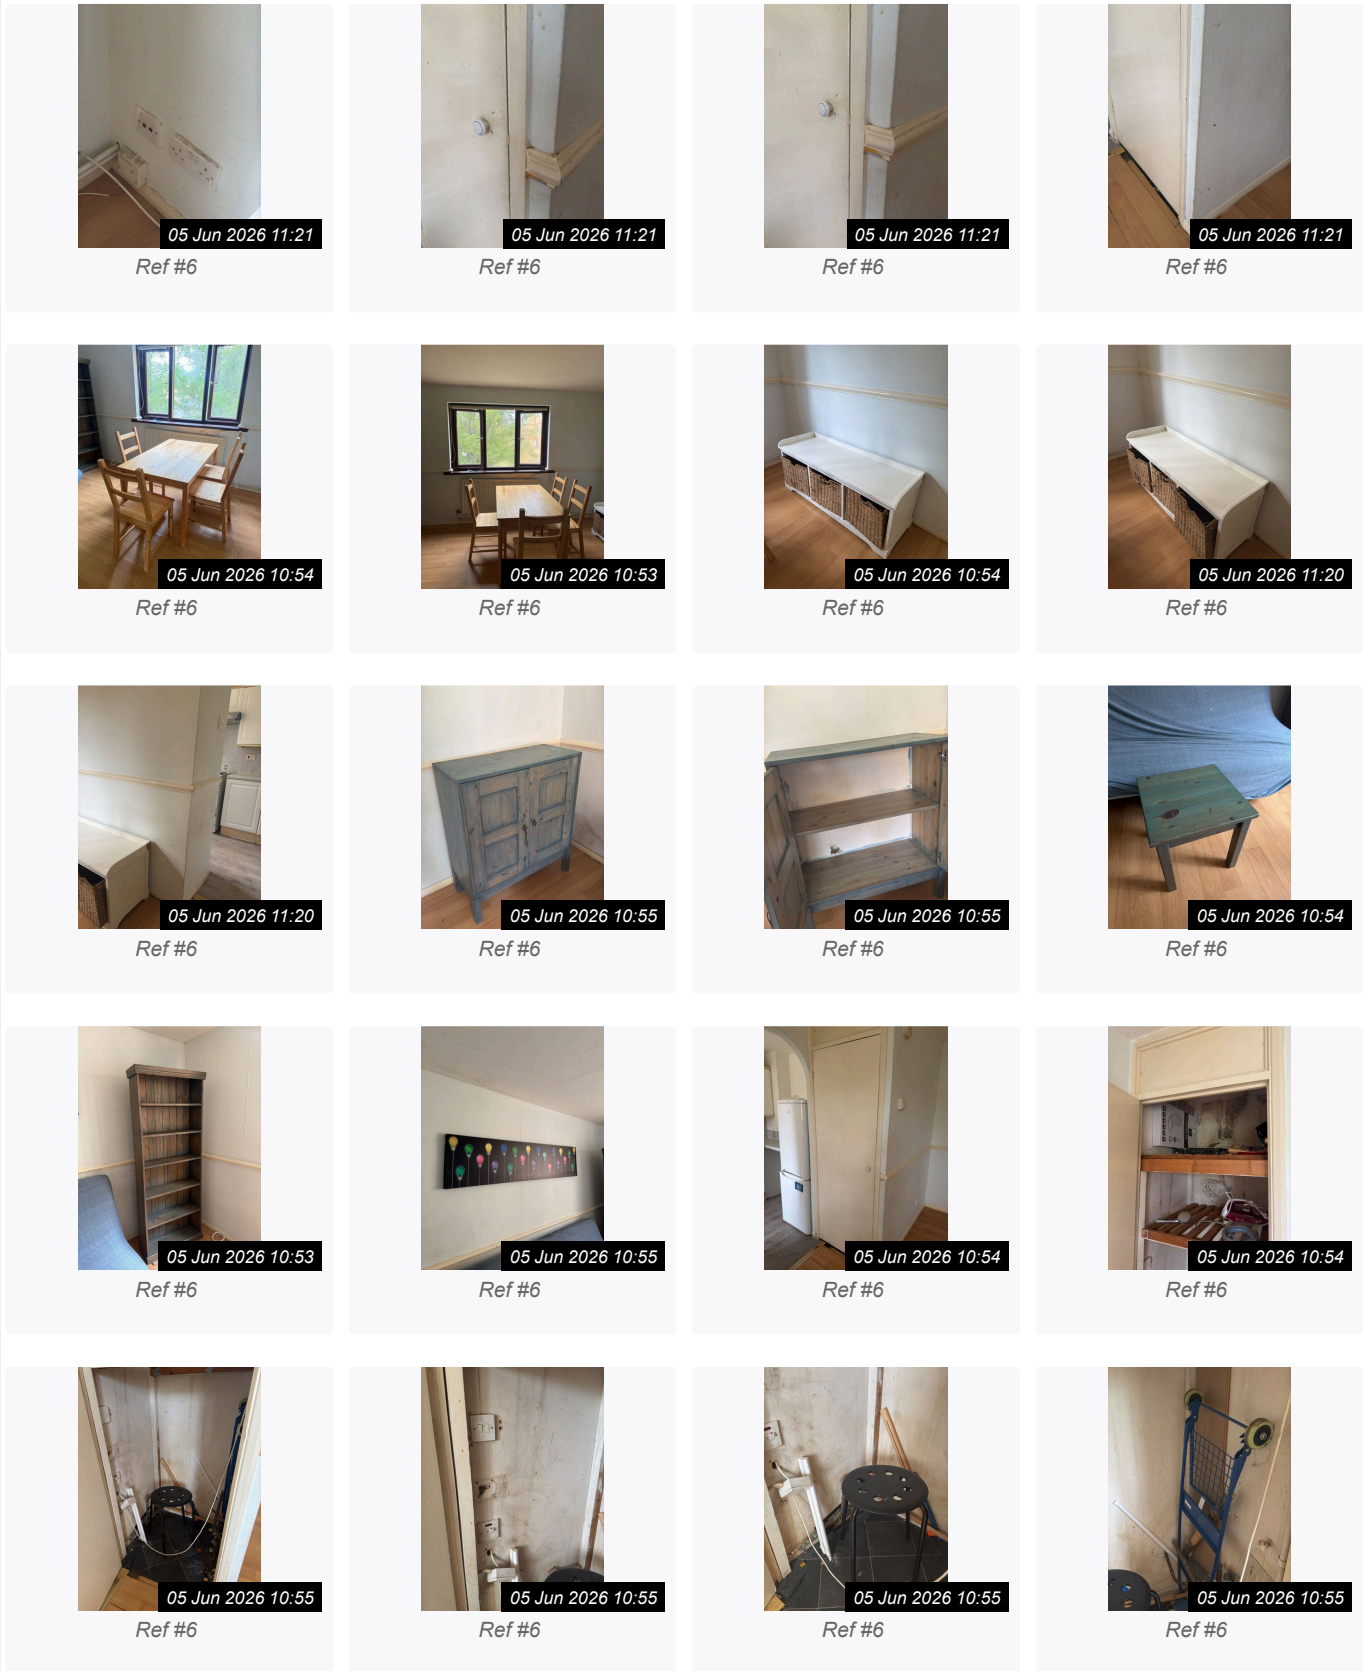
Ref #6

6. LIVING ROOM/LOUNGE				
Ref	Name	Description	Condition at Inventory & Check In	Condition at Check Out
6.1	Door (Internal)	Wood Single Glazed; White	In Good Condition; Scratches & Smudges Visible; Handles Tarnished; Dusty	<p><i>As Inventory & Check In +</i></p> <p>Cream/white painted finish, with 10 clear glass panes set within timber frame and mullions.</p> <p>Paintwork heavily worn, scuffed, marked and chipped throughout; extensive scratches, crayon marks and discolouration visible, especially on lower sections and edges. Paint is flaking and uneven, with gaps and wear around all glass rebates.</p> <p>Panes intact but dusty and marked; putty/ sealant around edges is cracked, missing, loose and discoloured in many places.</p> <p>Metal lever handle fitted; backplate heavily worn, corroded, discoloured and scratched; fixings visible and loose. Hinges painted over, worn and slightly misaligned, causing the door to hang unevenly and not close flush.</p> <p>Structurally sound but cosmetically very poor; extensive wear, damage, uneven paintwork and poor sealing around glass; operates but with poor fit and finish.</p> <p>Damage / Neglect - Tenant</p>

6. LIVING ROOM/LOUNGE (CONT.)				
6.3	Ceiling	Plaster Painted White	In Good Condition; Painted Over Defects Visible	<p>White painted textured finish, showing widespread discolouration, faint yellow/brown stains and small dark marks across the whole area. Paintwork is uneven, faded and worn in places, with patchy coverage and a generally tired appearance.</p> <p>Prominent, long running cracks visible across sections, including along joins and near corners; fine hairline cracks also present elsewhere. Minor unevenness and slight sagging noted along junction lines; small areas of staining and discolouration concentrated near edges and fittings.</p> <p>Structurally intact but cosmetically poor; multiple cracks, marks, stains and uneven finish throughout, with clear signs of age and long-term wear.</p>

6. LIVING ROOM/LOUNGE (CONT.)				
6.6	Walls	Wallpaper Painted Grey; Dado Rail Present	In Good Condition; Wallpaper Edges Peeling; Dado Rail Dusty & Scratched in Places	<p><i>As Inventory & Check In +</i></p> <p>White painted walls, extensively marked, scuffed and stained overall; paintwork is uneven, worn, chipped and discoloured, with patches of overspray, crayon marks and general grime.</p> <p>Plaster directly behind and below the radiator is heavily stained, discoloured, peeling and damaged, with clear signs of damp and mould growth - consistent with moisture from the pipework or radiator itself.</p> <p>Heavy, widespread mould growth visible across large areas, particularly at low levels, in corners, along joins and near skirting and pipework.</p> <p>Moisture readings taken between 4.0% and 5.0%; surfaces were not wet to touch, but significant active mould growth is present. A strong, distinct mould odour is noticeable throughout the room.</p> <p>Plasterwork shows fine cracks, unevenness and minor damage; paint is lifting and discoloured where affected by mould. Dado rails and trim are loose, damaged or poorly fitted, with gaps and dirt at joins.</p> <p>Overall condition is poor, with severe mould contamination and clear evidence of underlying damp issues, despite surfaces appearing dry.</p> <p>Damage / Neglect - Tenant</p>

6. LIVING ROOM/LOUNGE (CONT.)				
6.8	Windows & Sills	Brown UPVC Double Glazed; Chrome Handles; Wooden Sills; White Roller Blinds	In Good Condition; Sills Dusty; Blinds Smudged/Dirty & Holes Visible	<p><i>As Inventory & Check In +</i></p> <p>Constructed from timber with a mahogany/brown stained or varnished finish; colour is faded, uneven and worn across frames, with scratches, scuffs and marks visible on all surfaces. Varnish is peeling, flaking and dull, particularly along edges, corners and joints.</p> <p>Timber frames show signs of age and wear; joints are slightly open, with gaps and minor movement. Seals and gaskets are brittle, cracked, discoloured and failing, allowing draughts and moisture ingress. Extensive mould growth is present along top edges, under cills and in corners, directly linked to damp conditions.</p> <p>Panes are intact but dirty, marked and streaked; some panes show misting or condensation between layers.</p> <p>Metal handles, hinges and stays are painted over, worn and slightly corroded; operation is stiff but functional, with minor misalignment noted.</p> <p>Window Sill: Matching brown/mahogany wood finish; surface is heavily marked, scratched, stained and worn, with faded varnish and bare patches. Edges are chipped, rounded and damaged from use. Gaps exist between sill and wall, filled with dirt, dust and active mould growth along the back edge and corners. Surrounding plaster is</p>

Timber windows are structurally sound but cosmetically very poor, with failing finishes, defective seals and widespread mould growth. Sill is worn, damaged and dirty. Blind is stained, mouldy and damaged; all areas show clear effects of long-term damp and lack of maintenance.

6. LIVING ROOM/LOUNGE (CONT.)				
6.21	Storage Cupboard	Wood Flat Panelled White Door with Plastic Knob	Smudges Visible; Paint Marks Visible; Nail Holes Visible; Miscellaneous Items Present	<p><i>As Inventory & Check In +</i></p> <p>Timber frame and shelving, painted cream/white internally and externally. Paintwork is heavily worn, discoloured, peeling and flaking; large areas are stained and deteriorated, with paint completely missing in many spots. Architrave and trim are loose, damaged, ill-fitting and mould-affected.</p> <p>Severe, heavy mould growth covers almost all internal surfaces - walls, ceiling, shelves, back and side panels. Mould is thick, dark and widespread, running down walls, across joins and behind shelving. Surfaces show clear damp staining, discoloration and water marks; moisture damage is extensive and active. A strong, pungent mould odour is present.</p> <p>Wooden slatted shelves are dirty, dusty, mouldy and stained; timber is discoloured and feels damp. Walls and plaster are crumbling, soft and deteriorated; corners and joins are rotten or breaking down.</p> <p>Exposed wiring, loose fittings and damaged switches/sockets are present; plates are broken, missing or covered in grime and mould. Exposed pipework is rusted, corroded and stained; joints show signs of past leaks or ongoing dampness.</p> <p>Floor is tiled but cracked, broken, uneven and covered in debris, dirt and mould. The entire space is</p>

Extremely poor condition; severe contamination, significant damp penetration, structural deterioration and unsafe/unhygienic state throughout.

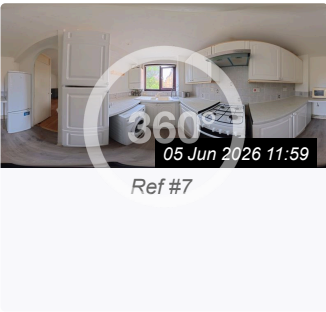
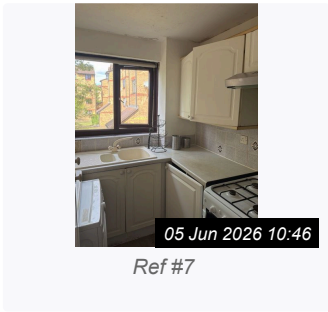
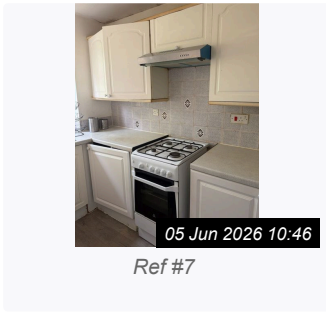
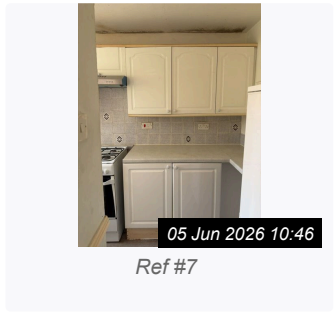
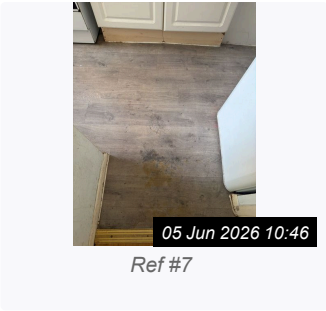
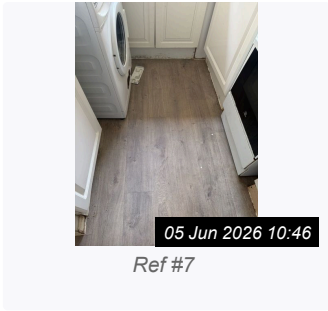
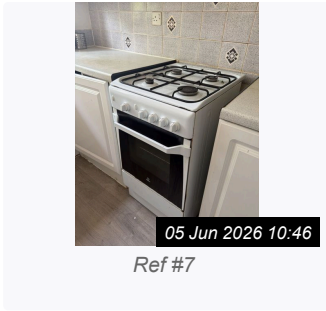
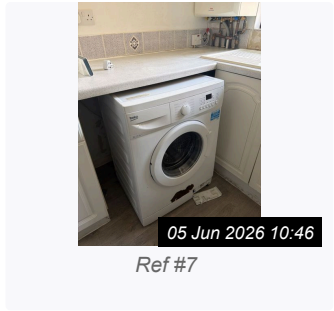
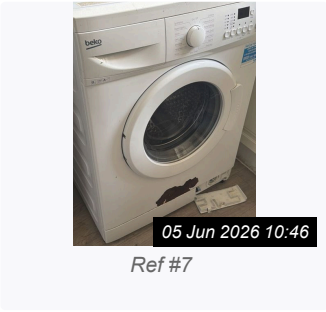
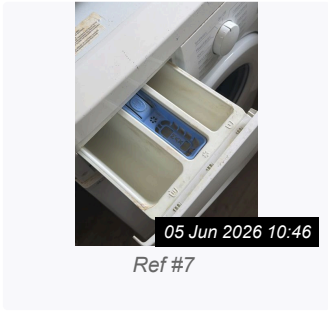
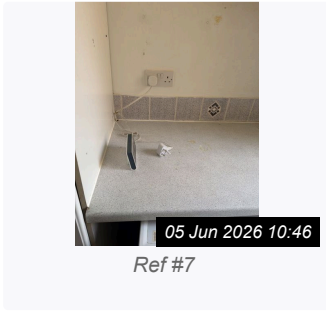
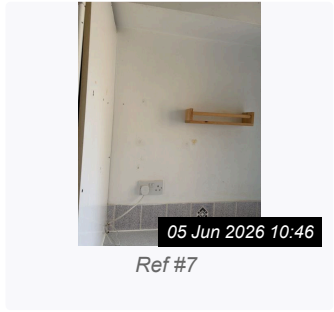
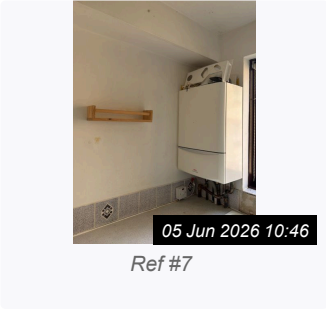
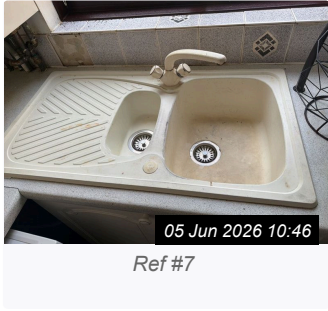
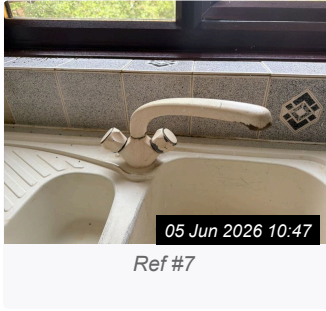
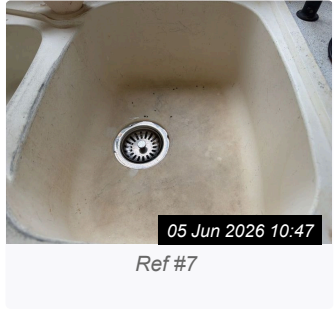
7.15.1	-	Items Noted:	<i>Item added after Check In</i>	<ul style="list-style-type: none"> - Large grey plastic container (water softener/filter). - Wire storage basket. - Plastic bags. - Cleaning brushes (purple & green/black handles). - Metal utensil holders (x2). - Black wire fruit/vegetable stand. - Black plastic bucket/bin. - Small wooden wall shelf. - Smart meter.
--------	---	--------------	----------------------------------	---
