Check Out

Property inspected by A. Clerk

123 Preview Street
Sample City
London
AB1 2CD

June
5th 2026
10:00

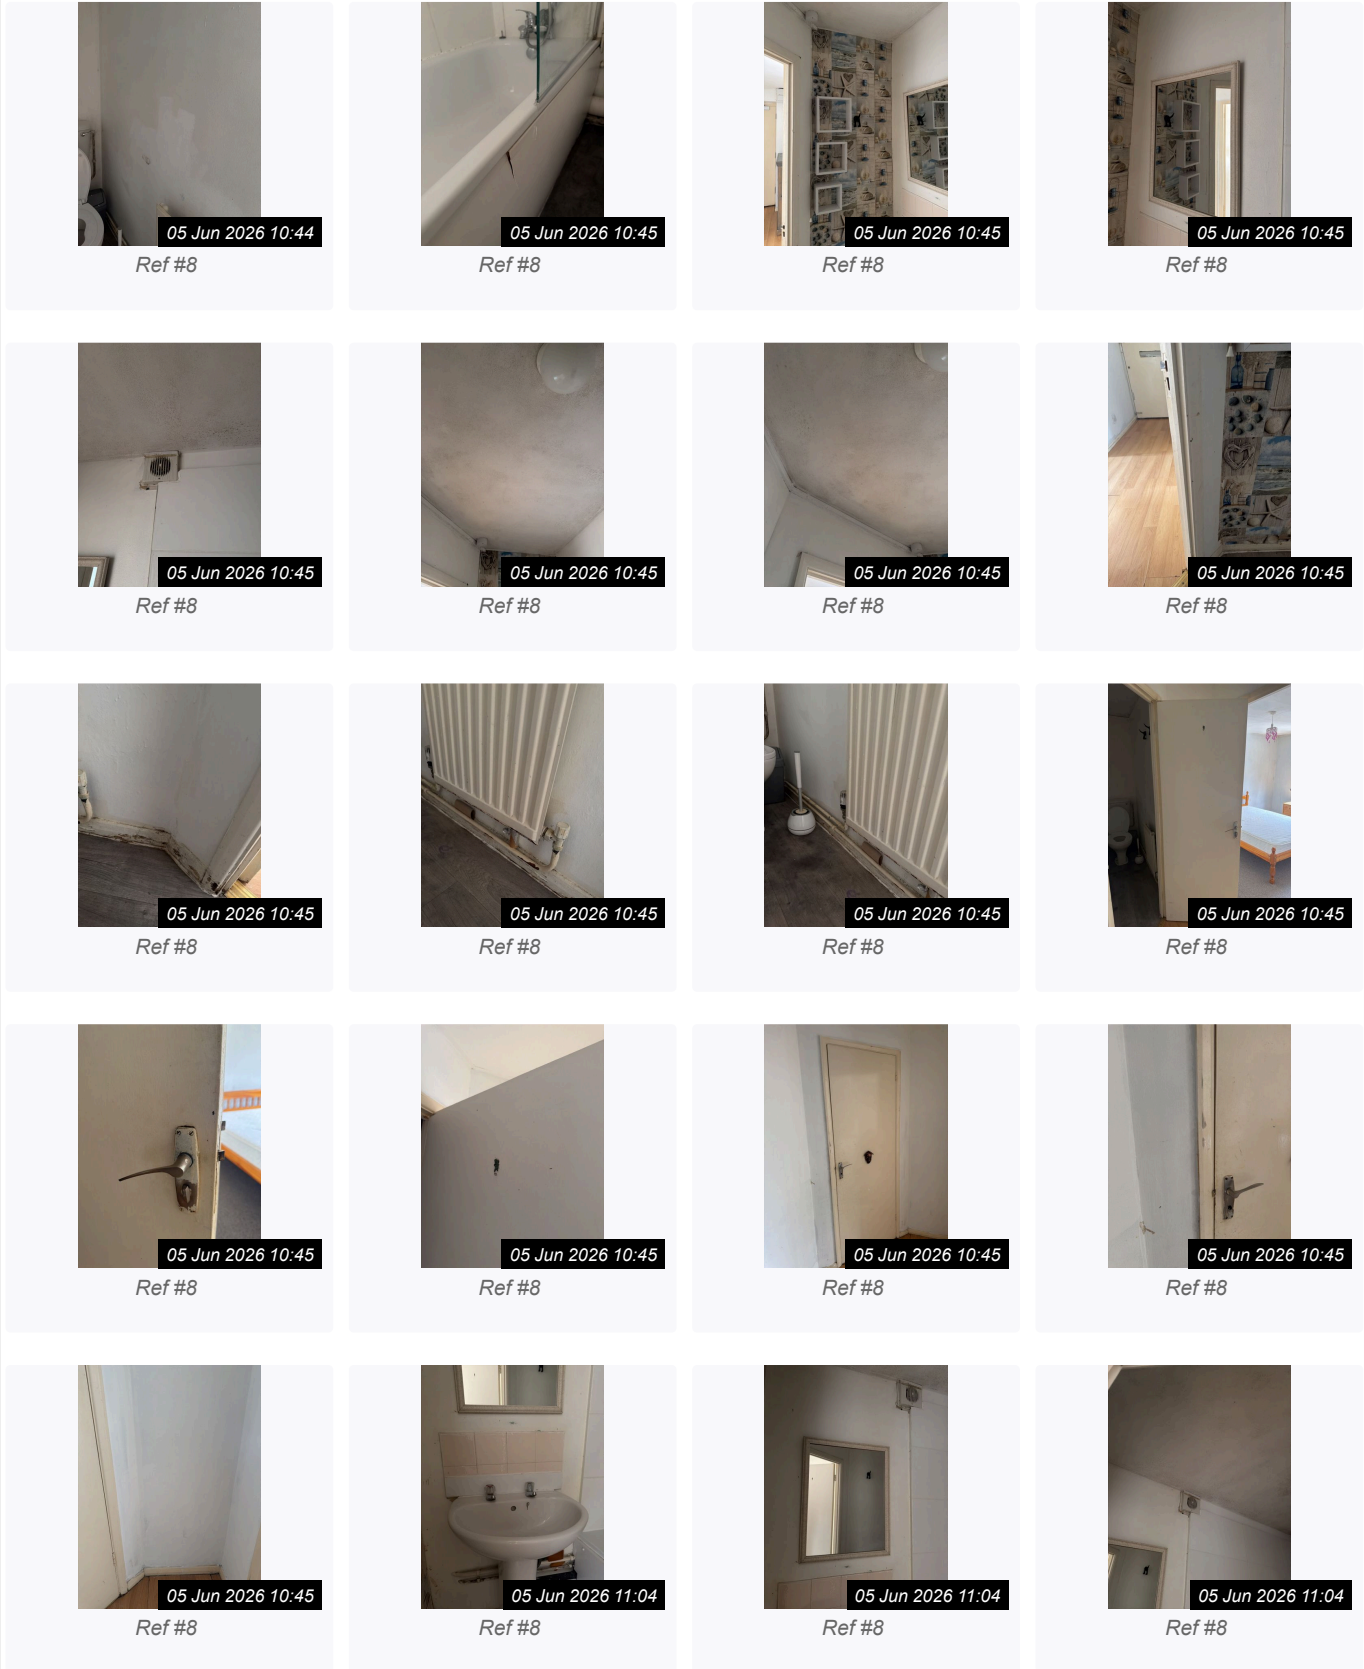
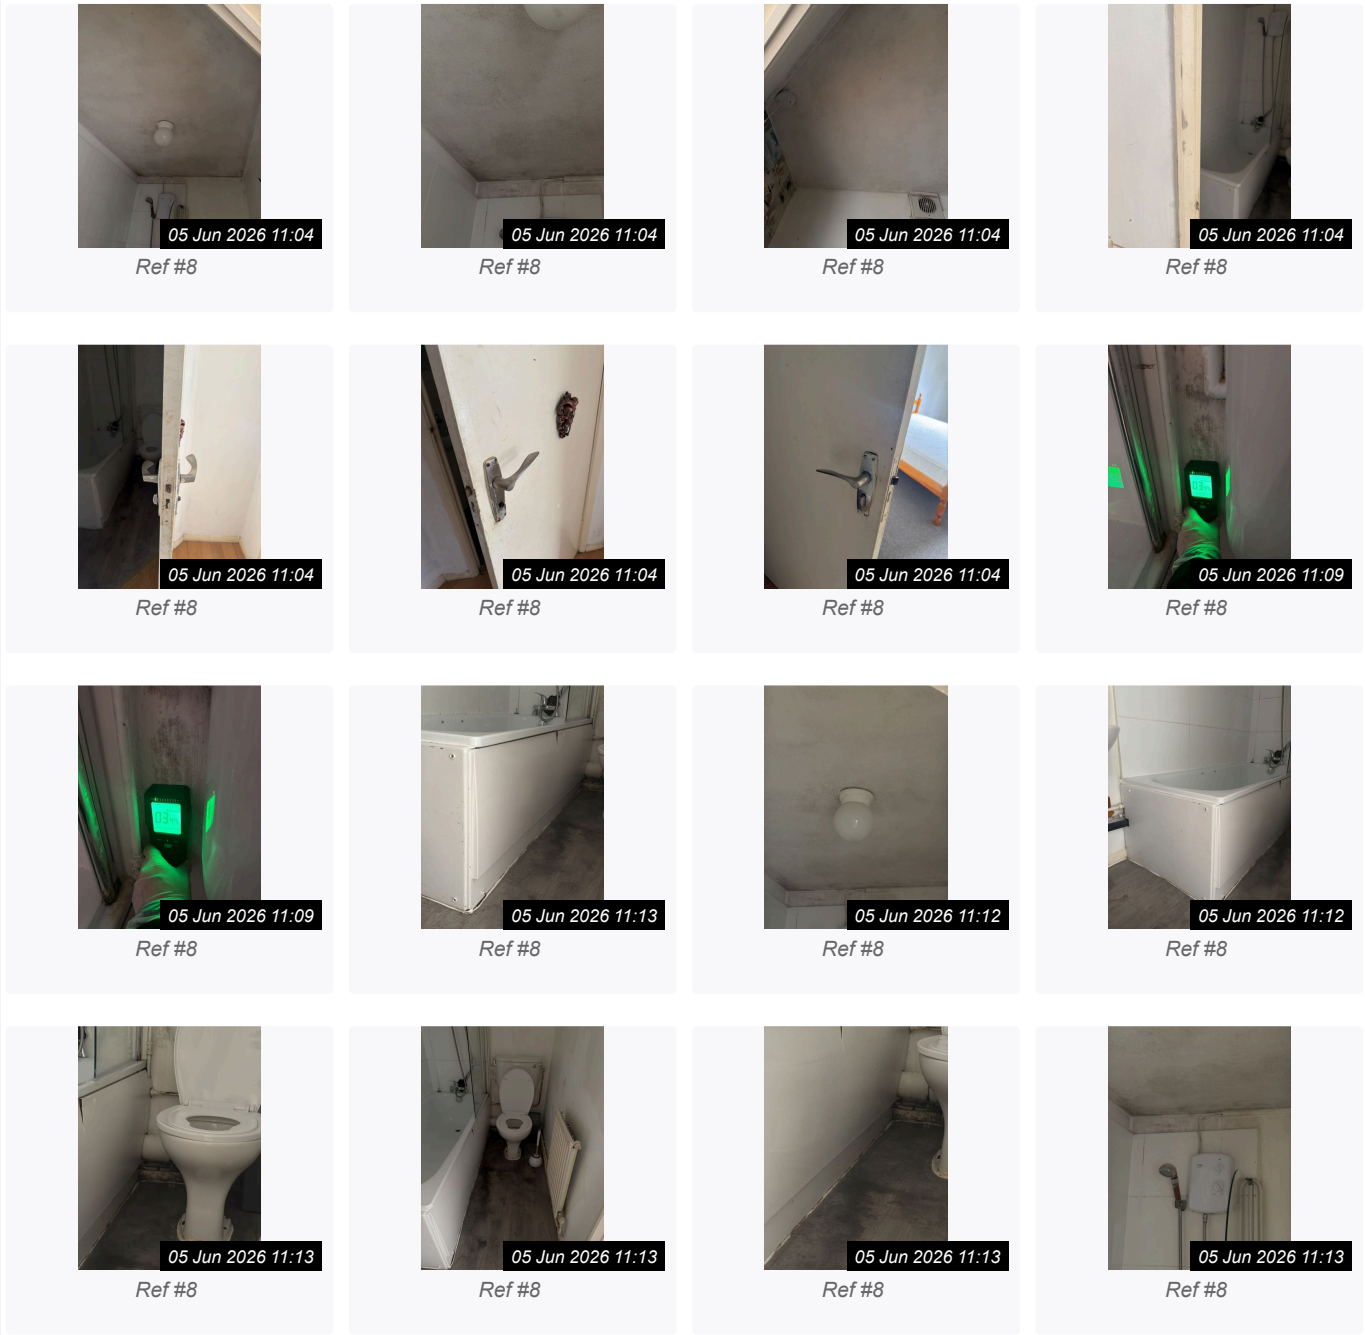
05 Jun 2026 10:44
Ref #8

1.9	Bathroom(s)	In Good Condition; Except Where Noted; Limited Inspection Due to Lack of Light		Heavily affected by mould growth visible throughout the entire space. The area shows clear signs of severe neglect, with all fittings and finishes appearing old, worn and heavily soiled. Needs Cleaning - Tenant Damage / Neglect - Tenant
-----	-------------	--	--	--

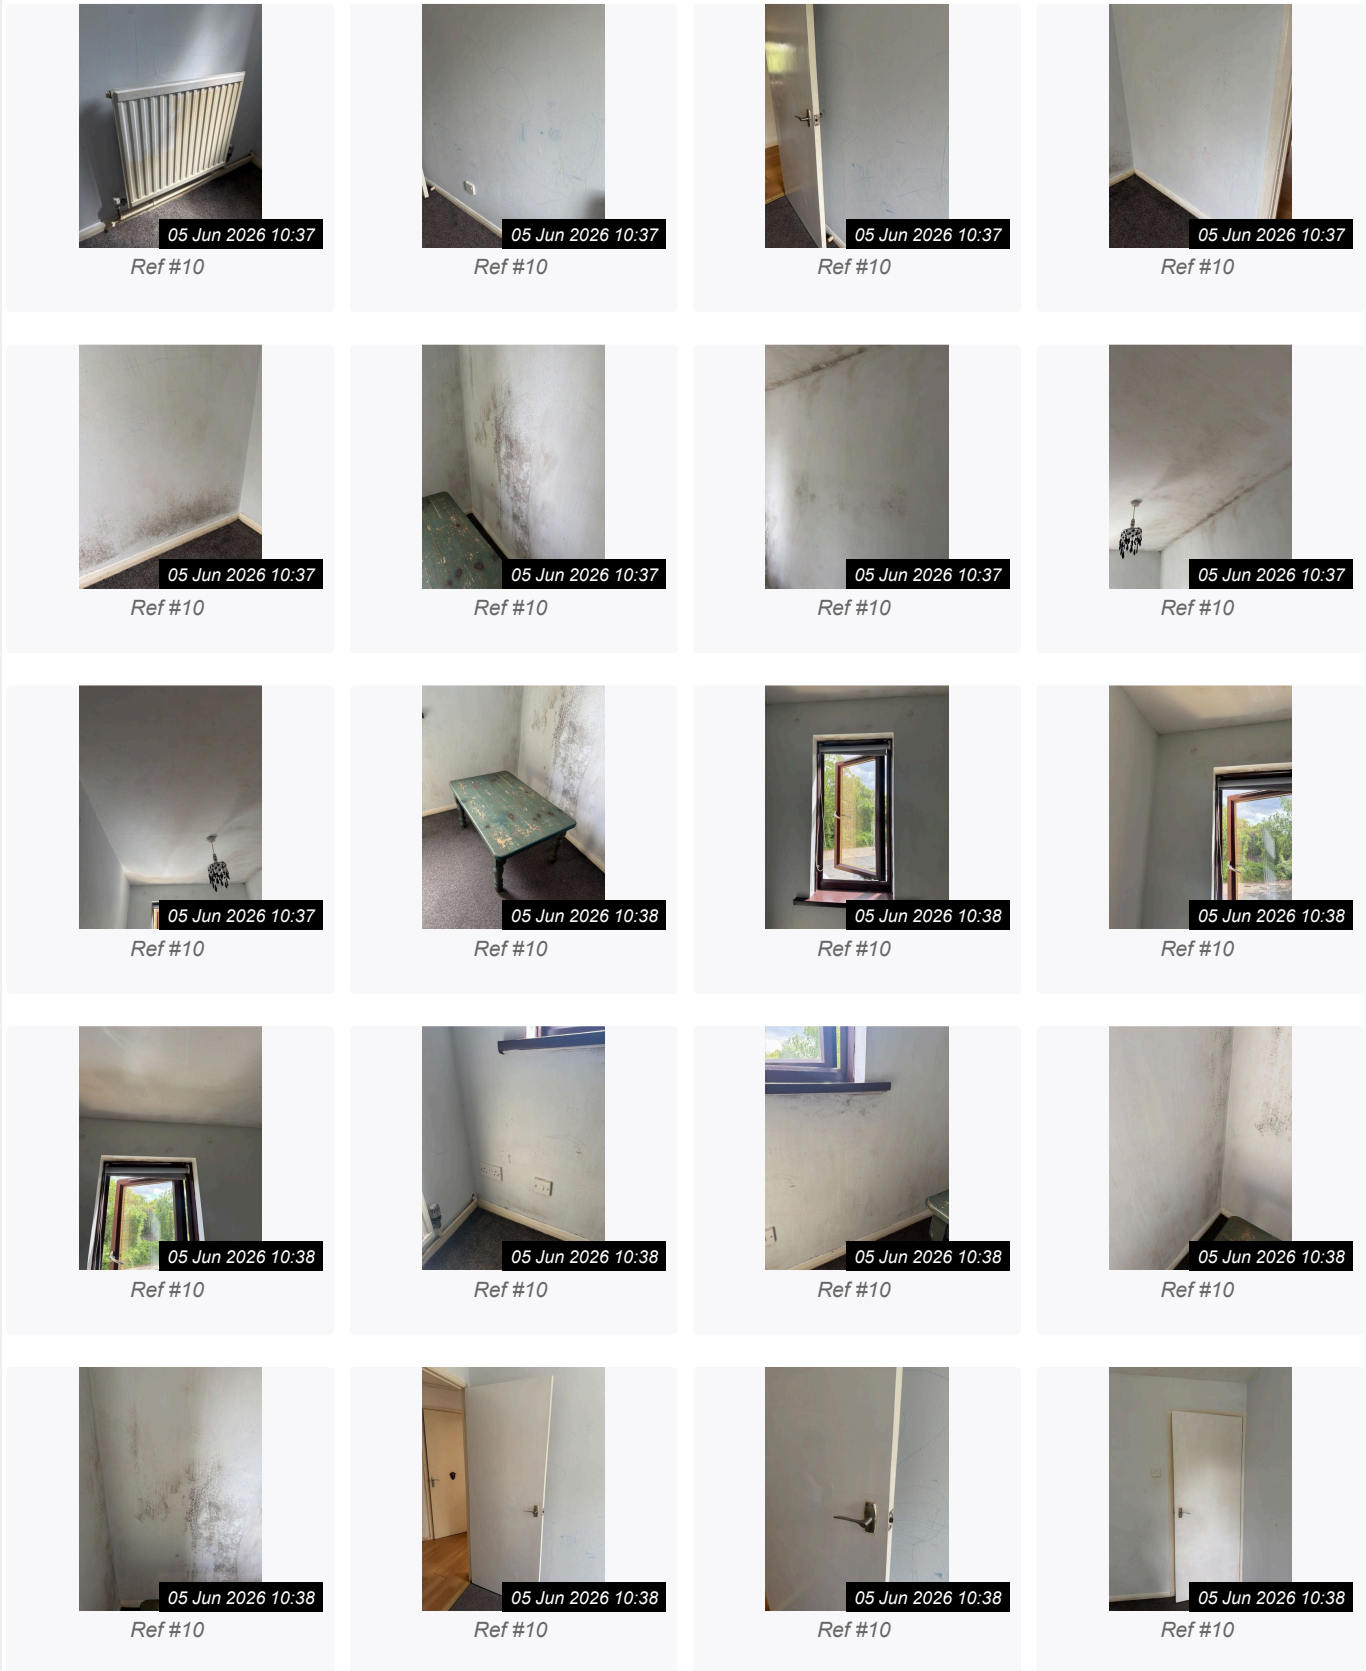
Ref #10

Ref	Name	Description	Condition at Inventory & Check In	Condition at Check Out
10.1	Door (Internal)	Wood Flat-Panelled; White; Chrome Handle; White Over Door Hook Present	In Good Condition; Smudges Visible; Painted Over Defects Visible; Patchy Paintwork	<p><i>As Inventory & Check In</i> +</p> <p>Internal door, white painted; scuffs, marks; handle fitted; frame worn, paint chipped.</p>
10.2	Door Frame	Wood Painted White	In Good Condition; Chipped & Marked in Places	<p><i>As Inventory & Check In</i> +</p> <p>General scuffs, minor marks and slight discolouration from age/ use; surface worn but intact.</p> <p>Chipped and uneven along edges, joints and architrave. Aged, cosmetic wear.</p>
