Inventory & Check In

Address

123 Preview Street
Sample City
London
AB1 2CD

May
30th 2026
17:00

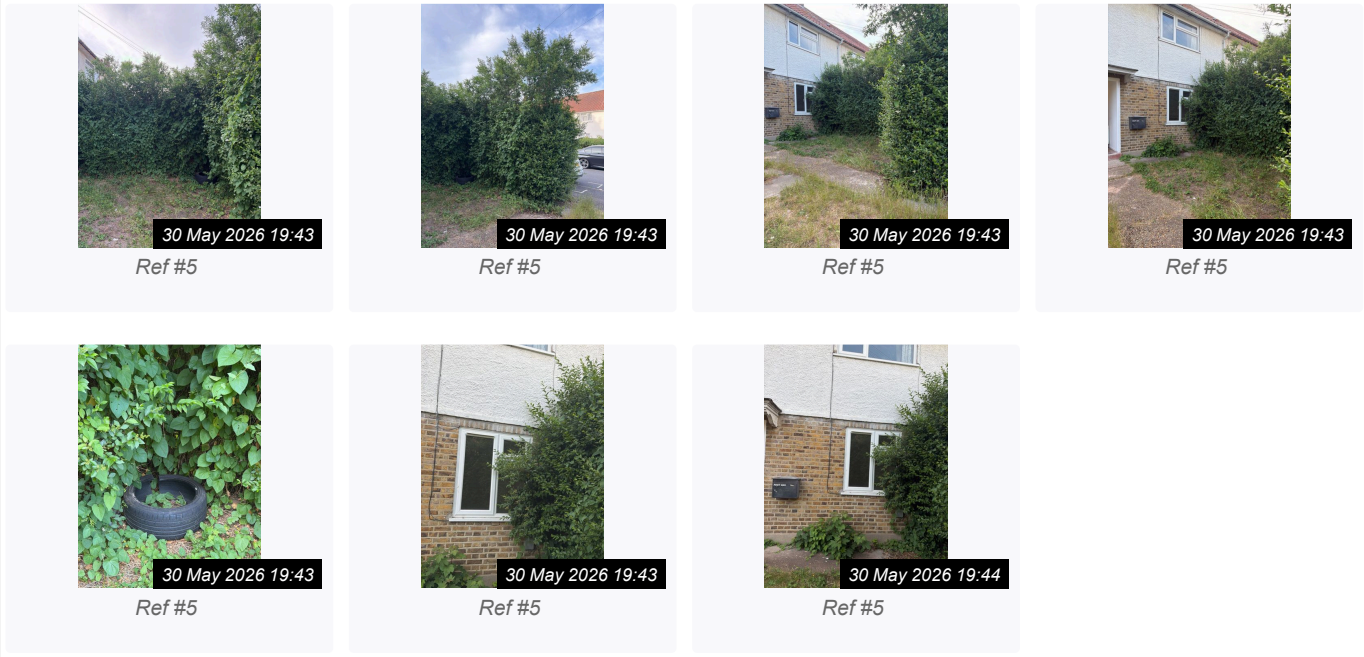
Ref #4

5. FRONT GARDEN			
Ref	Name	Description	Condition
5.1	Garden Overview		Unkempt; requires complete tidying. Hedges and shrubs significantly overgrown - branches encroach over the property boundary and block light/view to the dining window. Needs Maintenance - Landlord
5.2	Additional Items / Information		Black tyre present at the end of the garden.

Ref	Action Required	Responsibility	Comments
5.1 Front Garden » Garden Overview	Needs Maintenance	Landlord	Unkempt; requires complete tidying. Hedges and shrubs significantly overgrown - branches encroach over the property boundary and block light/view to the dining window.
6.2 Exterior Front » Door	Needs Maintenance	Landlord	Door and frame show general wear. Door stiff to operate due to expanded timber; must be slammed to close/secure. Black marks visible on upper and side areas. Letterbox cover missing to exterior.

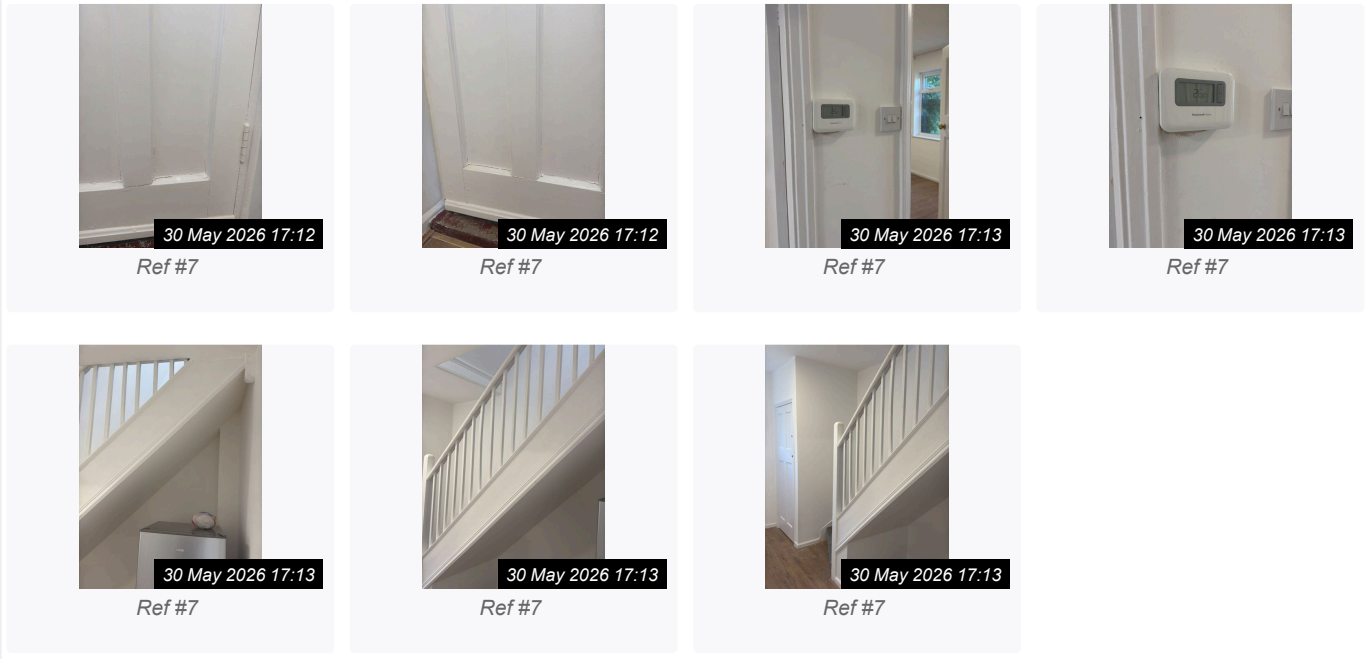
Ref #7

Ref	Name	Description	Condition
7.1	General Overview		Overall condition good, subject to issues noted below.
7.2	Door	White-painted.	<p>Top hinge: Upper hinge is aged but in working order; smooth movement observed with no functional impairment.</p> <p>Latch and strike plate: Latch and lock plate are exposed and exhibit signs of corrosion/rusting; still firmly attached and secure in position.</p> <p>Door function: Door operation is restricted; it jams and is stiff to use. Expansion of the timber edge is evident, meaning significant force or slamming is currently needed to close the door fully.</p> <p>Internal hardware: Internal pull/lever handle is missing or not installed; only a simple latch knob is in place for opening.</p> <p>Needs Maintenance - Landlord</p>

7.10	Heating	White double panel radiator.	Heavy rust, surface marks and staining present across all panels and visible surfaces. Significant discolouration and corrosion noted. No thermostatic radiator valve (TRV) fitted or visible.

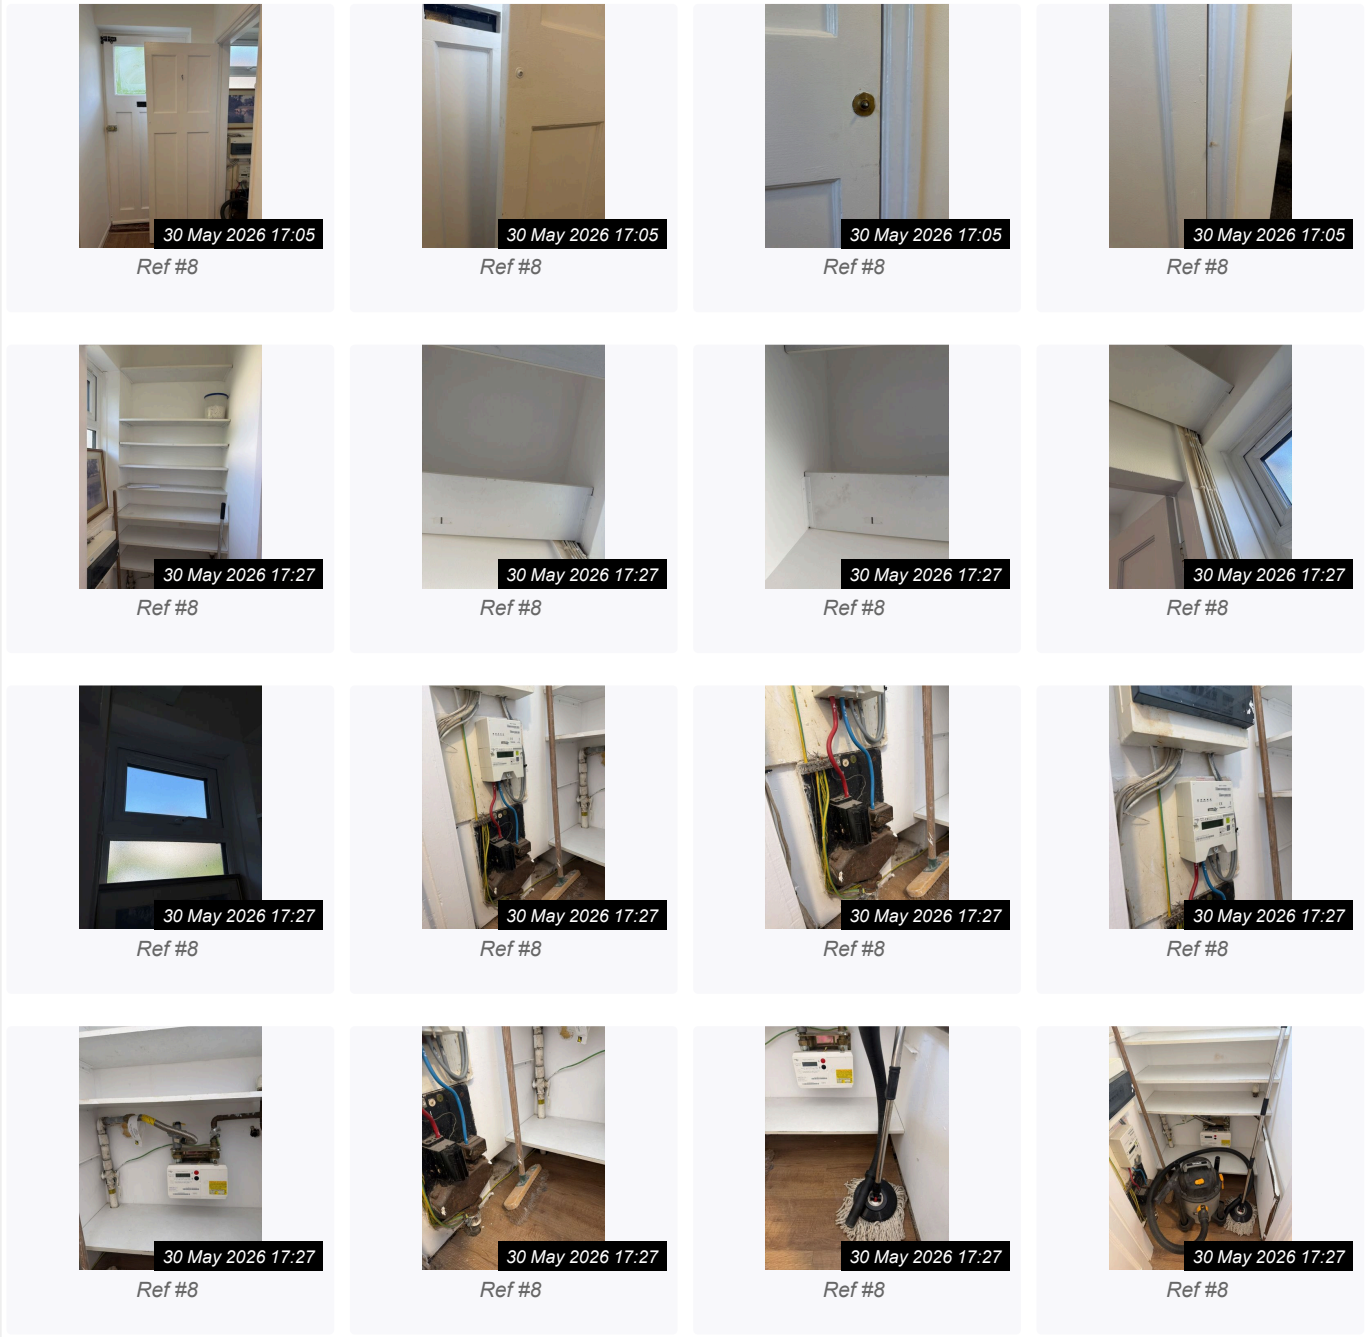
Ref	Name	Description	Condition
8.1	General Overview		Wear and tear marks observed throughout.
8.2	Door	White panelled door, painted white.	Scuff marks observed on sections of the door surface, both internally and externally. Door handle is missing and not present. Needs Maintenance - Landlord

8.10	Flooring	Wood-effect laminate flooring, laid in straight planks with a medium-brown grain finish.	Flooring is dirty with paint splatter spots present.

8. UTILITY ROOM / AREA (CONT.)			
8.11	Additional Items / Information		
8.11.1	-	8x white wooden fixed shelves.	Surfaces are heavily dusty throughout, with several marks and scuffs visible. All appear structurally sound and securely fixed at time of inspection.
8.12	Fuseboard	Hager consumer unit.	Heavily discoloured and dirty.
8.13	Obsolete Meter/ Connection Block		Old connection block is open, unenclosed and shows signs of corrosion.
8.13.1	-	Titan black and grey hoover.	Appears in good/fair condition - used.
8.13.2	-	1x mop stick with head.	In old and heavily used condition.
8.13.3	-	1x wooden broom.	In old condition.
8.13.4	-	1x picture frame.	In old condition.
8.13.5	-	1x clear container.	Clear plastic container (blue rim/lid) with small white coiled items; top-right shelf - contents unconfirmed due to access limits.

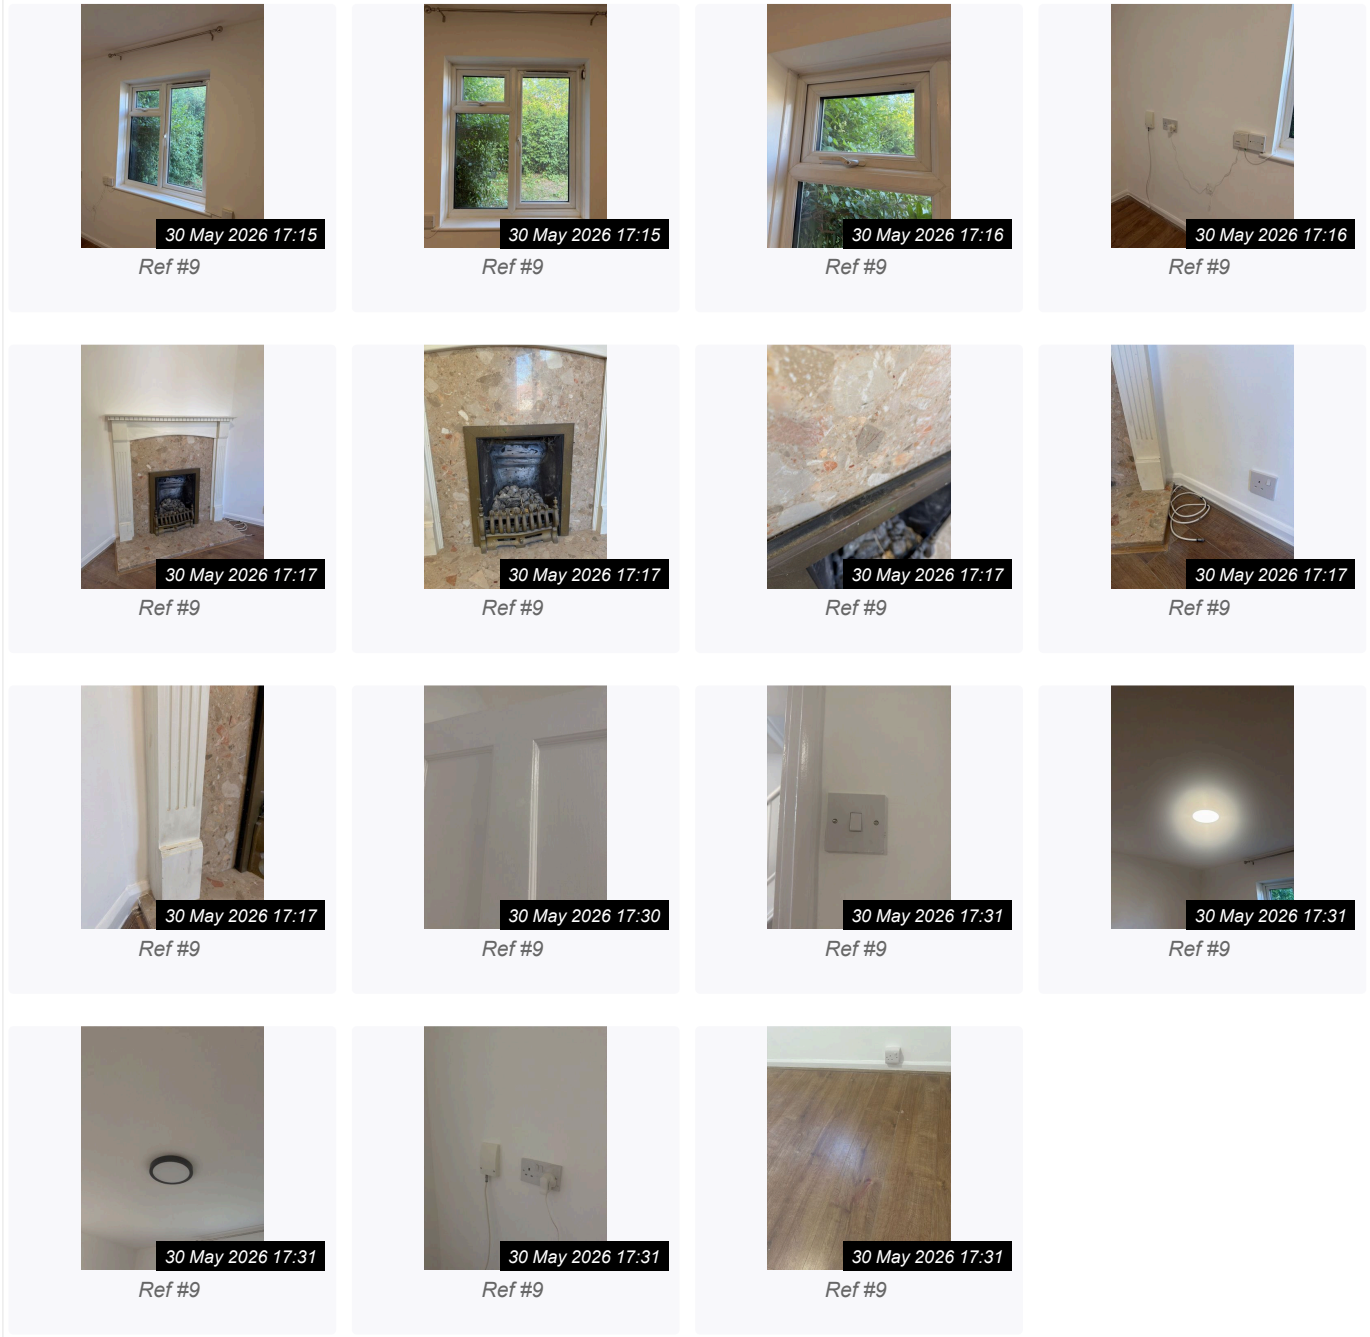
9. DINING ROOM (CONT.)

9.11	Sockets	3x single gang socket. 1x double gang socket.	White, fitted, secure and undamaged.
9.12	Heating	White panel-type radiator, floor-mounted.	Paint chipped, stained and discoloured; rust in places. TRV fitted right-hand side; pipework visible, no leaks. Unit intact and secure; worn, damaged and corroded with age.

9.13	Flooring	Wood-effect laminate flooring, laid in straight planks with a medium-brown grain finish.	Surface covered in paint splatters and stains; prominent red stain between window and radiator. Minor scuffs and wear visible.

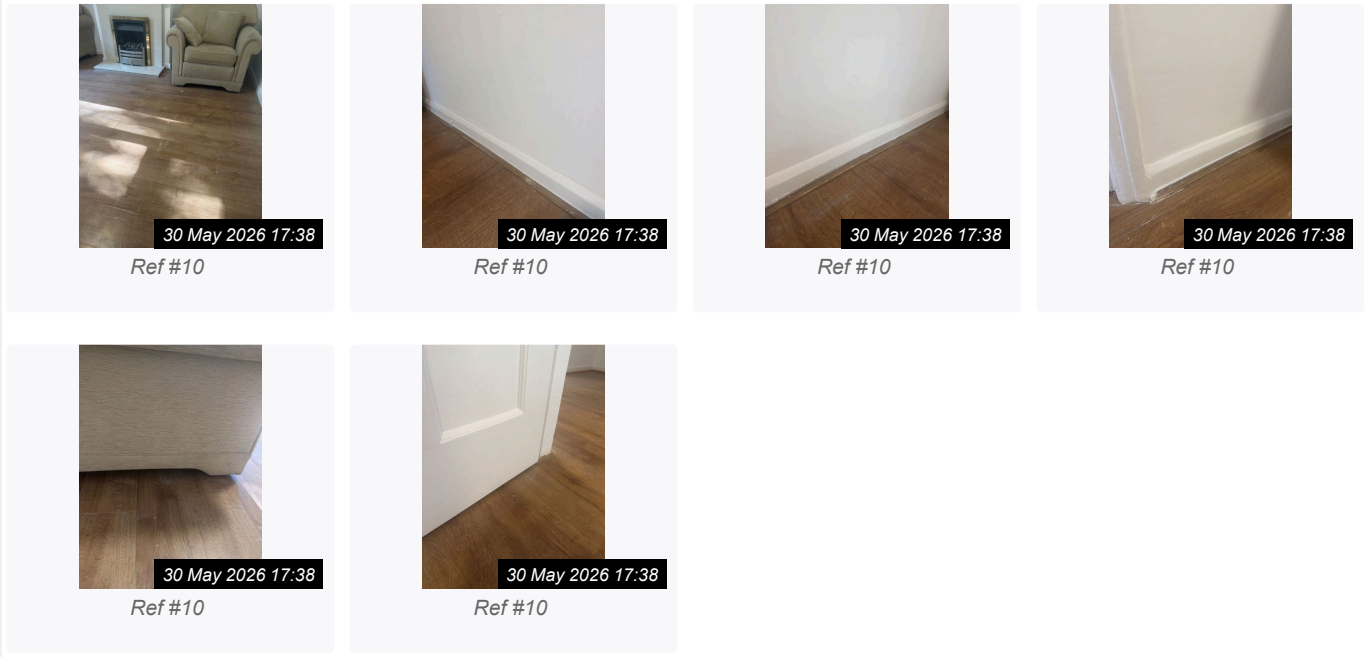
10. RECEPTION ROOM (CONT.)

10.11	Sockets	White single plastic socket.	In tact, and in good working order.
10.12	Heating	White double panel radiator.	Heavy rust, marks and staining across surface and panels; significant discoloration and corrosion present. TRV fitted to right-hand side.

10.13	Flooring	Laminate flooring – medium brown wood-effect finish.	Visible white scuff marks and surface damage to finish on various planks; coating worn/removed, leaving distinct lighter patches.

10.15	Additional Items / Information		
10.16	Sofa	<p>Fabric beige 3-seat sofa.</p> <p>Upholstered in a textured fabric material, in a light beige/neutral brown tone.</p>	Multiple stains and dirt marks visible, notably on seat cushions, right-hand armrest and side panels; general discolouration present.

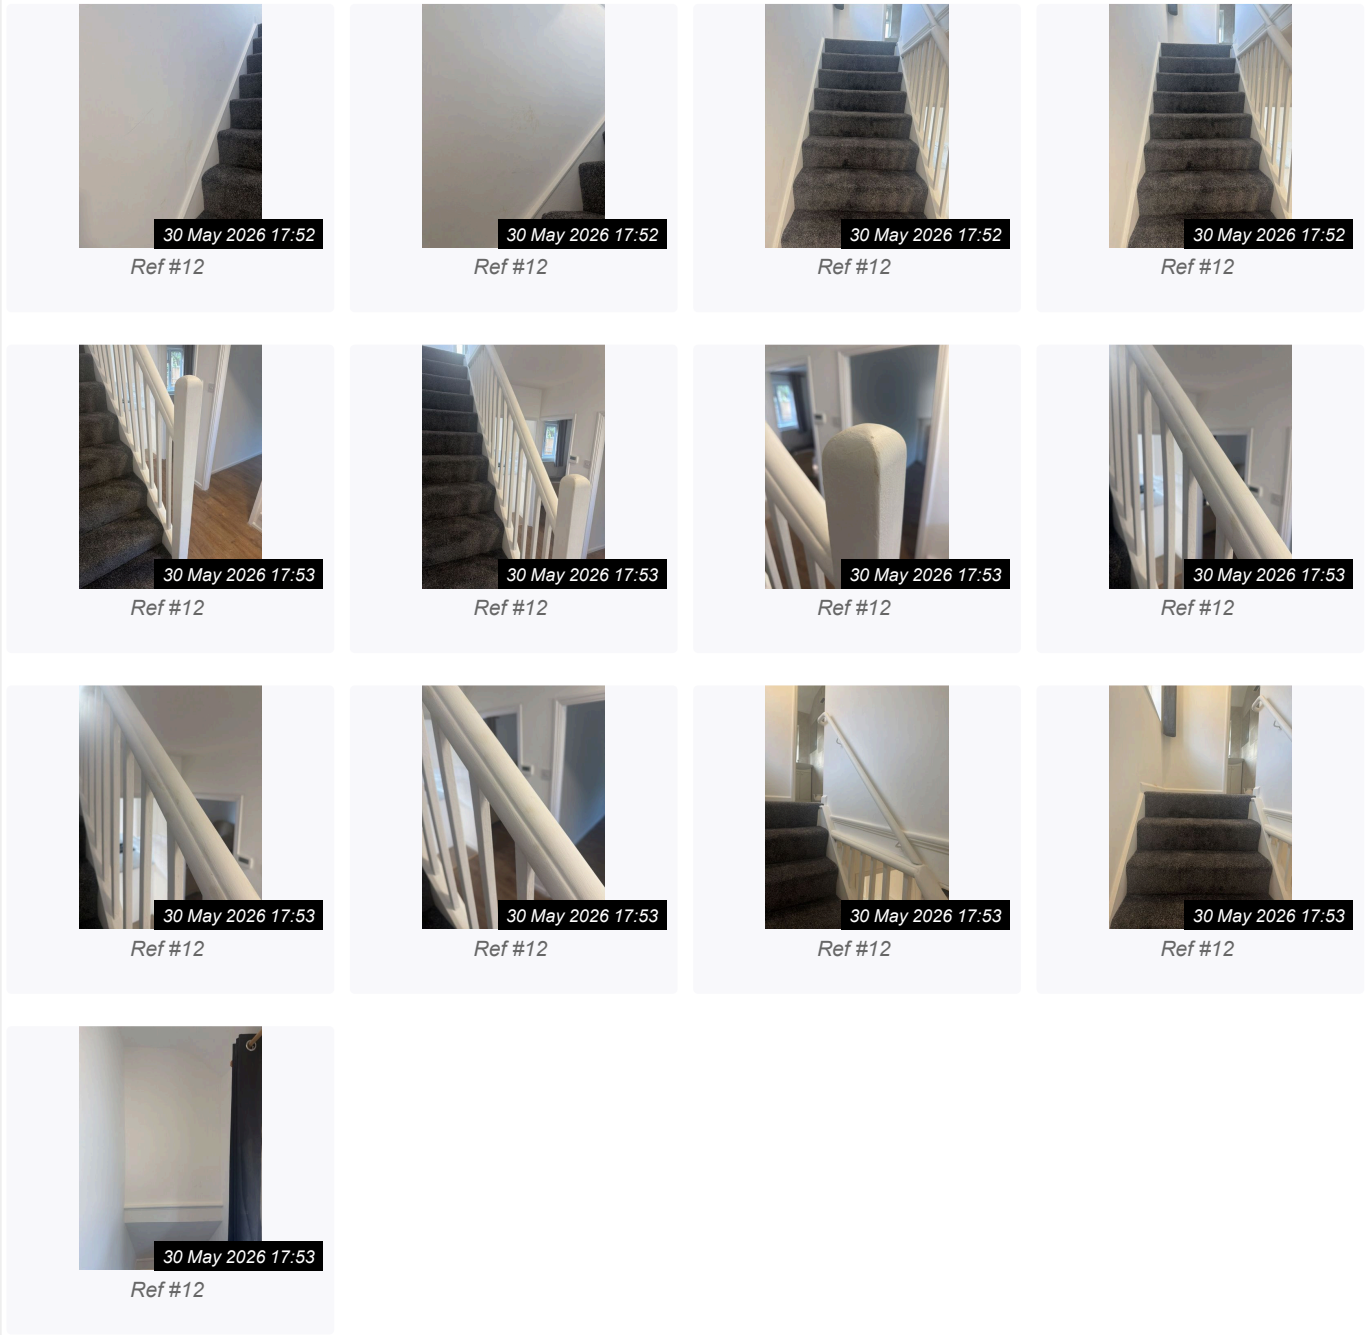
Ref #12

Ref	Name	Description	Condition
12.1	General Overview		Generally in good condition.
12.2	Ceiling	White-painted.	Appears in good condition - some marks are visible to sections.
12.3	Walls	White-painted.	Scuff marks seen to multiple places. Yellow stains observed on the left-hand side wall.
12.4	Skirting	White-painted.	Appears freshly painted.
12.5	Flooring	Grey carpet.	Appears newly fitted.
12.6	Additional Items / Information		
12.7	Banister	White-painted.	Some scuff marks visible. Small yellow stains noted to several spindles. All spindles are intact and secure.

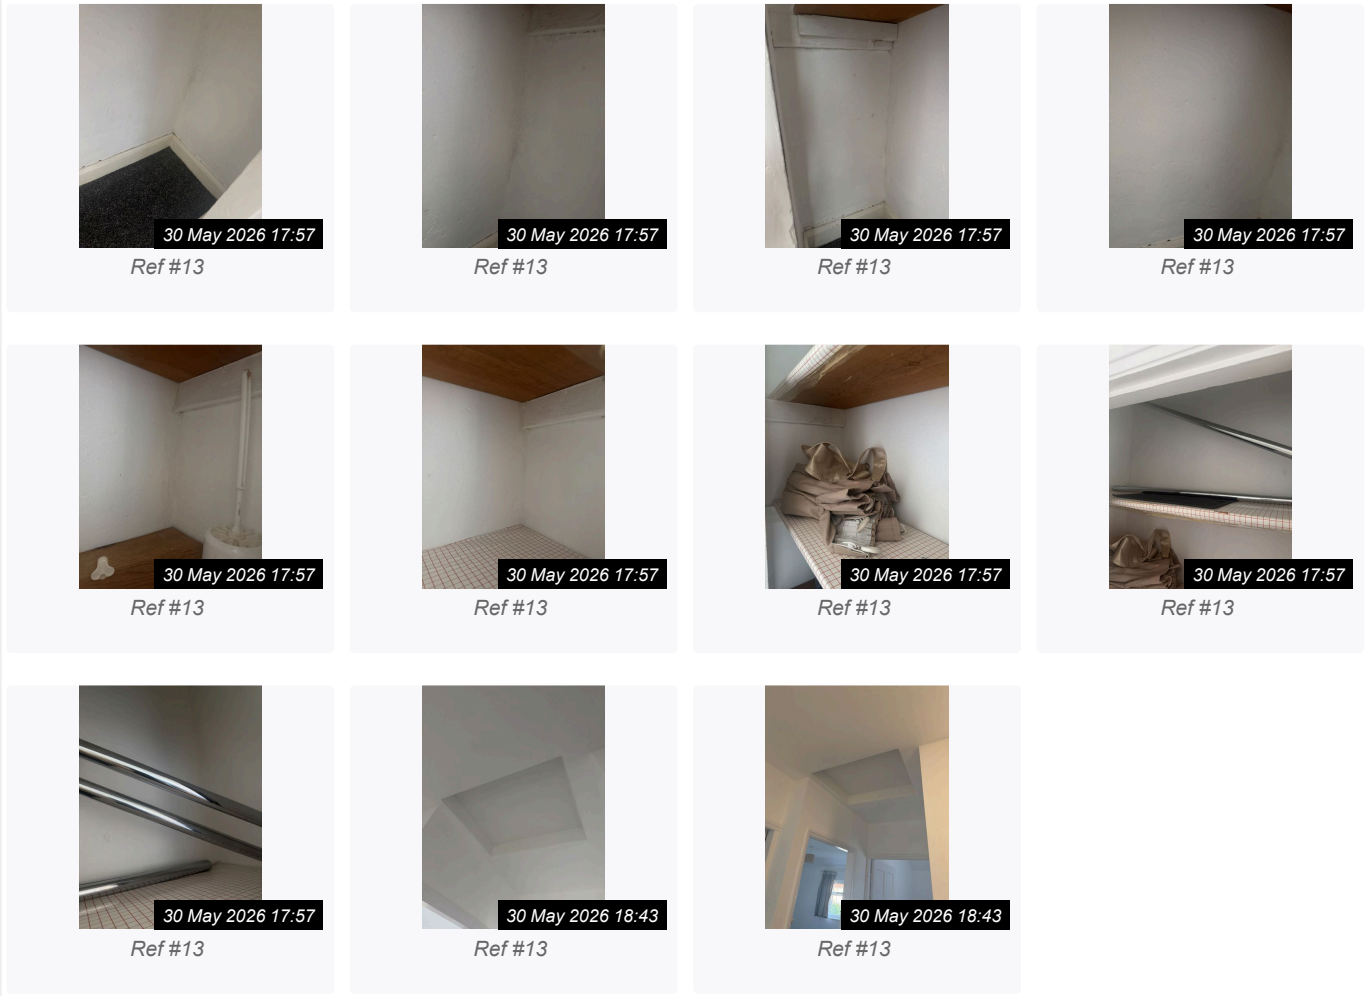
13. LANDING & STORAGE CUPBOARD (CONT.)

13.7	Curtains	1x pair of black curtains	Visible marks, discolouration and staining present on fabric, particularly towards lower sections.
13.8	Switch	White plastic single switch plate, standard design and appearance.	In good working order.

13.9	Sockets		No electrical sockets installed.
13.10	Flooring	Grey carpet.	Newly fitted - in good condition.
13.11	Additional Items / Information		
13.11.1	-	2x Black curtains	Numerous white stains throughout.

13.12	Handrail	White-painted.	White curved handrail shows marks and stains along its surface.
13.13	Storage Cupboard	1x Beige/brown curtains with gold hooks - curtain hooks and fittings detached and left on surface. 4x Chrome poles. Blue protective roll (likely vinyl or film) left on shelf with other items. 1x Domestos bleach. 1x Flash bathroom spray. 1x Plastic toilet brush.	Items listed above are present and accounted for. Curtain hooks and associated fittings have become detached and are placed on the adjacent surface. All remaining items are stored and left in position as noted.

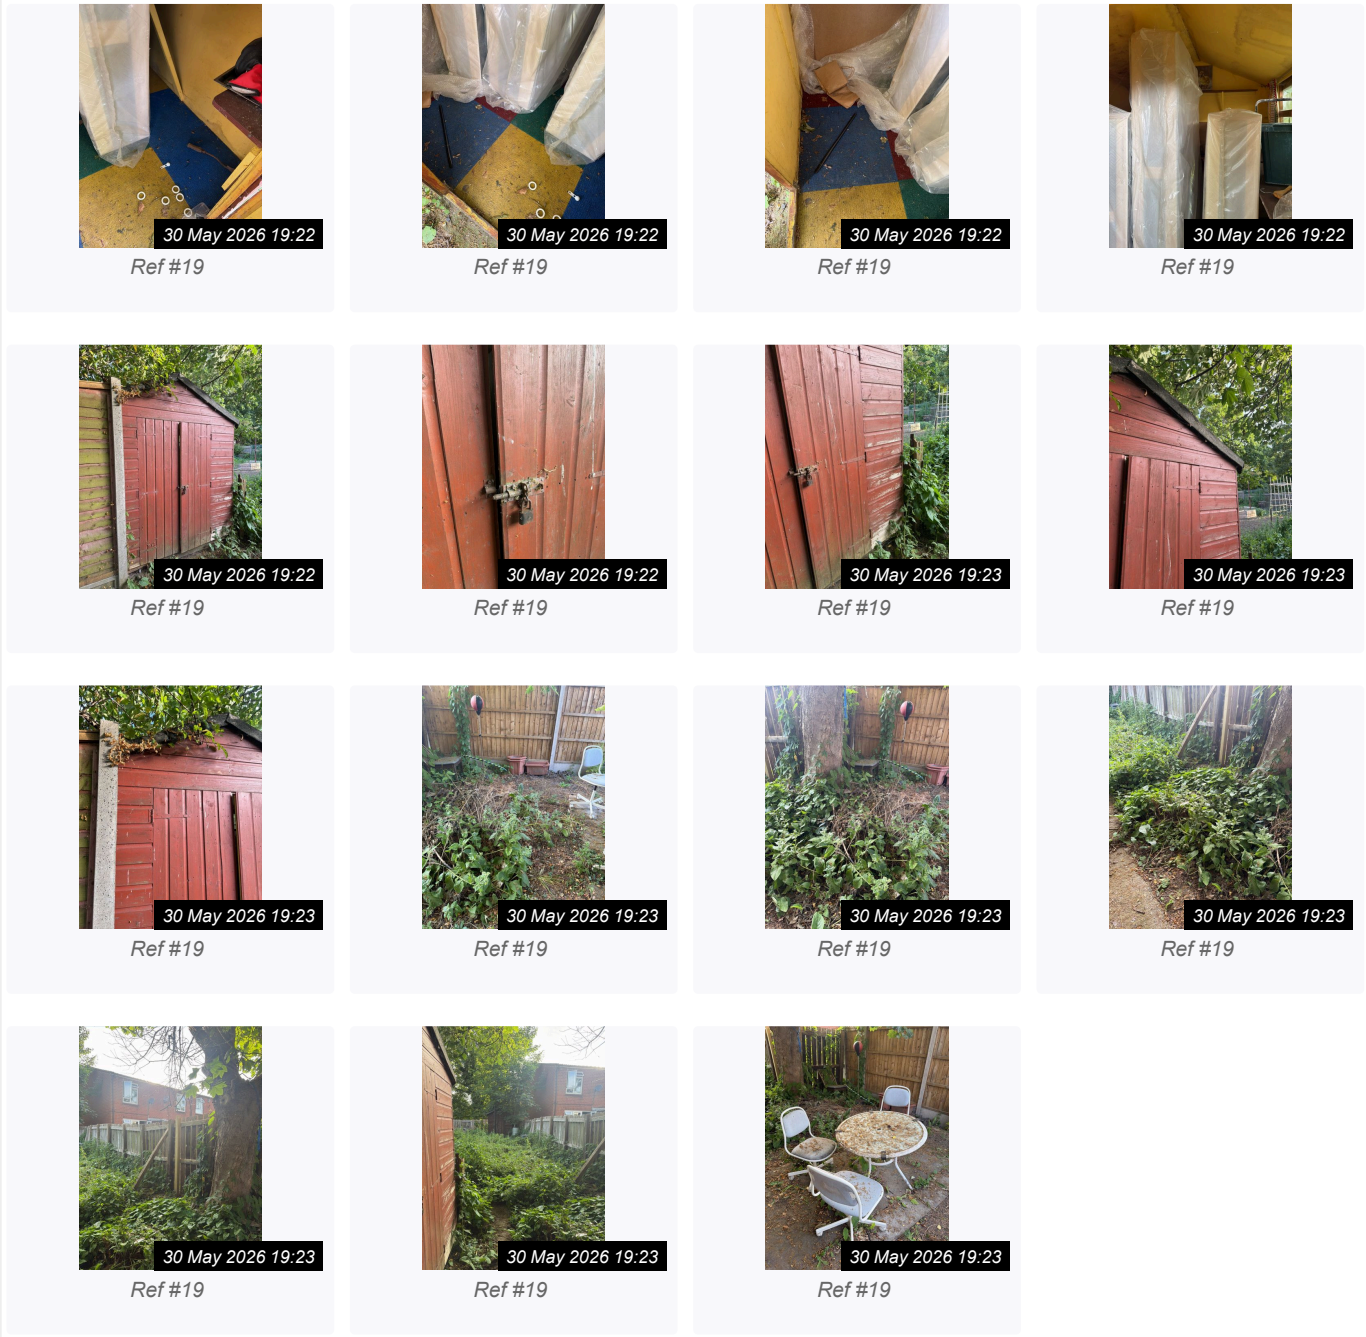
Ref #19

Ref	Name	Description	Condition
19.1	Garden Description		<p>Main garden area: Overgrown with unkempt grass, weeds and shrubs; includes garden furniture, washing line and established trees/ bushes; timber fencing along side boundaries is present and generally intact.</p> <p>End section of garden: Heavily overgrown.</p> <p>No fence or boundary structure visible at the rear end of the garden.</p> <p>Area around base is unclean, with weeds growing up around pipes; surrounding brickwork shows discolouration, staining and some loose or missing mortar.</p>

19.3	Guttering	External pipework and guttering.	<p>Painted finish is worn, chipped and peeling in places; metal fittings and valves show signs of corrosion, rust and age.</p> <p>Fitted with an external tap/outlet valve - connection likely links to internal kitchen plumbing.</p> <p>Concrete cover/access panel at ground level is dirty, marked and uneven; general condition of the installation is aged.</p>

19.4	Additional Items / Information		
19.4.1	-	<p>Items found in the garden:</p> <ul style="list-style-type: none"> Table with chairs Punching bag Plant pots Extra chair Wooden shelf Mop bucket Doormat positioned outside the garden door 	<p>Overused and show signs of damage, wear and deterioration throughout.</p> <p>Needs Maintenance - Landlord</p>
