Inventory & Check In

Property inspected by A. Clerk

123 Preview Street
Sample City
London
AB1 2CD

June
3rd 2026
10:00

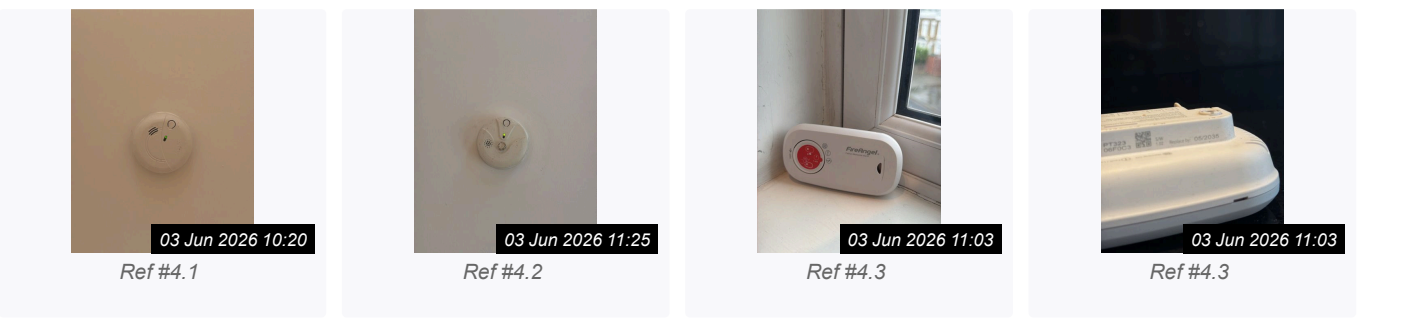
4. HEALTH & SAFETY | SMOKE & CARBON MONOXIDE ALARMS

Ref	Name	Location Room & Floor	Test Result
4.1	Smoke Alarm(s)	1x Hallway.	Alarm tested for power only. Audible alarm noted.
4.2	Heat Sensor Alarm(s)	1x Kitchen.	Alarm tested for power only. Audible alarm noted.
4.3	Carbon Monoxide Alarm(s)	1x Kitchen.	Alarm tested for power only. Audible alarm not noted. Needs Replacing - Landlord

Ref	Action Required	Responsibility	Comments
4.3 Health & Safety Smoke & Carbon Monoxide Alarms » Carbon Monoxide Alarm(s)	Needs Replacing	Landlord	Alarm tested for power only. Audible alarm not noted.
8.4 Open-Plan Kitchen Area » Lighting	Needs Replacing	Landlord	1x spotlight not in working order.

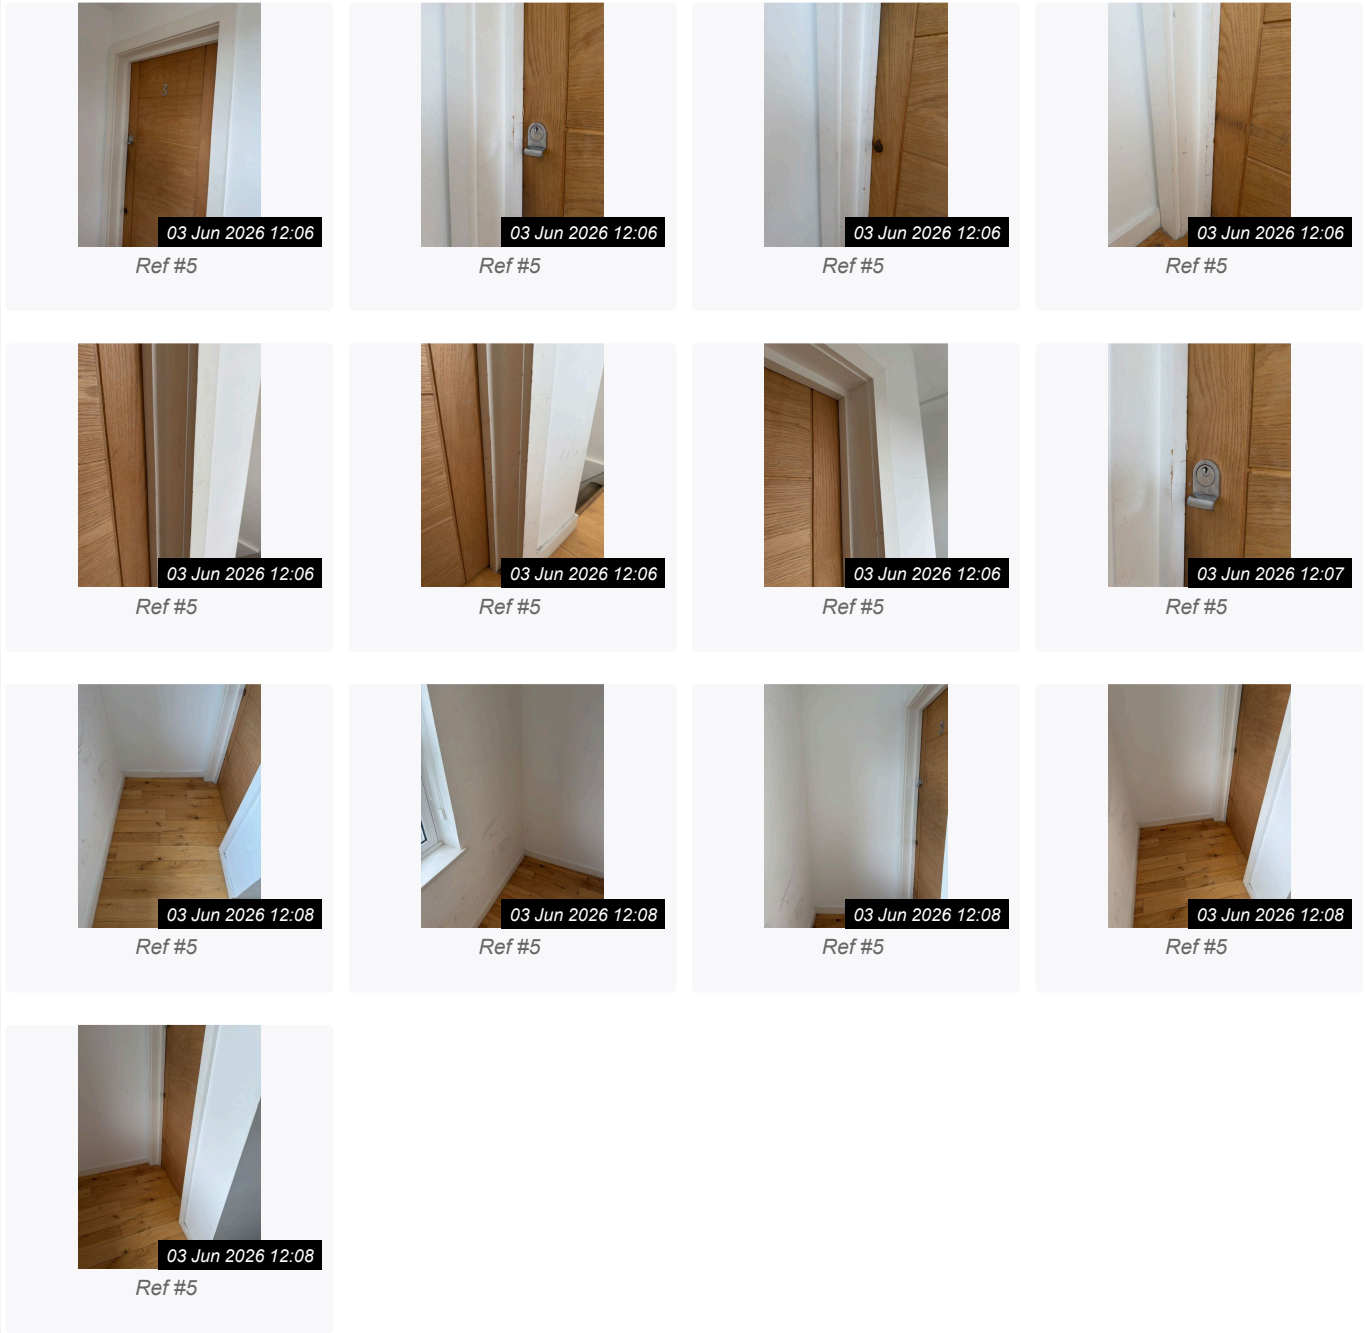
5. EXTERIOR FRONT (CONT.)

5.2	Door	Light wood-effect finish with horizontal panel detailing; number "3" fitted to face.	Surface generally clean, with minor light scuffs visible. Cylinder lock with chrome surround fitted; no key present. Operates correctly, fits well within frame.
5.3	Door Frame	White painted timber.	Surface generally clean, with minor light scuffs visible. Cylinder lock with chrome surround fitted; no key present. Operates correctly, fits well within frame.

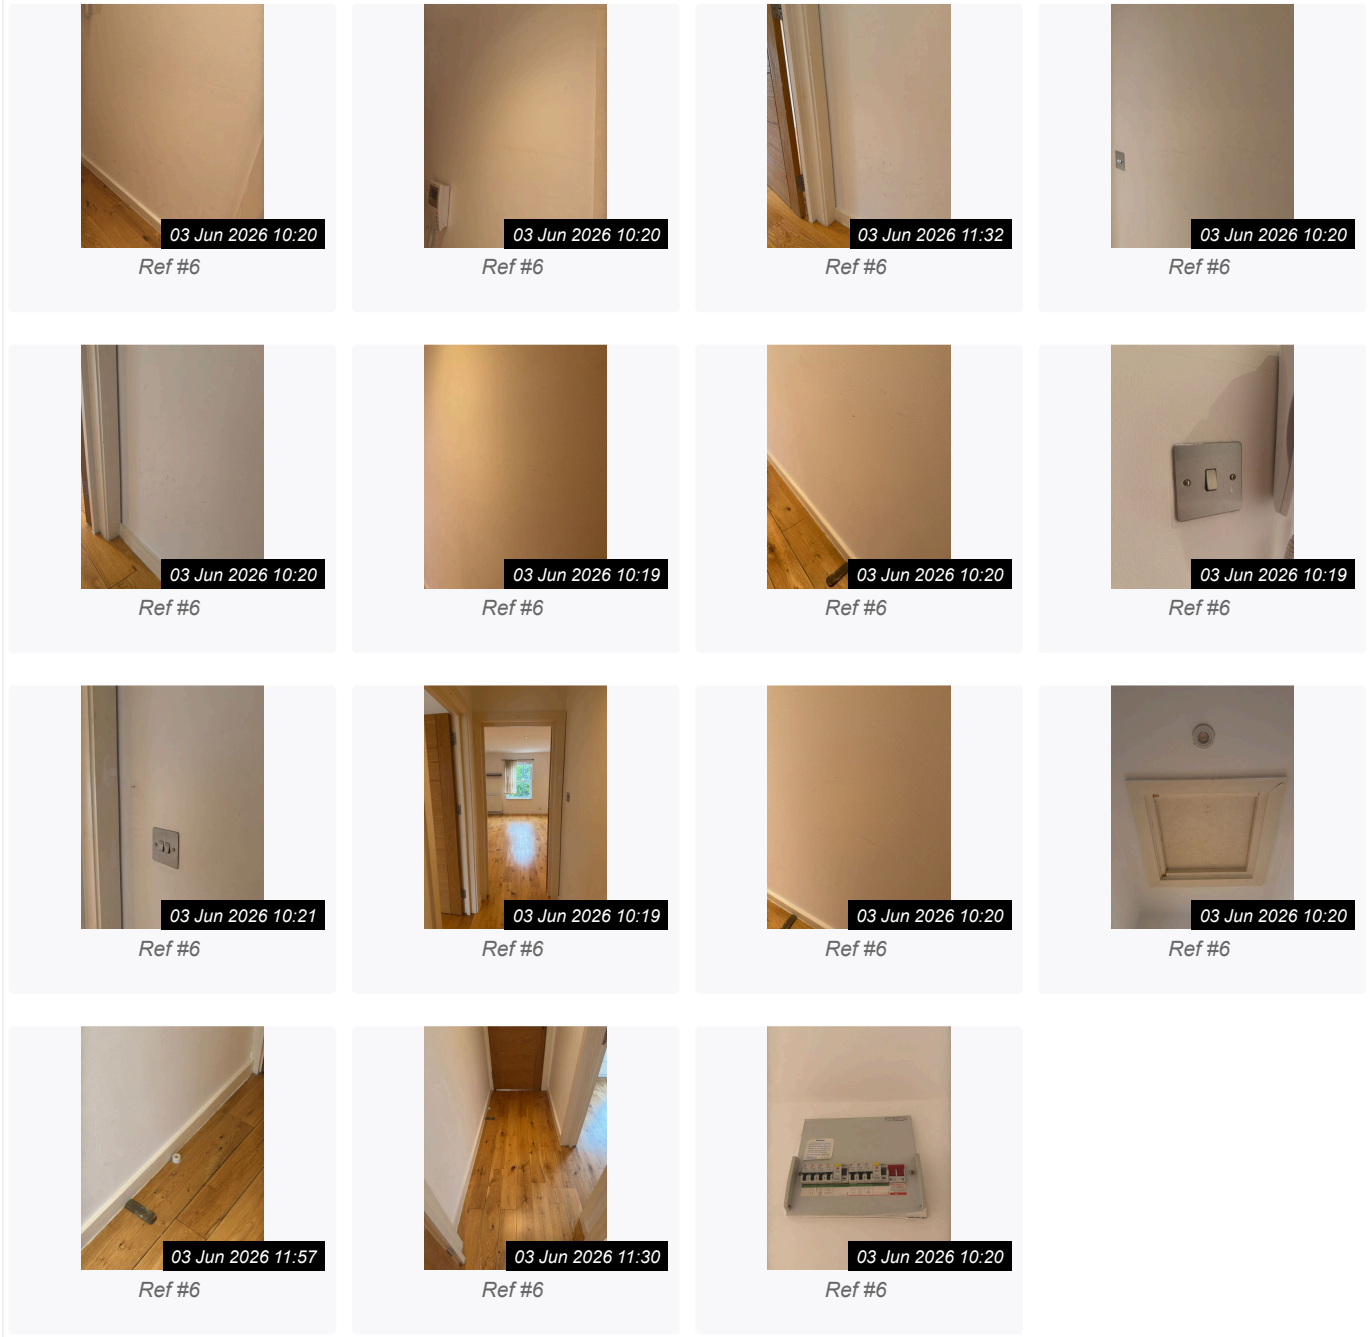
Ref #6

6. ENTRANCE / HALLWAY			
Ref	Name	Description	Condition
6.1	General Overview	Odours	Generally in good condition, with the exception of numerous wear and tear marks present on both sides of the walls.

6.3	Door Frame	White-painted timber frame.	Paintwork shows wear, scuffs, and small chips, especially along edges and at the base. Clear vertical cracking visible along the edge next to the hinge, with paint split and slightly lifted. Minor paint chips and unevenness also present.

6.4	Walls	White-painted.	1x single pin/fixing visible protruding from surface; no obvious fitting attached. Wall beside double light switch has faint scuff marks and light paint smudges; frame edge shows minor wear.

6.6	Skirting	White-painted.	Clean but with slight wear and small scuffs, sealant intact.
6.7	Ceiling	White-painted.	Appears in good condition. Ceiling Access Panel / Recess: Square recessed panel/void in ceiling, with moulded/boxed surround trim. Off-white/cream in colour; surface marked, dusty and lightly stained. Small wooden blocks visible at corners; trim joints slightly open/gapped; no cover panel fitted or present. Structure sound but cosmetic marks, dust and minor gaps in trim; needs cleaning and proper cover.

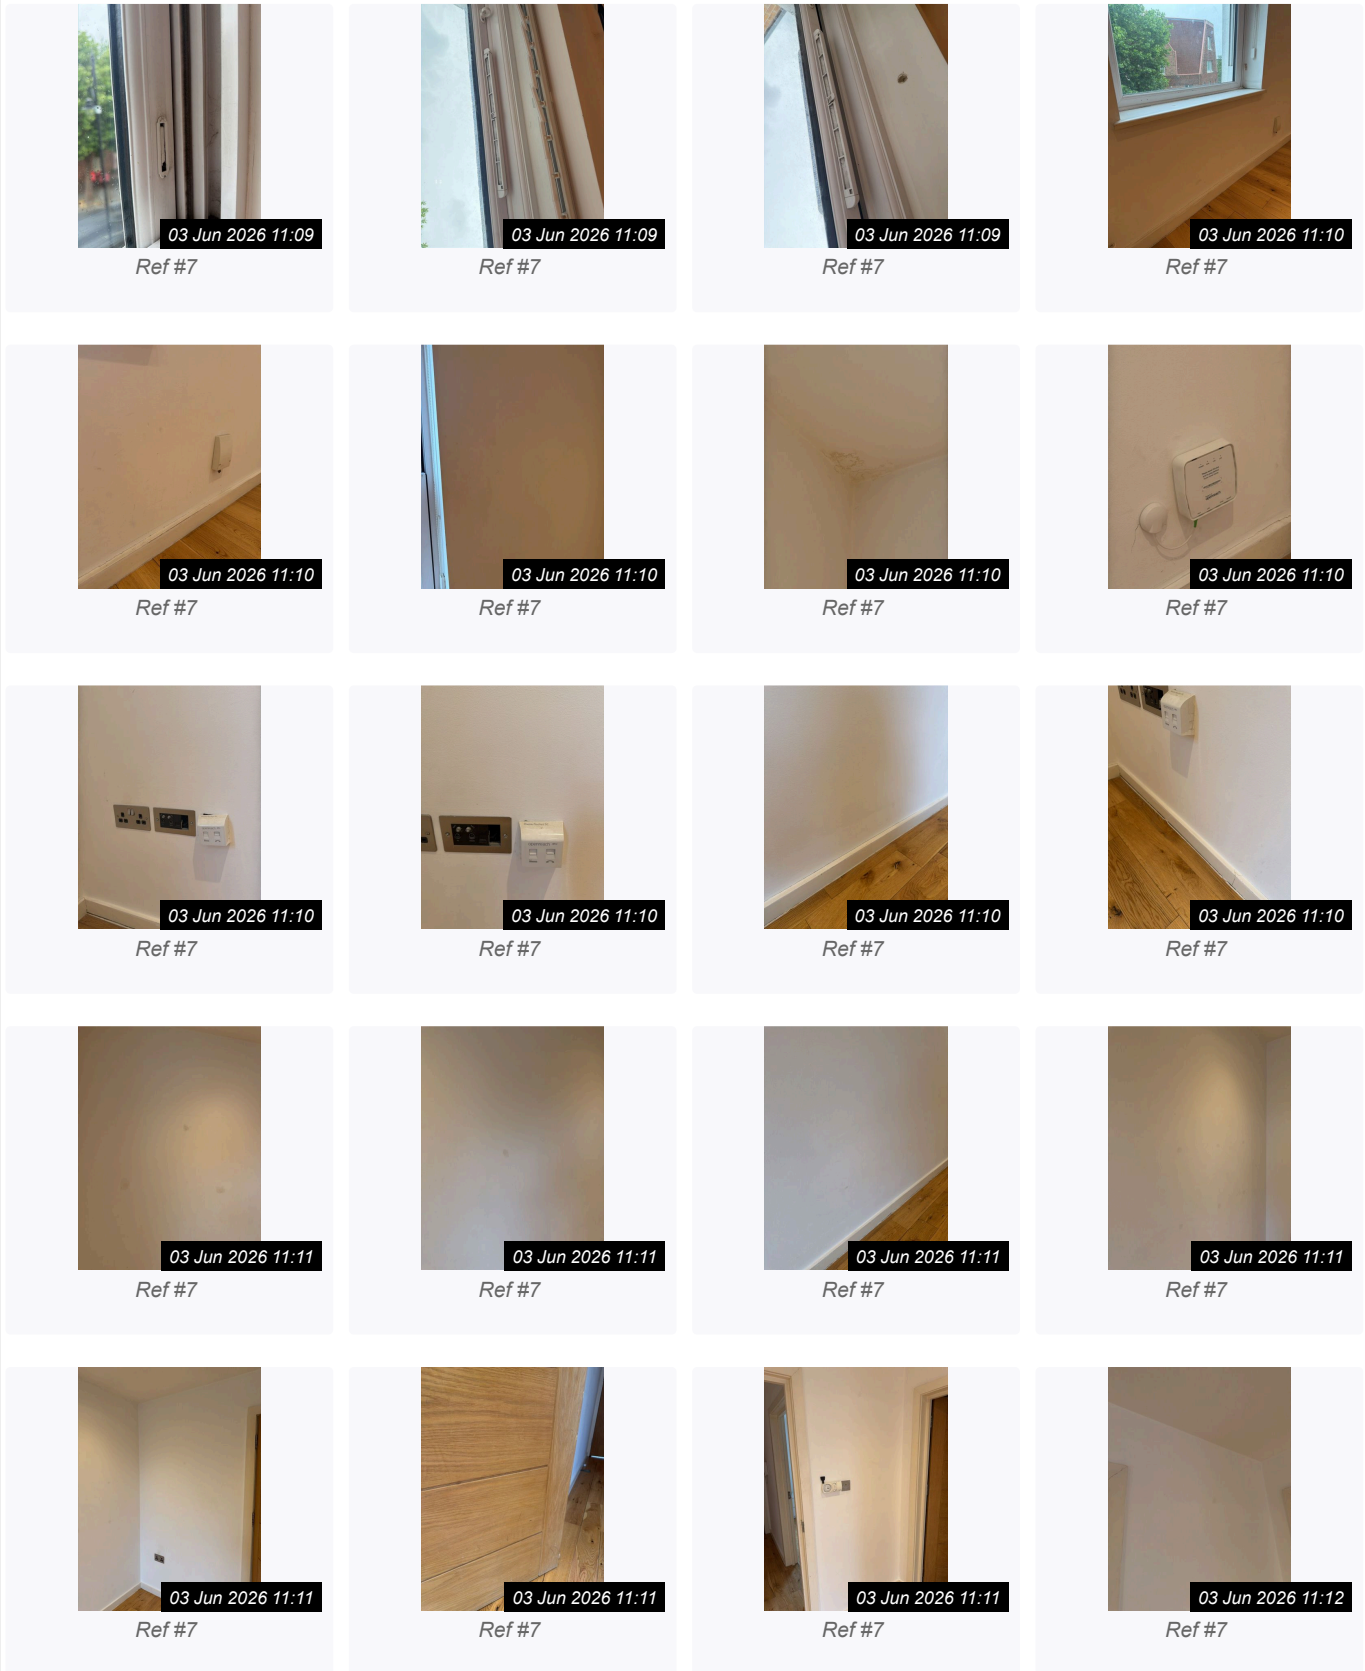
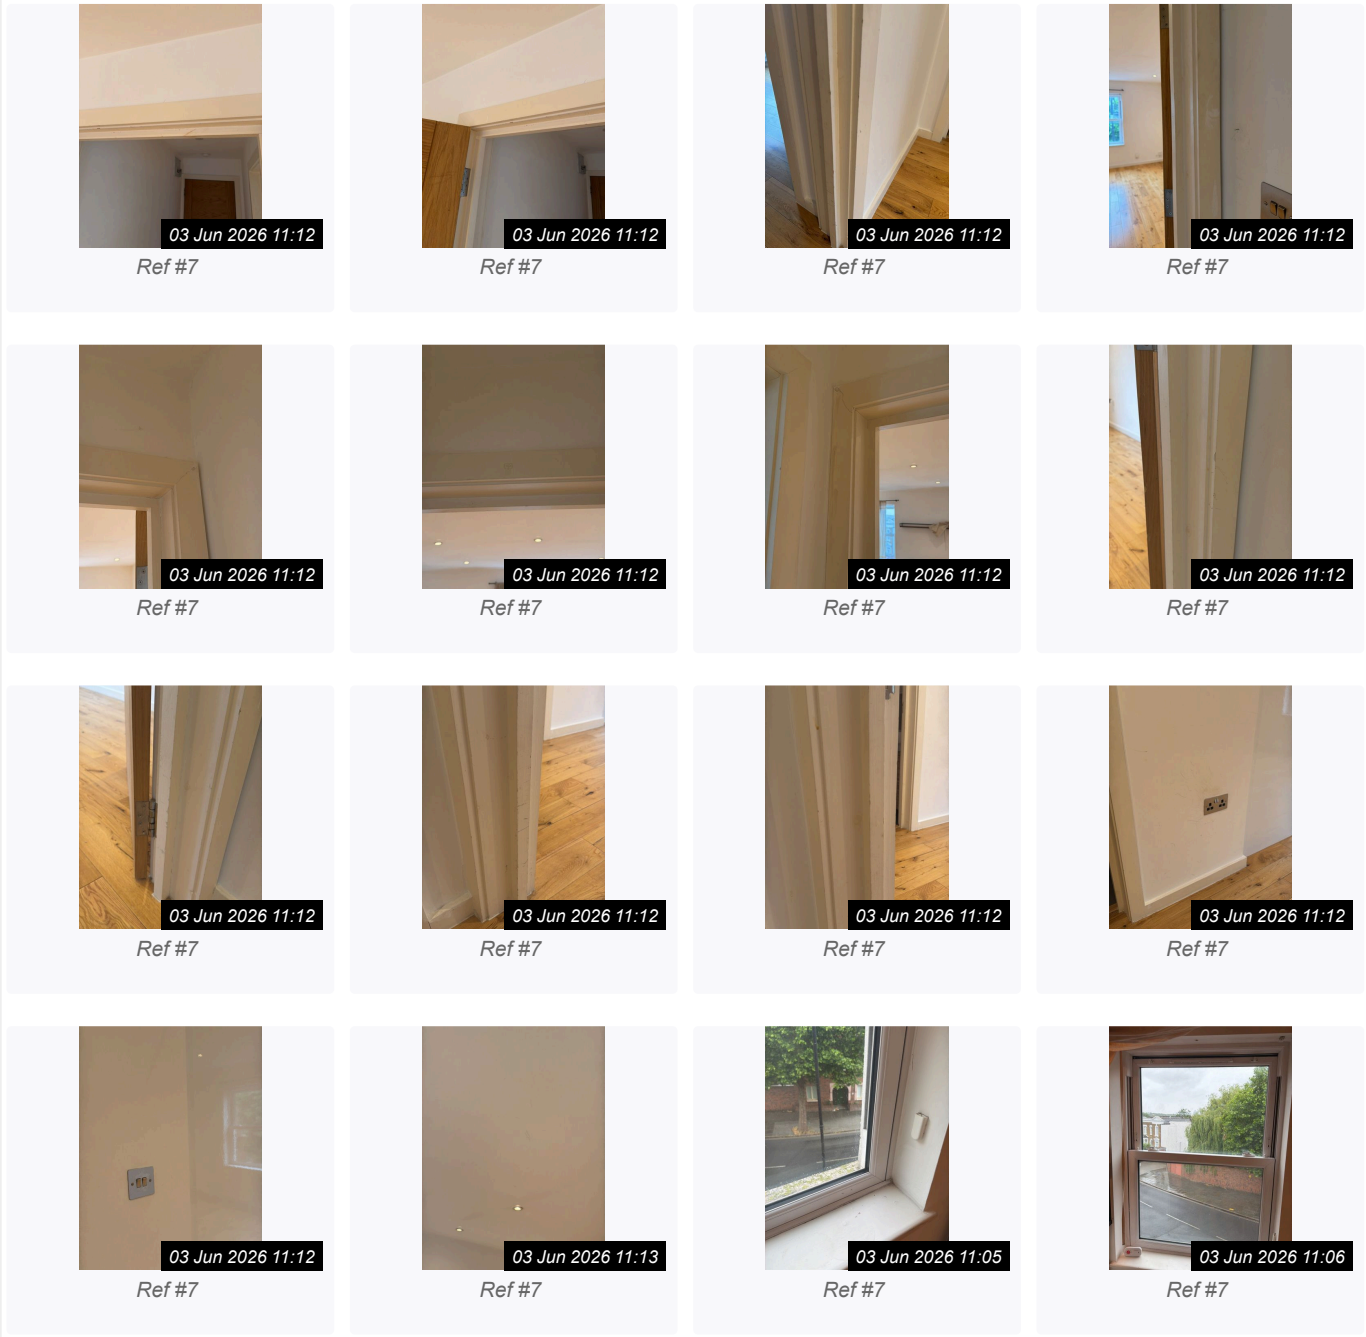
Ref #7

Ref	Name	Description	Condition
7.1	General Overview		Generally in good condition, with the exception of numerous wear and tear marks present on both sides of the walls and other defects noted below.

7. OPEN-PLAN RECEPTION AREA (CONT.)			
7.2	Door	<p>Light oak-effect wood veneer/laminate door, modern flush design with horizontal panel lines, silver metal lever handle fitted.</p> <p>1x Chrome coat hook.</p>	<p>Door has discolouration mainly at side and above handles (both sides); damage above handle on interior face.</p> <p>Visible split/crack running vertically along the edge stile near the handle; section of surface veneer/wood is chipped and lifting/coming away, leaving an open defect. Small indentation/blemish also present close by.</p> <p>Door closes but not fully; gap present inside frame.</p>

7.3	Door Frame	<p>White-painted timber or MDF frame/architrave, standard internal style.</p>	<p>Frame heavily scuffed, yellowed, multiple marks/stains (interior + exterior).</p> <p>Chipped, cracked and worn in multiple areas - especially at corners, edges and near hinges; paint is flaking and missing in small patches, revealing the base material underneath.</p> <p>Heavy scuffing, surface scratches and grey/black dirt marks across the face and edges, from use and contact.</p> <p>Heavily marked and discoloured at floor level; paint uneven, worn and stained.</p> <p>Overall poor cosmetic condition - looks aged, heavily used and in need of repainting and minor repairs.</p>

7.4	Walls	<p>White-painted.</p>	<p>Wear and tear marks throughout; painted-over defects/holes possibly present.</p>
7.5	Ceiling	<p>White-painted,</p>	<p>Appears in good condition.</p>

7.7	Skirting	<p>White-painted.</p>	<p>Scuff marks visible throughout.</p> <p>Sealant damaged throughout.</p>
7.8	Lighting	<p>9x Spotlights.</p>	<p>All in good working order.</p>

7.13	Heating	1x Double panel radiator.	Chips, marks, scratches and discolouration in places; TRV intact.
7.14	Additional Items / Information		
7.14.1	-	Worcester Thermostat / Programmer.	<p>Wall-mounted heating programmer/thermostat with 7-day timer dial, temperature and mode controls (Comfort, Economy, Setback).</p> <p>Securely fitted, complete and intact; slight discolouration/yellowing to plastic casing consistent with age; no damage or missing parts; appears functional.</p>

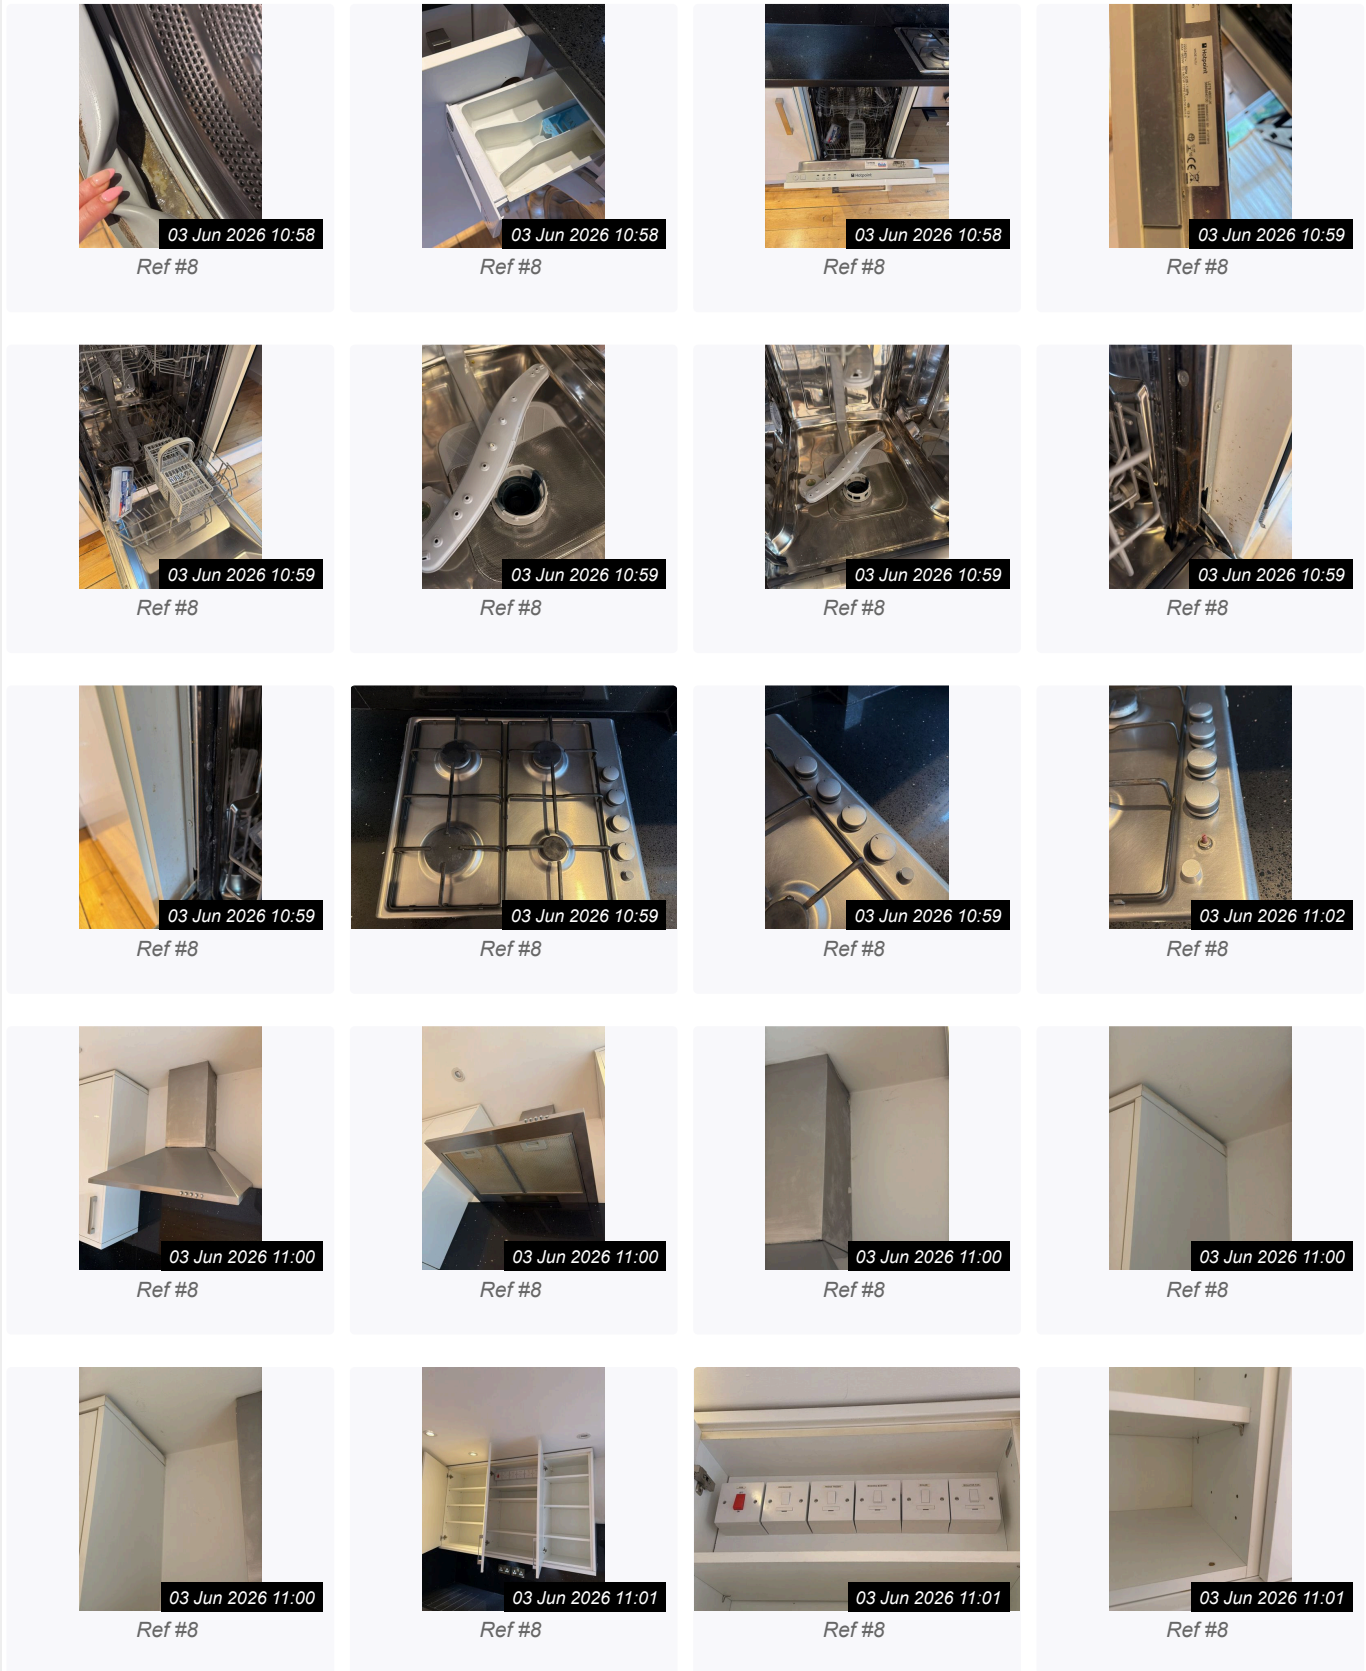
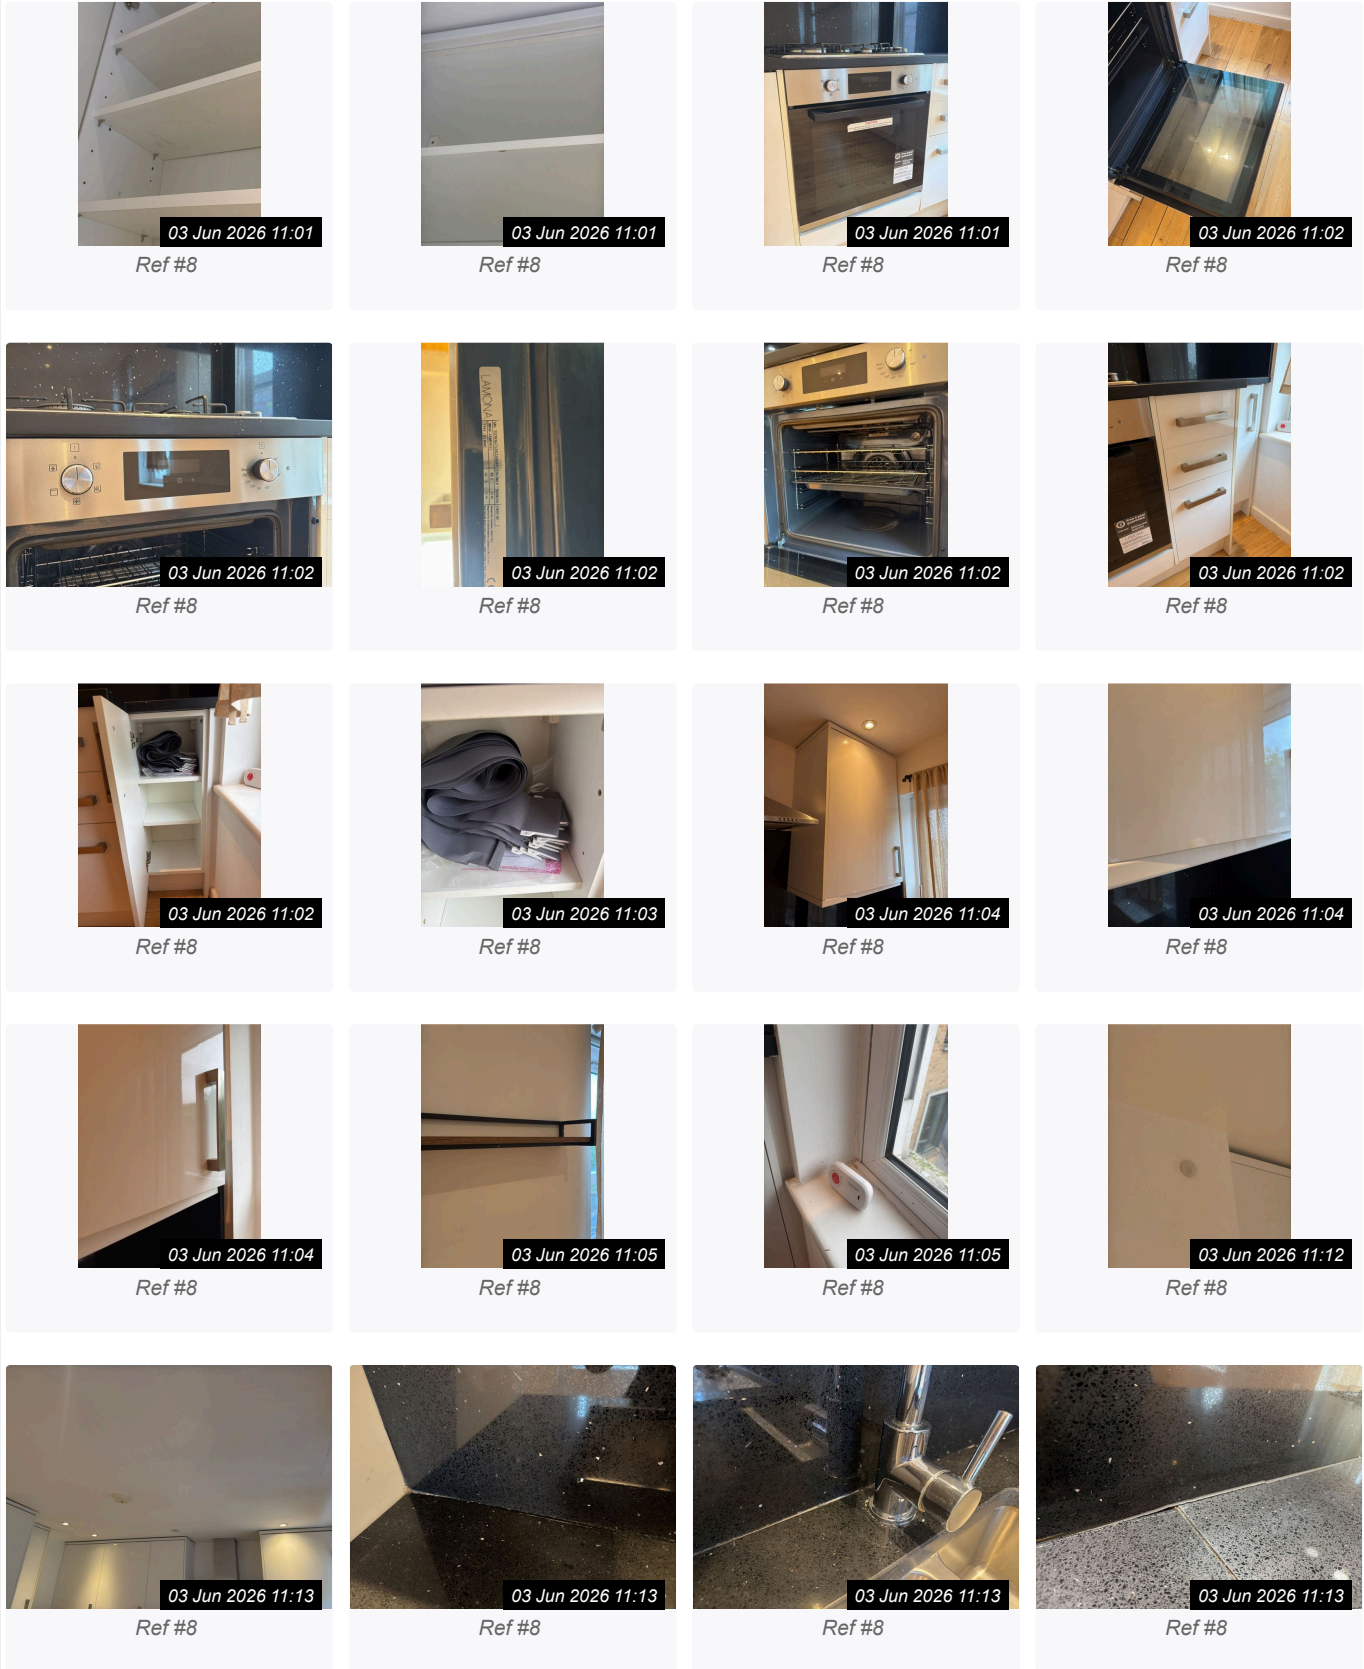
Ref #8

8.4	Lighting	4x spotlights.	<p>1x spotlight not in working order.</p> <p>Needs Replacing - Landlord</p>
8.5	Window(s) / Sill	<p>White uPVC double-glazed sliding sash style, clean frame with smooth finish.</p> <p>White painted wooden or composite sill, flat and level.</p>	Cosmetic wear and light surface marks visible.

8.6	Curtains	<p>Single curtain panel in light beige/cream textured fabric.</p> <p>Metal curtain pole with black finish, wall-mounted above window; securely fixed with brackets..</p>	<p>In used condition,</p> <p>Obstructs boiler cupboard door; pole and fittings loose on wall.</p>

8.10	Worktop(s)	Black worktop finish.	<p>Appears in good condition generally.</p> <p>Black sealant along edges damaged and uneven in places.</p>

8.12	Extractor Hood	<p>Chimney-style extractor hood in brushed stainless steel.</p>	<p>Both filters are heavily greasy, with thick residue and build-up across mesh surfaces.</p> <p>Overall Condition: Structurally sound and controls work correctly. Main issue - filters heavily contaminated with grease, and one bulb failed; otherwise in good order.</p>

8.13	Hob	<p>Built-in gas hob with stainless steel surface and trim, four burner zones, set into black composite worktop.</p> <p>Heavy-duty cast iron pan supports fitted over each burner, all matching and correctly positioned.</p> <p>5x control knobs along front edge.</p>	<p>Control knobs all present, intact and turn smoothly. Ignition button detached/missing, with only the threaded spindle visible.</p> <p>Burners & Components: All burner caps, rings and bases present.</p> <p>Stainless steel surface generally clean, with minor scratches and light marks consistent with normal use; no dents or discolouration.</p> <p>Overall Condition: Functional and structurally sound; only issue - ignition button detached, requiring replacement. Otherwise clean, complete and in good working order.</p> <p style="background-color: #FFC107; padding: 2px; display: inline-block;">Needs Maintenance - Landlord</p>

8.16	Washing Machine	Integrated Hoover. Model: HDB 485D2ACE/1-80; 1400 rpm, 1600 W, IPX4 rated.	<p>Exterior: White casing with chrome door trim; control panel, dial and display all present and intact. Minor scuffs/marks on casing consistent with use.</p> <p>Door & Seal: Large porthole door opens/closes smoothly. Door seal heavily moulded and discoloured, with visible grime, black mould and foul-smelling residue throughout.</p> <p>Detergent Drawer: Fully extendable, clean inside, no damage or blockages; small amount of residual product visible.</p> <p>Interior Drum: Perforated stainless steel drum, clean and free from damage or rust.</p> <p>Overall Condition: Mechanically appears complete, but seal is unserviceable due to heavy mould and odour.</p> <p style="background-color: #FFD700; display: inline-block; padding: 2px 5px;">Needs Replacing - Landlord</p>

Actions Required			
8.13 Open-Plan Kitchen Area » Hob	Needs Maintenance	Landlord	<p>Control knobs all present, intact and turn smoothly. Ignition button detached/missing, with only the threaded spindle visible.</p> <p>Burners & Components: All burner caps, rings and bases present.</p> <p>Stainless steel surface generally clean, with minor scratches and light marks consistent with normal use; no dents or discolouration.</p> <p>Overall Condition: Functional and structurally sound; only issue - ignition button detached, requiring replacement. Otherwise clean, complete and in good working order.</p>

8.16 Open-Plan Kitchen Area » Washing Machine	Needs Replacing	Landlord	<p>Exterior: White casing with chrome door trim; control panel, dial and display all present and intact. Minor scuffs/marks on casing consistent with use.</p> <p>Door & Seal: Large porthole door opens/closes smoothly. Door seal heavily moulded and discoloured, with visible grime, black mould and foul-smelling residue throughout.</p> <p>Detergent Drawer: Fully extendable, clean inside, no damage or blockages; small amount of residual product visible.</p> <p>Interior Drum: Perforated stainless steel drum, clean and free from damage or rust.</p> <p>Overall Condition: Mechanically appears complete, but seal is unserviceable due to heavy mould and odour.</p>

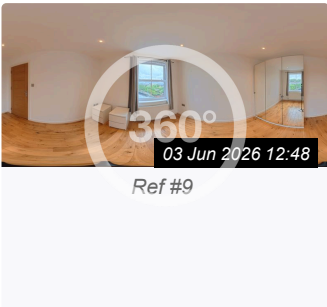
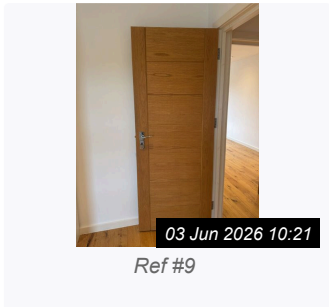
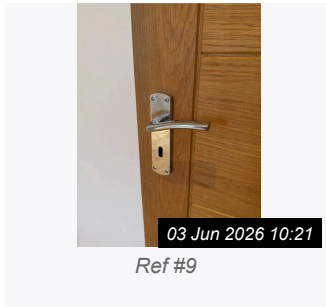
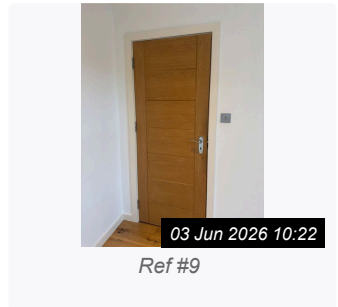
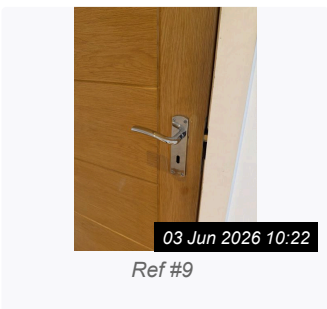
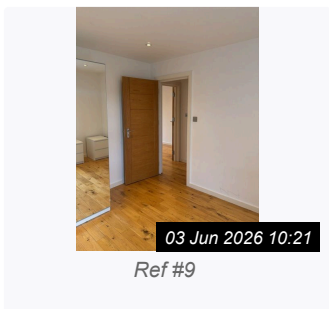
9. BEDROOM 1 (CONT.)			
9.3	Door Frame	White-painted.	Dirt and scuff marks visible across all sections, showing general wear and use.
9.4	Walls	White-painted.	Scuff marks, painted-over defects and light shading/discolouration visible across various areas including around the windows and above curtain pole; surfaces generally sound but show signs of wear and previous repairs.

9.7	Skirting	White-painted.	Sealant along the join between skirting board and flooring damaged, cracked, peeling or missing all around the room; gaps visible in multiple sections. Section directly beneath the radiator - visible damage including cracking, chipping and peeling paint; surface broken and uneven. Sealant along the edge is also damaged and incomplete.

9. BEDROOM 1 (CONT.)			
9.13	Heating	White panel radiator fitted beneath window; TRV valve on left side, standard valve on right.	<p>Pipes and connections secure.</p> <p>Surface has minor scuffs and light marks; skirting board directly underneath shows damage and indentation. No leaks, dents, though some rust visible; appears fully functional.</p>

9.16	Bedside Tables	Pair of white wooden units, each with flat top and two drawers.	<p>Scuffs and marks visible on the top surface of both tables.</p> <p>Top drawer on the right-hand unit is stiff to open and close; all other drawers operate smoothly. No other damage or defects noted.</p>

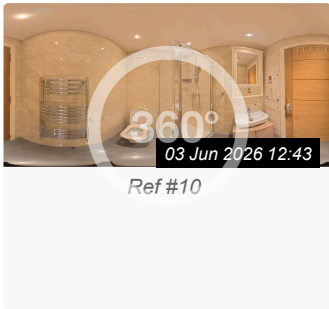
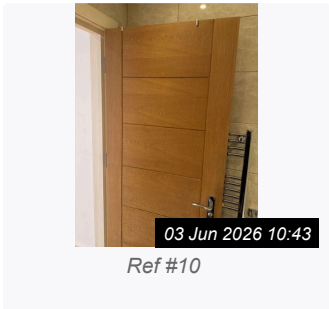
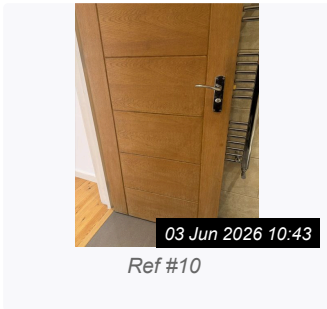
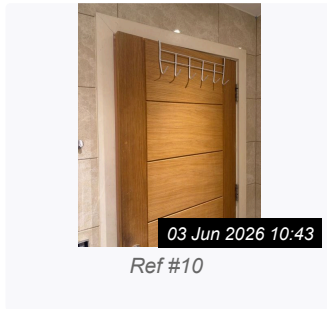
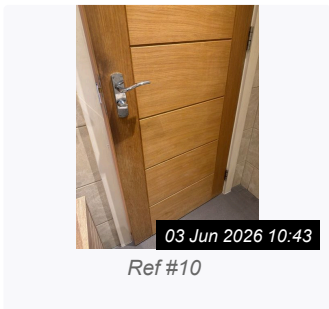
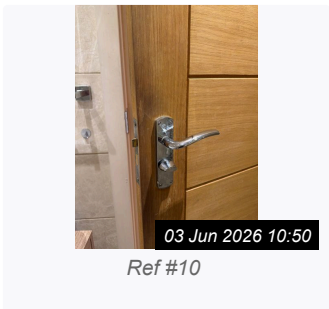
10. BATHROOM (CONT.)			
10.6	Flooring		<p>Grouting damaged: floor tiles near WC, top of right-hand tile at entry, upper corner of shower cubicle above shelf.</p> <p>1x chip to floor tile - left-hand side near entry.</p>

10.7	Lighting	3x Spotlights.	All in good, working order.
10.8	Extractor Fan	Unbranded fan.	All in good, working order.
10.9	Toilet	White ceramic, clean finish; cistern with top push-button flush, operates correctly.	<p>Flushes well; seat loose and noticeably yellowed/ discoloured; slight staining visible inside pan.</p> <p>Makes thumping noise after flushing. No cracks or leaks.</p> <p>Needs Maintenance - Investigate</p> <p>Needs Replacing - Landlord</p>

10.10	Basin / Tap	<p>Basin: White ceramic, clean, no visible cracks or damage.</p> <p>Tap: Chrome mixer.</p>	Crack on inner left-hand side; mixer tap works; square pop-up plug working; unbranded chrome tap with limescale below and around it.

10.10.1	-	Brown under-sink cabinet.	Generally good, damage to top right section.
10.11	Shower Unit / Cubicle	<p>Glass panels with chrome frames, white acrylic tray; mixer bar, riser rail, handset and hose.</p> <p>Black corner shelf and soap dish fitted.</p>	<p>Large light beige gloss tiles; grout damaged/ missing at internal corner, also damaged above shelf and generally discoloured.</p> <p>Mould on sealant; limescale on mixer and head; yellowing around drain. No cracks or leaks; structurally sound.</p> <p>Frames & Seals: Chrome frames and base tracks show rust and heavy limescale build-up, especially at corners, joints and seal edges.</p> <p>Fittings: Mixer valve, handset and hose have significant limescale deposits; shower head nozzles heavily blocked and encrusted.</p> <p>Structure: Glass and tray intact; no cracks or leaks, but metalwork and fittings badly marked and scaled.</p>

10.14	Heating	1x Chrome towel rail.	<p>Loose / moving, top fittings insecure; door strikes it - risk of damage.</p> <p>Needs Maintenance - Landlord</p>

10.9 Bathroom » Toilet	Needs Maintenance	Investigate	<p>Flushes well; seat loose and noticeably yellowed/discoloured; slight staining visible inside pan.</p> <p>Makes thumping noise after flushing. No cracks or leaks.</p>
