Inventory & Check In

Property inspected by A. Clerk

123 Preview Street
Sample City
London
AB1 2CD

June
3rd 2026
10:00

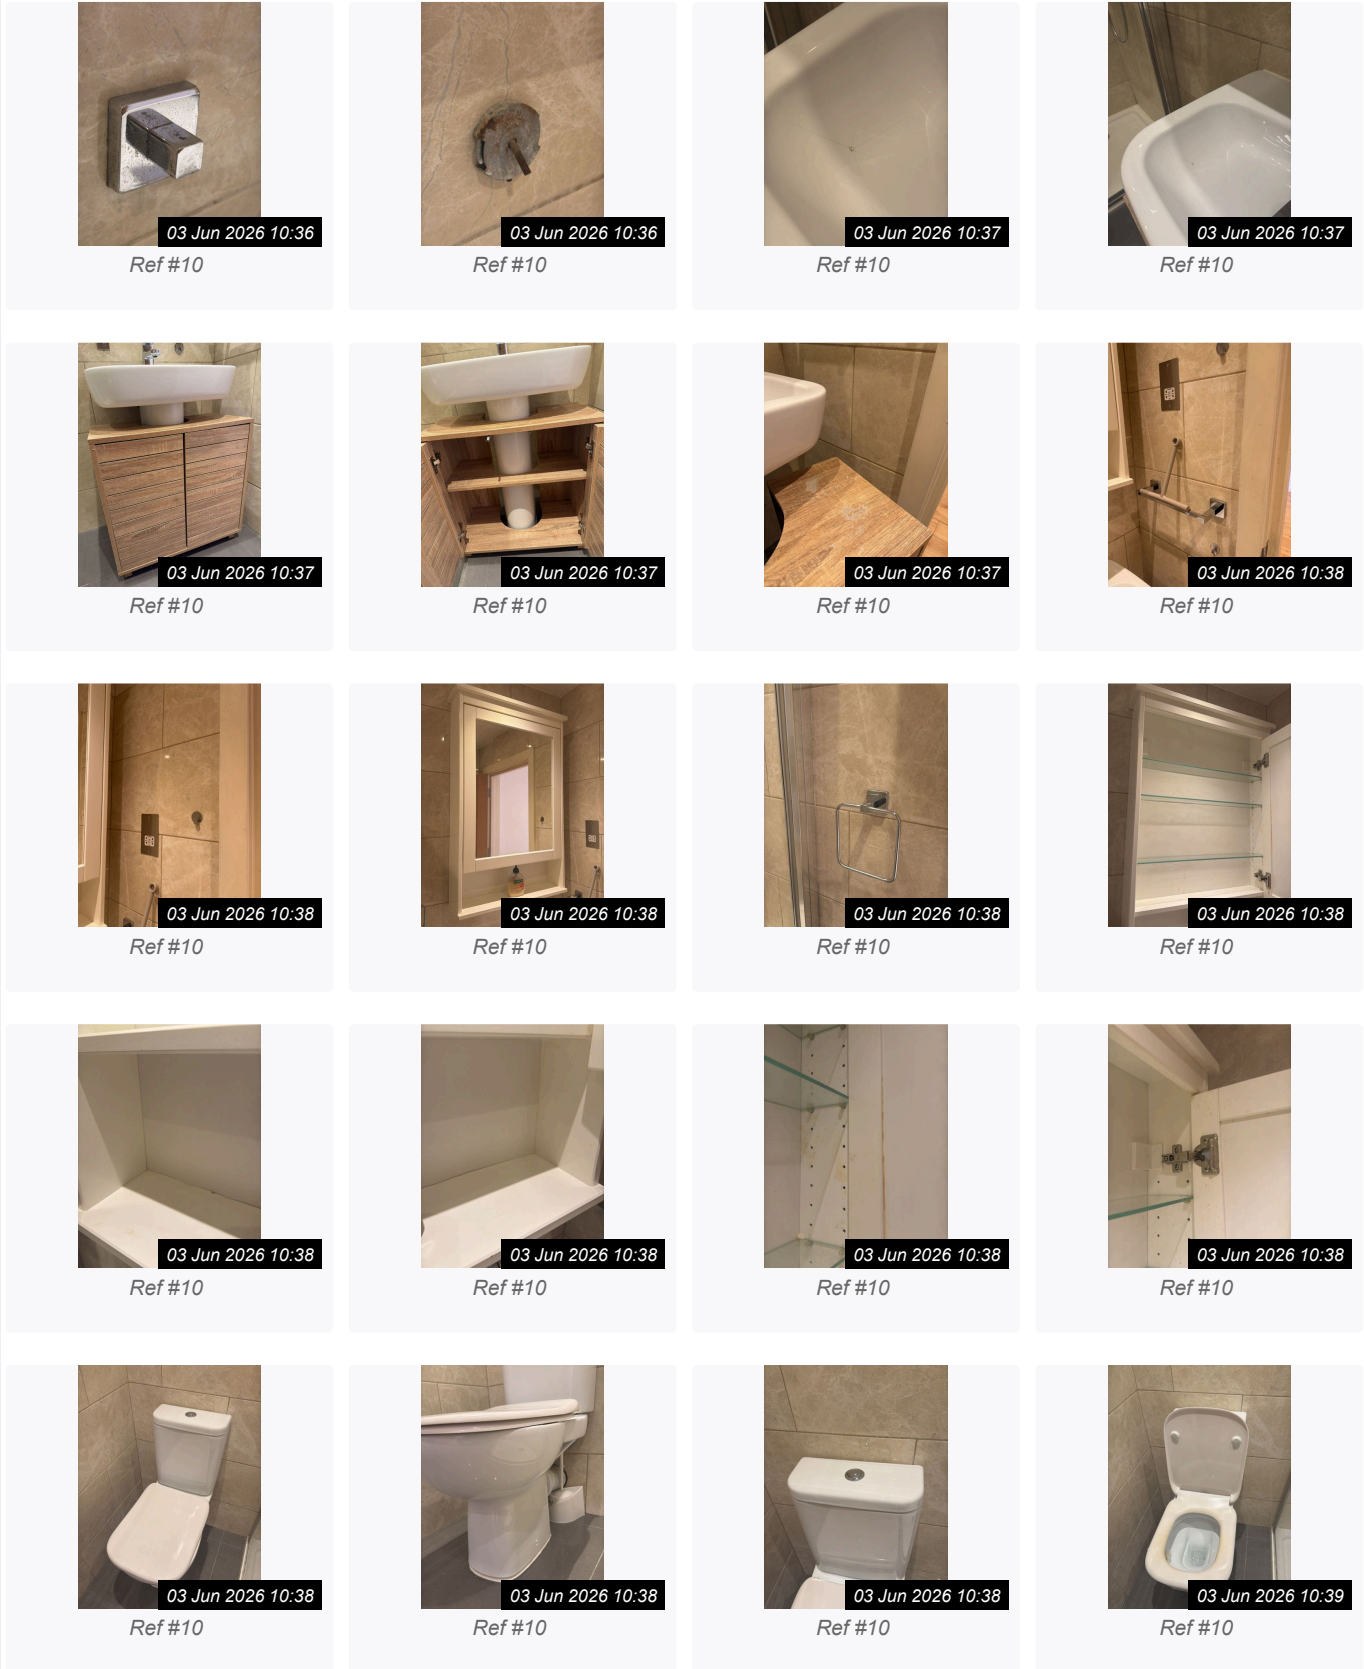
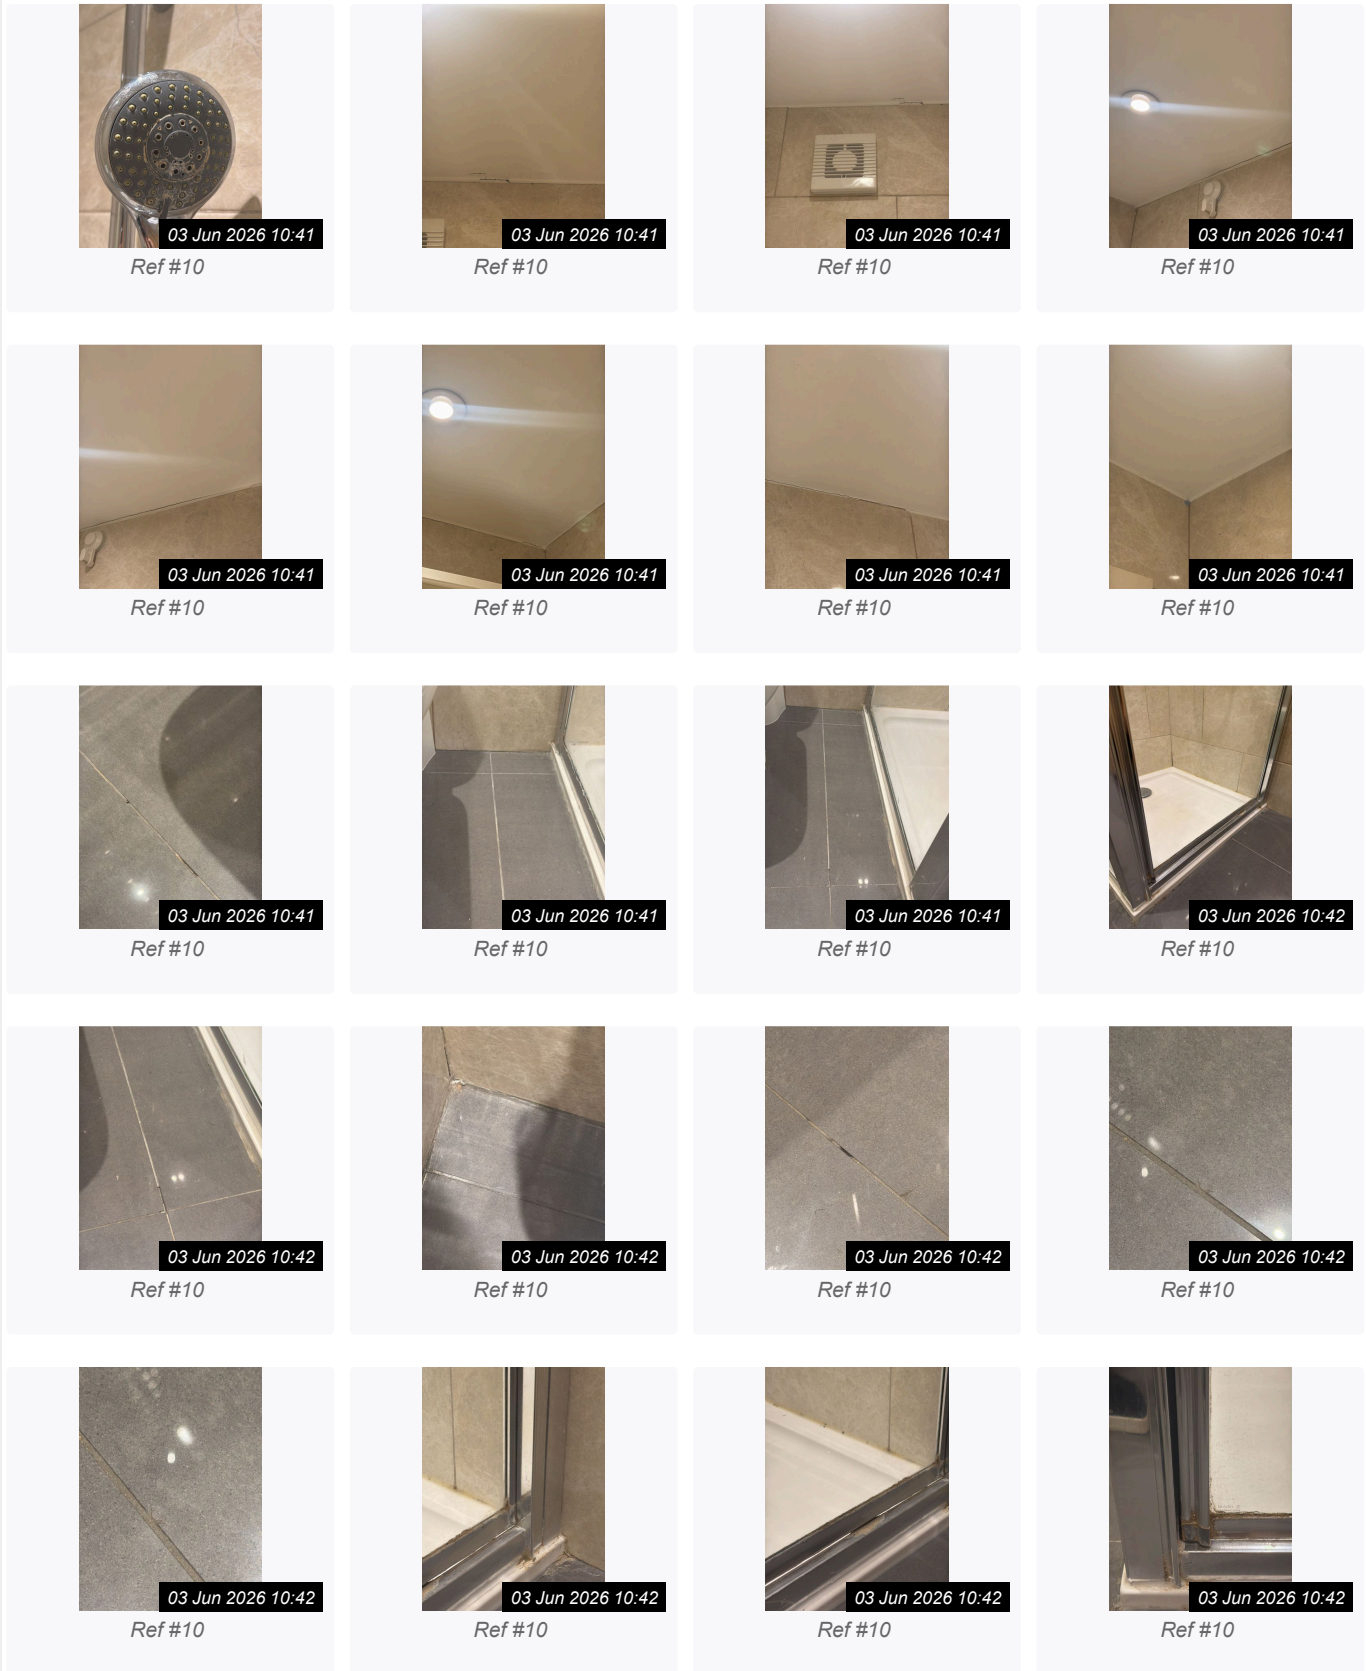
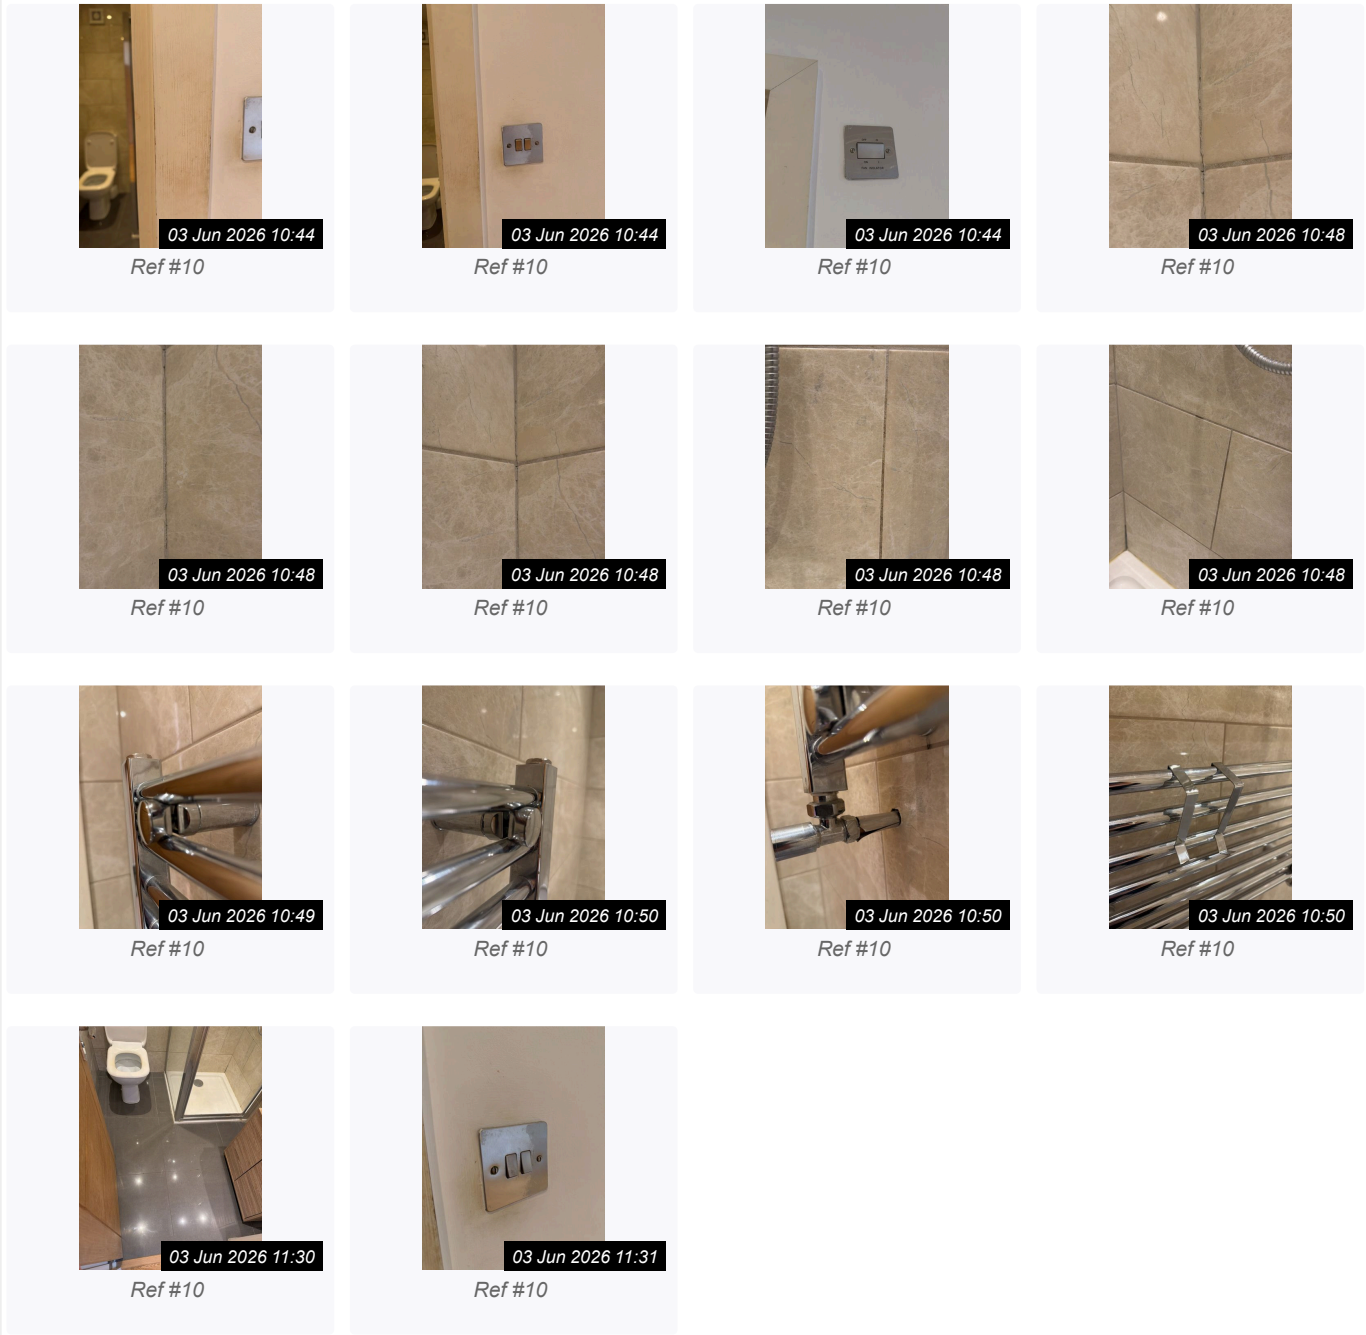
Ref	Name	Description	Condition
10.1	General Overview		The bathroom is functionally complete with all main fittings present and operational, but shows clear signs of age, use and maintenance needs. Key issues include grout damage and discolouration, limescale build-up, rust, mould on sealants, minor surface damage, water staining, loose fittings and cosmetic wear throughout. No major structural damage or leaks are present.
10.2	Door	Wooden door with chrome handles.	Shading/discolouration, more noticeable inside above handle.
10.3	Door Frame	White-painted.	Dirt and scuff marks visible across all sections.
10.4	Walls	Square/rectangular ceramic tiles, light neutral (white/cream) colour with smooth gloss finish.	Grouting discoloured on wall tiles to multiple places.
10.5	Ceiling	White-painted,	Appears in good condition.

10. BATHROOM (CONT.)			
10.6	Flooring		<p>Grouting damaged: floor tiles near WC, top of right-hand tile at entry, upper corner of shower cubicle above shelf.</p> <p>1x chip to floor tile - left-hand side near entry.</p>

10.7	Lighting	3x Spotlights.	All in good, working order.
10.8	Extractor Fan	Unbranded fan.	All in good, working order.
10.9	Toilet	White ceramic, clean finish; cistern with top push-button flush, operates correctly.	<p>Flushes well; seat loose and noticeably yellowed/ discoloured; slight staining visible inside pan.</p> <p>Makes thumping noise after flushing. No cracks or leaks.</p> <p>Needs Maintenance - Investigate</p> <p>Needs Replacing - Landlord</p>

10.10	Basin / Tap	<p>Basin: White ceramic, clean, no visible cracks or damage.</p> <p>Tap: Chrome mixer.</p>	Crack on inner left-hand side; mixer tap works; square pop-up plug working; unbranded chrome tap with limescale below and around it.

10.14	Heating	1x Chrome towel rail.	<p>Loose / moving, top fittings insecure; door strikes it - risk of damage.</p> <p>Needs Maintenance - Landlord</p>

10.9 Bathroom » Toilet	Needs Maintenance	Investigate	<p>Flushes well; seat loose and noticeably yellowed/discoloured; slight staining visible inside pan.</p> <p>Makes thumping noise after flushing. No cracks or leaks.</p>
