# Inventory & Check In

Prepared on behalf of Example Lettings Ltd

123 Preview Street  
Sample City  
London  
AB1 2CD

**October  
9th 2026**

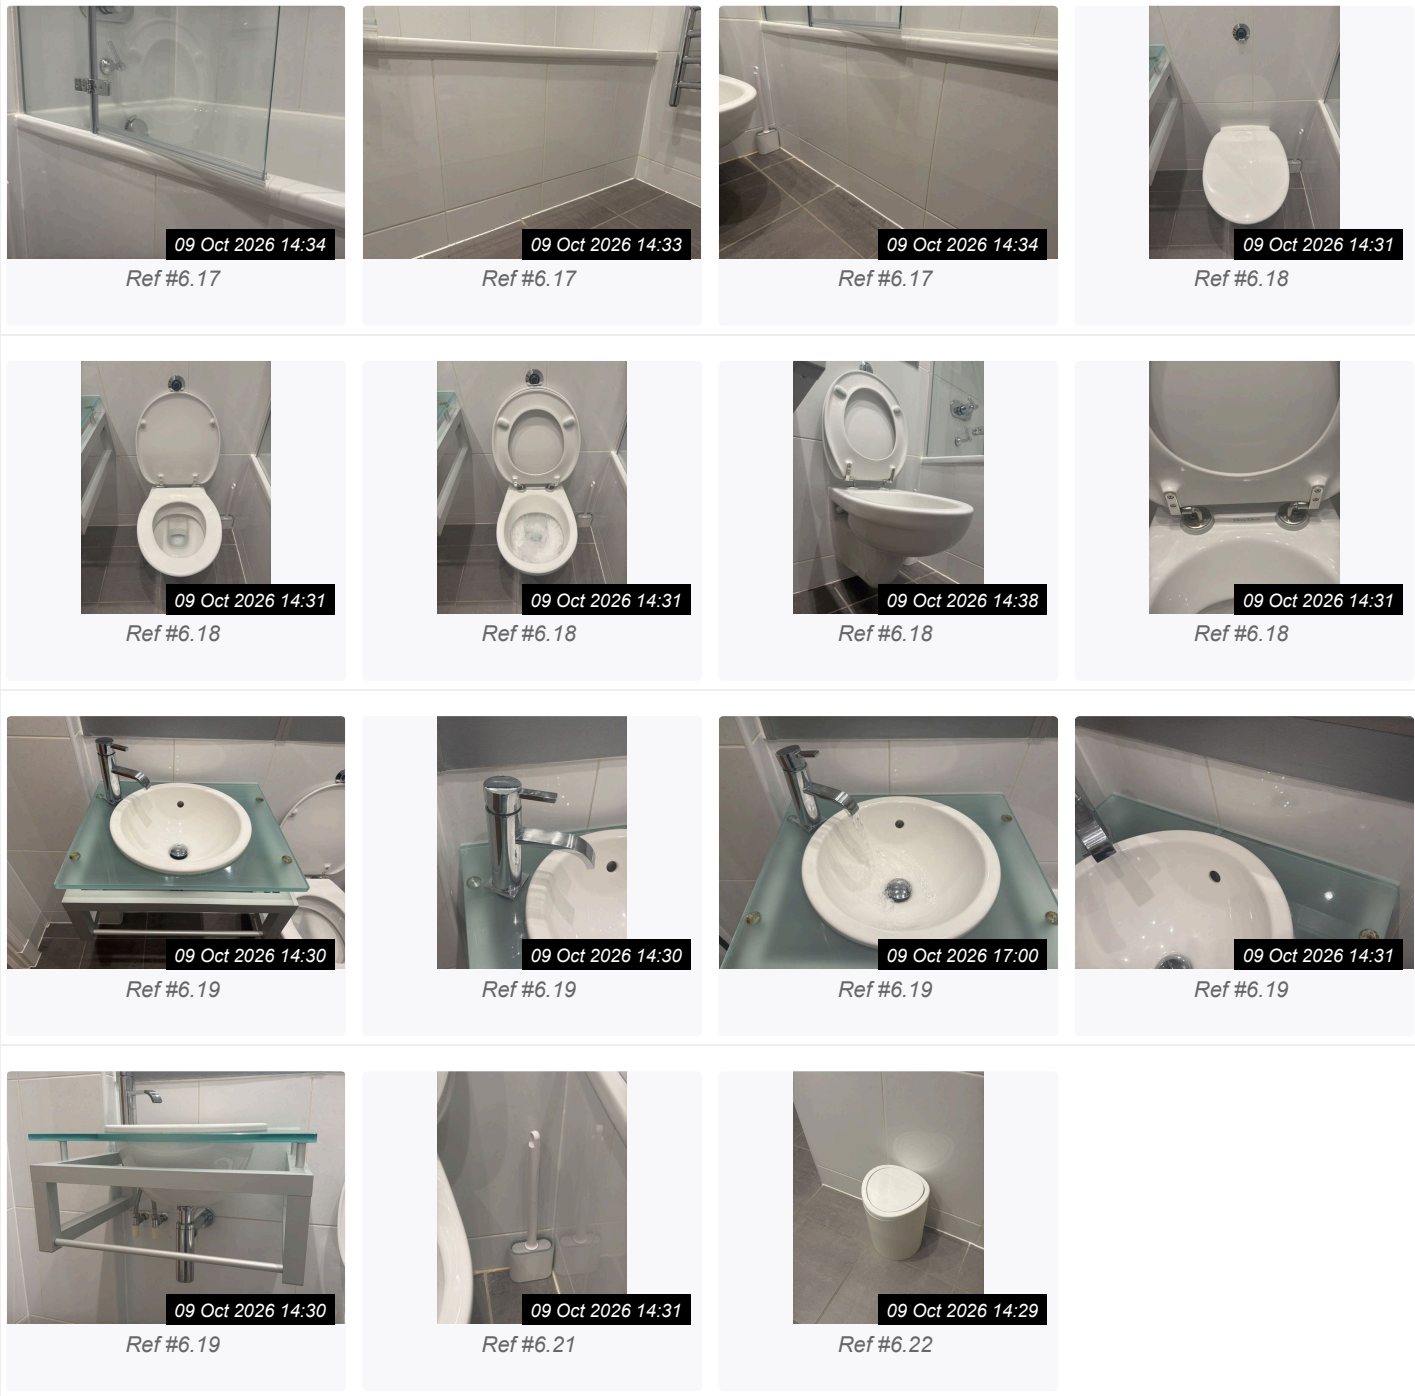
09 Oct 2026 14:36  
Ref #6.17

| 6.17 | Bath / Bath Panel | White ceramic bath.<br>Hansgrohe bath/shower mixer control.<br><br>Fixed overhead shower head and arm.<br><br>Bath pop-up waste and operating mechanism.<br><br>Folding glass shower screen.<br><br>Tiled front panel section. | In good overall condition - no damage/chips visible.<br>Tested - in full working order.<br>Mould growth visible to inner clear seal.<br>Tested - in full working order.<br>- Shower head detached from wall mounting; arm still fixed; unit intact otherwise.<br>Pop-up waste in working order; operates via mechanism on bath rim; clear, no leaks.<br>Fixings secure; glass undamaged, hinges functional. |

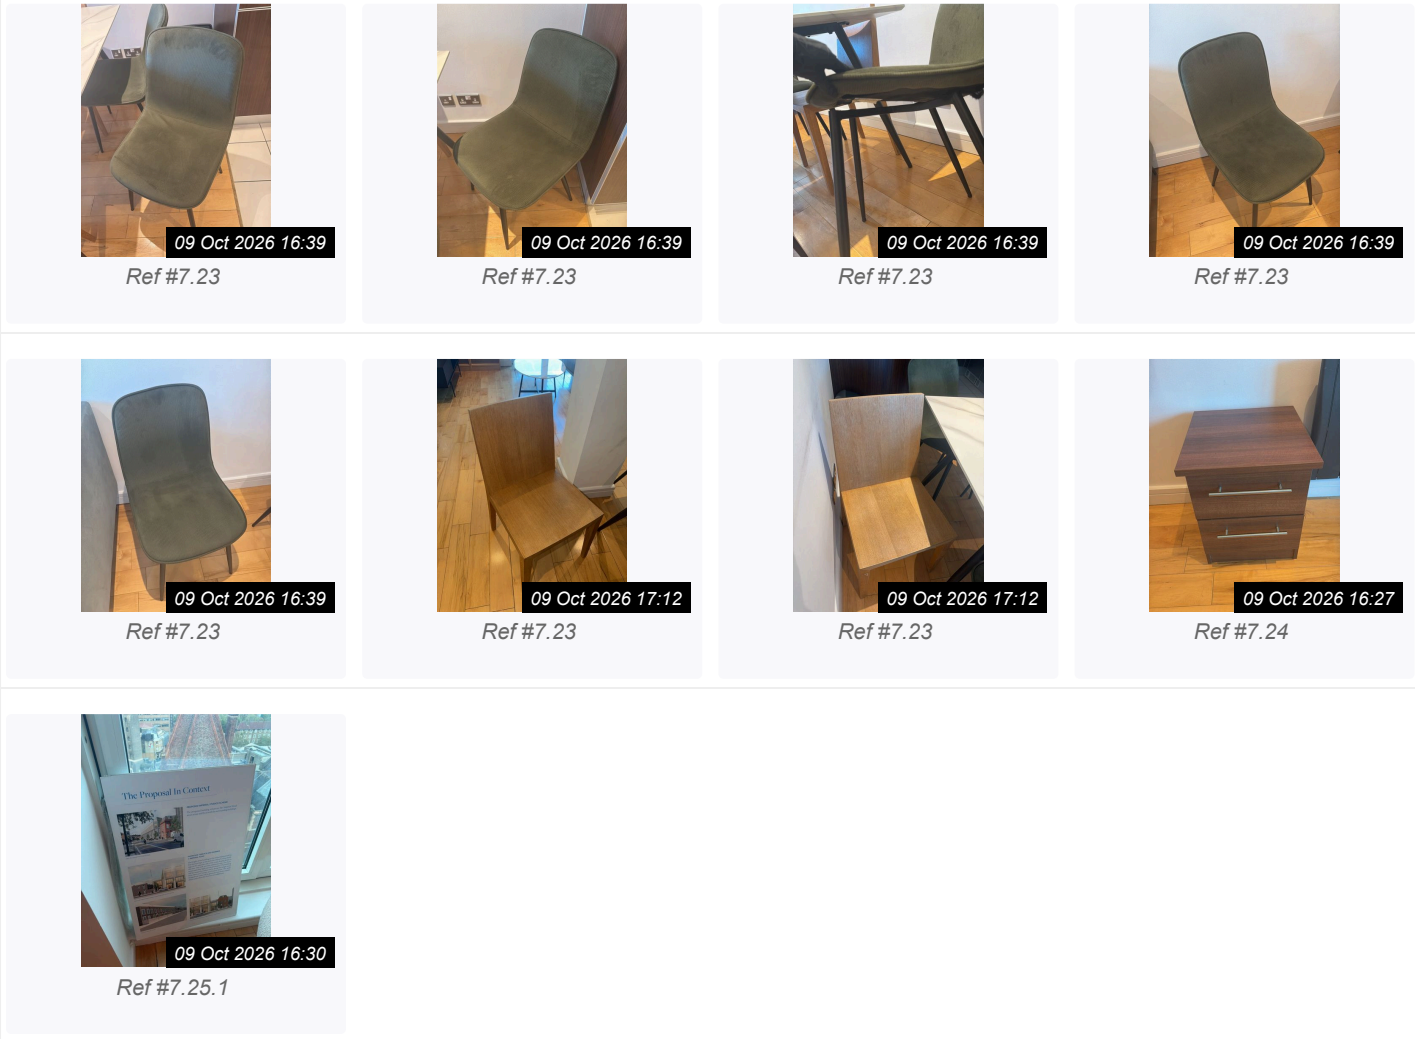
| <p>09 Oct 2026 16:38</p> <p>Ref #7.23</p> | <p>09 Oct 2026 16:40</p> <p>Ref #7.23</p> | <p>09 Oct 2026 16:40</p> <p>Ref #7.23</p> | <p>09 Oct 2026 16:40</p> <p>Ref #7.23</p> |

| 7.23 | Dining Table & Chairs | Dining table: white marble-effect top, black metal legs; vinyl protective cover fitted.<br>4x Green/grey fabric/suede dining chairs.<br>2x Light wood dining chairs. | Vinyl/protective cover: A few pink scuff lines visible; small imperfections scattered in places.<br><br>Small white stains seen to suede chairs in places.<br>One seat detached from frame. |

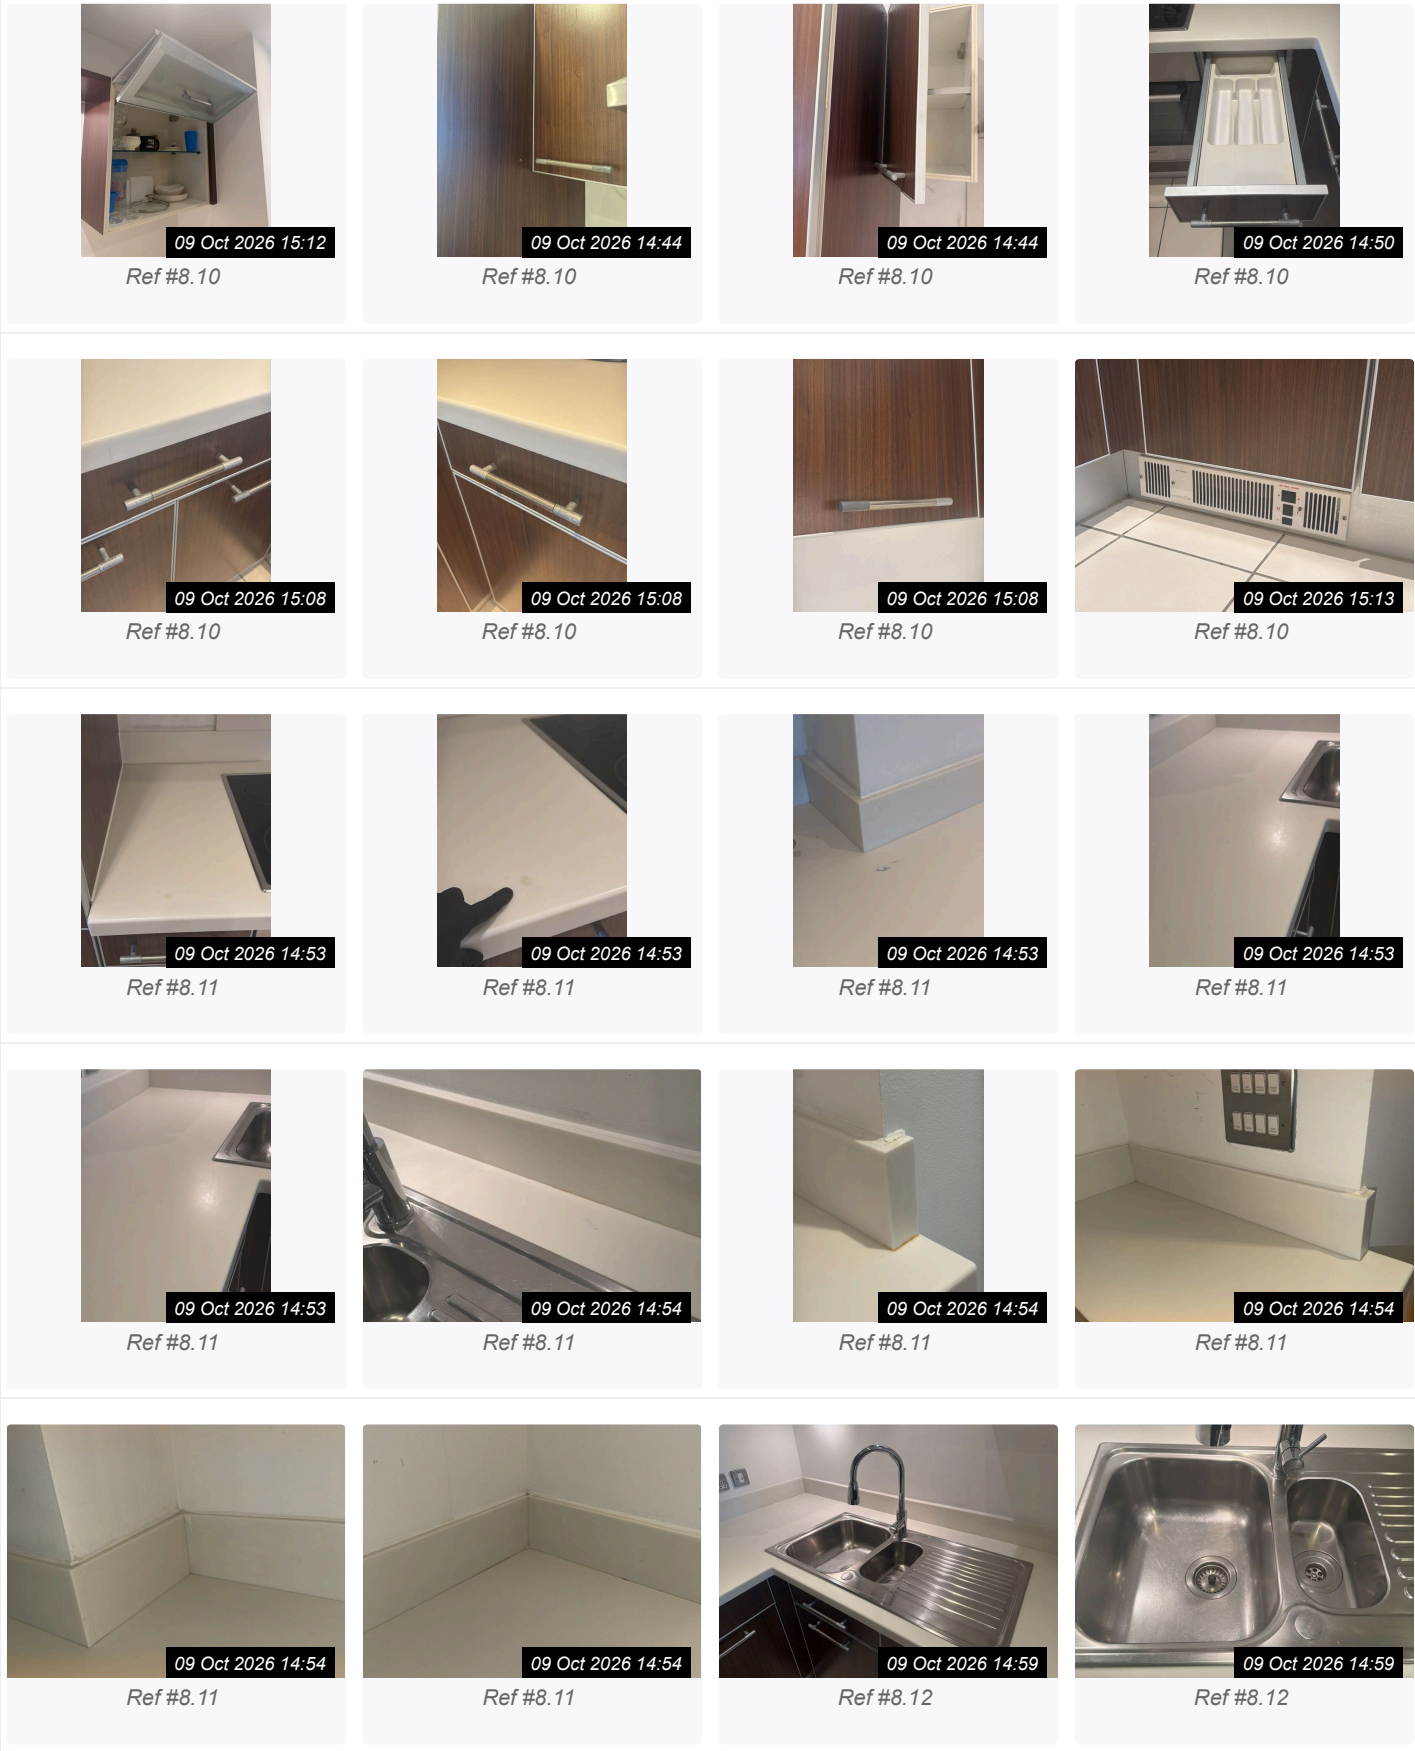
| <p>09 Oct 2026 14:43</p> <p>Ref #8.9</p> | <p>09 Oct 2026 14:44</p> <p>Ref #8.10</p> | <p>09 Oct 2026 14:44</p> <p>Ref #8.10</p> | <p>09 Oct 2026 14:44</p> <p>Ref #8.10</p> |

| 8.10 | Kitchen Units | Dark walnut-effect veneer finish.<br>Glazed 2-door wall unit (recessed frosted glass).<br><br>20x Chrome bar-style handles (includes fridge & dishwasher).<br><br>1x Drawer with white plastic cutlery insert.<br><br>Silver-finish kickboard/plinth.<br>Kickspace heater unit beneath cabinetry. | Top cabinet door - RHS of fridge: Handle contacts cabinetry on closing. One dent visible.<br>Corner folding top cabinet door RHS - Not aligned. Does not sit flush to frame.<br>Edges tarnished on all handles.<br><br>In good condition.<br><br>Appears in good condition.<br>Control panel intact. Grille clean. Full function not tested. |

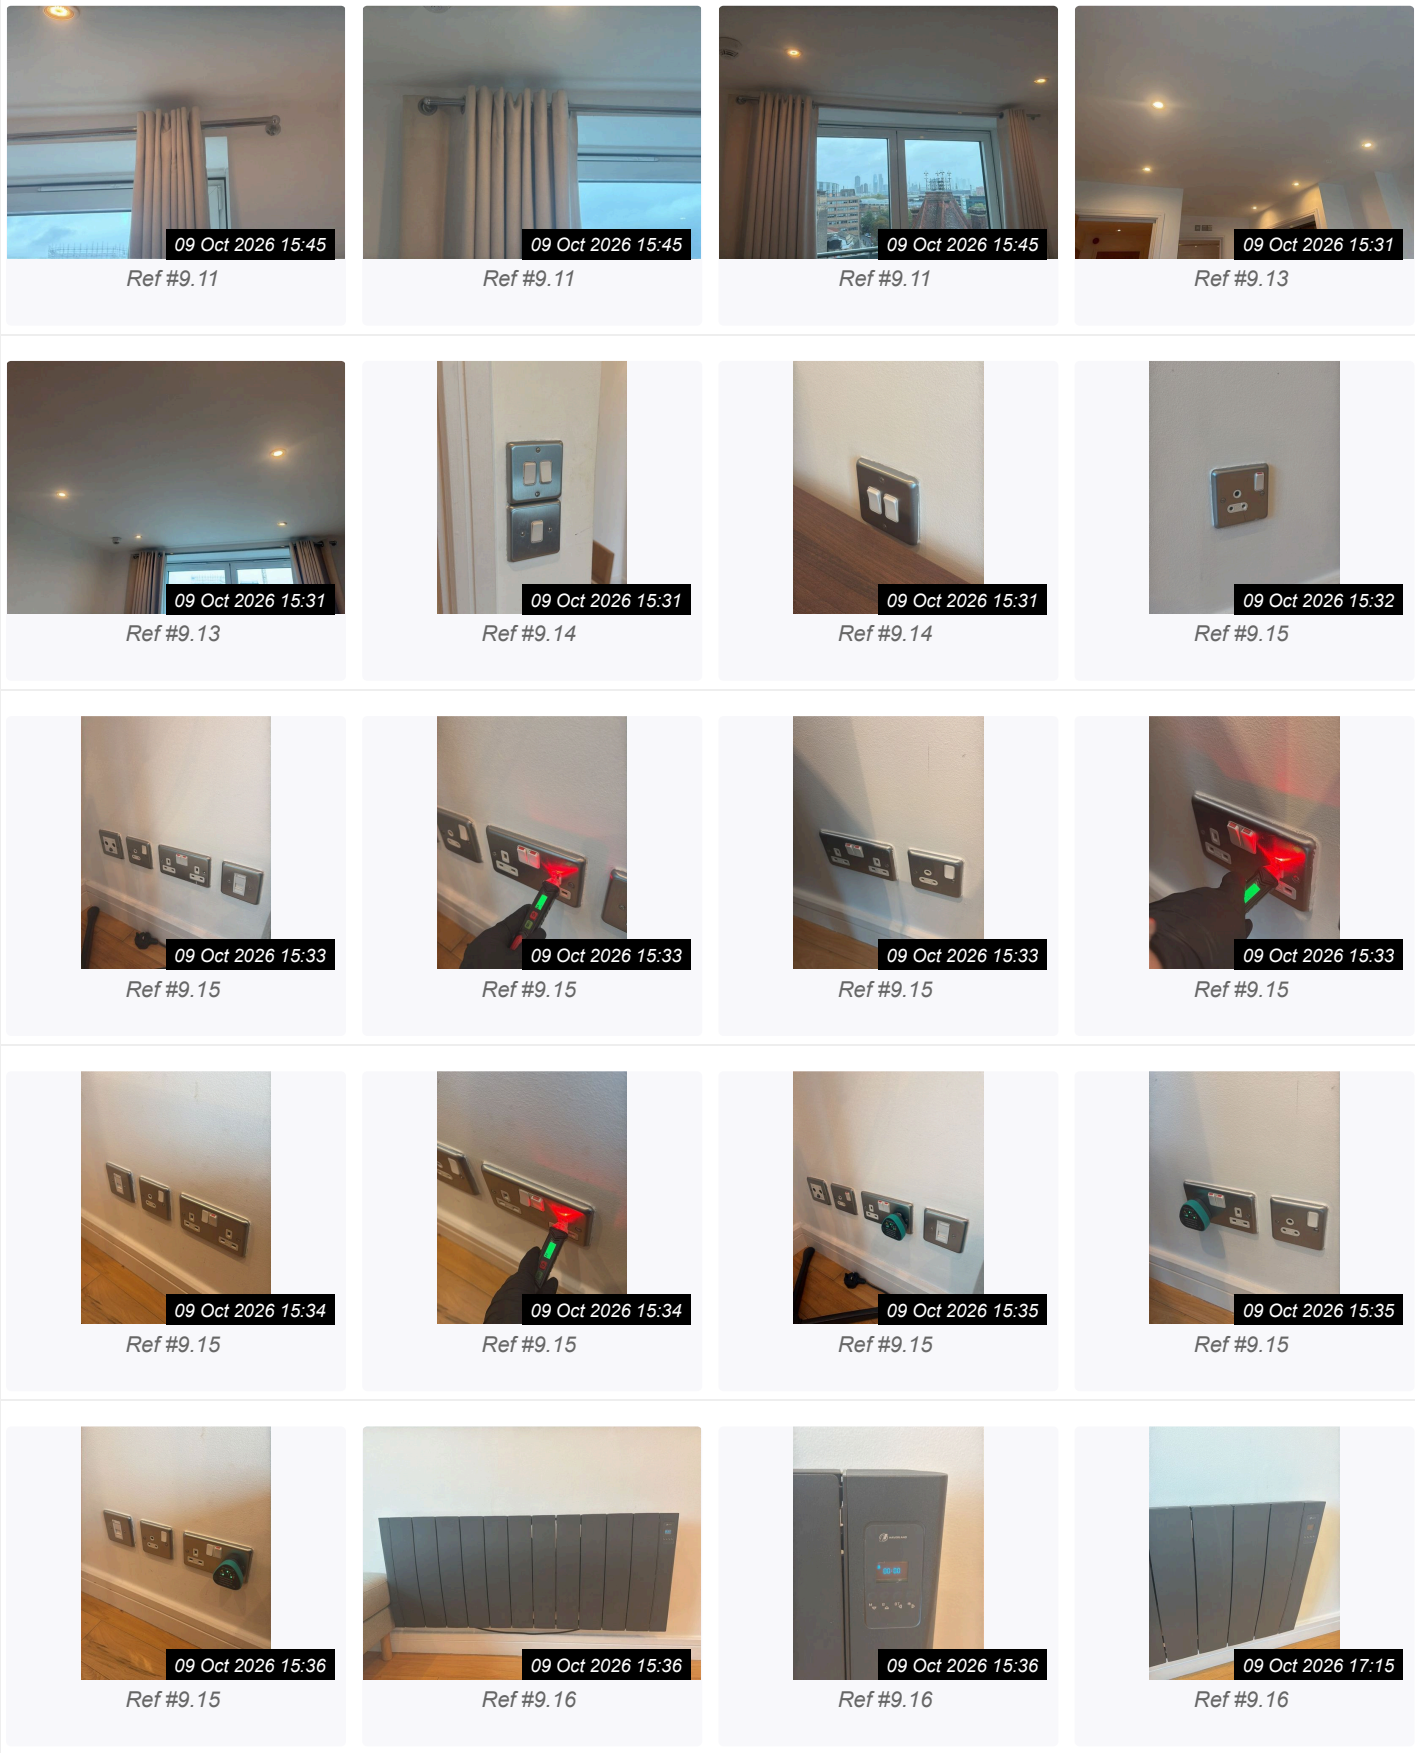
09 Oct 2026 15:29  
Ref #9.11

| 9. BEDROOM ONE (LEFT-HAND SIDE) | | | |
|---|---|---|---|
| 9.11 | Curtains | Pair of beige suede-effect curtains.<br><br>Polished chrome curtain pole. | Dark shading / discolouration across top section of both curtains.<br>Small orange and brown stains scattered on outer lining, both sides.<br>Pole appears slightly warped at the centre. |
