Pallet Wrapper Interim Service Report

Service x1 _____ **Service - MHFG** _____

Youngsun _____ **MHFG-2000B** _____ **2021** _____ **Yes** _____

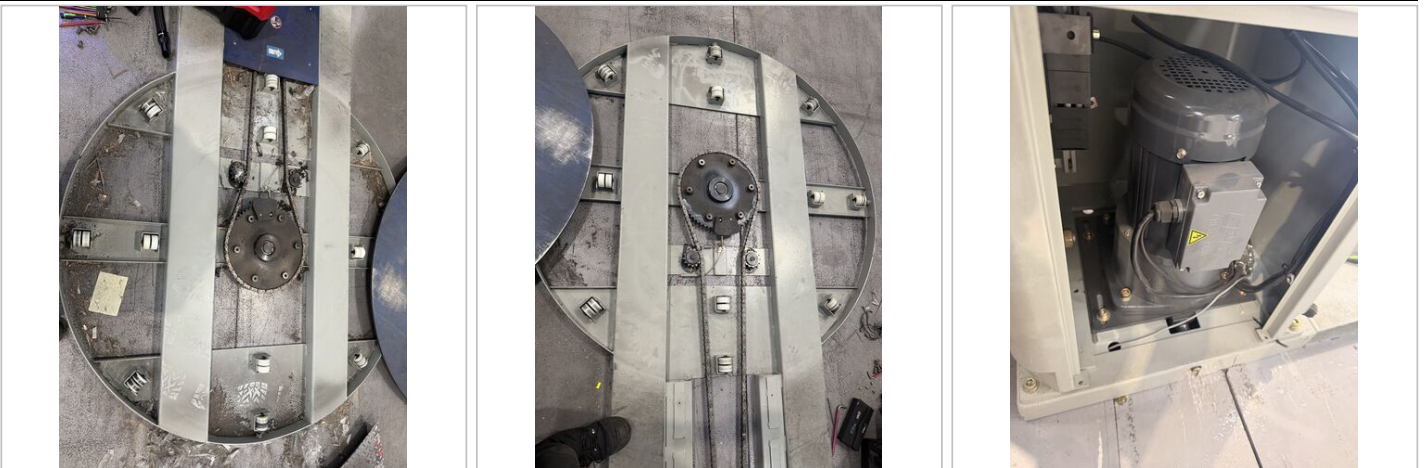
Turntable photos

Turntable chain loose, adjusted accordingly, customer had to move the machine to allow access to the tension assembly. Chain lubricated and contaminants cleared out.

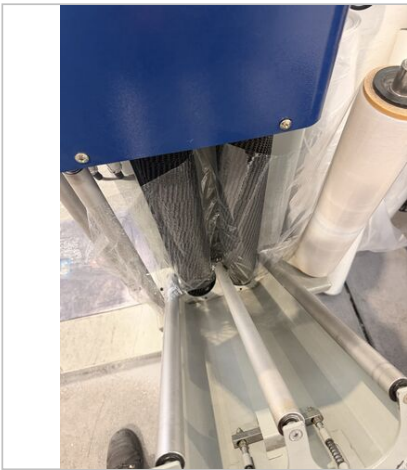
Correct way to load film
11 Jun 2026 11:20

Customer reported shaft missing for hinge on door. This has been repaired but will require replacing next service. Hinge is operational. Customer has the film loaded incorrectly, this has been shown to operators to get proper tension from the film and stretch.

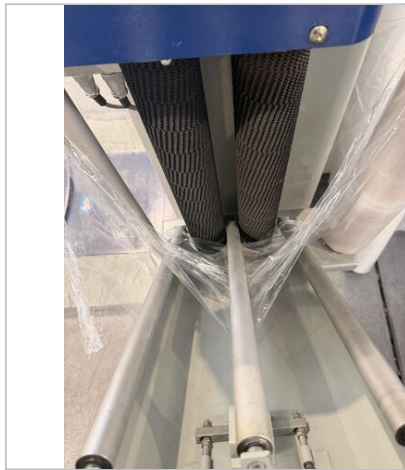
Incorrect way to load film
11 Jun 2026 11:20

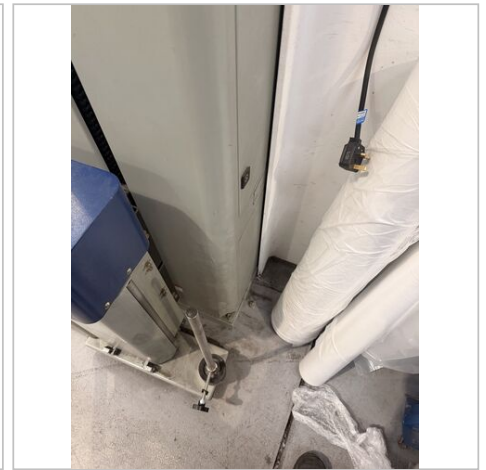
Machine to close to pillar to allow for maintenance of the internals of the machine
11 Jun 2026 11:20

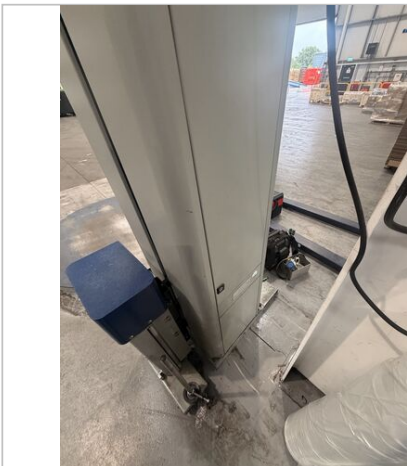
Moved and repositioned
11 Jun 2026 11:20

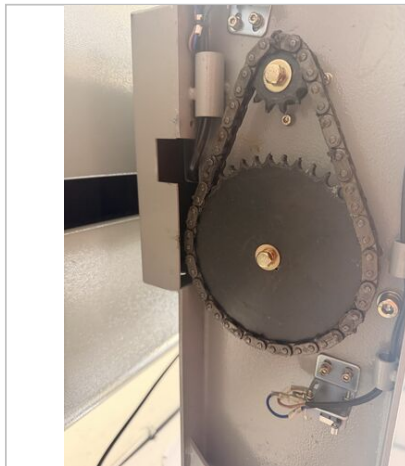
Stretch chain all okay
11 Jun 2026 11:21

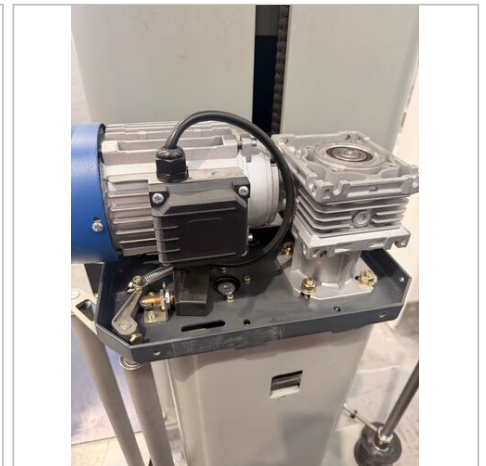
All okay
11 Jun 2026 11:21

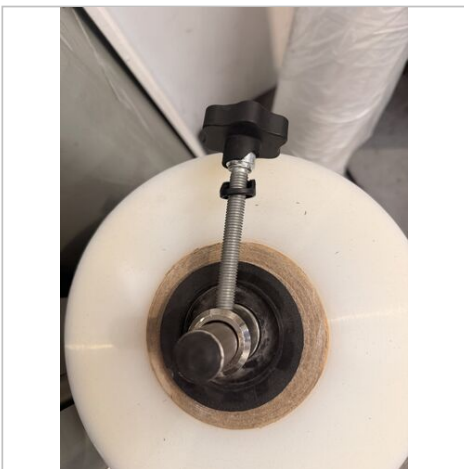
Top handle plastic broken, still functional
11 Jun 2026 11:21
