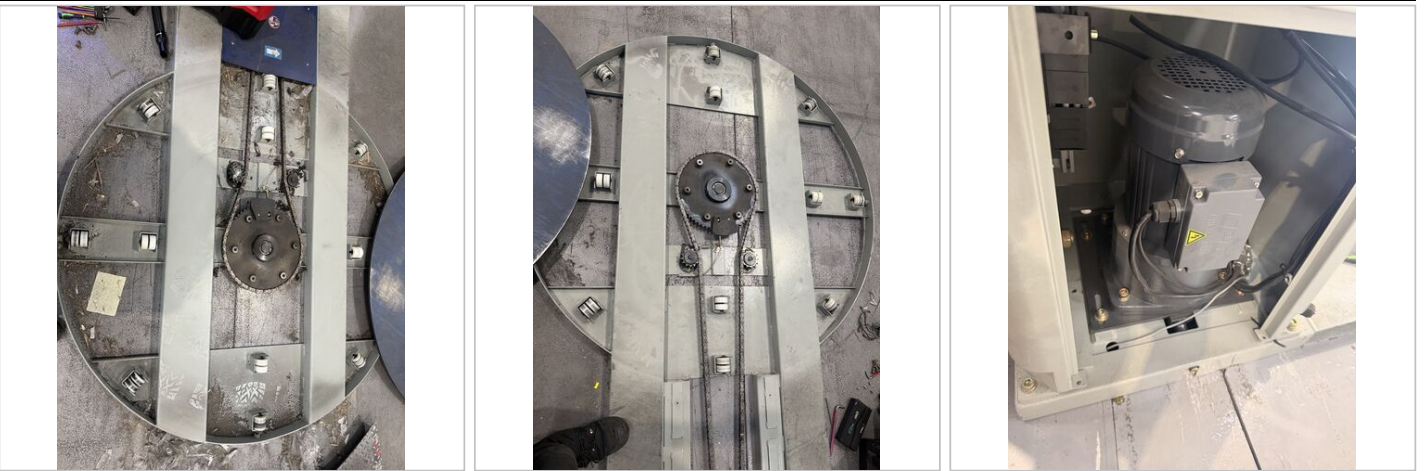
Turntable photos

Turntable chain loose, adjusted accordingly, customer had to move the machine to allow access to the tension assembly. Chain lubricated and contaminants cleared out.
