Report and Load Survey of: Turnlok loading bay scaffold components

Document number: *TES000142*
Client: *VR Access Solutions Ltd*

Report number TES000142: VR Access solutions Ltd

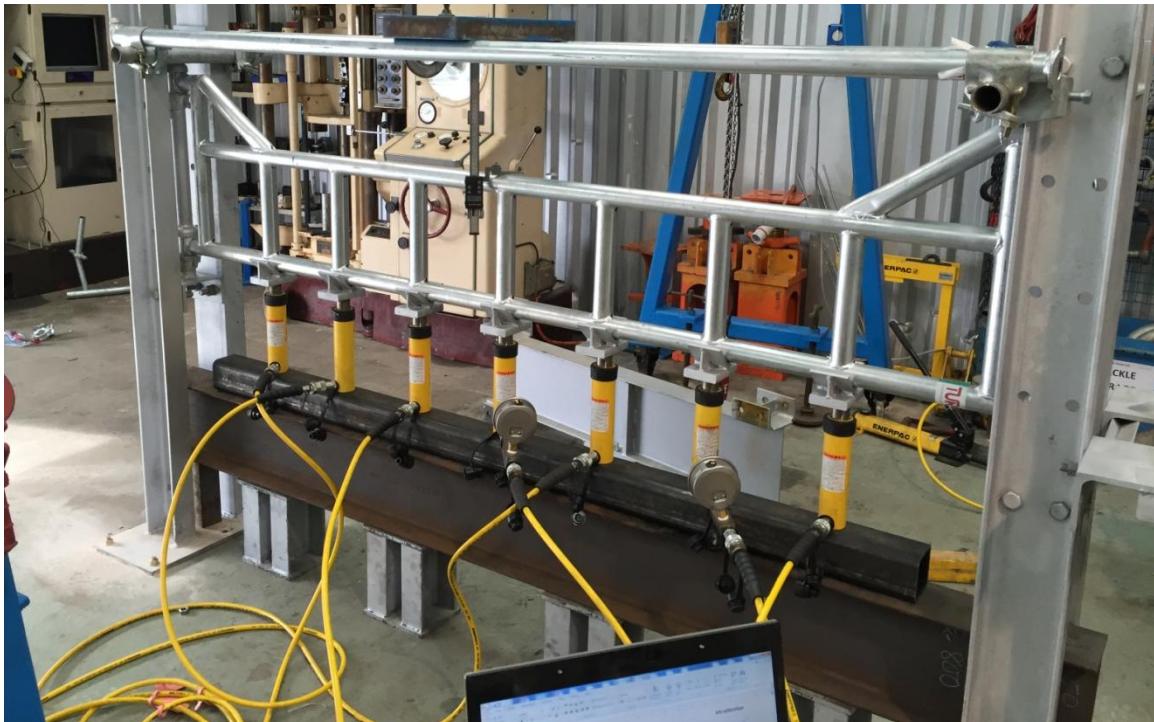
Typical image of Load Bay Beam test assembly

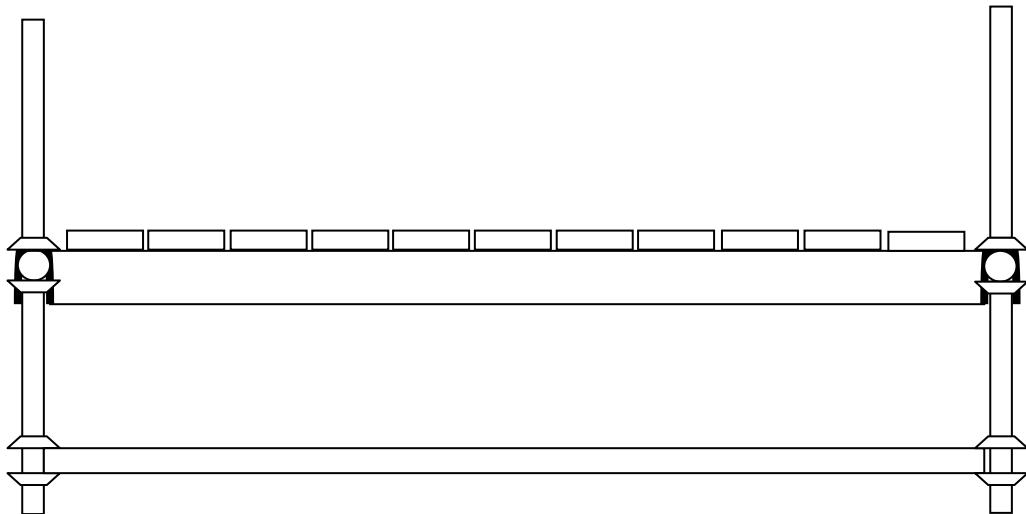
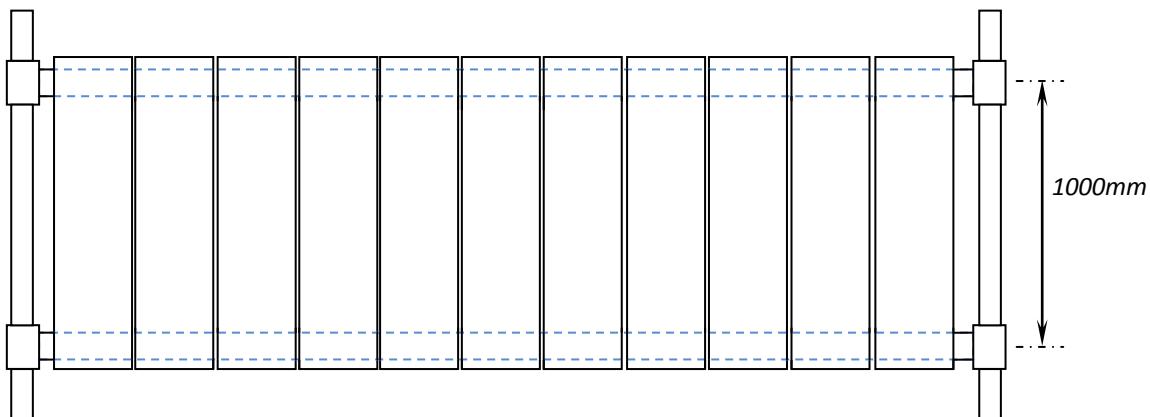
1.3.1. Typical diagram of board bearer assembly.

SHS beam bearers subject to a Uniformly distributed load applied across a pair of beams set at a distance of 1000mm centres, dynamic live mass application applied at a SLS & ULS condition.

Arrangement as per 1.3.1.

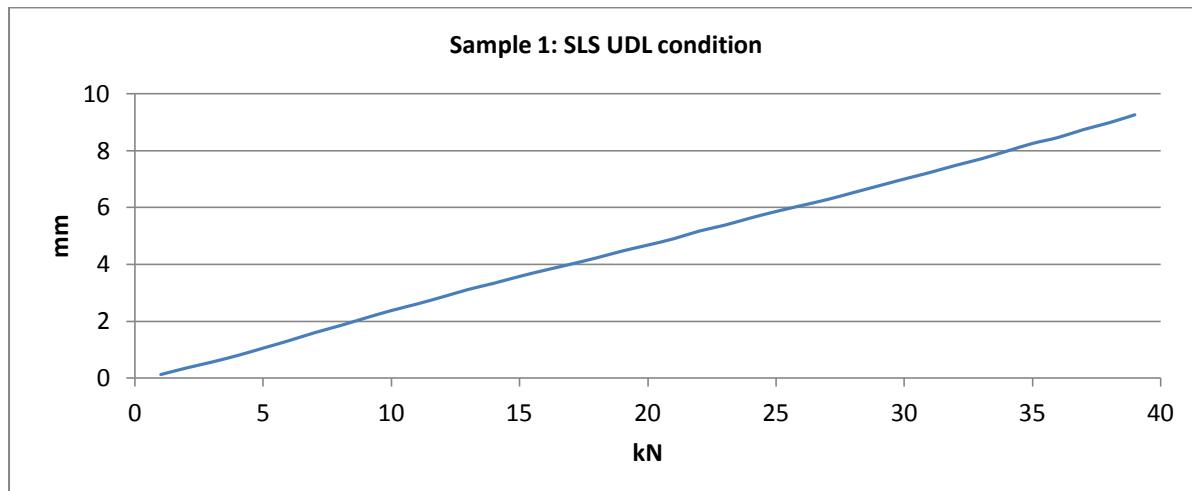
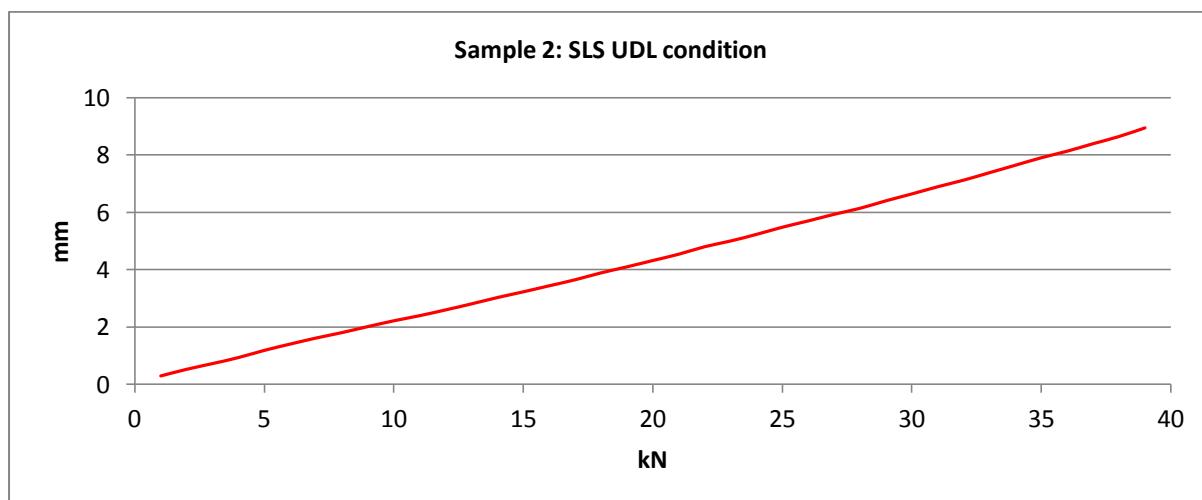
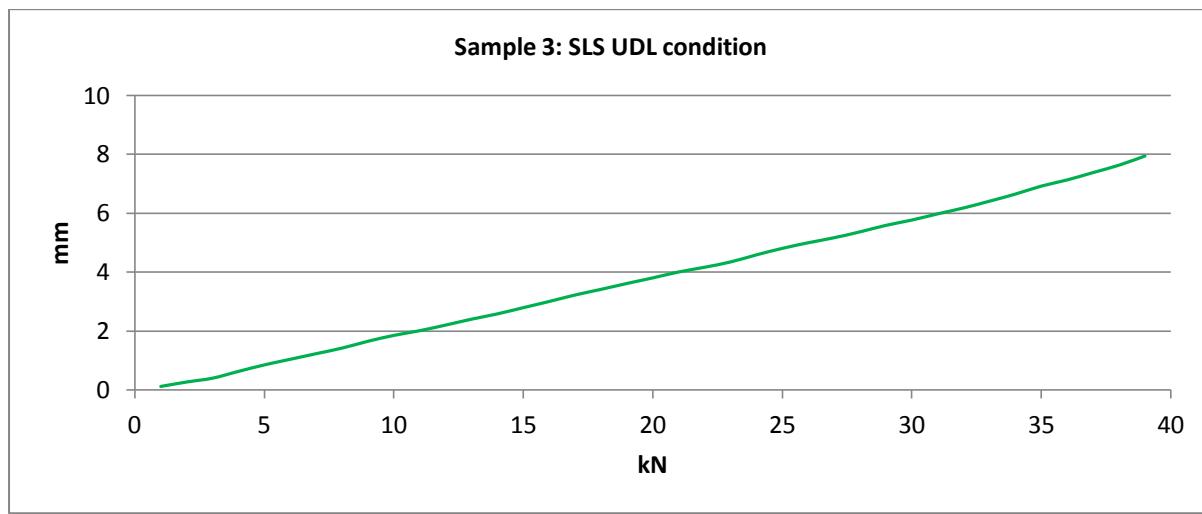
2.1.2. Load displacement graphs samples 1-3 SLS concentrated UDL

The submitted load for SLS condition for the VR Turnlok load bay beams = 15.6kN/m

Total applied load: 15.6kN x 2.5m = 39kN

Load beam displacements monitored and recorded at 39 increments

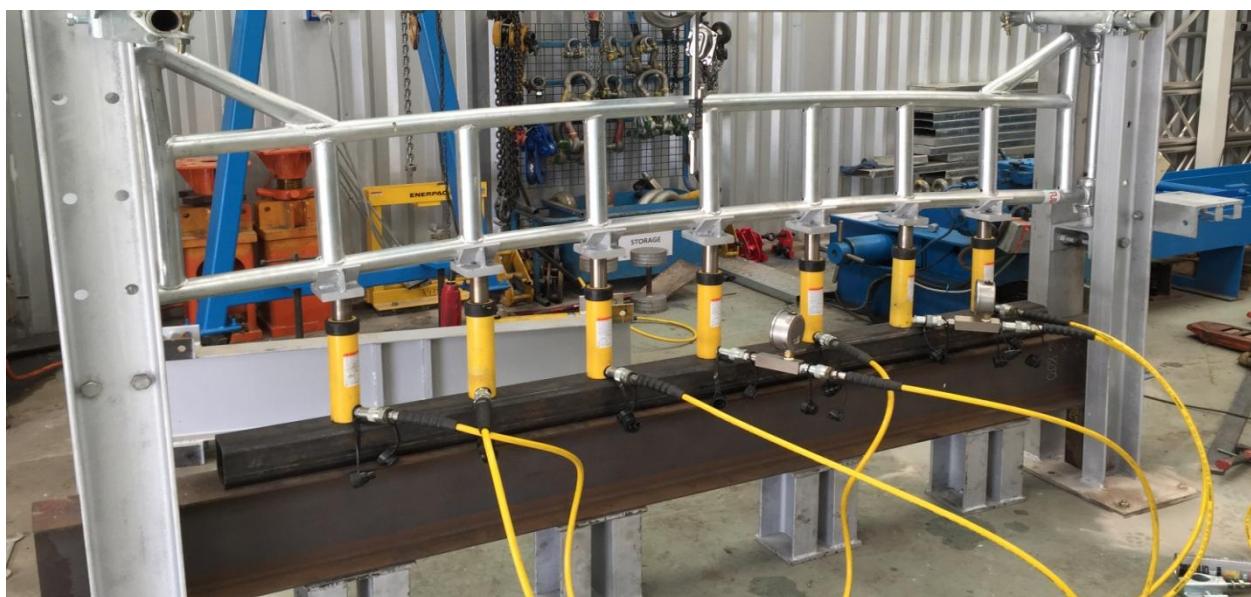
2.2.2. Typical image of load beam subject to concentrated UDL application

Load bay beams subject to a concentrated uniformly applied load at each vertical node point and a central point load condition. Uniform loads applied at a SLS & ULS condition, each sample was then subject to a failure application. CPL application applied through to failure.

Load survey to a single loading bay ladder beam through to ultimate failure. Concentrated load application as per digital image 2.2.1.

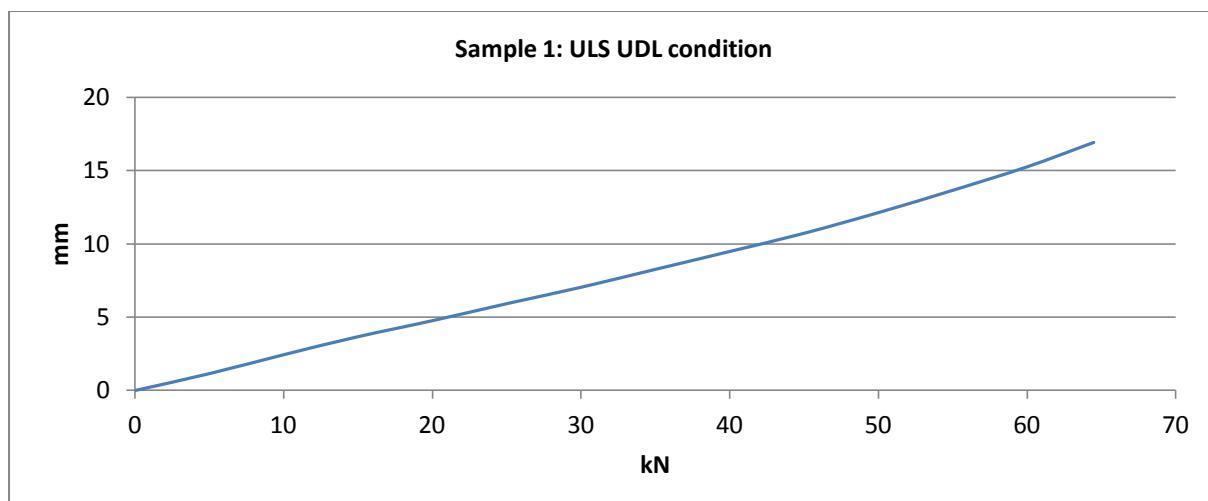
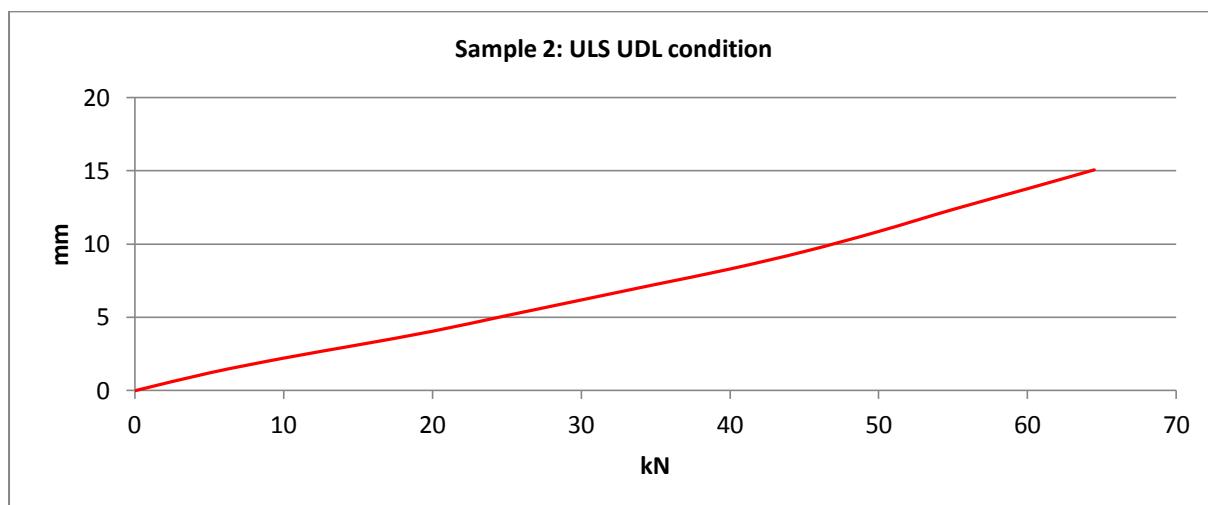
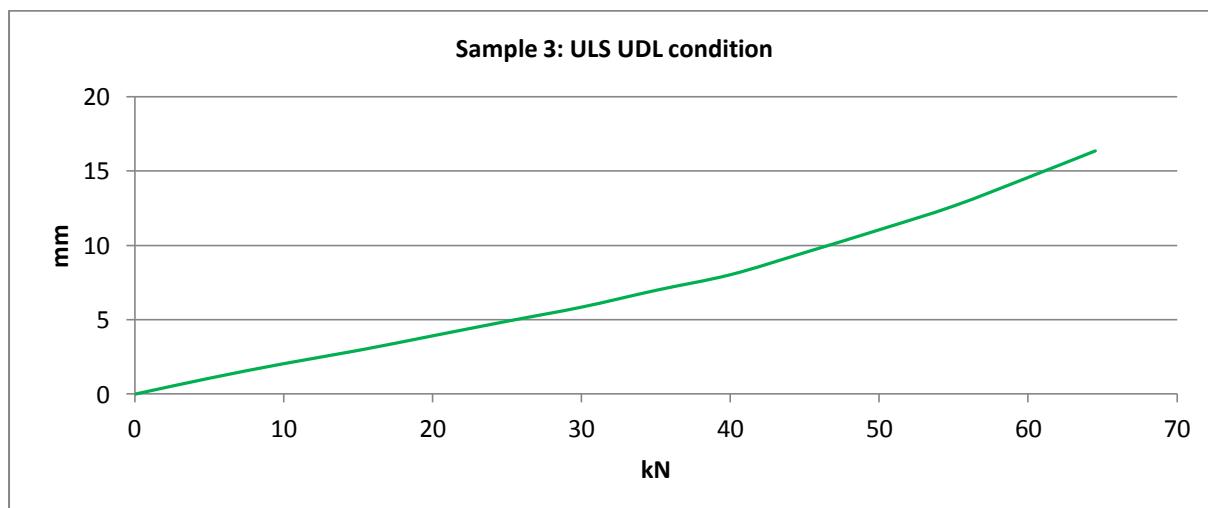
2.2.3. Load displacement graphs samples 1-3 ULS concentrated UDL

The submitted load for ULS condition for the VR Turnlok loading bay beams =

25.8kN/m Total applied load: $25.8\text{kN} \times 2.5\text{m} = 64.5\text{kN}$

Load beam displacements monitored and recorded at 13 increments

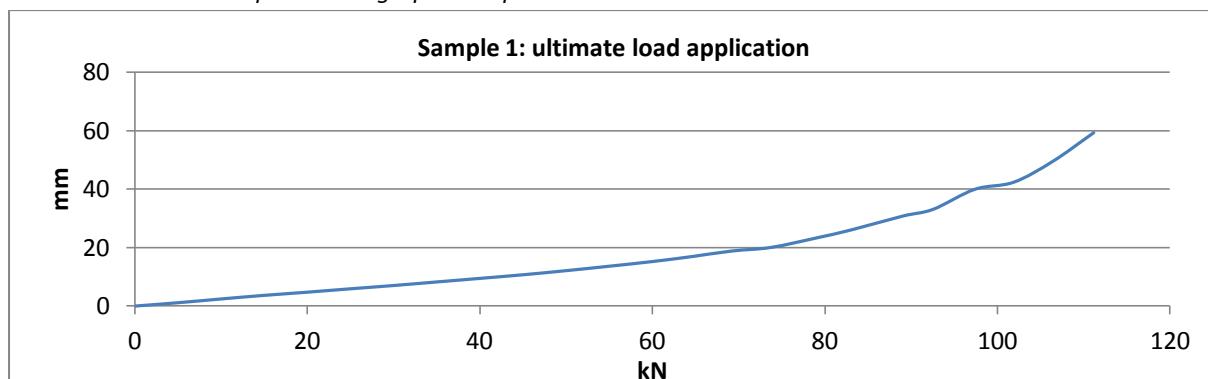
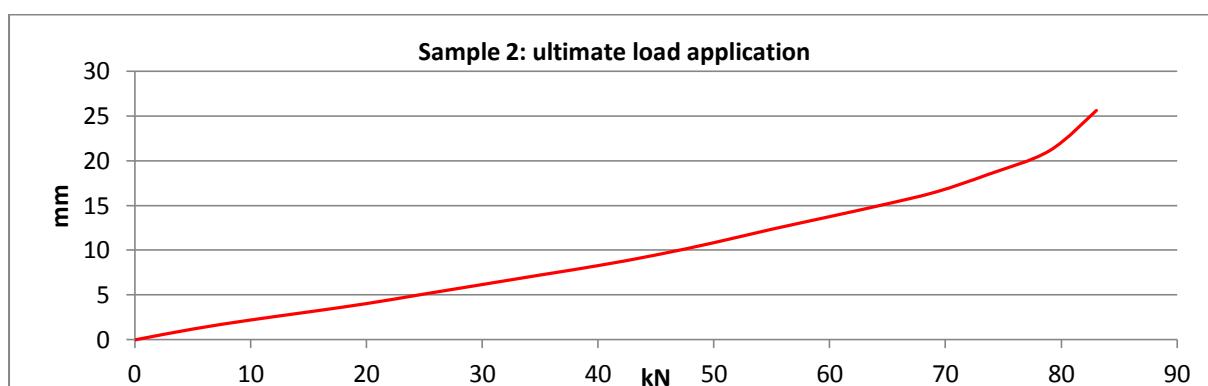
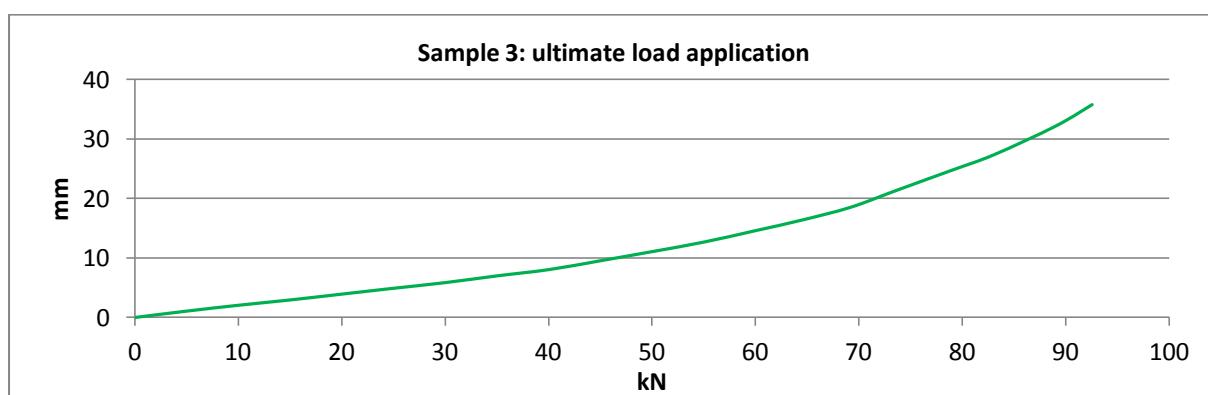
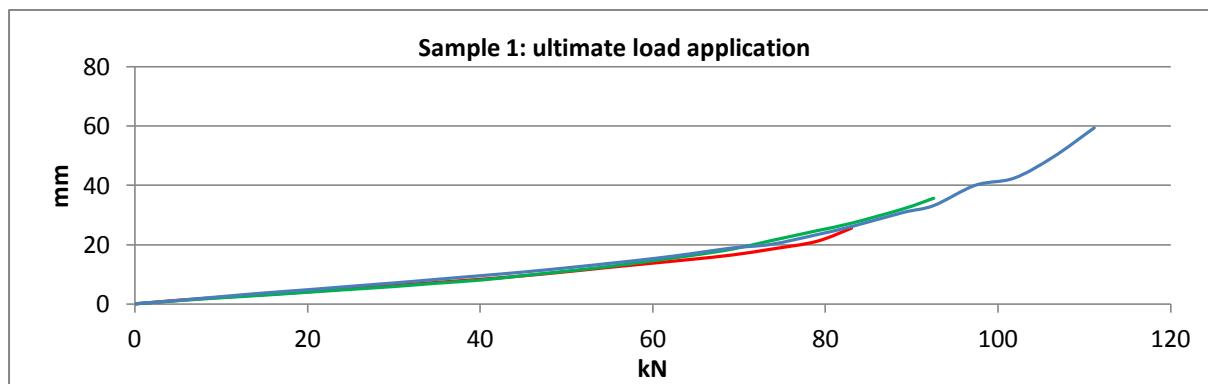
2.3.2. Ultimate load displacement graphs samples 1-3

Each sample upon achieving the requested ULS load was then subject to an increased load through to failure.

Sample 1: No more load could be achieved past the recorded 111.14kN. Node weld fractures evident and cup weld fractures evident upon visual examination

Sample 2: Audible weld fracture recorded at 89.08kN. Test stopped, examination showed fractures around the vertical nodes at sections 1,2 and 3 propagating from the drilled holes at the node base.

Sample 3: Minor weld fracture recorded at 92.54kN at the third vertical node base weld propagating from the drilled holes at the node base.

Ultimate load achieved 95.13kN

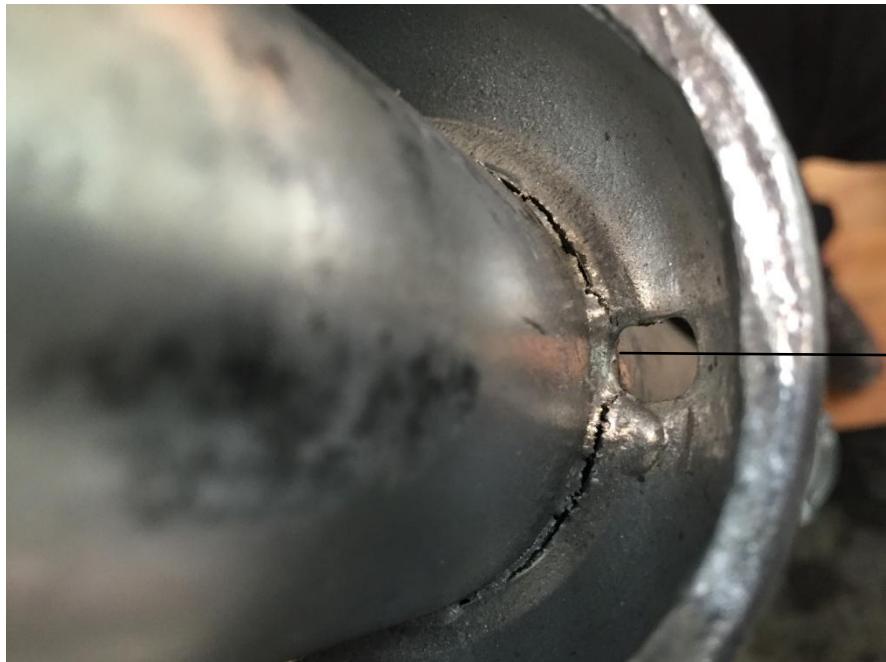
2.3.3. Post load failure images

*Radial weld fracture
Sample 1 post failure
load, propagating from
galvanizing relief hole.*

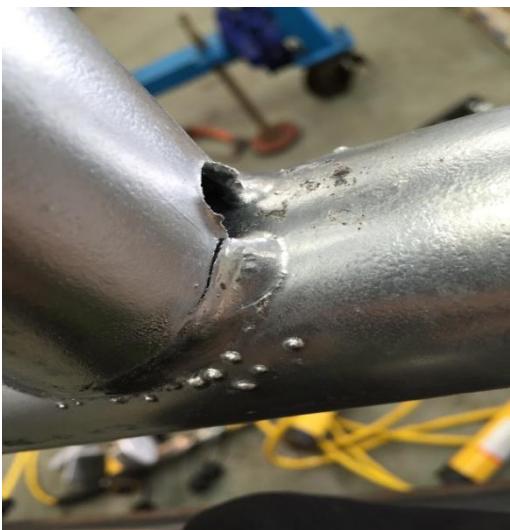
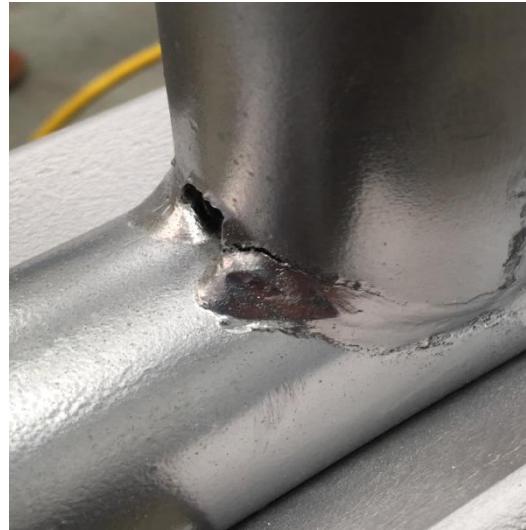
Typical weld fracture propagating from galvanising relief holes. Upper load bearing chord welds in tension. The relief hole is a man made stress raiser and prevents the weld from being complete and is therefore weaker and any stresses will relieve themselves in that stop / start weld area. The weld deposition / fusion may not be equal to both faces and will render the joint weaker.

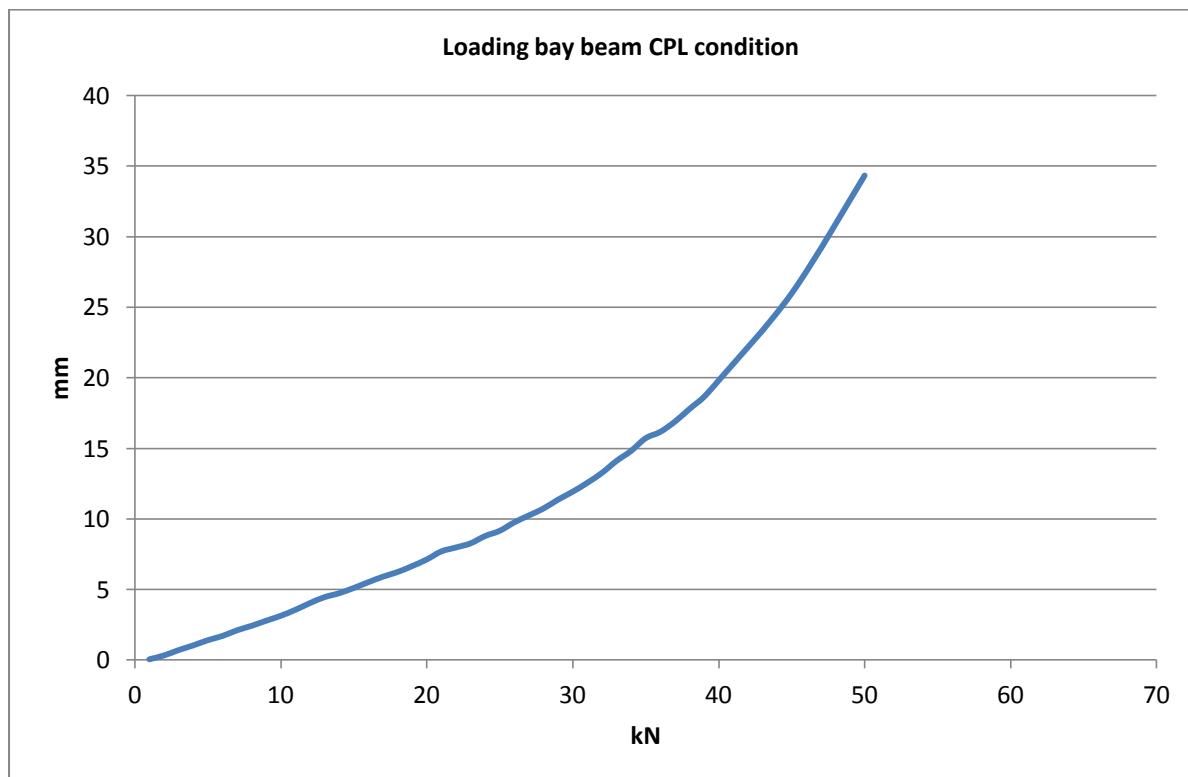
2.4.3. Load displacement graph CPL condition

Vertical node weld to lateral tube fracture recorded at 50kN; 2nd an 3rd node from end upper chord (load bearing chord welds in tension).

Permanent displacement recorded at 16.91mm after load removal.

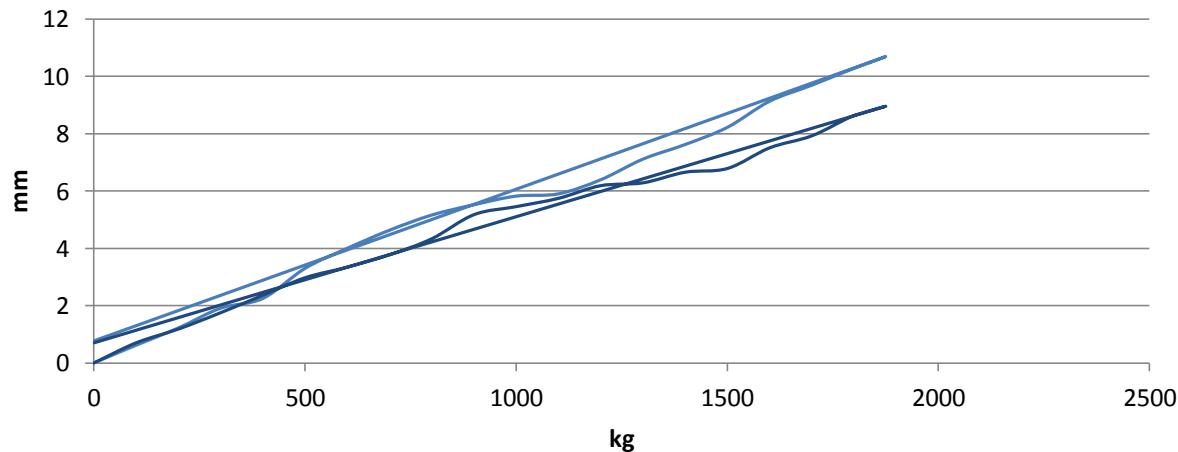
Sample 1 assembly: Δ^1 & Δ^2

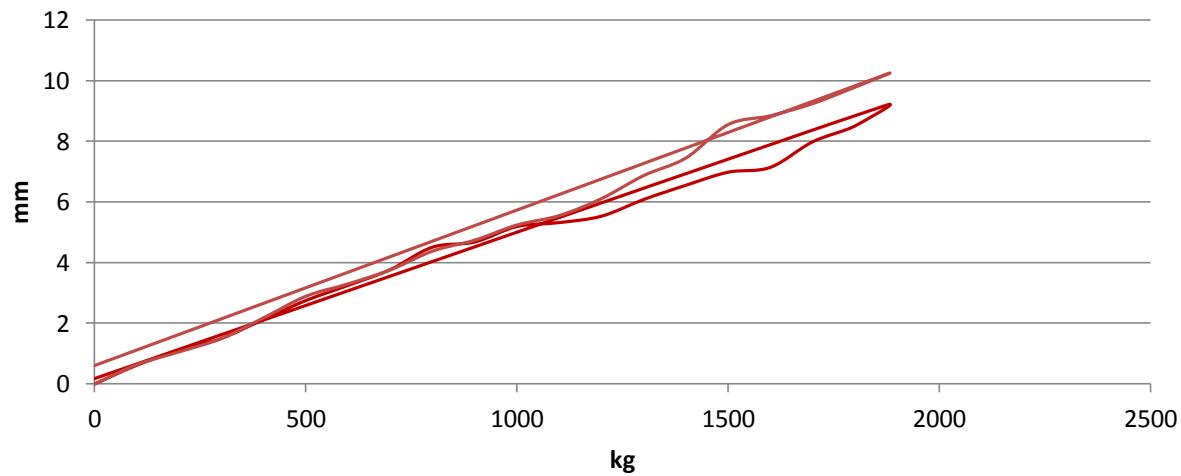
Sample 2 assembly: Δ^1 & Δ^2

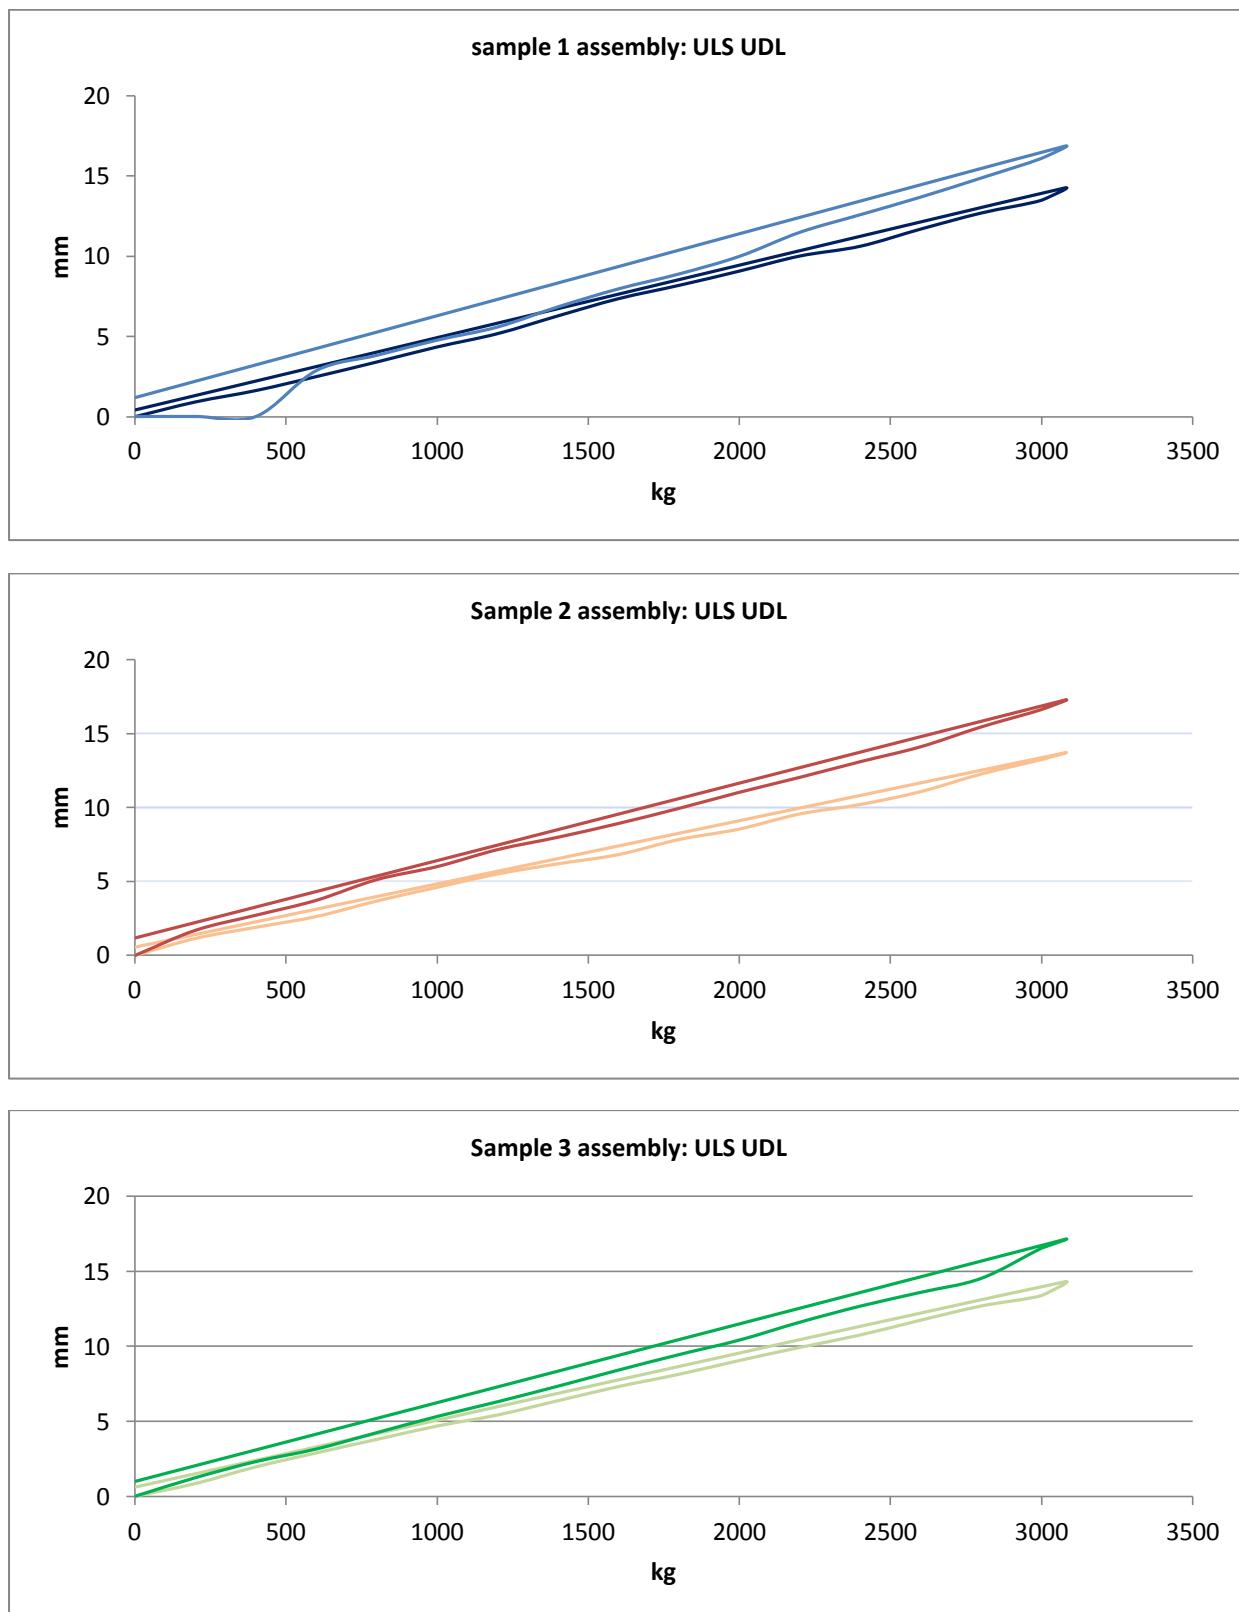
3.2.2. Load displacement graphs ULS condition

Requested SLS load 6.23kN/M

$6.23 \times 2 = 12.46 \text{ kN/m}^2$; *total application* $12.5 \times 2.4 = 30 \text{ kN}$

$30 \text{ kN} = \text{kg actual applied } 3075 \text{ kg exclusive of boards}$

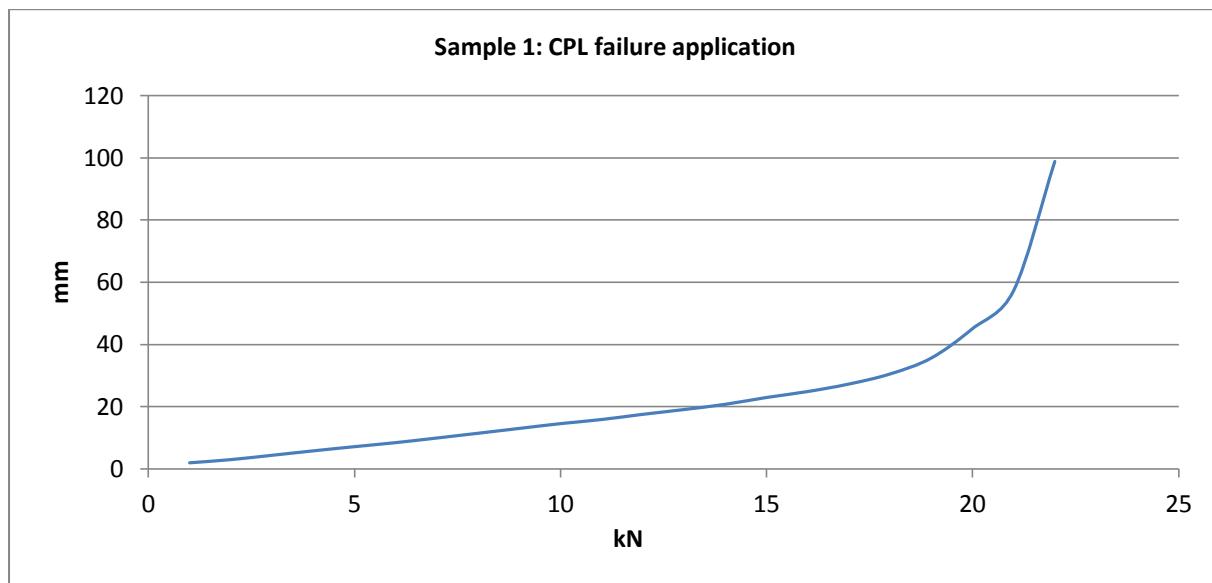
3.3.2. Load displacement graph CPL

A sample board bearer was subject to a CPL load condition through to ultimate failure.

A concentrated central point load was applied to a simply supported section as requested.

Permanent displacement recorded at 16.91mm, no more load achievable at a maximum recorded 22.36kN

Minor weld fracture noted upon vertical node at 22.36kN

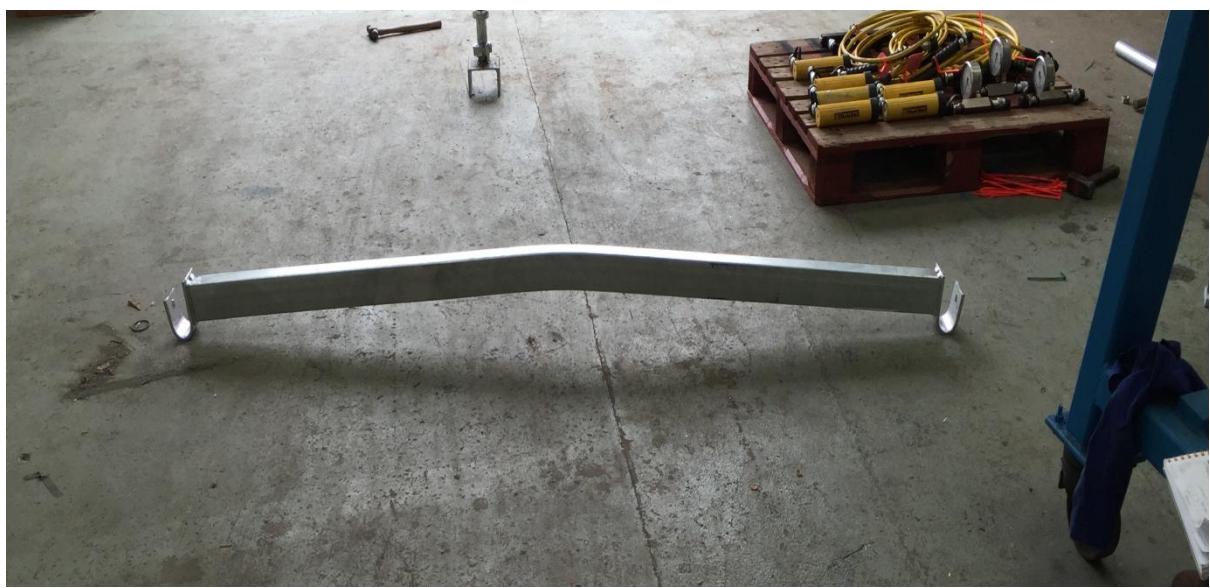
3.3.4. Post load digital image showing permanent displacement to section

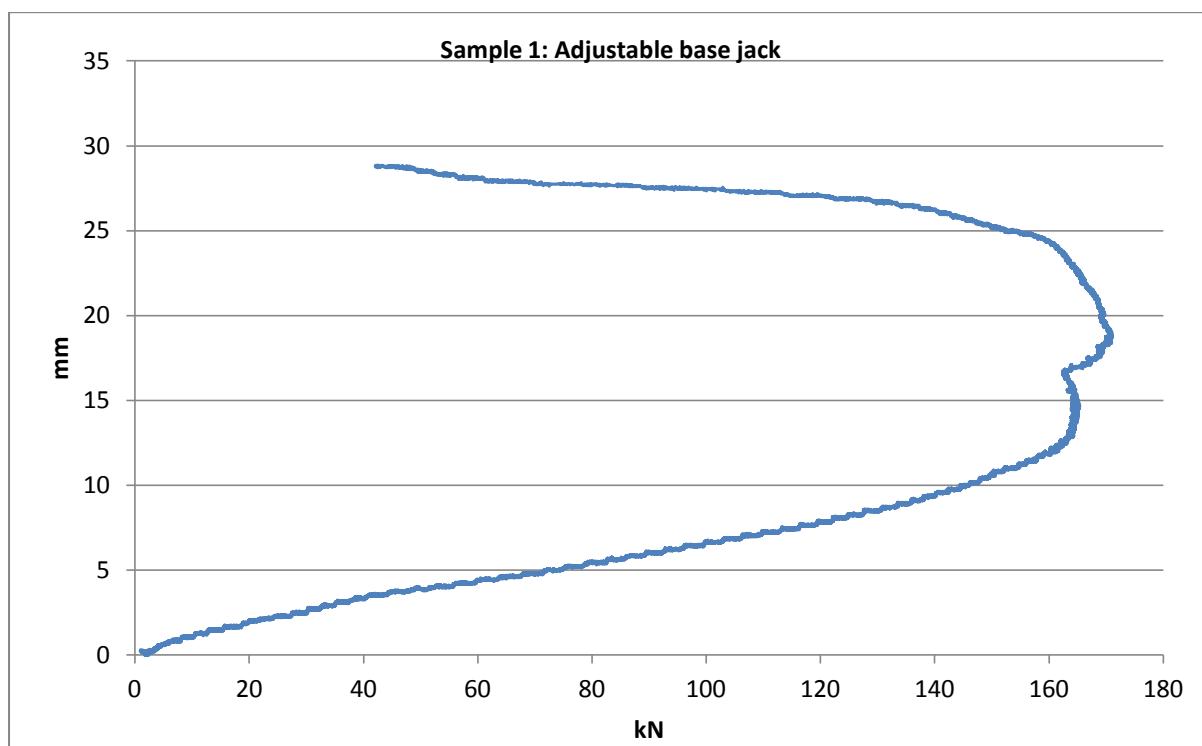
4.1. Sample 1 bottom scale adjustment approx 100mm thread exposed.

Pre load applied at 2kN displacement recorded at pre load.

Ultimate peak value logged at 171.1kN

Load rate applied at 2mm/min

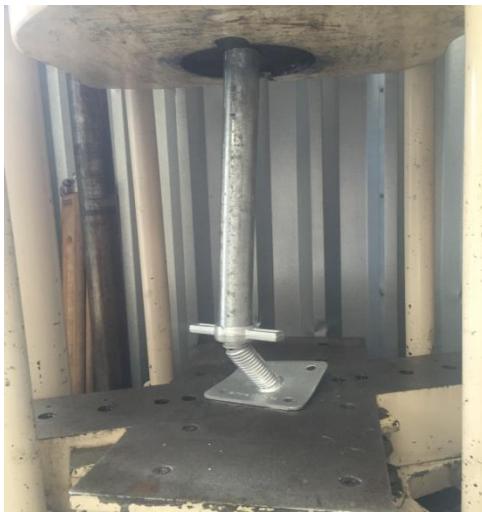
4.1.1. Digital image showing ultimate failure mode.

The material fracture shown in image 4.1.1. occurred after the base jack had showed signs of yield.
Fracture at base of tube location nut due to the bending of the jack body.
No visual signs of weld fracture at screw thread to main base connection.

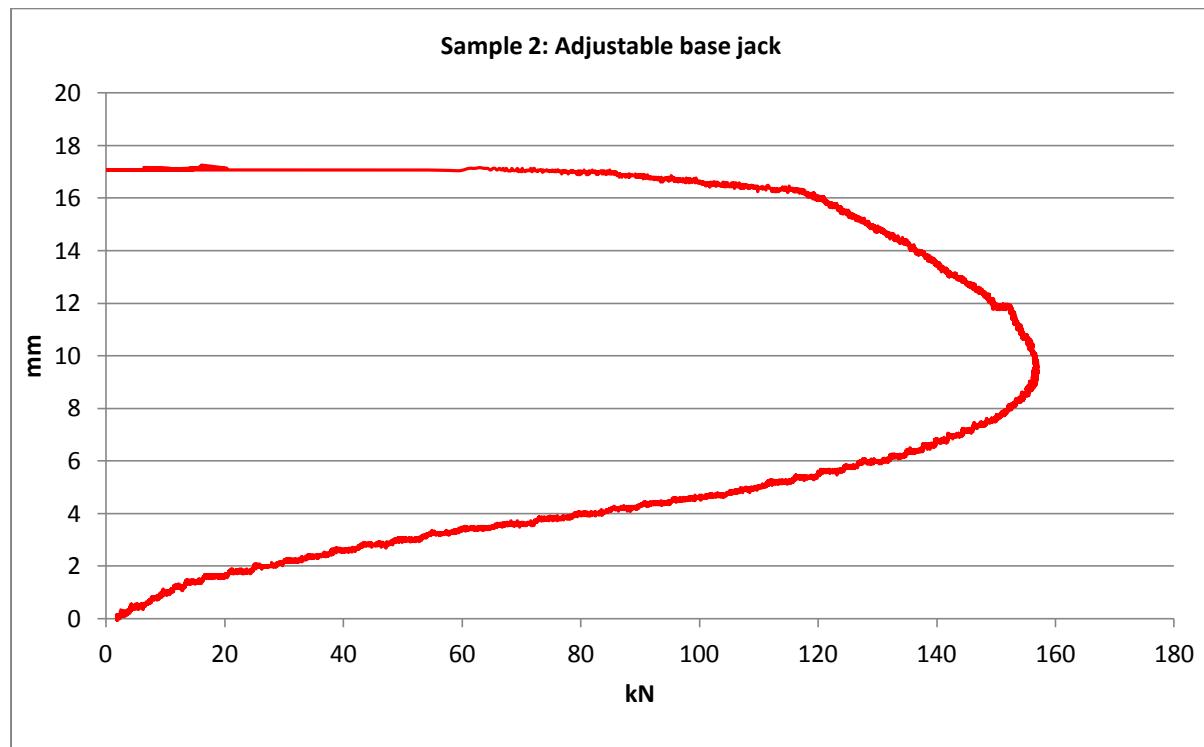
4.2. Sample 2 mid scale adjustment approx 250mm thread exposed.

Pre load applied at 2kN displacement recorded at pre load.

Ultimate peak value logged at 157.05kN

Load rate applied at 2mm/min

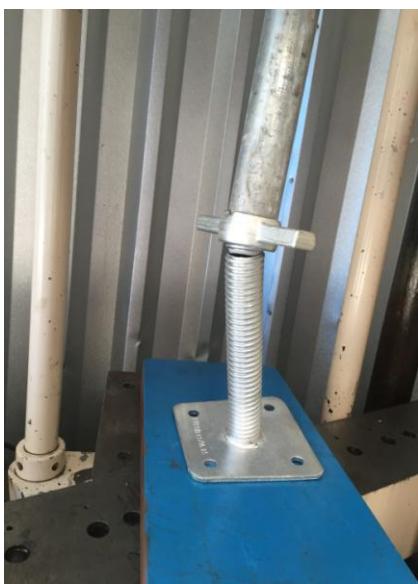
4.2.1. Digital image showing ultimate failure mode

The material fracture shown in image 4.2.1. occurred after the base jack had showed signs of yield.

Fracture at base of tube location nut due to the bending of the jack body.

No visual signs of weld fracture at screw thread to main base connection.

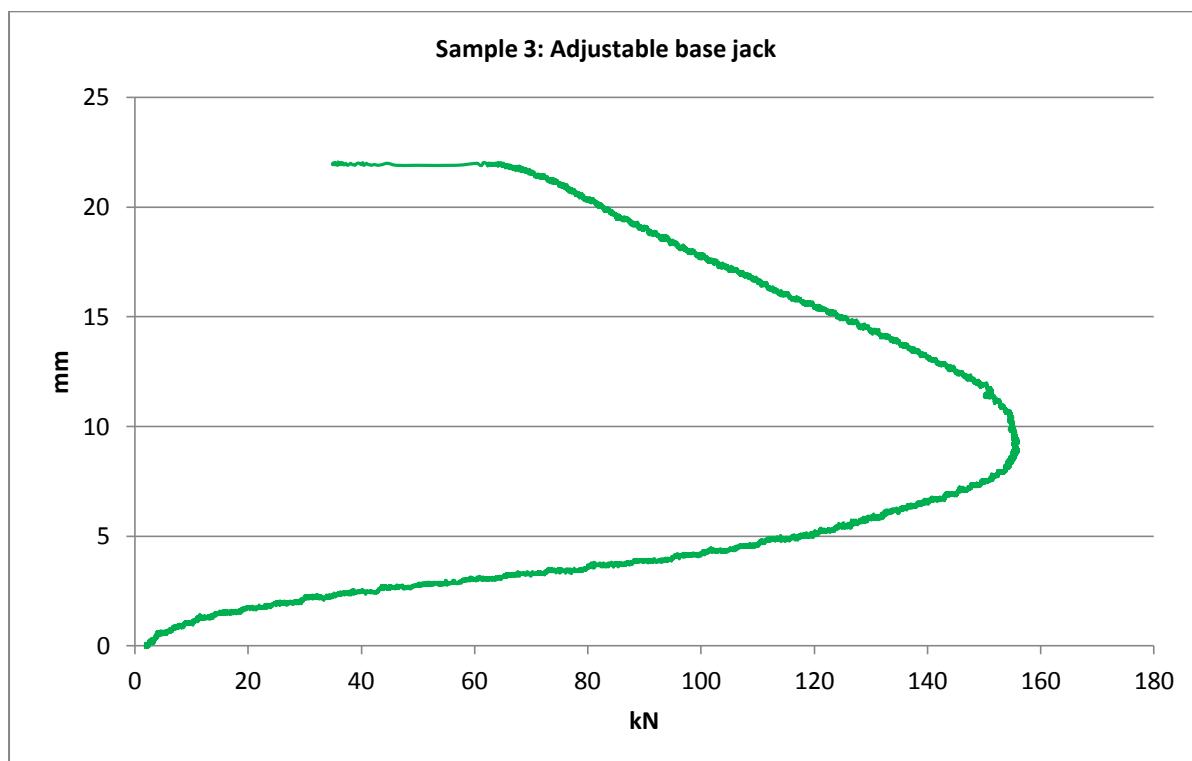
4.3. Sample 3 upper scale adjustment approx 450mm thread exposed.

Pre load applied at 2kN displacement recorded at pre load.

Ultimate peak value logged at 156.03kN

Load rate applied at 2mm/min

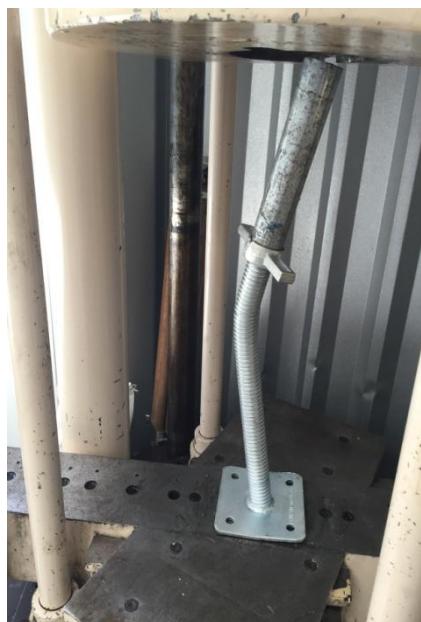
4.3.1. Digital image showing ultimate failure mode

*Digital image 4.3.1. showing mode of failure at extended height of 450mm. No visual signs of tread form fracture.
No visual signs of weld fracture at screw thread to main base connection*

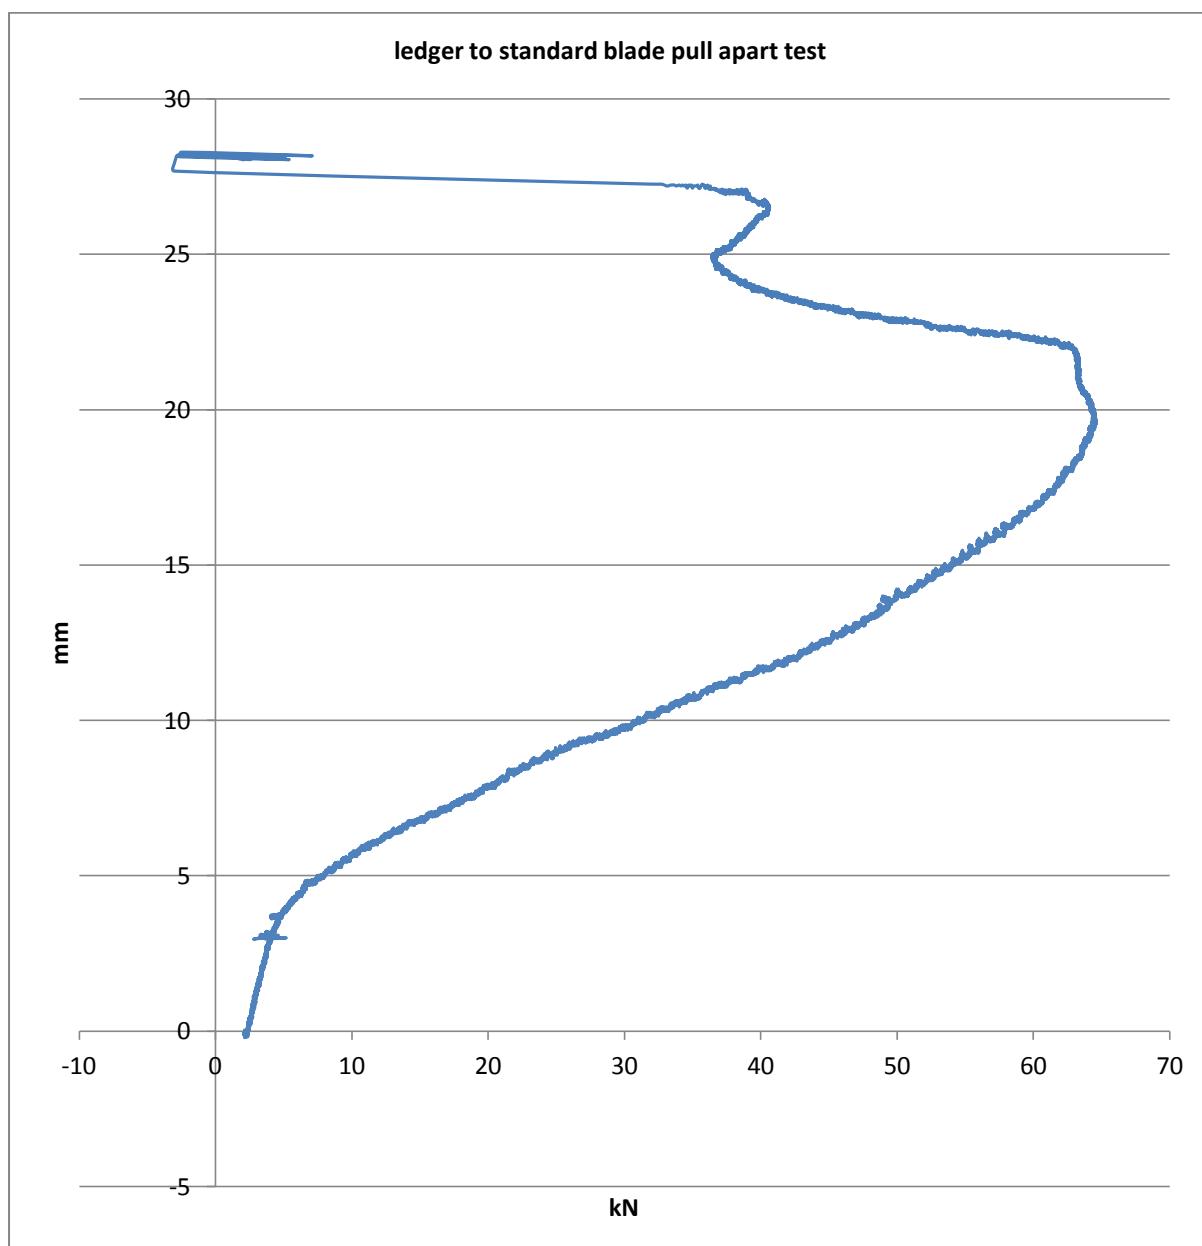
A sample of two tubular ledgers and an isolated standard section were subject to an axial tensile pull apart test to ascertain failure mode and load.

Pre load applied at 2kN: displacement recorded at pre load.

Ultimate peak value logged at 64.63kN

Load rate applied at 2mm/min

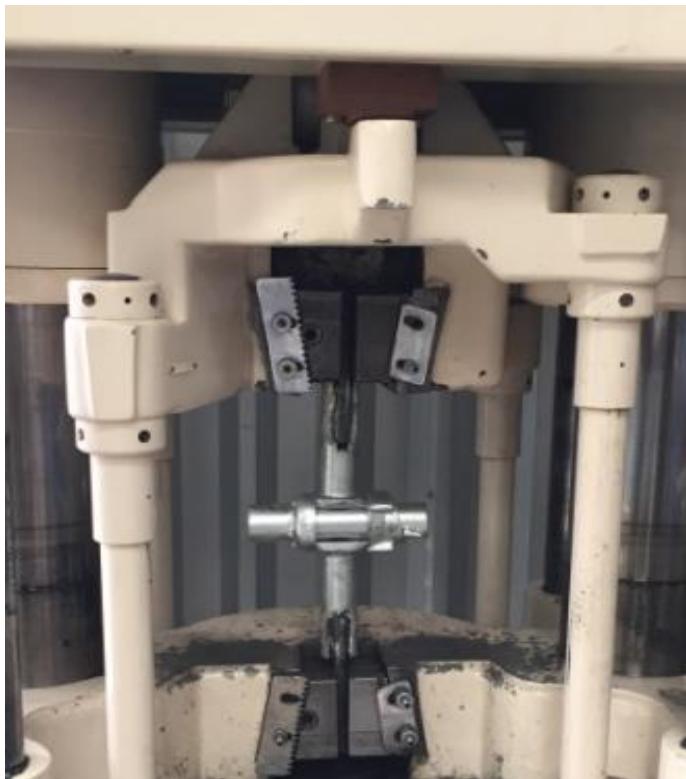
Sample subject to pull apart application pre load.

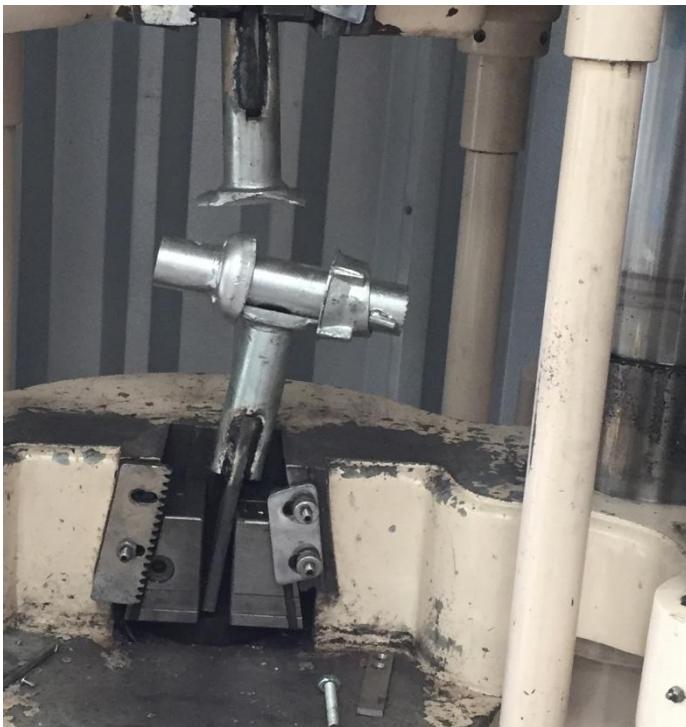
*Post load image showing separation.
Blade and cup yield evident, blade tip
Distortion and cup distortion evident.*
