**Tests on Turnlok (TM) System Scaffold Components**

**for VR Access Solutions Ltd**

**Report No 407**

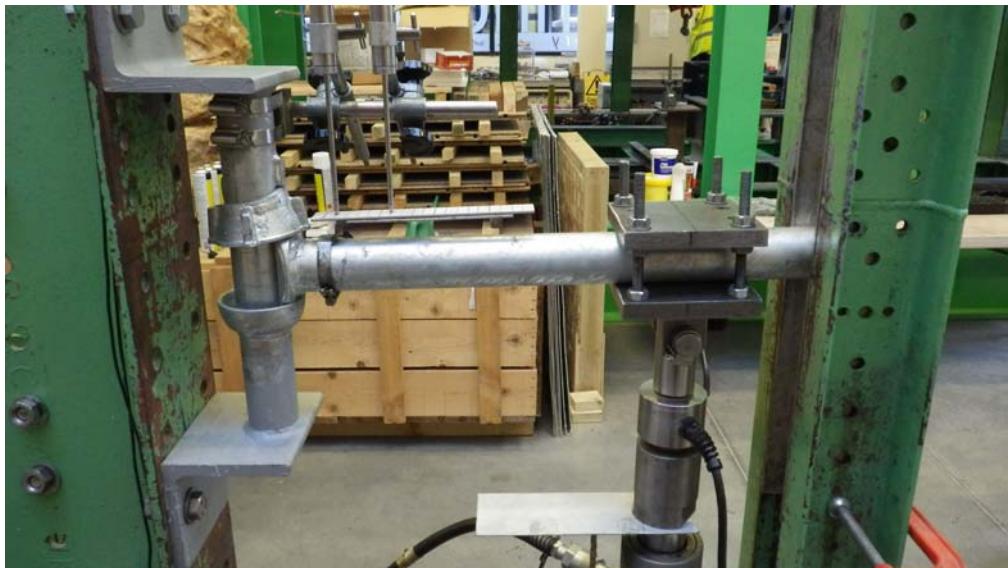
Figure 1: Connection Test arrangement

The test arrangement for these tests is shown in Figure 1. Figure 2 shows a transom-standard test where the load and the corresponding rotation are taken to be positive. The arrangement for negative loading and rotation is shown in Figure 3.

In these assemblies the standard was clamped to a rigid support and a ledger/transom attached to it. The load was applied hydraulically on a line 400mm from the centreline of the standard. The ledger/transom was set between greased guides to ensure vertical displacement only. In all the cyclic tests on ledgers and transoms loading was conducted under displacement control at a rate of 0.2 mm per second with a sampling rate of 1 sample per second. The rotation of the ledger relative to the standard was measured by observing the difference in the movement of two displacement transducers mounted 50mm apart on a bracket fixed to the ledger.

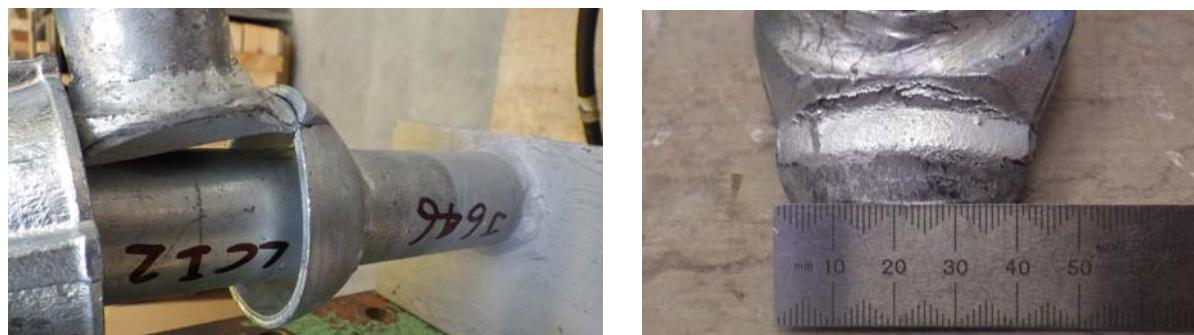
Figure 4: Cup split and tongue fracture

For the ledger to standard connection, the modes of failure were primarily due to distortion/splitting of the cup and tongue fracture. See Figure 4.

Test Number	Test file	Cup elongation	Cup split	Cup rotation	Tongue bending	Tongue fracture	Standard distortion	Ledger distortion
3	J646LLFI	Y	Y	N	Y	N	N	N
5	J646LLFN	N	N	Y	N	Y	N	N
6	J646LCI1	N	Y	N	N	N	N	N
7	J646LCI2	N	Y	N	N	N	N	N
8	J646LCI3	N	Y	N	N	N	N	N
9	J646LCN1	N	Y	N	N	N	N	N
10	J646LCN2	Y	Y	N	N	N	N	N
11	J646LCN3	Y	Y	N	N	N	N	N

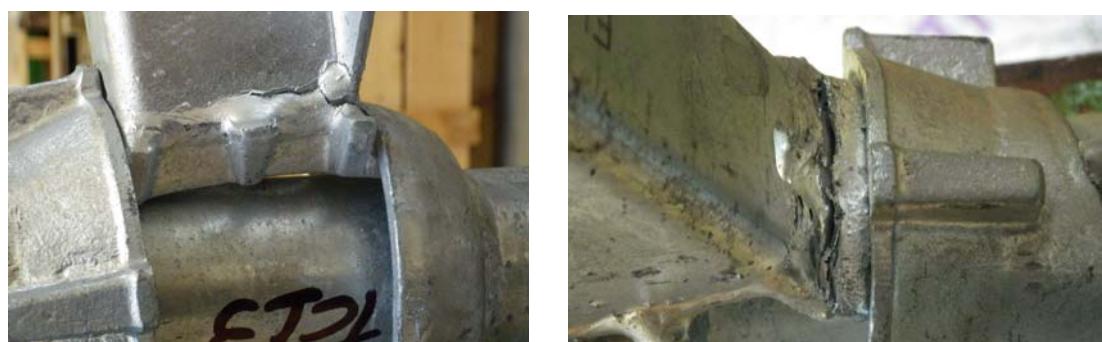
Figure 5: Weld and tongue fracture

For the transom to standard connection, the modes of failure were primarily due to distortion/splitting of the cup and tongue bending/fracture. See Figure 5.

Test Number	Test file	Cup elongation	Cup split	Weld fracture	Tongue bending	Tongue fracture	Cup ring distortion	Standard/ Transom distortion
14	J646TLFI	N	N	Y	N	N	N	N
16	J646TLFN	N	N	Y	Y	Y	Y	N
17	J646TCN1	N	N	Y	Y	Y	N	N
18	J646TCN2	N	N	Y	Y	Y	Y	N
19*	J646TCN3	N	N	N	N	Y	N	N
20	J646TCI1	Y	N	Y	Y	N	N	N
21	J646TCI2	Y	N	Y	N	N	N	N
22	J646TCI3	Y	N	Y	N	N	N	N

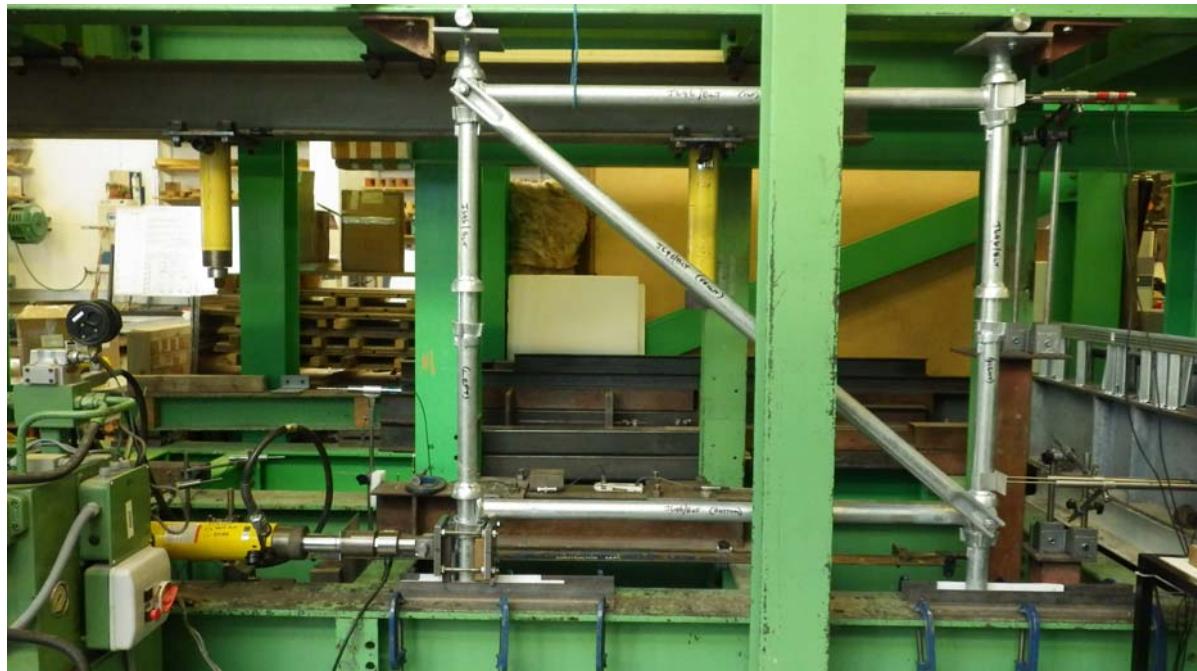
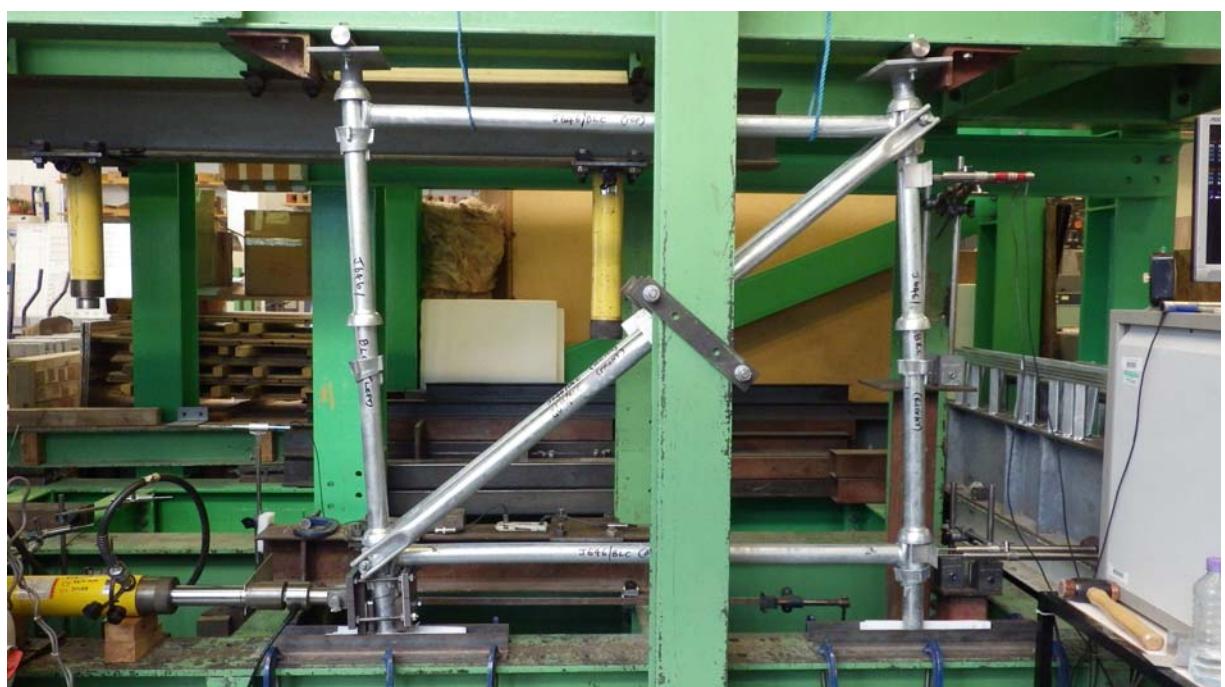
Figures 10 and 11 are a general view of the test arrangements for tension and compression, partially obscured by the straining frames. The test frame was founded on two pin bearings which were bolted to the support frame to provide horizontal resistance to the applied loads.

Figure 10: General view of test arrangement (tension)

Figure 11: General view of test arrangement (compression)

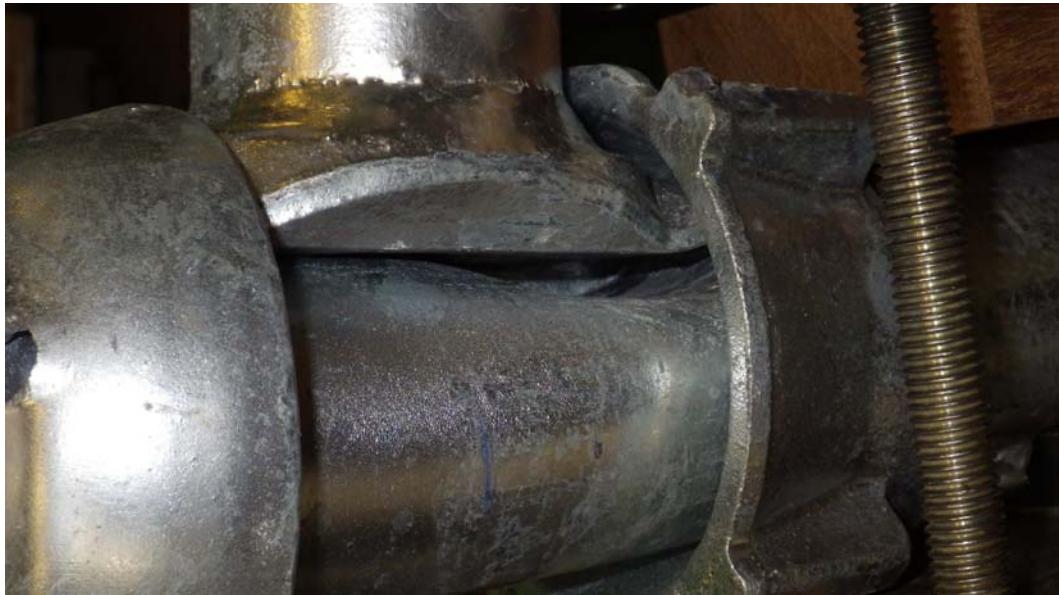
The loading regime for the bracing cyclic tests is given in Table 1. Failure of the bracing assembly occurred when the pivot pin at the end of the diagonal twisted and started to pull from its mounting or the uprights bent. Examples of failure modes are given in Figures 12-14.

Figure 12: Bolt failure

Figure 13: Standard distortion

Figure 14: Standard distortion at joint

Test Number	Test file	Brace popped out	Weld failure	Bolt failure	Standard distortion	Standard buckled	Brace movement	Brace distortion
23	J646BLT	N	N	N	Y	Y	Y	N
24	J646BLC	N	N	Y	N	N	N	N
25	J646BCC1	N	N	Y	N	N	N	N
26	J646BCC2	N	N	Y	N	N	N	N
27	J646BCC3	N	N	Y	N	N	N	N
28	J646BCC4	N	N	N	N	N	N	N
29*	J646BCT1	Y	N	N	Y	N	N	N
30*	J646BCT2	Y	Y	N	Y	N	N	N
31*	J624BCT3	Y	N	N	N	N	Y	N
32*	J624BCT4	Y	N	N	N	N	Y	N

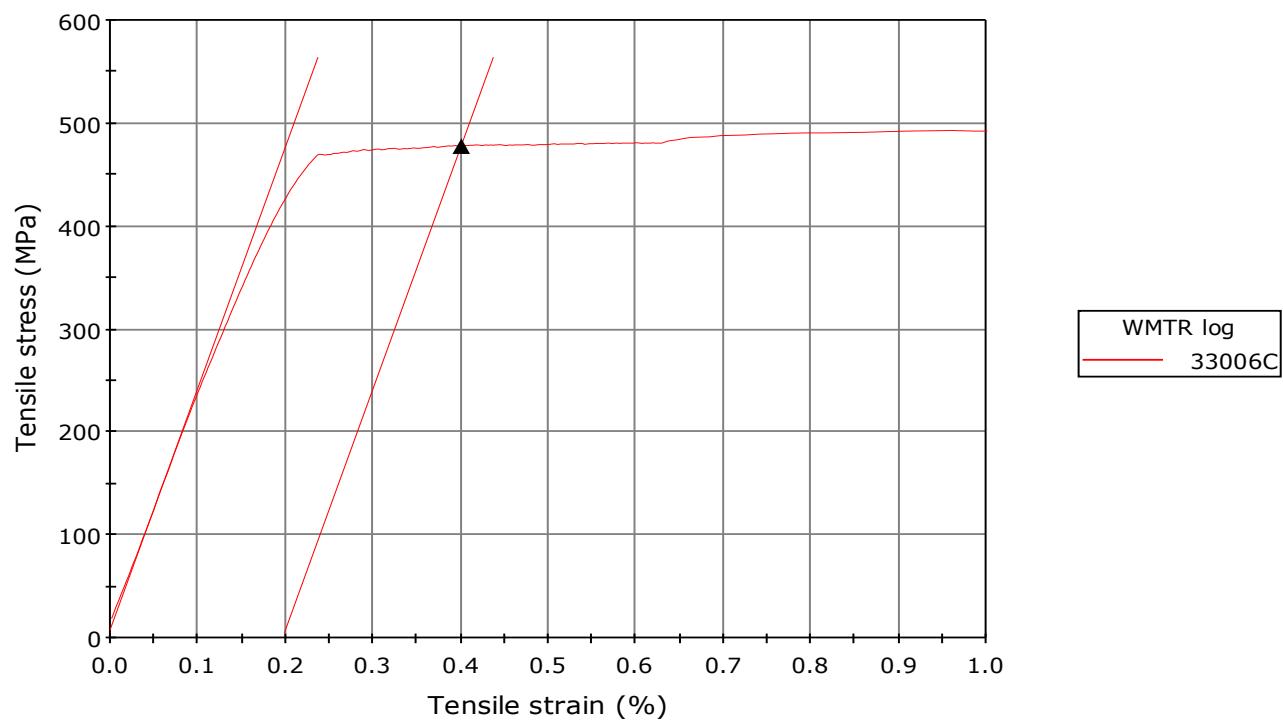
The specimens were of nominal width 6.0mm and parallel length (Lc) 32.0mm, marked with a 25.0mm gauge length for determination of elongation.

The specimens were instrumented with a dual averaging extensometer and tested at ambient temperature

The specimens were tested in strain rate control at the first rate to beyond yield at which point the second rate was adopted and the extensometry was removed.

Testlog	Sample Id	0.2% PS (MPa)	UTS (MPa)	Elong. (%)
33004C	BCT/1S	478	575	17.0 *
33005C	BCT/2S	461	554	17.3 *
33006C	BCT/3S	478	564	16.2 *
