**Load survey of: Fabricated
aluminium scaffold stair case**

TEST REPORT NUMBER TES000251TR-1

VR Access solutions Ltd | Load study of aluminium stair case | April 26, 2017

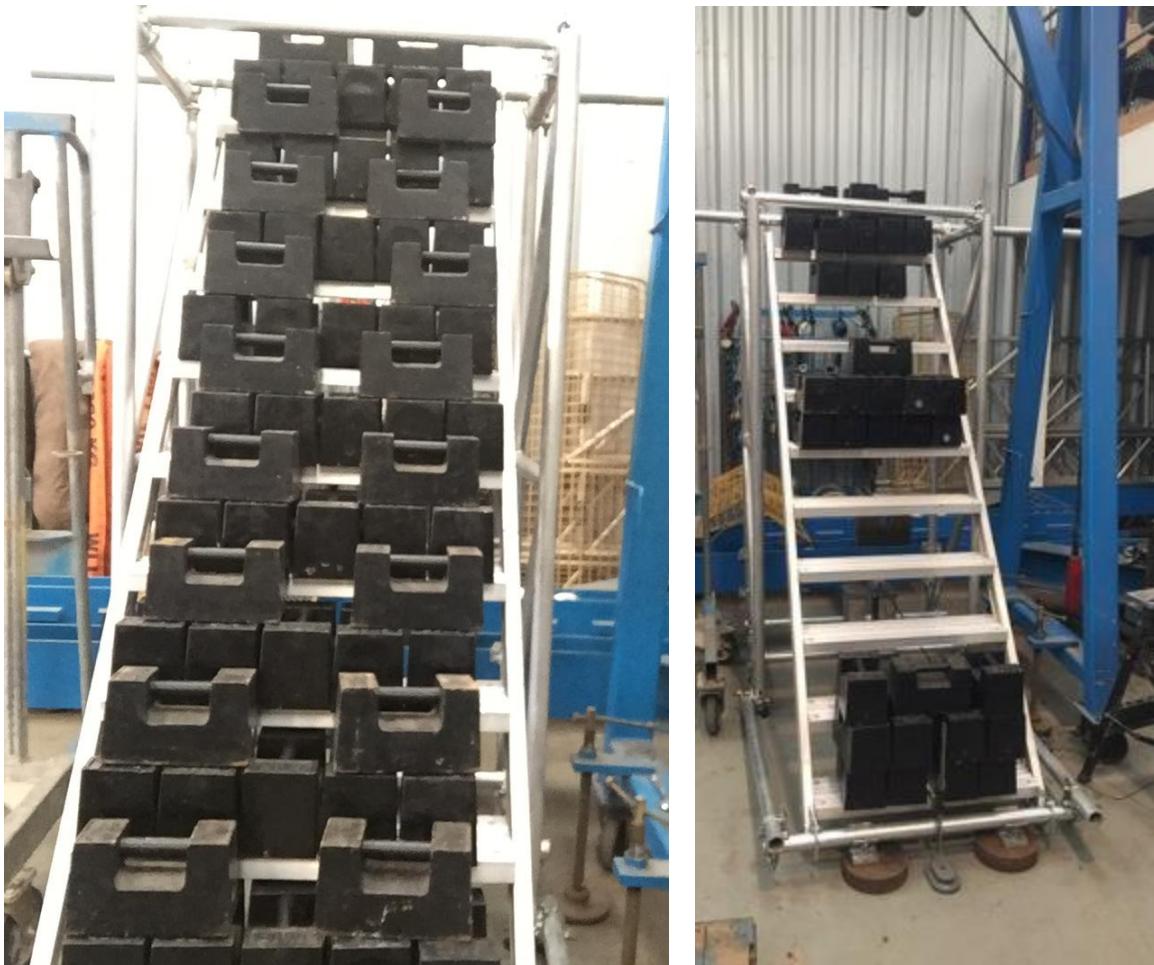
APPENDIX A

Following the requested load applications, no looseness of tread fixings was evident.

No failure, fracture or separation of any part of the assembly was evident post load application.
