Report and Load Survey of: Fabricated post pallets

Document number: TES000149TR-1

Client: VR Access Solutions Ltd

Item description: Free issue fabricated open sided post pallets, material assumed carbon steel.
Vertical uprights constructed from 60mmx60mmx 2.8mm square hollow section, outer main structural frame constructed from 60mmx60mmx 2.8mm square hollow section, 2 number lateral base inserts constructed from 25mmx50mm hollow section.
Vertical uprights complete with pressed steel base cup for stacking and pressed steel domed capping top.
Triangular gussets welded beneath each outer perimeter SHS from vertical leg
Overall height at 750mm, overall width 1120mm²
Distance from floor to underside of base fabrication 140mm.
Digital image figure 1 shows fabrication.
Material finish: grey primer.

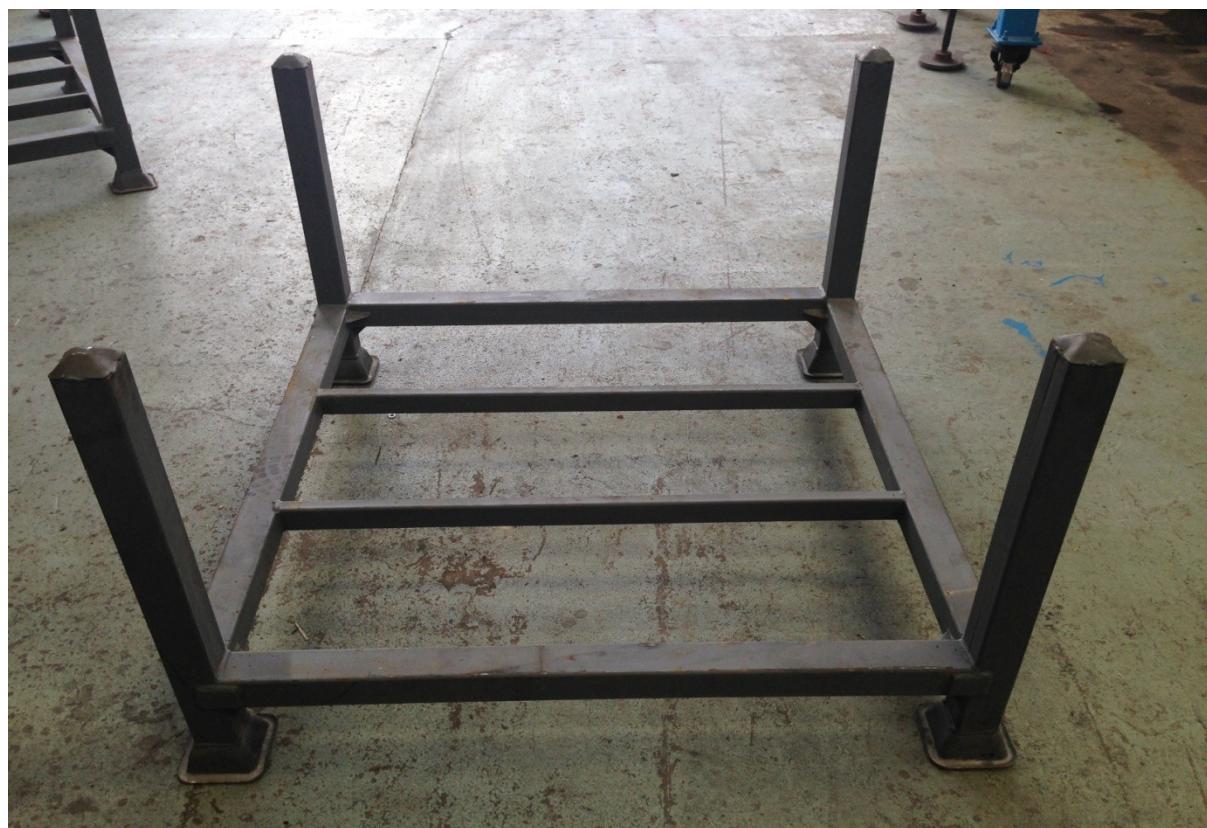
1.3 Figure 1

Typical image of submitted component

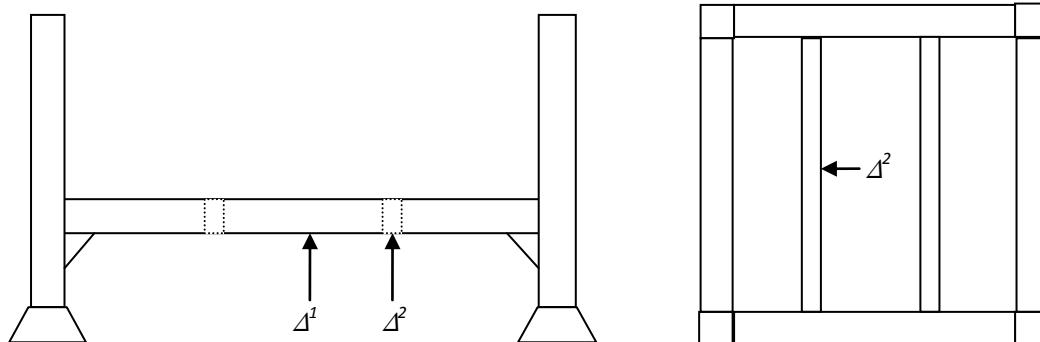
2.1.1. Displacement diagram 1

Displacements were monitored at the outer perimeter structure Δ^1 and internal lateral brace support Δ^2

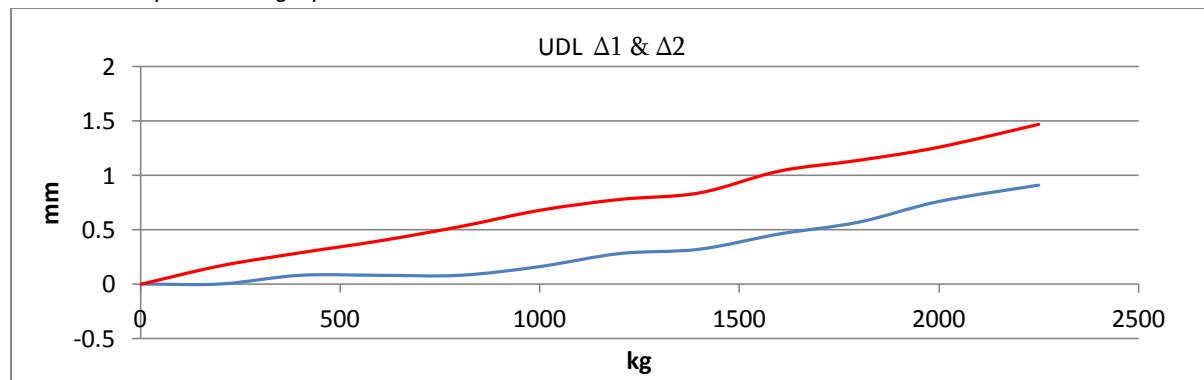
2.1.2 Load displacement graph UDL

Incremental UDL kg	Displacement Δ^1	Displacement Δ^2
200	0	0.17
400	0.08	0.29
600	0.08	0.4
800	0.08	0.53
1000	0.16	0.68
1200	0.28	0.78
1400	0.32	0.84
1600	0.46	1.04
1800	0.57	1.14
2000	0.76	1.26
2250	0.91	1.47
@30min dwell	0.92	1.47
No load	0.27	0.08

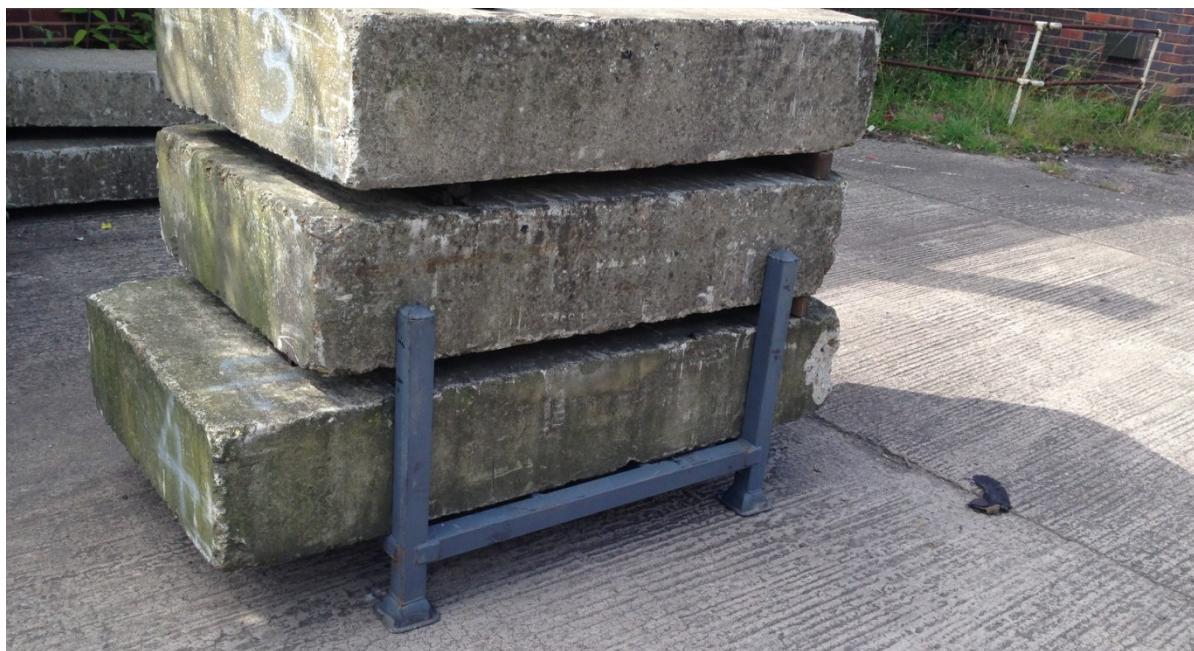
2.2.1. Digital image of concentrated UDL test coefficient of x2

*The sample was subject to a UDL application with a test coefficient of 2
1500x2=3000kg*

*The test load was sustained for 30 minutes and compressive readings pre and post load observed
No significant post load permanent displacement recorded.*

Actual applied load

Block number 3: 1190 kg

Block number 4: 1188 kg

Block number 5: 1170 kg

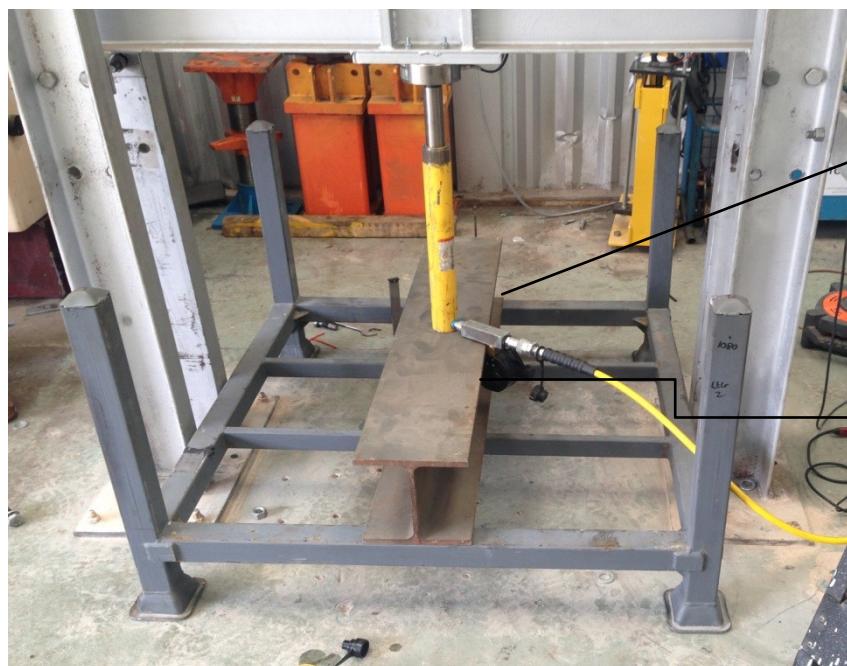
2.3.1. Digital image of concentrated application

250mm foot print across the length of the base fabrication positioned through the centre line.

$\Delta 1$ Displacement reading taken at end of main outer SHS structure at mid span.

$\Delta 2$ Displacement reading taken at lateral cross member mid span.

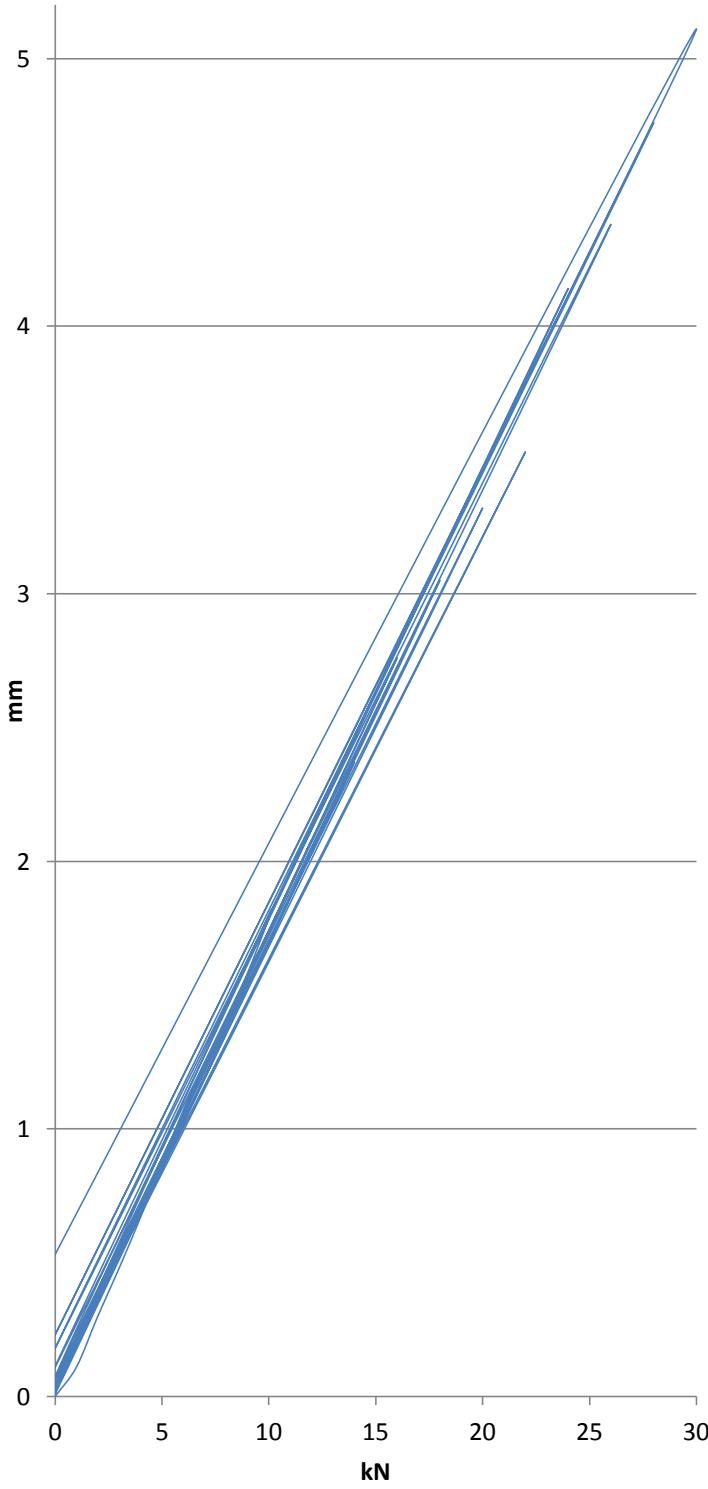
$\Delta 1$ load unload graph

2.3.3. Load displacement graph $\Delta 1$ & $\Delta 2$ showing unloading

Load application stopped at 30kN, permanent displacement recorded at a positive 0.53mm

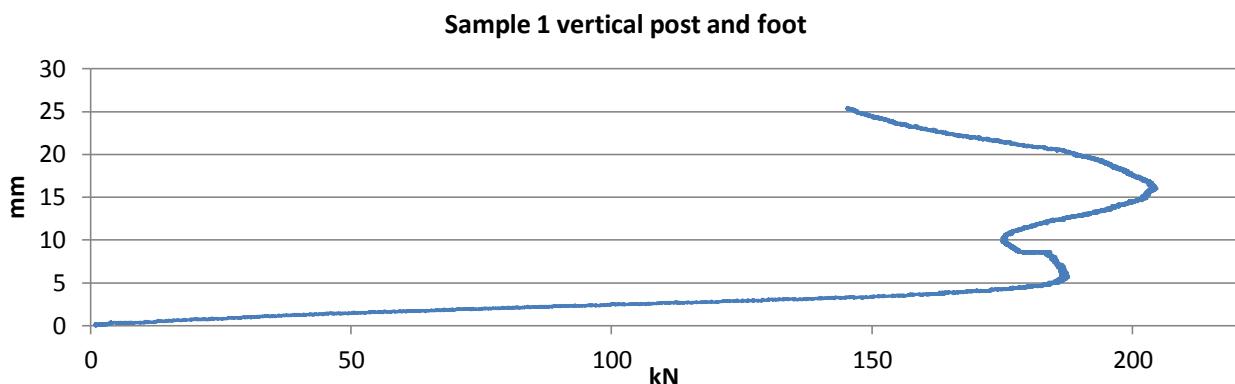
3.1.1. Load displacement sample 1

Sample 1 ultimate recorded load 204.72kN (20875.63kg) initial compressive yield recorded approximately at 180kN (load displacement graph 3.1.1.)

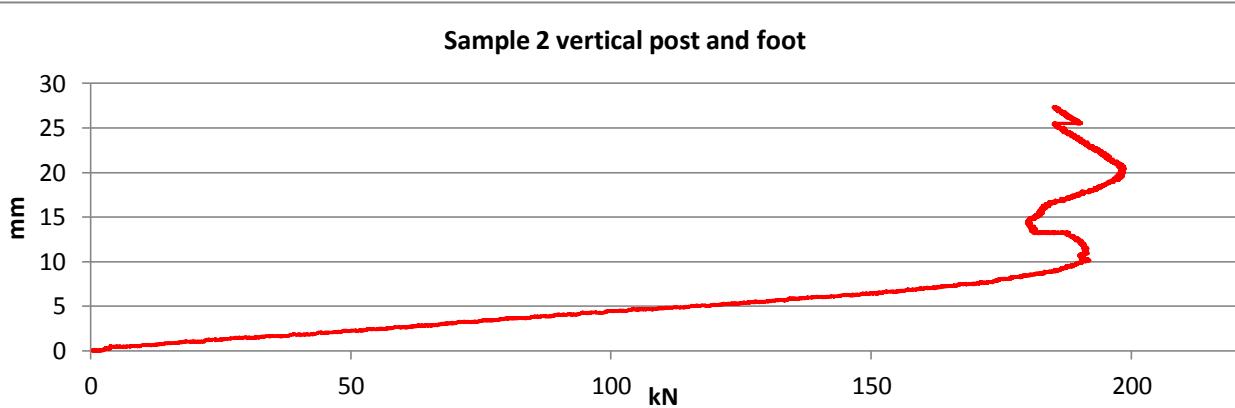
3.1.1.2. Load displacement sample 2

Sample 2 ultimate recorded load 198.86kN (20278.08kg) initial compressive yield recorded approximately at 190kN (load displacement graph 3.1.2.)

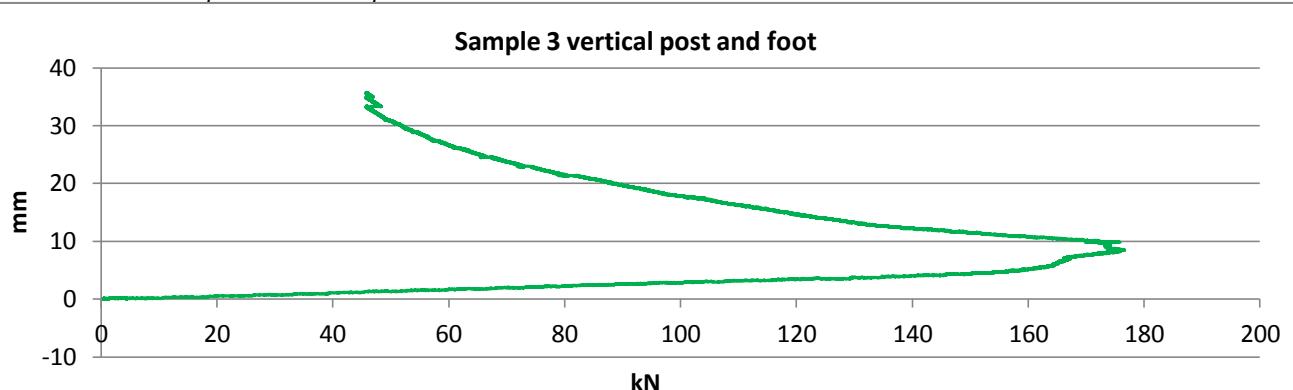
3.1.1.3. Load displacement sample 3

Sample 3 ultimate recorded load 176.61kN (18009.21kg) initial compressive yield recorded approximately at 170kN (load displacement graph 3.1.3.)

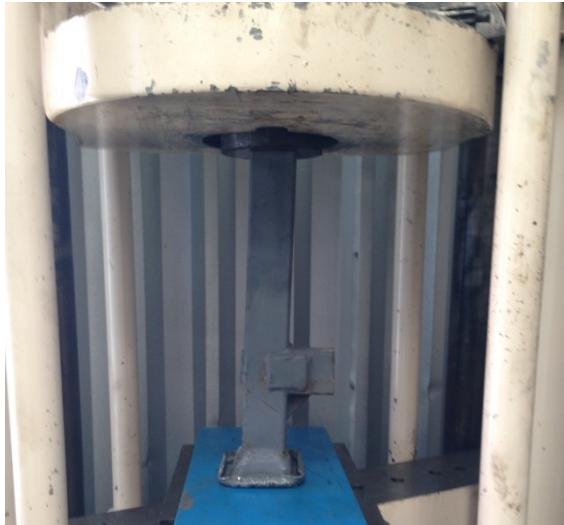
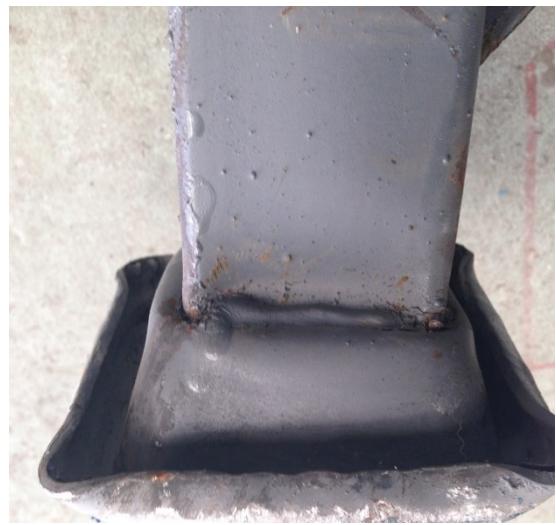
3.2.1. Sample 1

Typical compressive load application

Post load failure mode

Both sample 1 and sample 2 showed compressive failure at the foot pressing, the lower rolled lip folding and the SHS compressing the face of the mating section.
Side wall compressive yield evident,

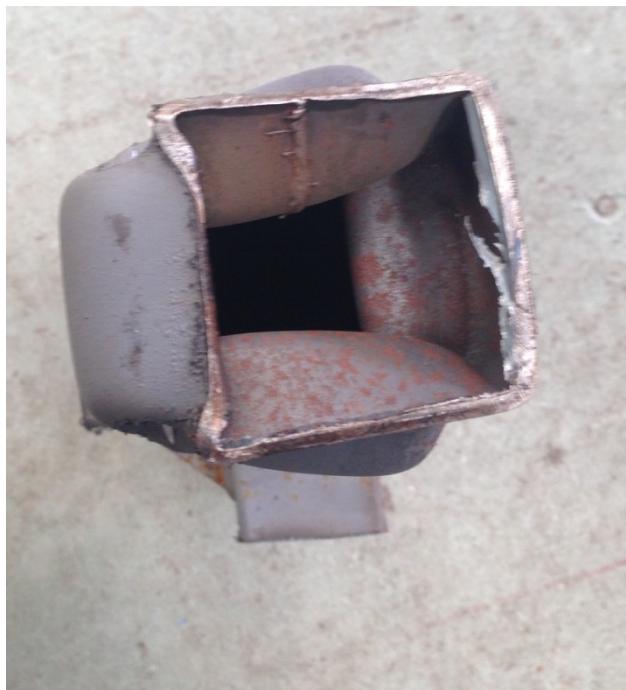
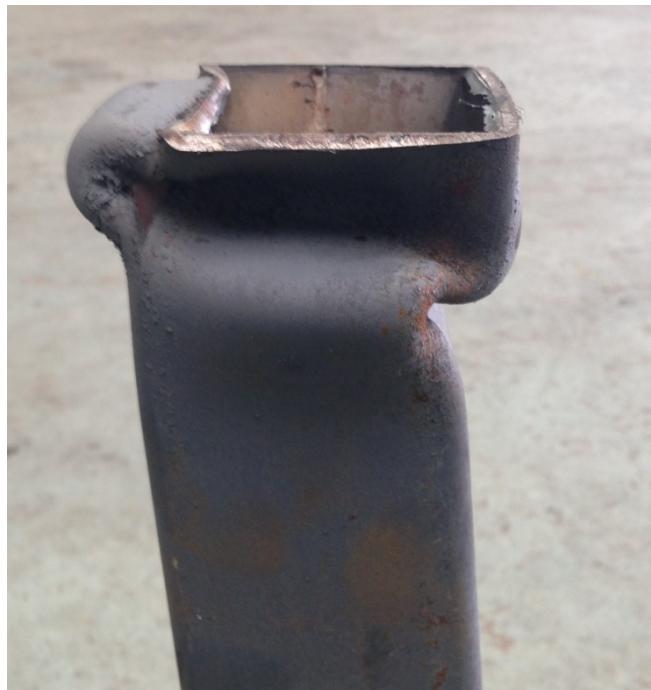
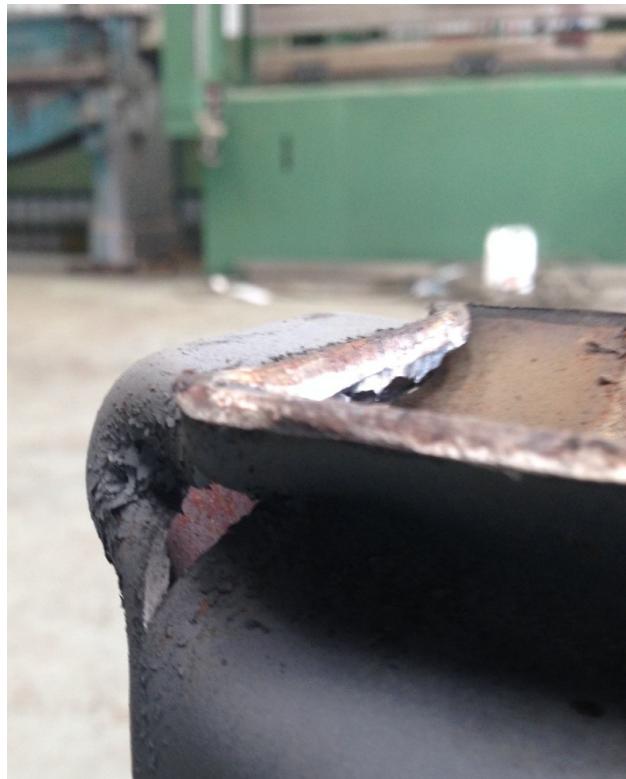
3.2.3. Sample 3

Sample 3: Compressive failure at elevated load of approximately 17 tonne.

The images show significant material deformation, this being confined to an area of 25mm to 40mm from the point of upper load application, no fracture appeared evident in the longitudinal hollow section seam, a material tear is evident in the concave fold as shown in the image.

Sample 3 vertical square hollow section compressive yield recorded (see digital image 3.2.3.)

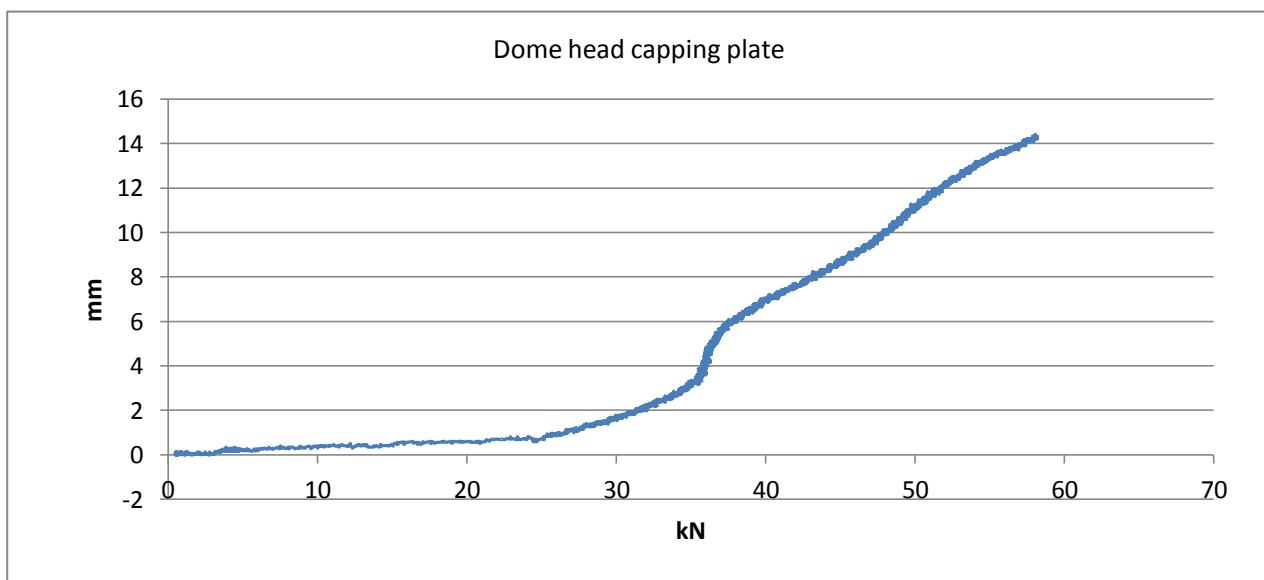
3.3.2. Load displacement graph capping plate

Compressive yield recorded at approximately 24kn (2447kg)

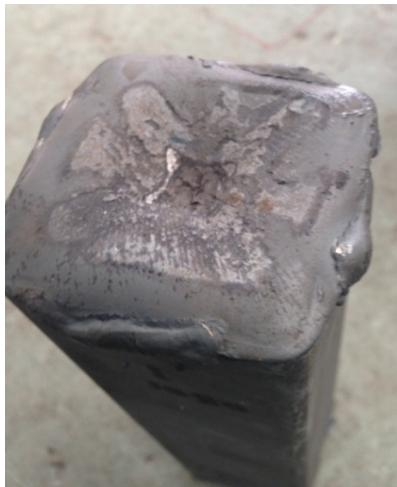
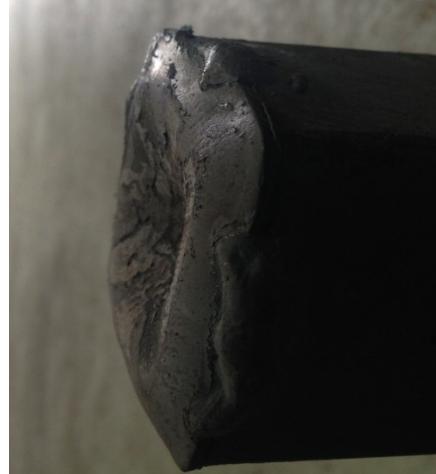
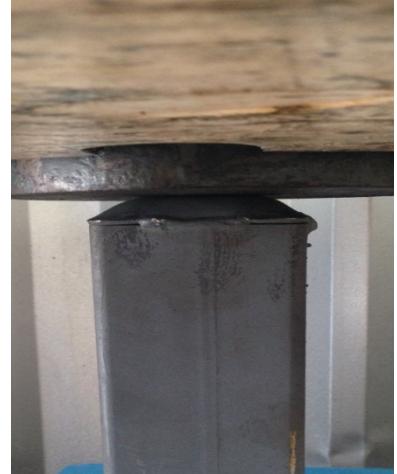
Post load image of capping domed plate failure mode

load application

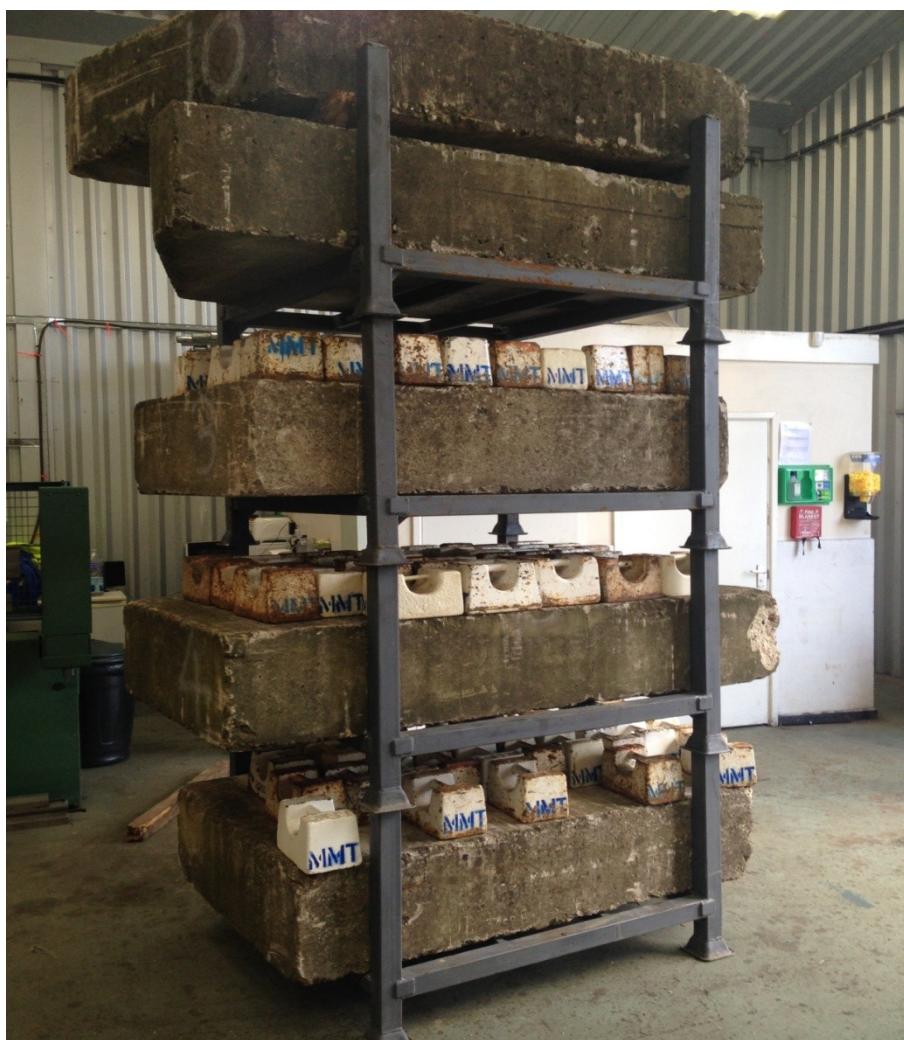
4.1. Digital image of proof load configuration

*The samples were subject to a stacking load application at 4 high with a UDL mass of 1500kg per pallet.
The samples were undisturbed for 24 hours with compressive displacements observed at initial stacking and post 24 hour dwell.
No visual increase in displacement found after load dwell.*

An increase in mass to 1.5 x the requested load was applied and again held for a 24 hour settlement period with displacements monitored pre and post.

Total load applied UDL 2250kg per pallet.

Applied load through lower vertical nodes of base pallet assumed shared over four point's 6750kg.

Due to fabrication tolerances load would be assumed shared over 3 vertical nodes only, giving a 2250kg per vertical node at 1.5 x 1500kg requested load.
