Report and Load Survey of: Free issue Readylock prefabricated transoms

Document number: TES000188TR-1

Client: VR Access Solutions Ltd

Item description: VR prefabricated transom system

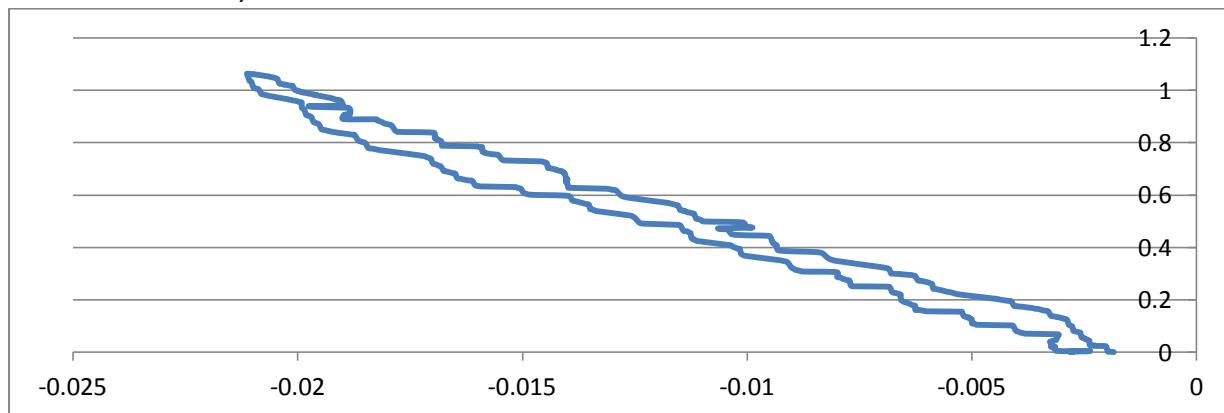
Sample 11: Test record 188-11 test type 3

Test load trace third cycle

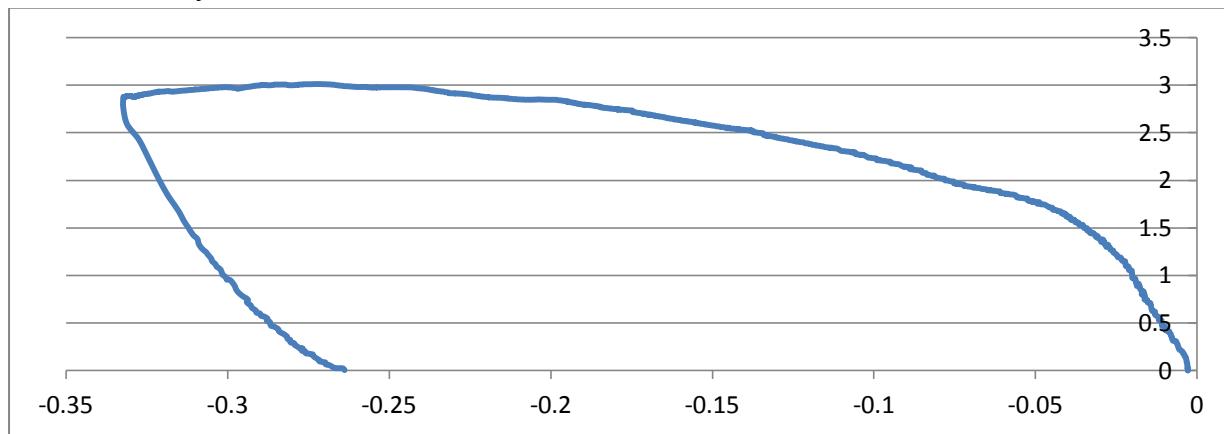
Sample 11: Test record 188-11 test type 3

Test load trace to failure

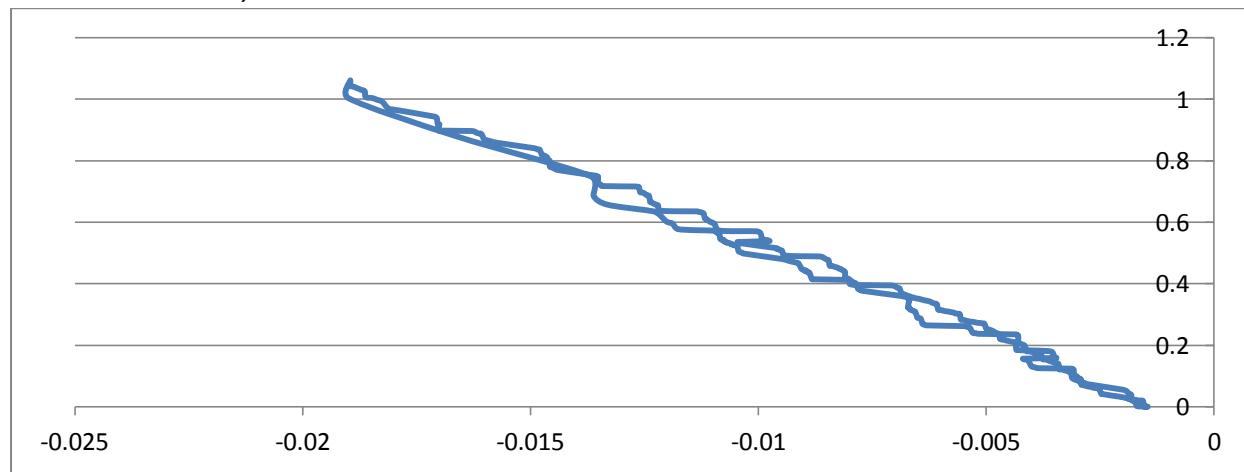
Sample 12: Test record 188-12 test type 3

Test load trace third cycle

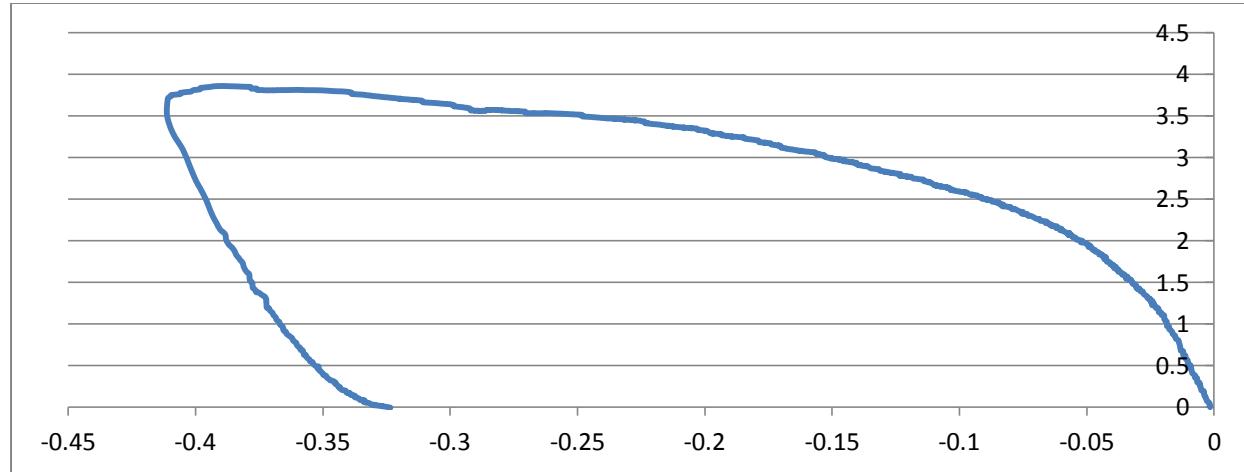
Sample 12: Test record 188-12 test type 3

Test load trace to failure

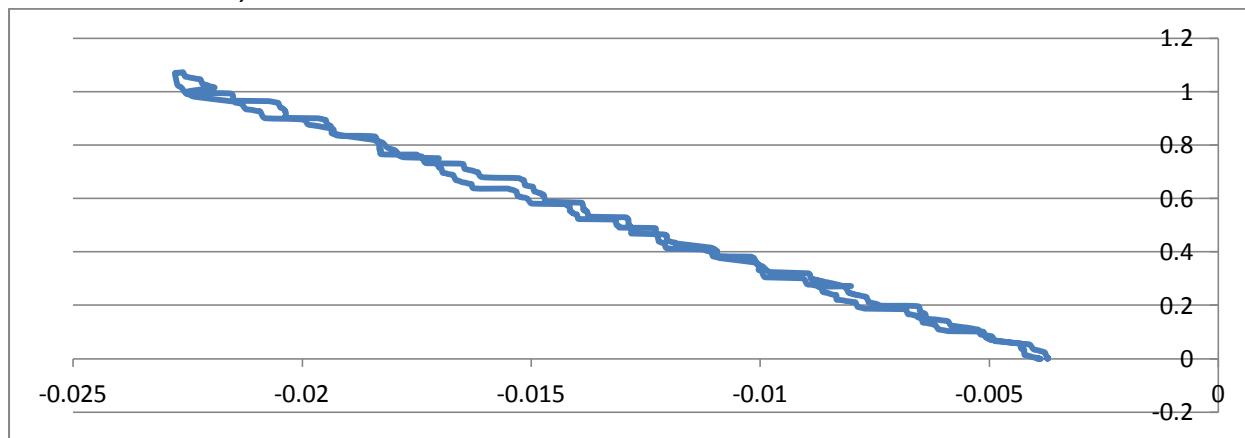
Sample 13: Test record 188-13 test type 3

Test load trace third cycle

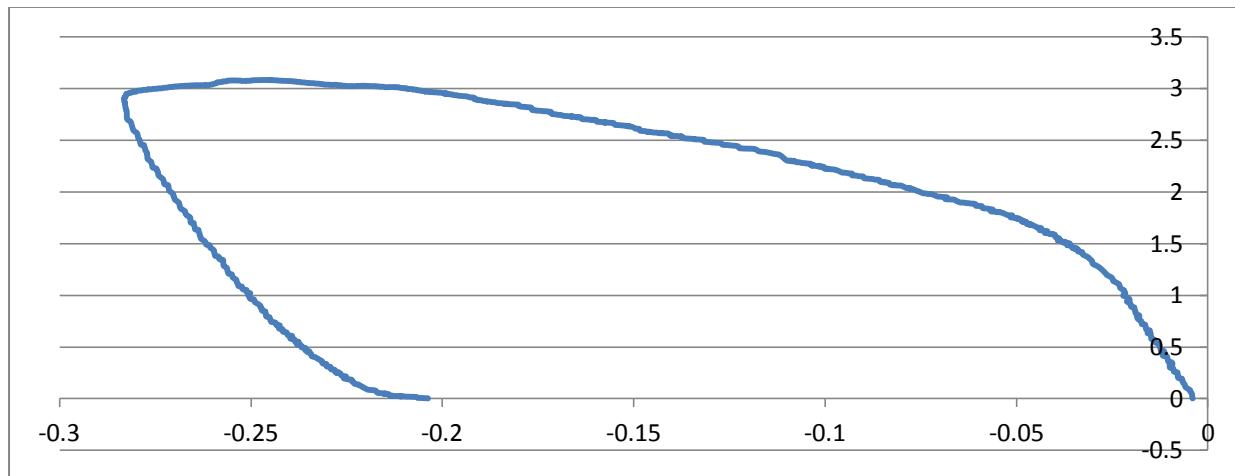
Sample 13: test record 188-13 test type 3

Test load trace to failure

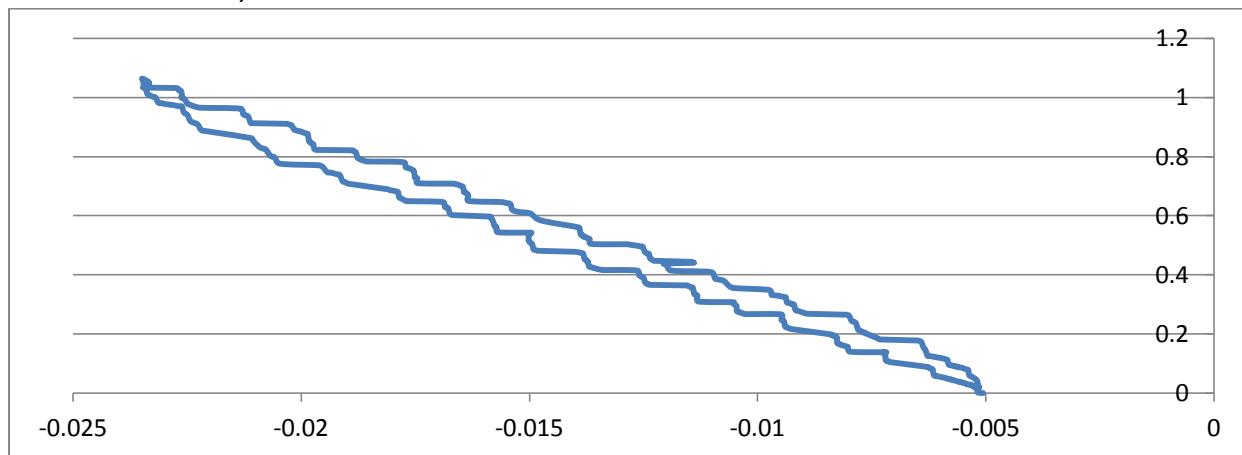
Sample 14: Test record 188-14 test type 3

Test load trace third cycle

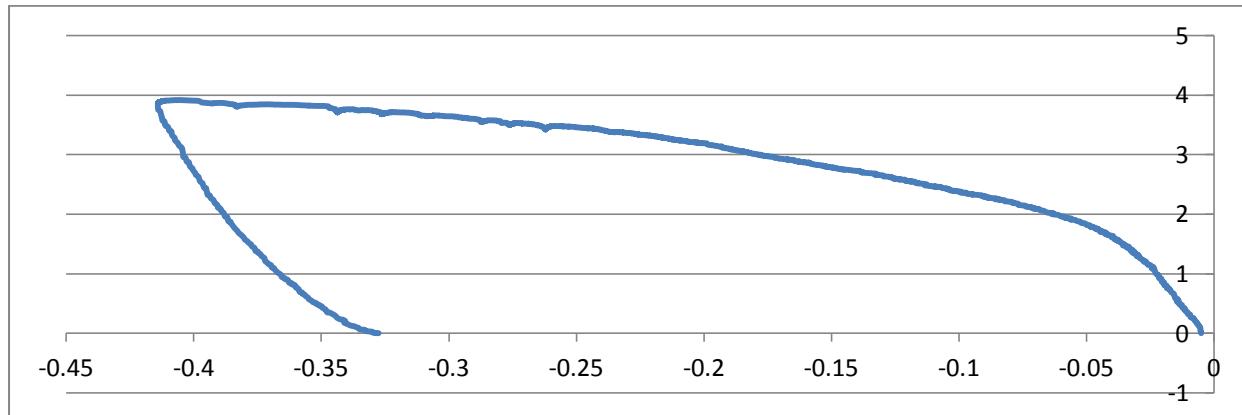
Sample 14: Test record 188-14 test type 3

Test load trace to failure

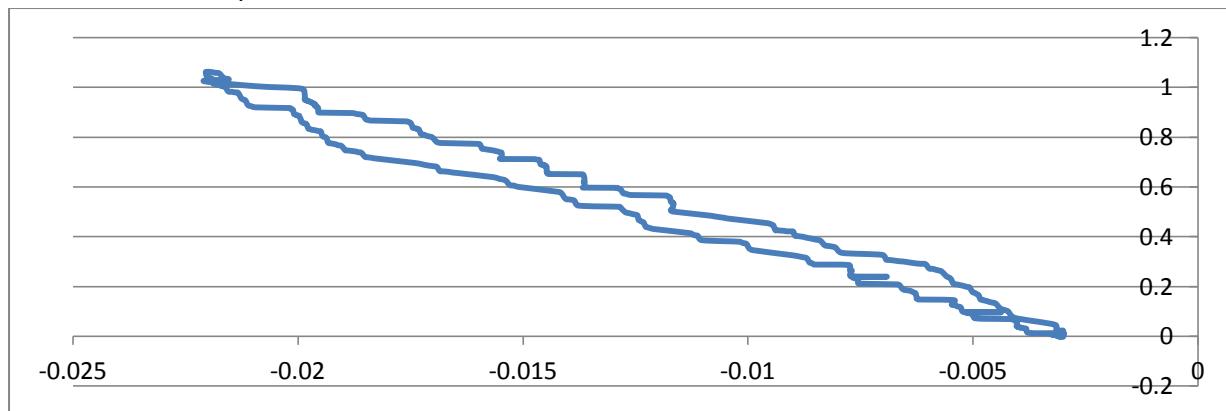
Sample 15: Test record 188-15 test type 3

Test load trace third cycle

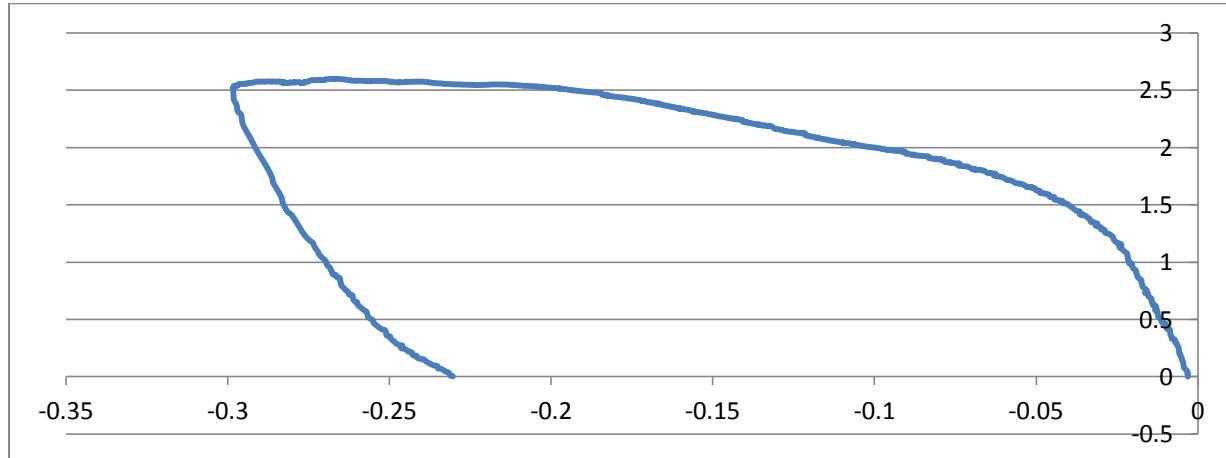
Sample 15: Test record 188-15 test type 3

Test load trace to failure

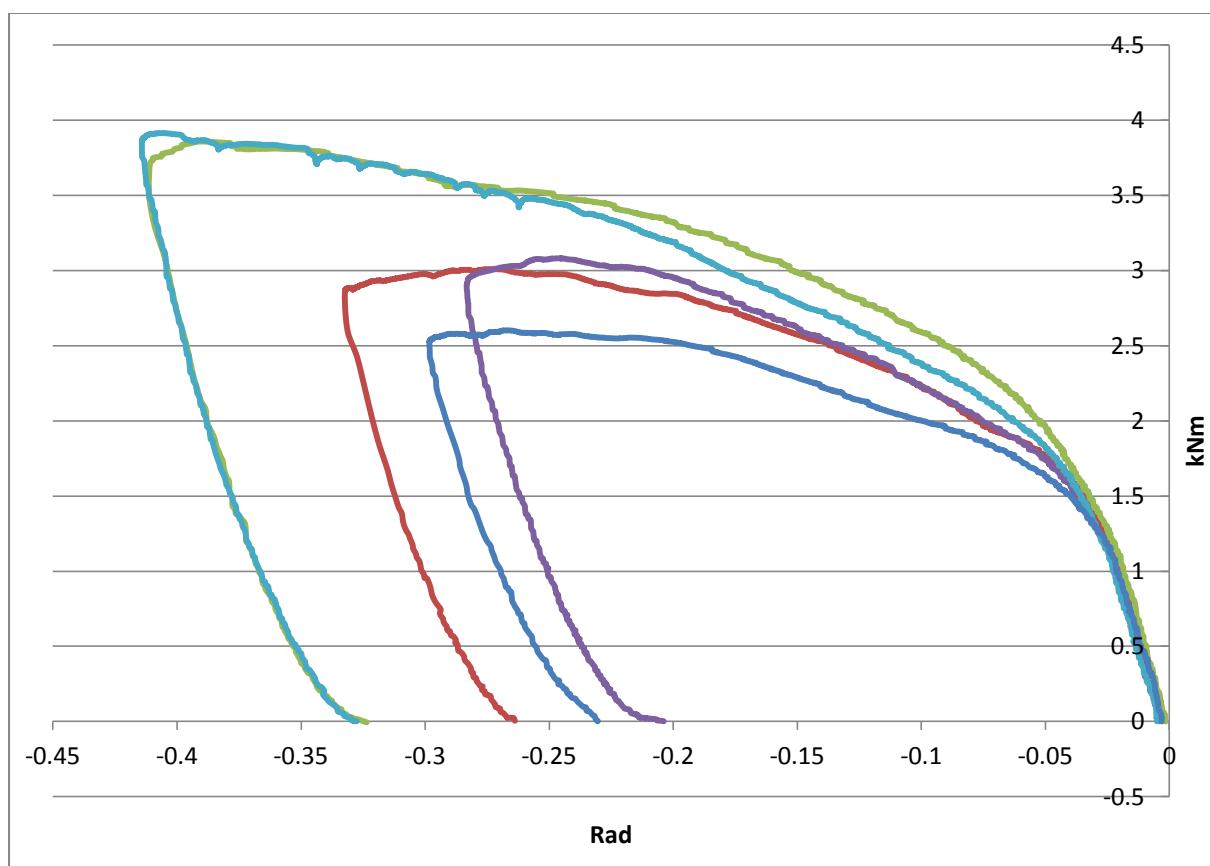
Samples 188-11 to 188-15 load to failure

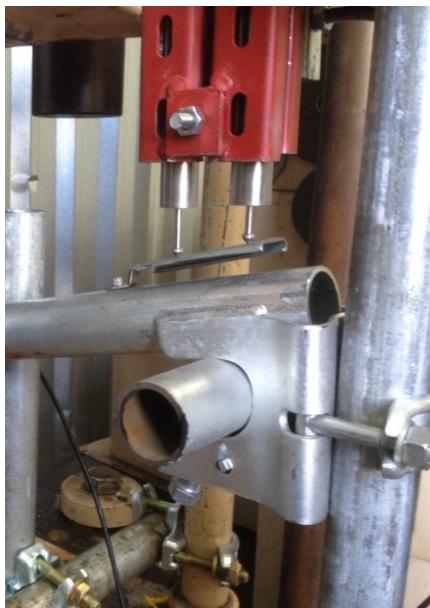
Typical arrangement

The load was applied to the transom at 500mm from the standard centre line, the displacements were recorded via the 2 number LDVT linear transducers set at 50mm distance apart the furthest away being centralised above the end of the transom coupler weld. Load applied in the positive direction only as required. All bolts were subject to torque of 50Nm 5 times prior to load application and 10 minutes resting time upon installation to test.

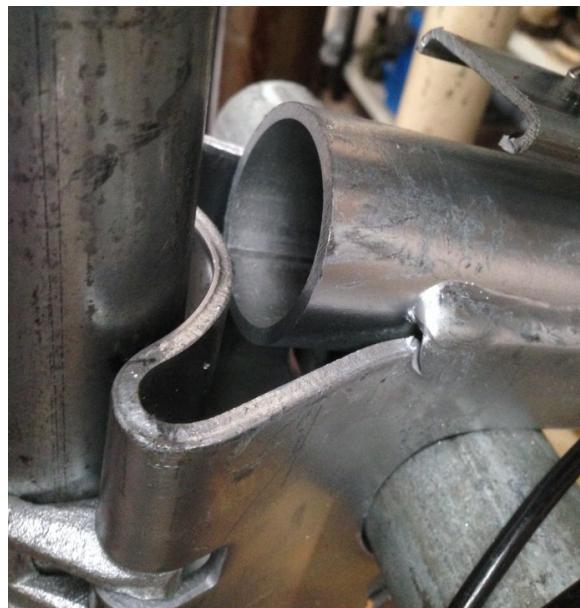
showing parent material fracture

- 1= Weld failure/fracture:
- 2= Parent material failure at weld area:
- 3= Clamp distortion/clamping components distortion:
- 4= Tube wall rotational distortion at end of welded clamp
- 5= Rupture of tube at weld area

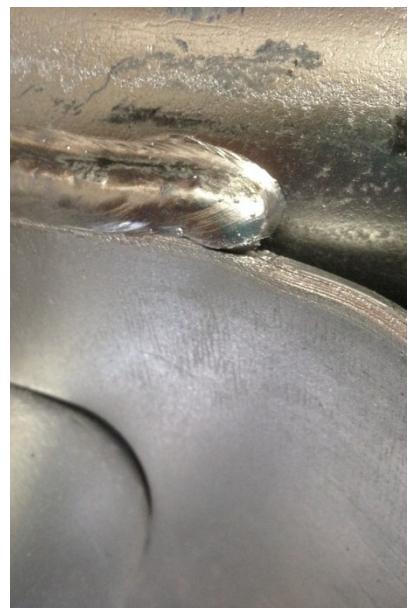
weld failure

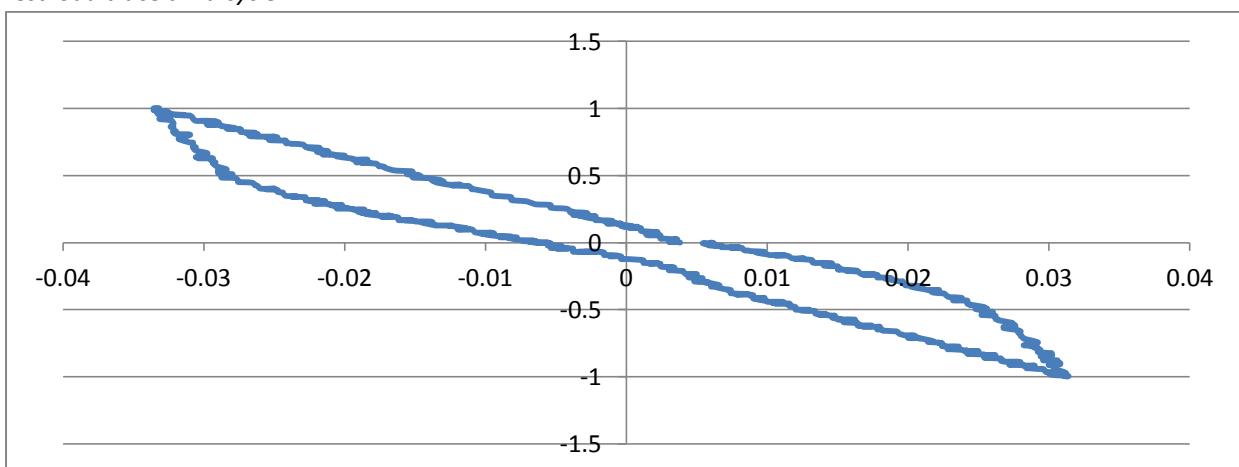
Sample 17: Test record 188-17 test type 4

Test load trace third cycle

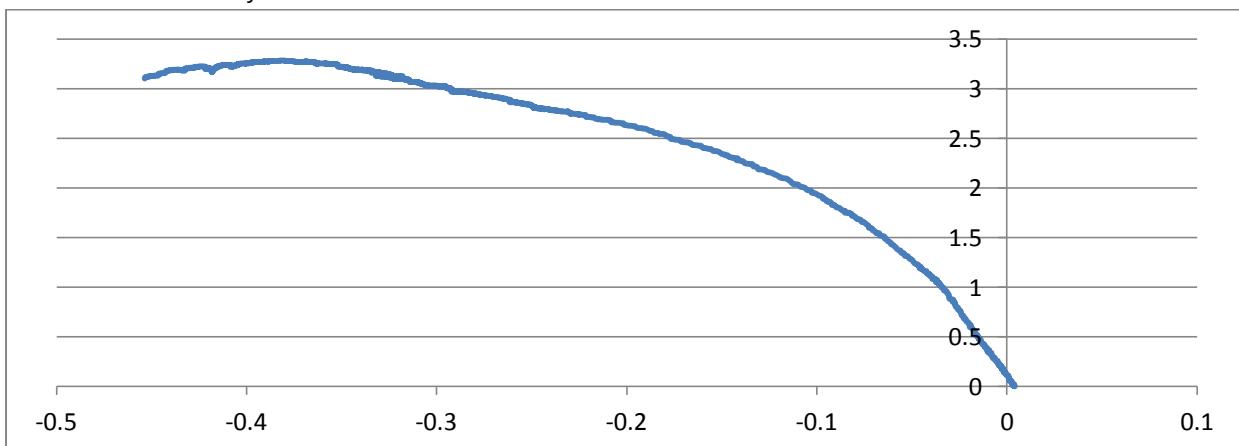
Sample 17: Test record 188-17 test type 4

Test load trace load to failure

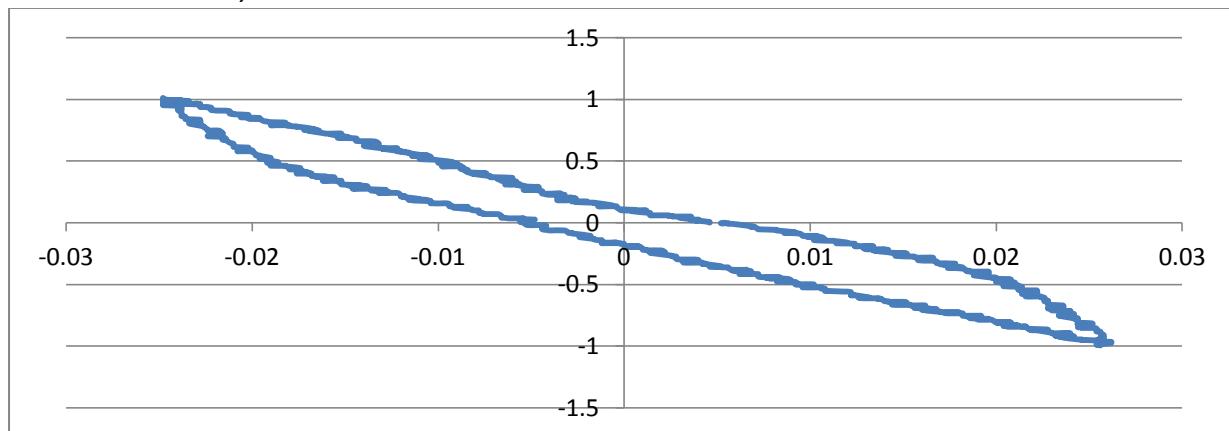
Sample 18: Test record 188-18 test type 4

Test load trace third cycle

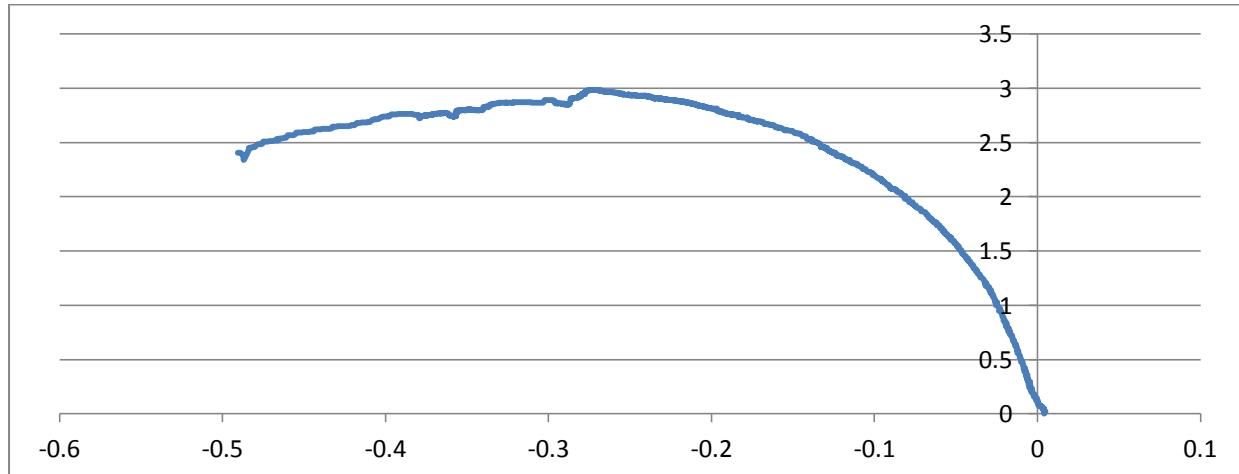
Sample 18: Test record 188-18 test type 4

Test load trace load to failure

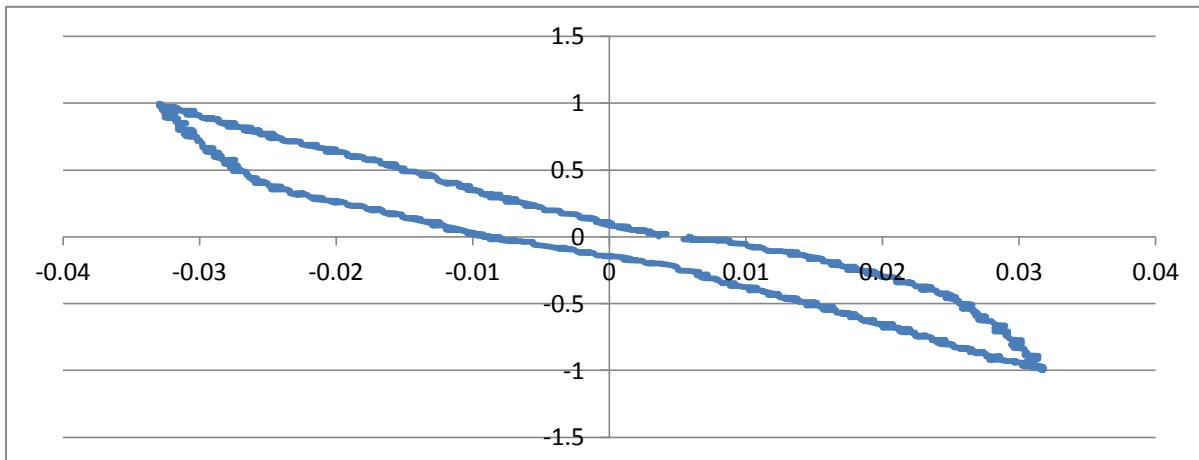
Sample 19: Test record 188-19 test type 4

Test load trace third cycle

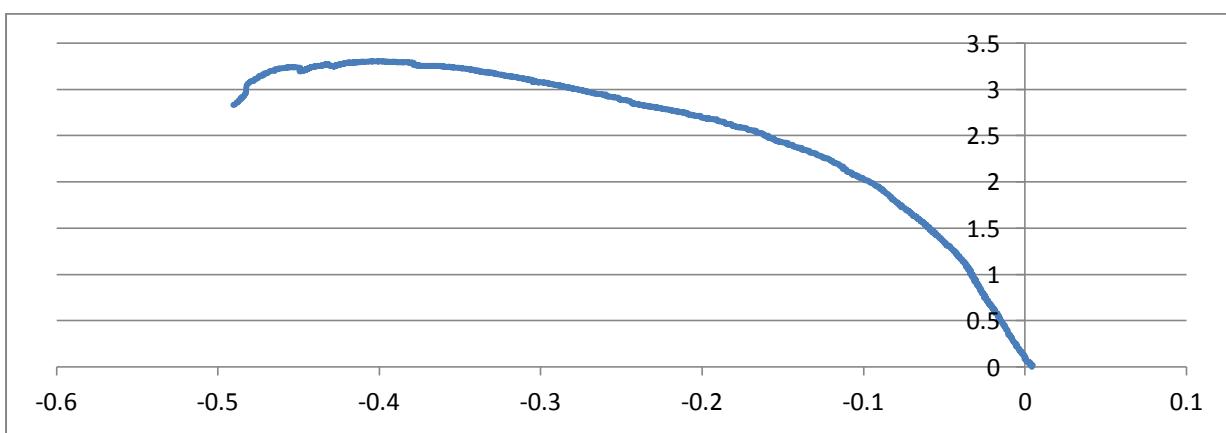
Sample 19: Test record 188-19 test type 4

Test load trace load to failure

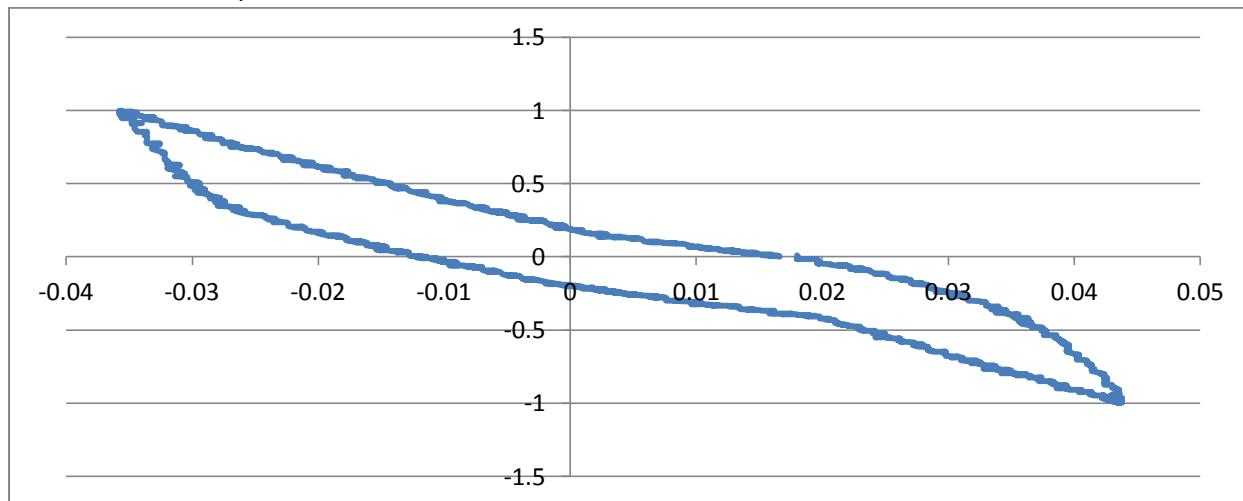
Sample 20: test record 188-20 test type 4

Test load trace third cycle

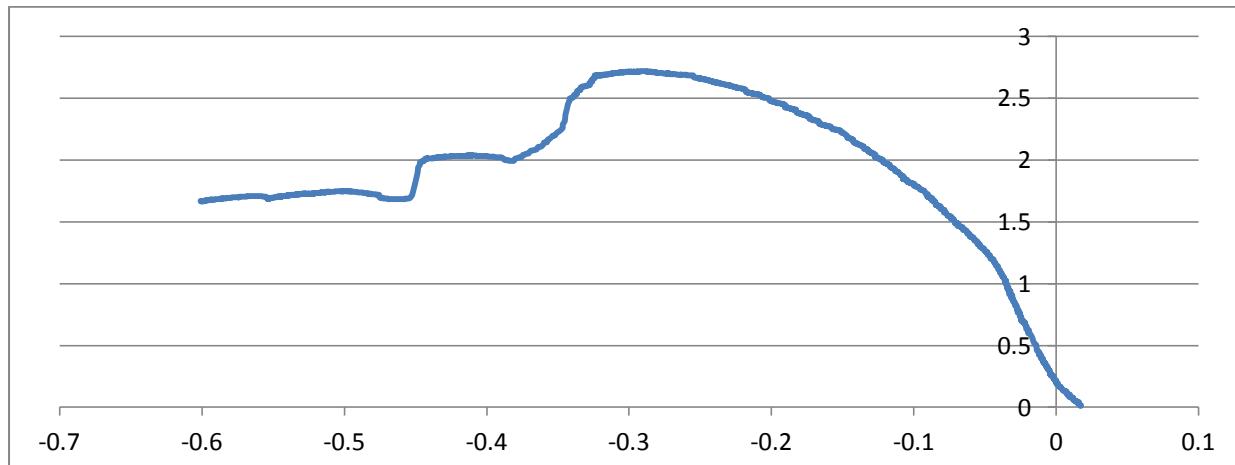
Sample 20: test record 188-20 test type 4

Test load trace load to failure

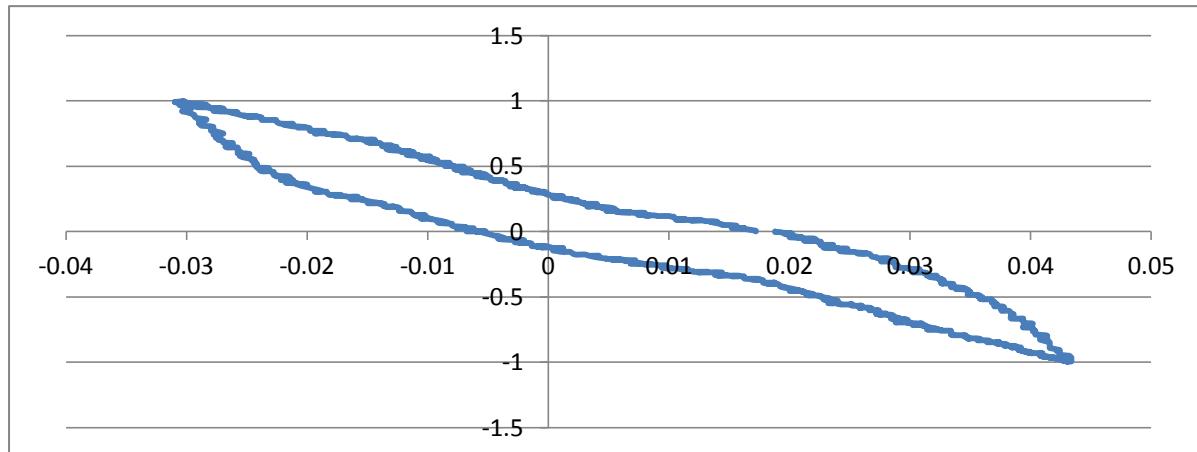
Sample 21: test record 188-21 test type 4

Test load trace third cycle

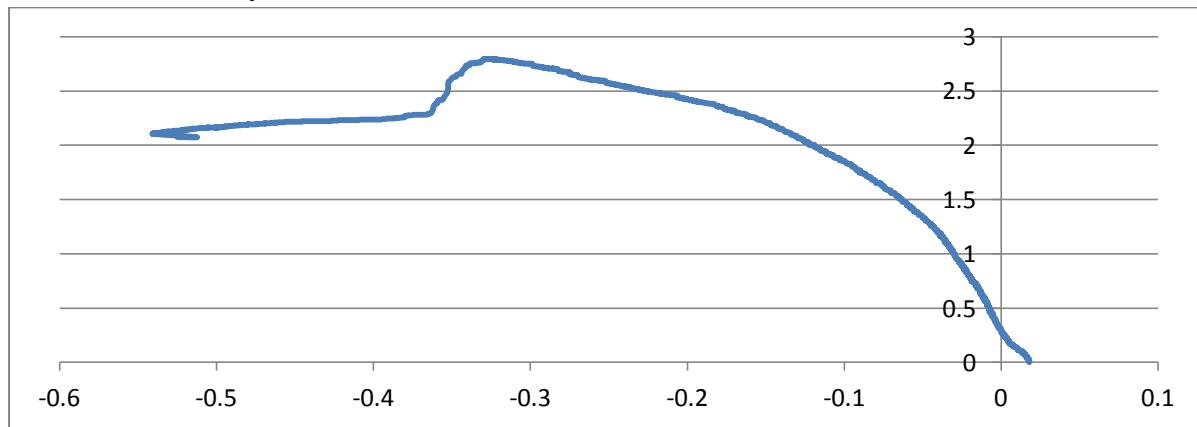
Sample 21: test record 188-21 test type 4

Test load trace load to failure

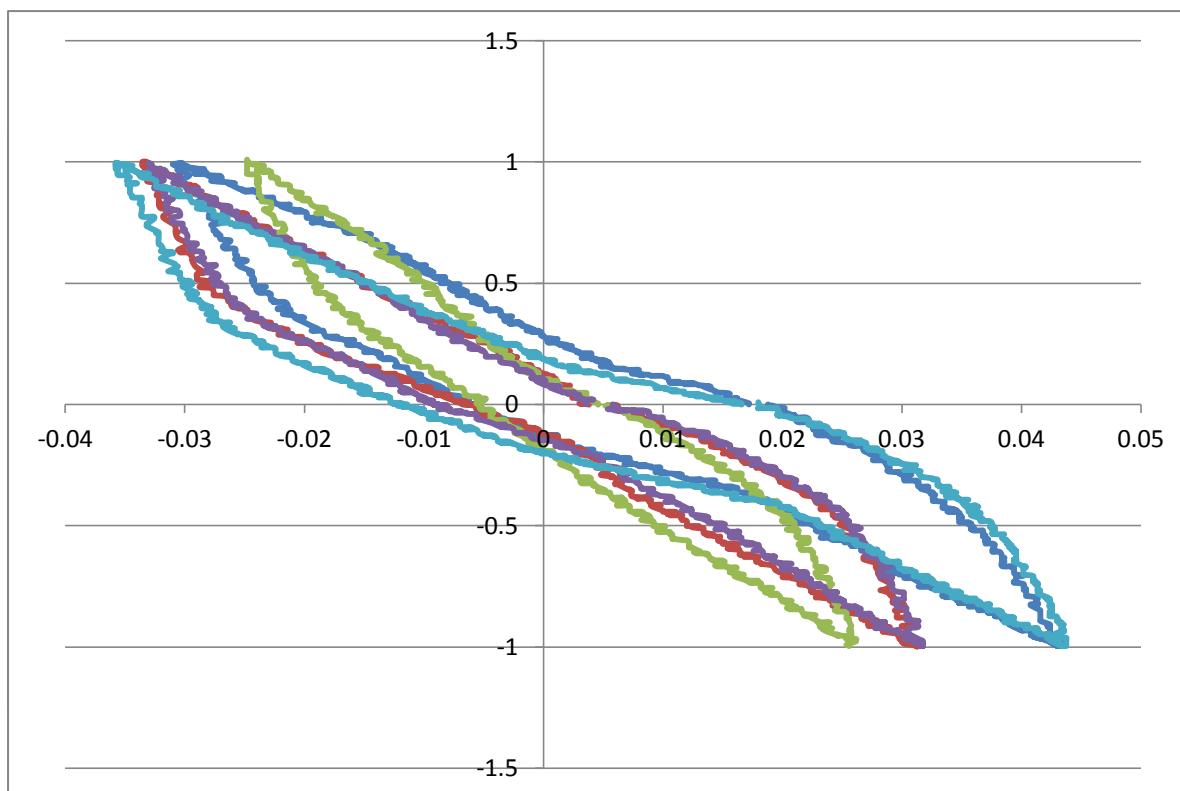
Samples 188-17 to 188-21 3rd cycle

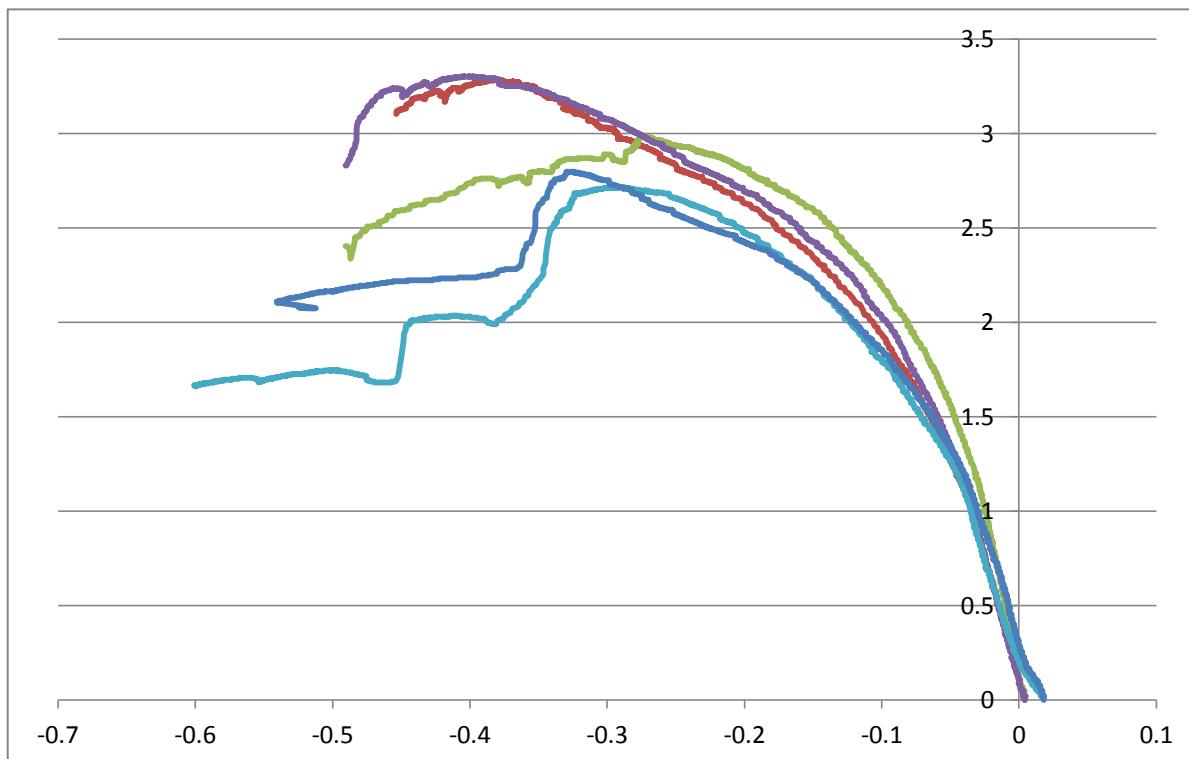
Samples 188-17 to 188-21 load to failure

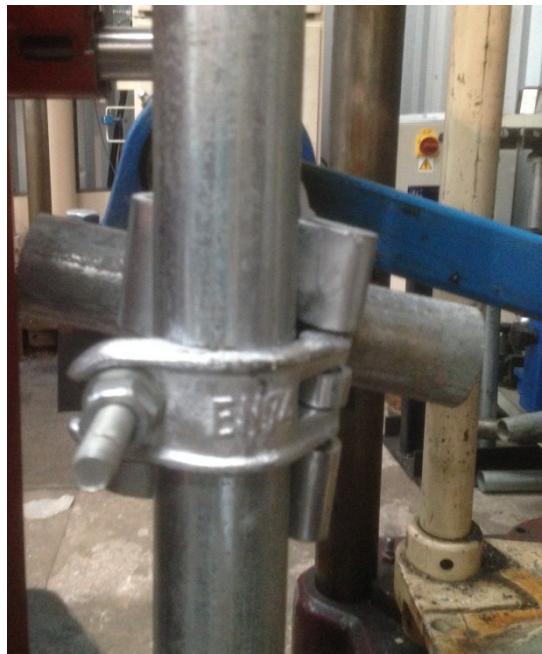
Typical arrangement

The load was applied to the transom at 500mm from the standard centre line via a welded lever arm, the displacements were recorded via the 2 number LDVT linear transducers set at 50mm distance apart the being centralised above the end of the transom coupler weld.

The remaining transom stub was fitted into a journal bearing to remove negative bending without frictional support. All bolts were subject to torque of 50Nm 5 times prior to load application and 10 minutes resting time upon installation to test.

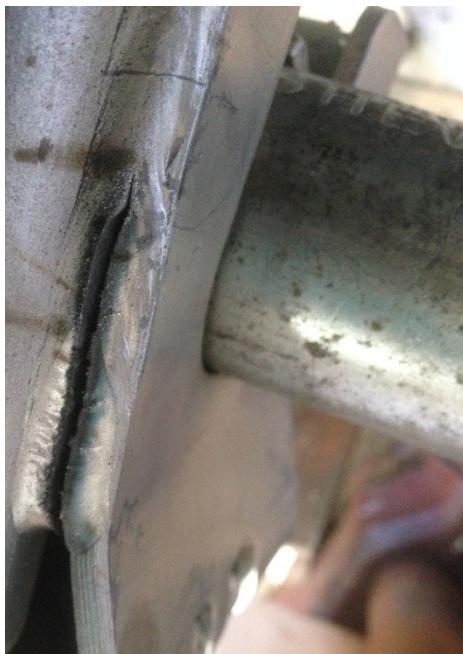
longitudinal weld fracture

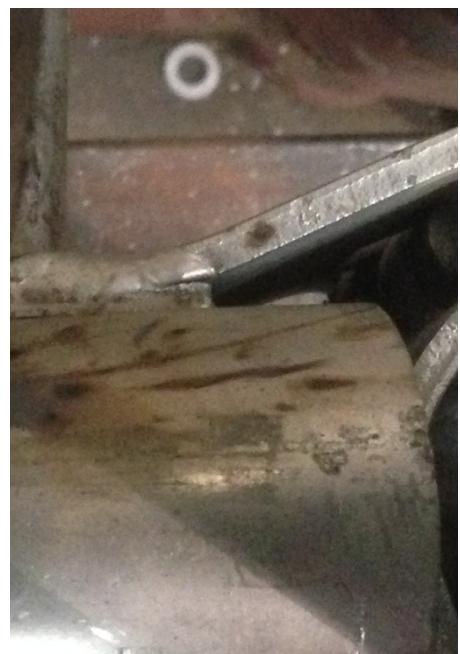
initial weld failure

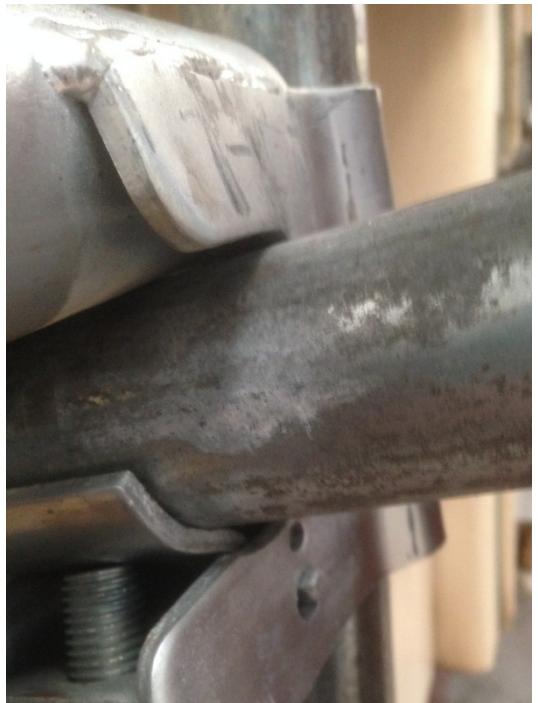
Typical side wall buckling

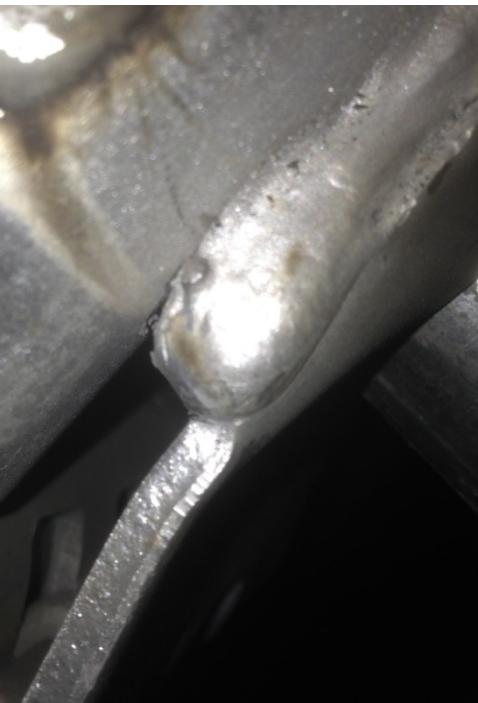
initial toe of weld failure

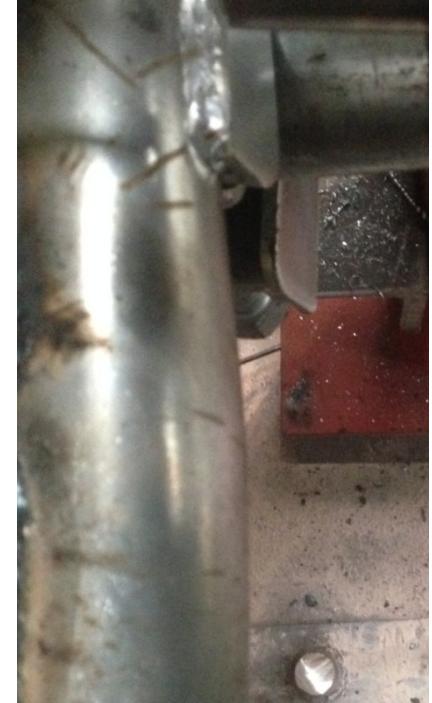
tube wall buckling

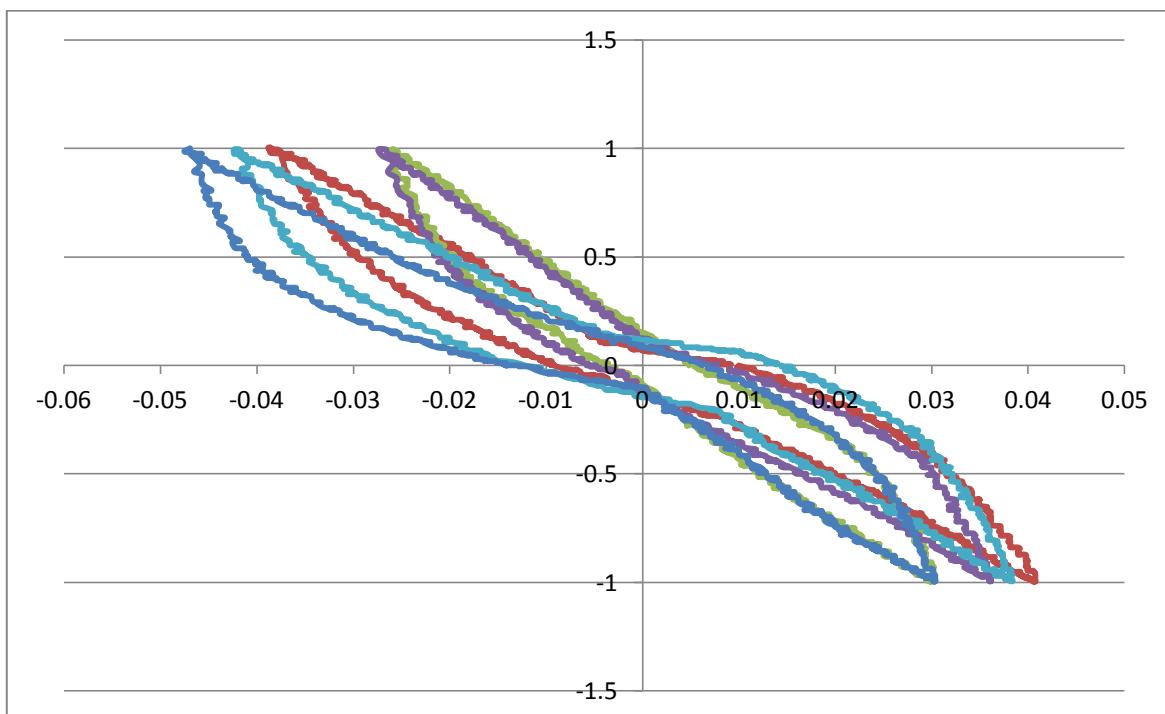
Samples 188-22 to 188-26 3rd Cycle

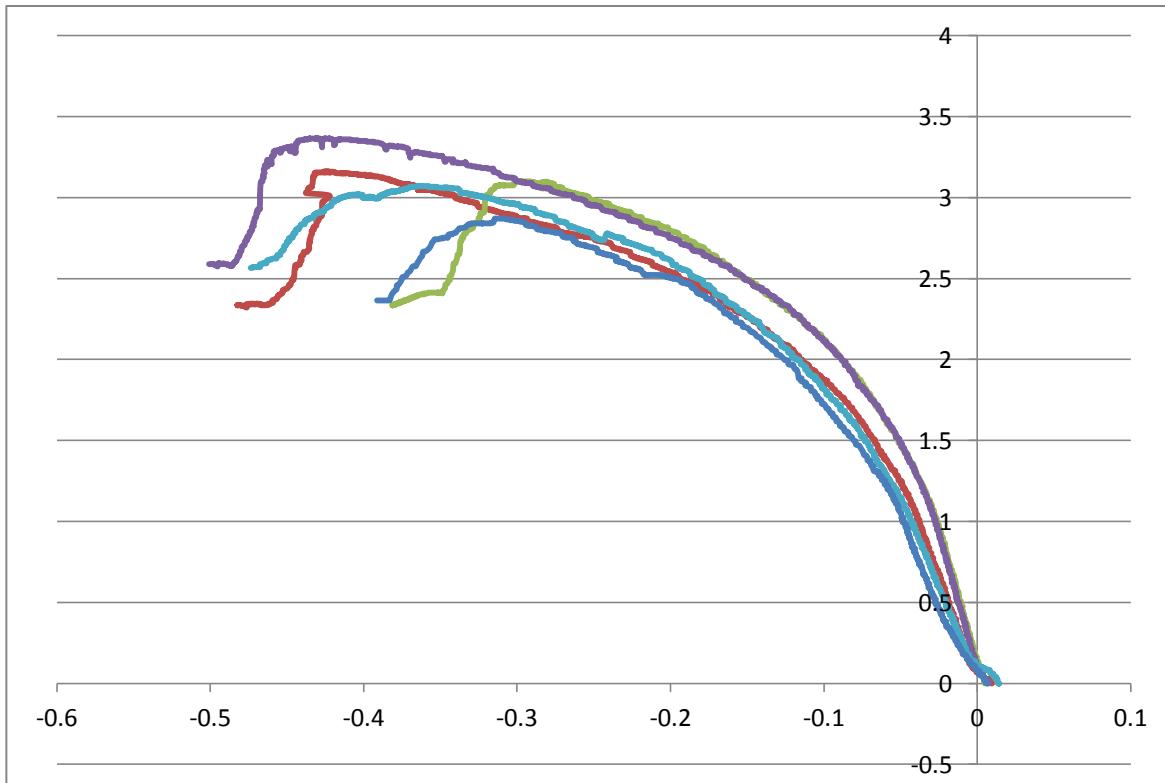
Samples 188-22 to 188-26 load to failure

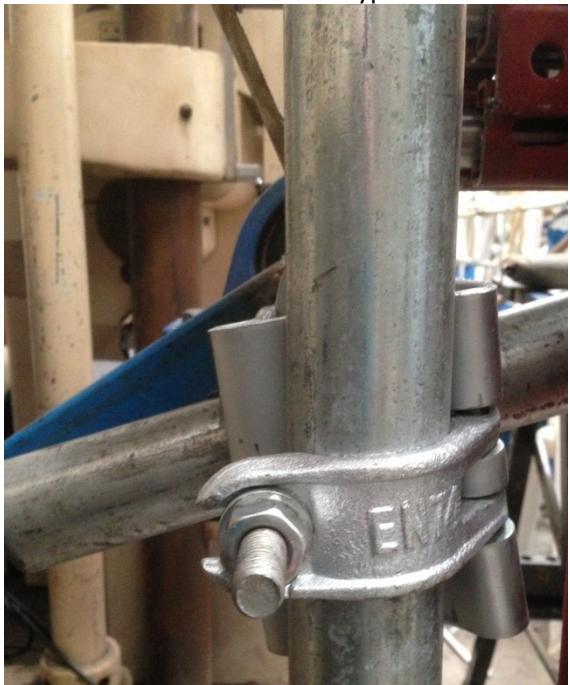
Typical arrangement inverted

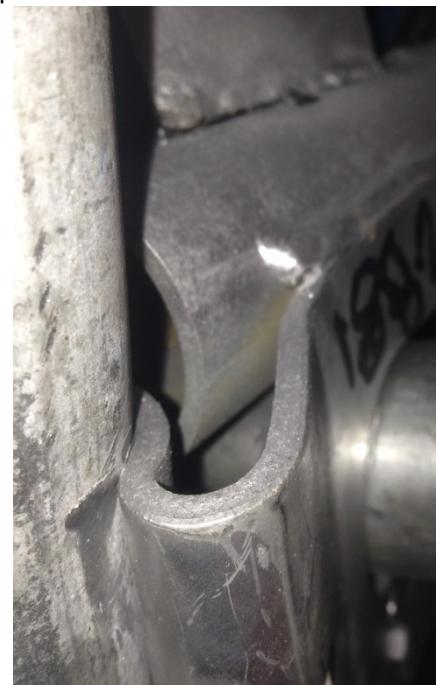
toe weld fracture

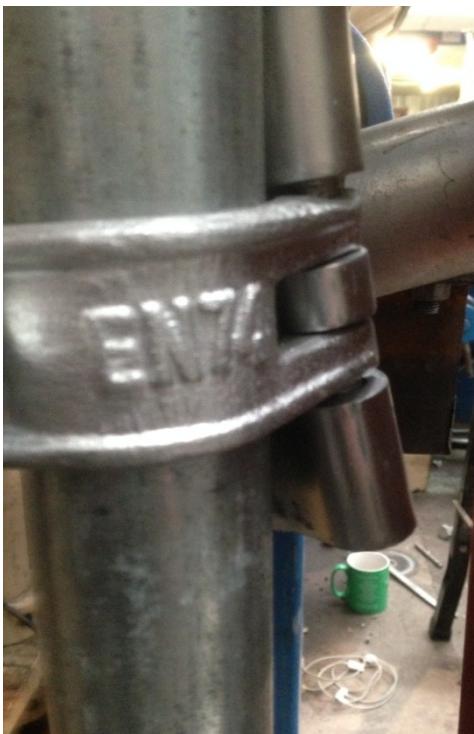
Hinge plate deformation

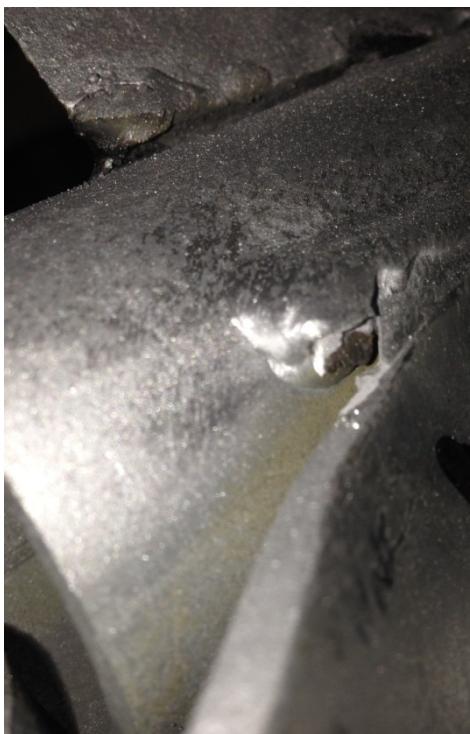
weld fracture

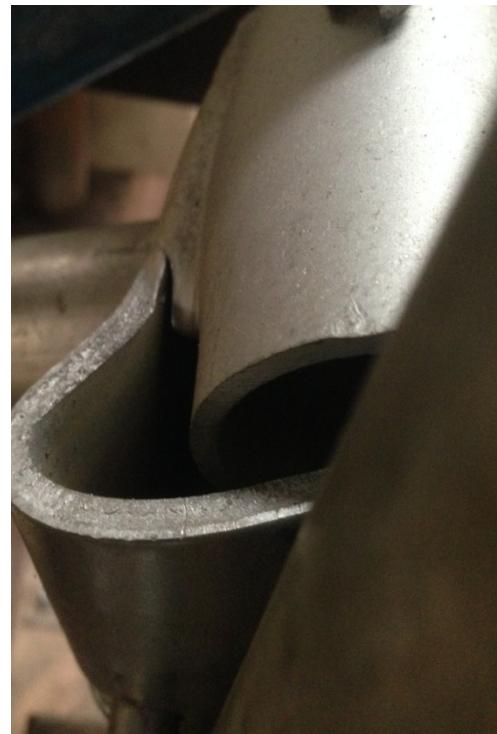
initial weld tear

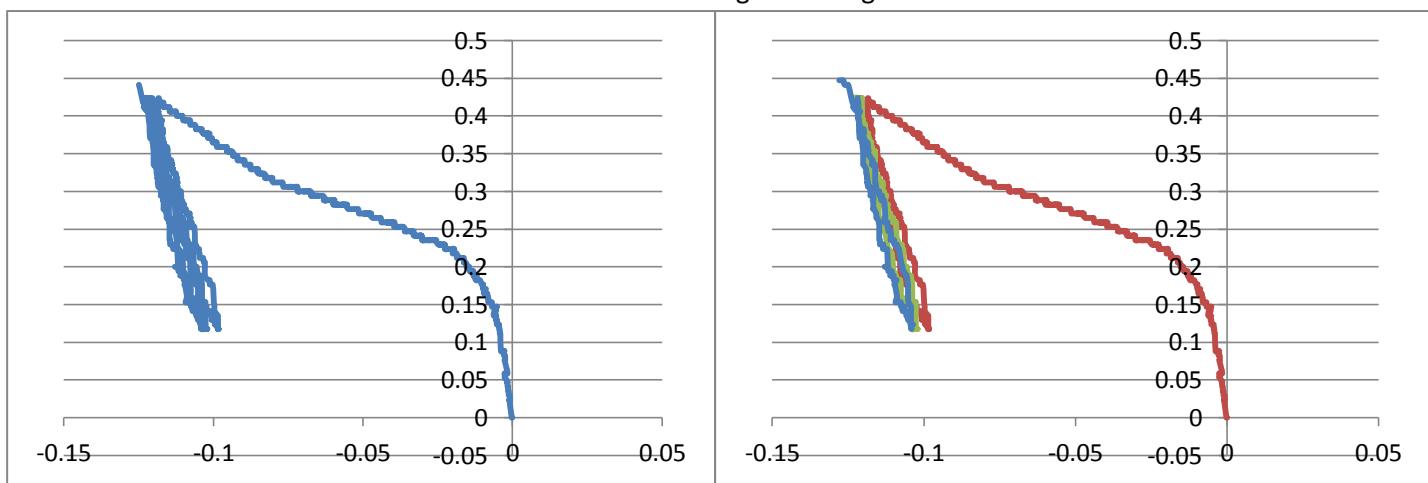
Test 188-28 showing unloading curves

With the guidance of S Mech the load cycles were reduced to give unloading curves to approximately 0.1kNm to eliminate transom to ledger slippage.

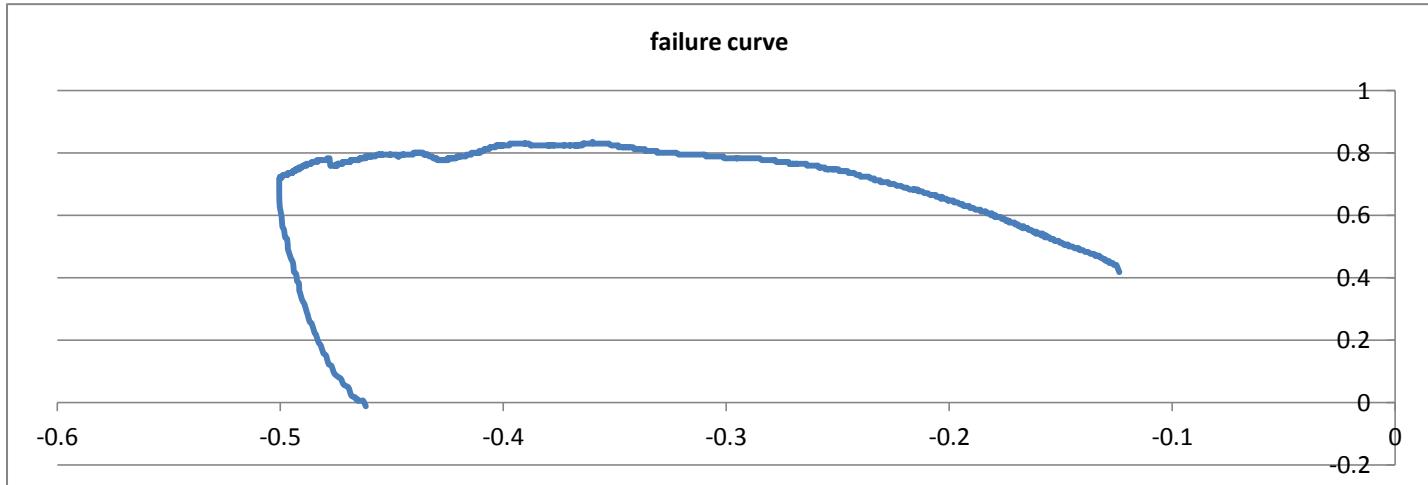
failure curve

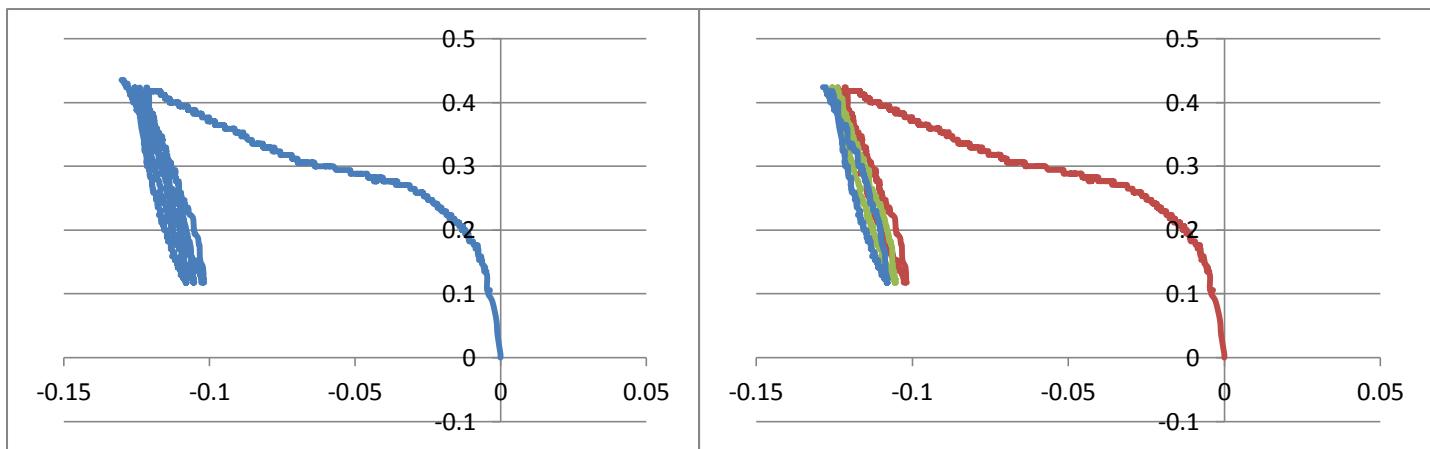
Test 188-29 showing unloading curves
