Report and Load Survey of: Free issue Readylock prefabricated transoms

Document number: TES000188TR-1

Client: VR Access Solutions Ltd

Item description: VR prefabricated transom system

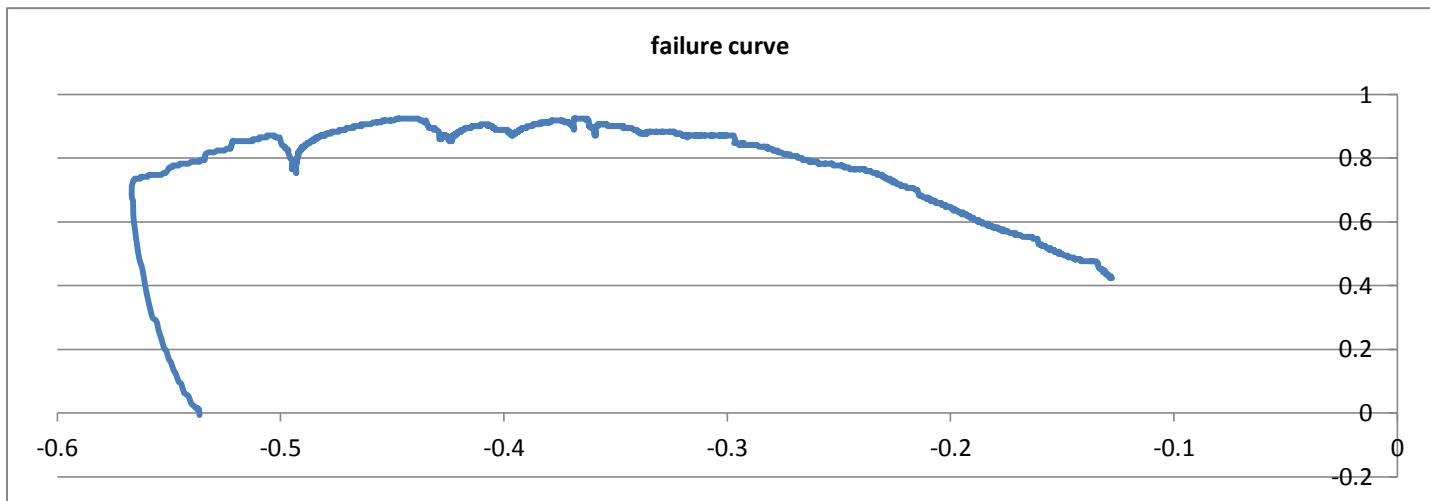
failure curve

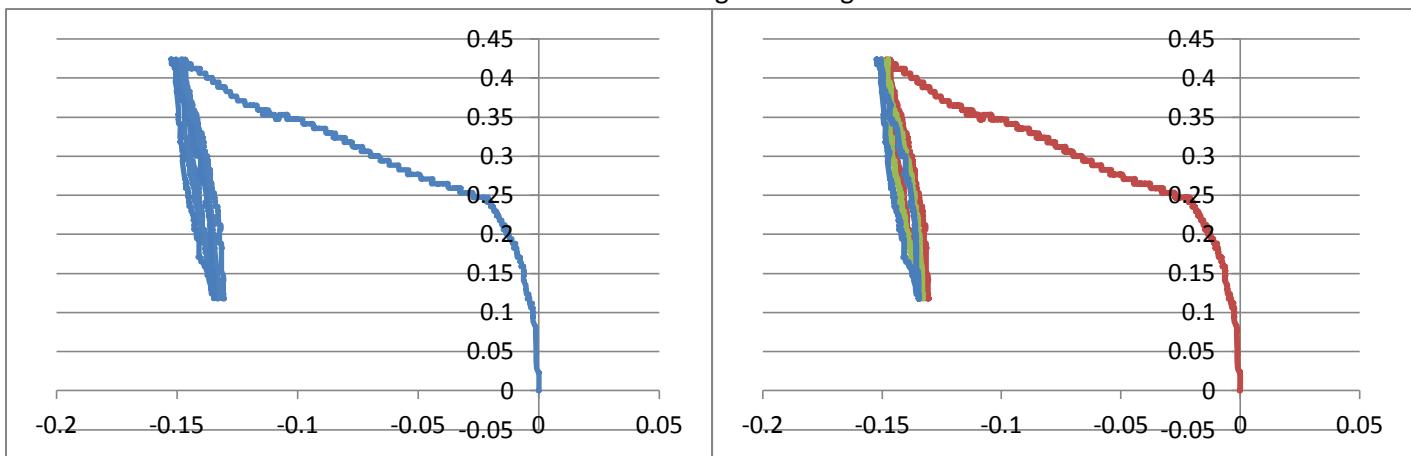
Test 188-31 showing unloading curves

With the guidance of S Mech the load cycles were reduced to give unloading curves to approximately 0.1kNm to eliminate transom to ledger slippage.

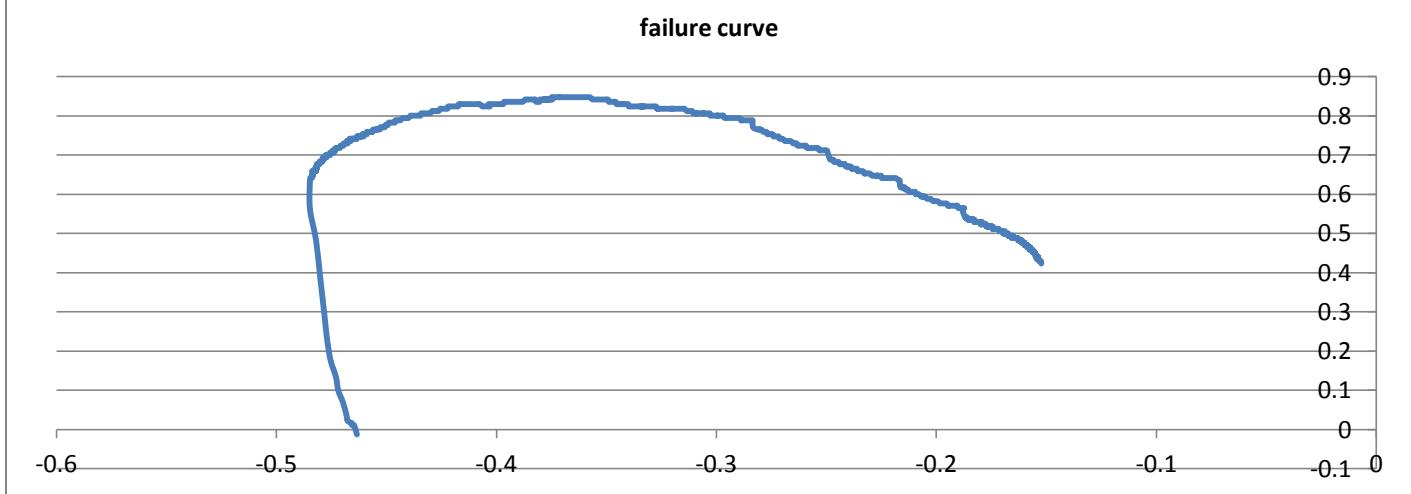
failure curve

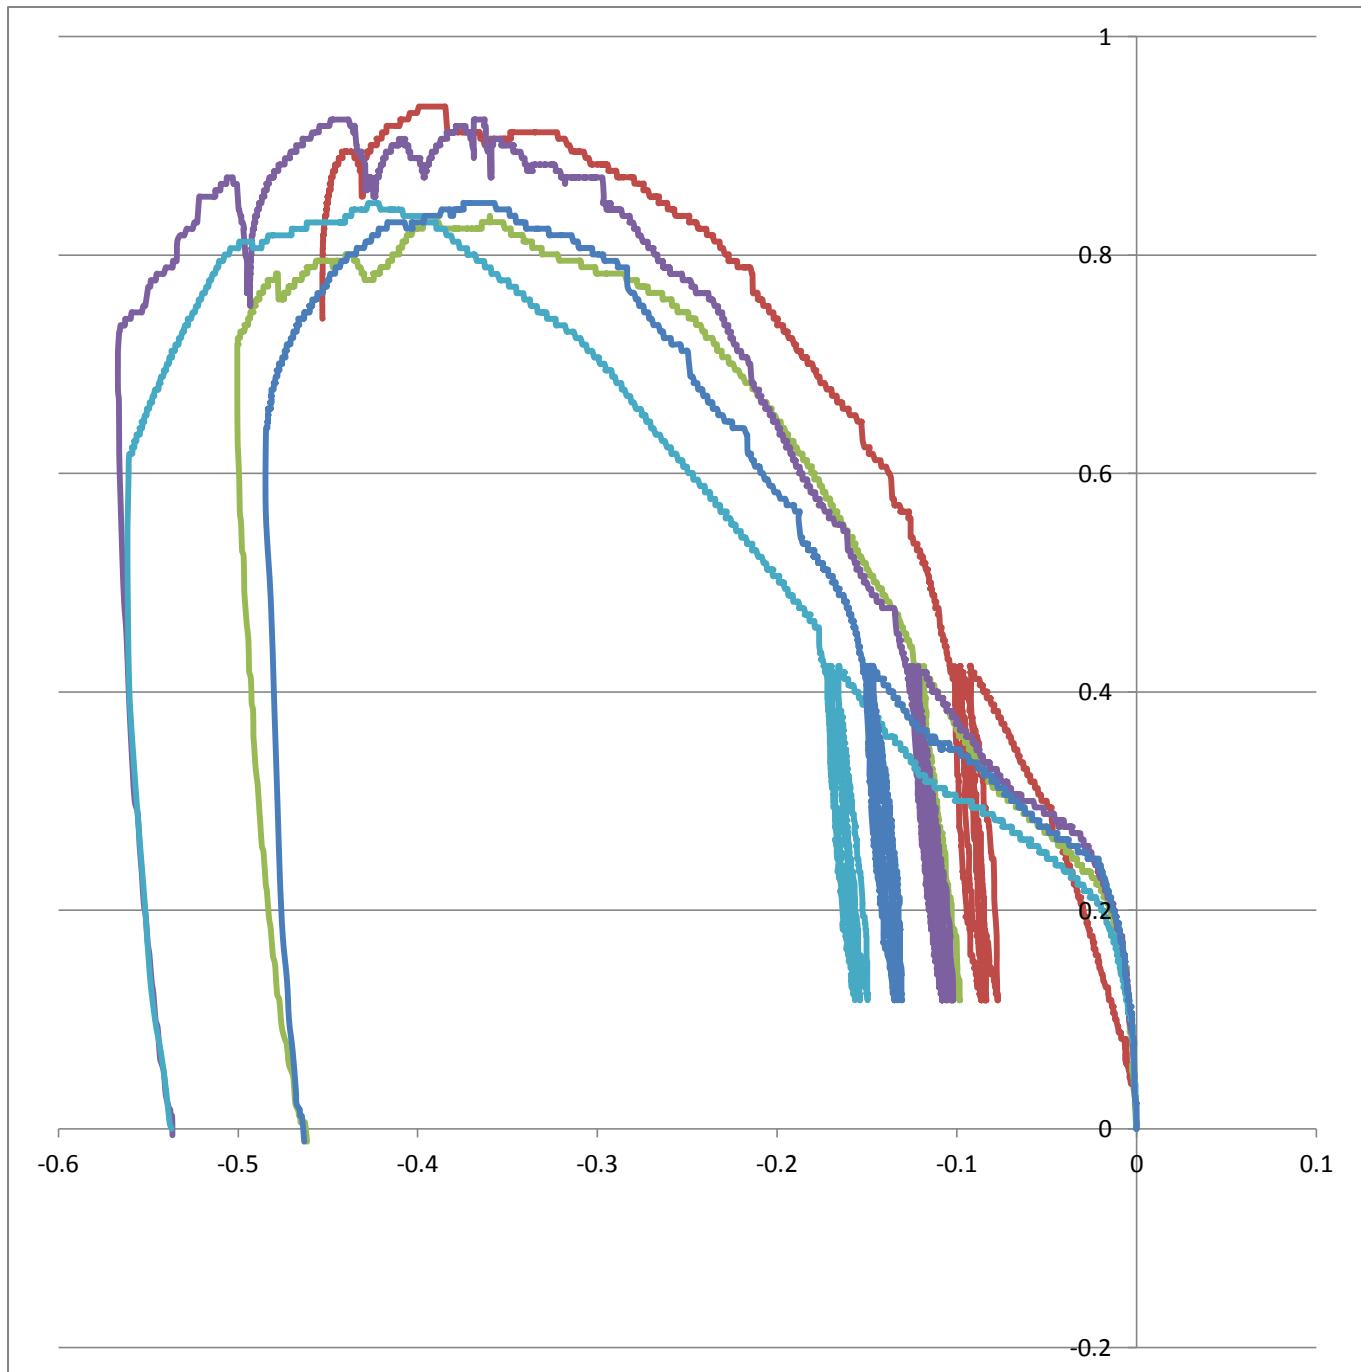
Tests 188-27 to 31 load traces

Upon initial pilot test runs the ledger plate and bolt connection showed looseness when load cycled.

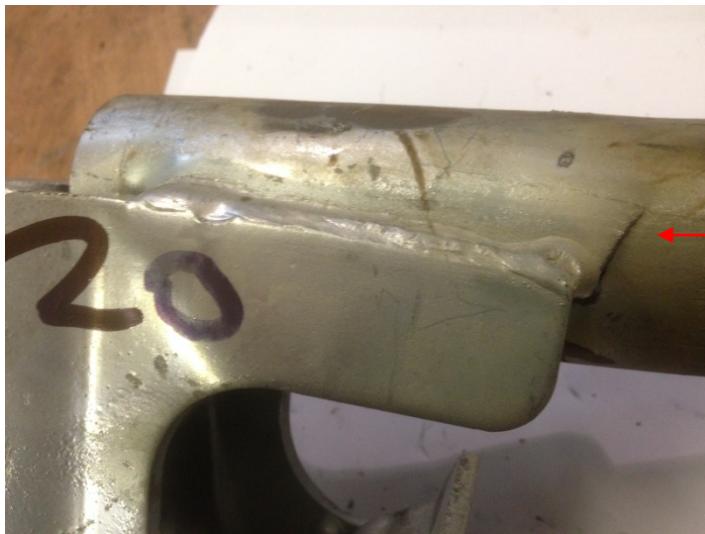
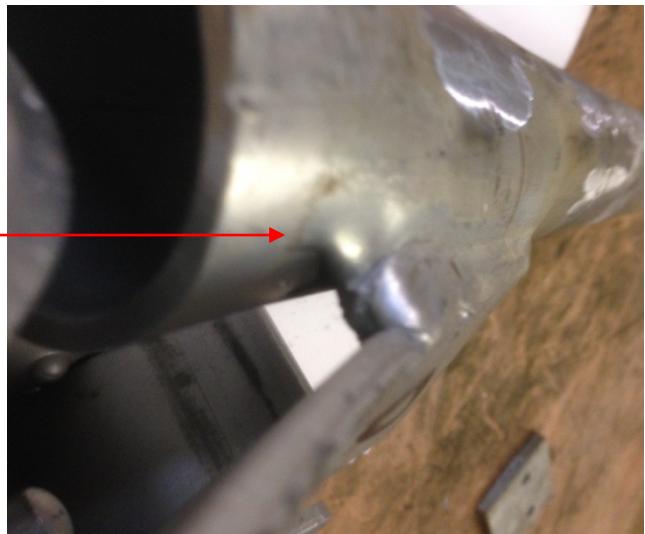
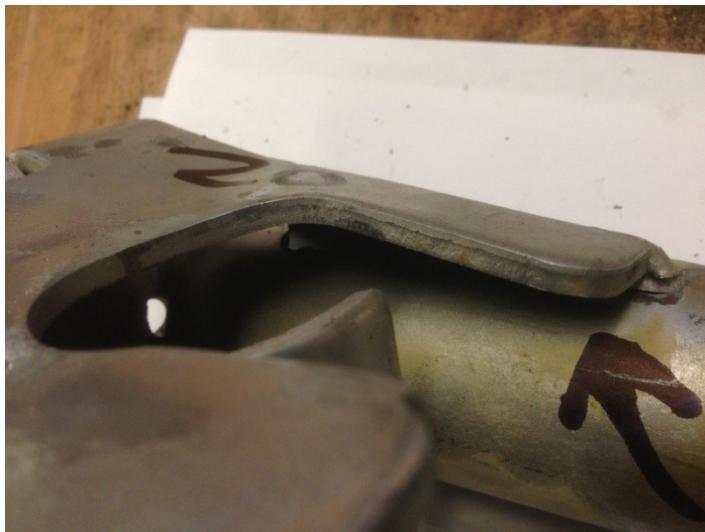
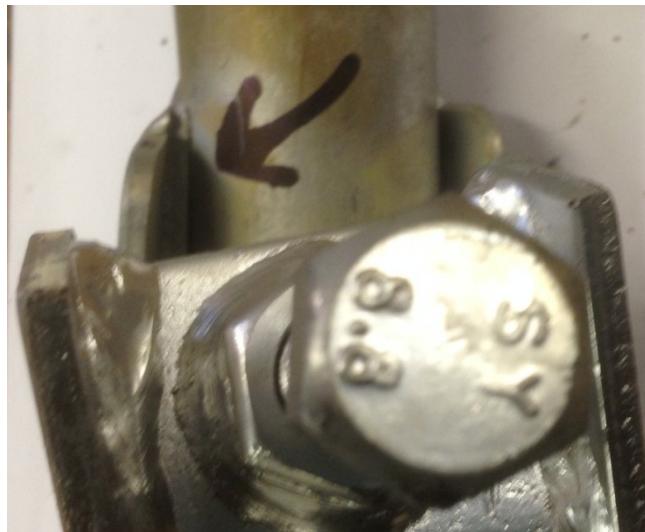
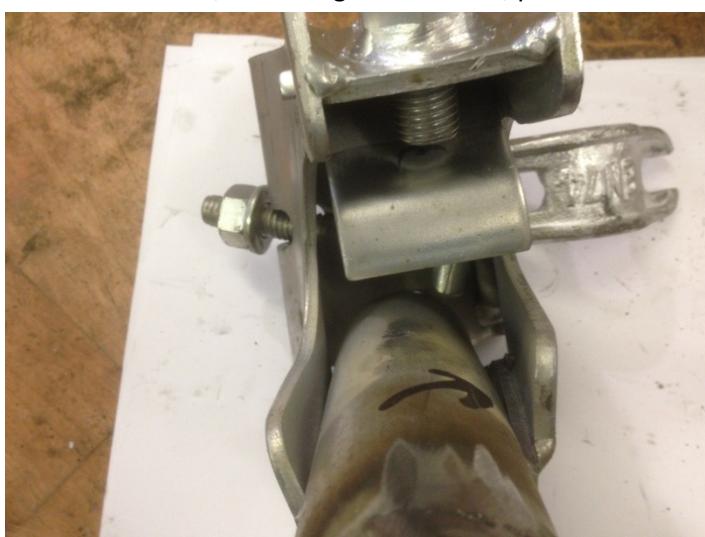
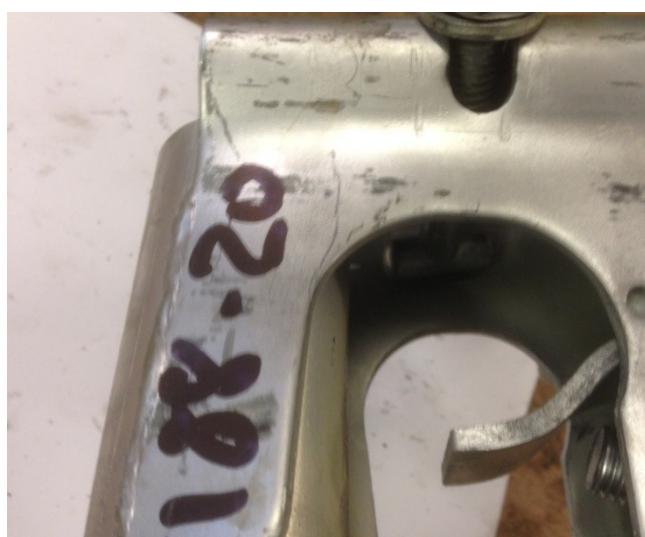
Sample 20 types 3.4. application positive load against clasp

Fracture/tare along tube at weld, parent material rupture
