# Mid-Term Inspection

Property inspected by A. Clerk

123 Preview Street  
Sample City  
London  
AB1 2CD

**May**  
**6th 2026**

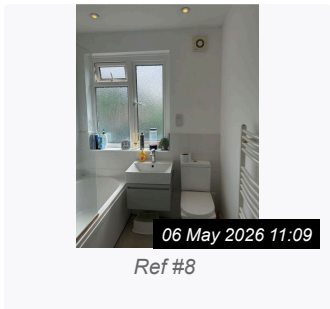
8. BATHROOM		
Ref	Name	Condition
8.1	Decoration / General Condition	<p>The bathroom walls show scuff marks in places with some visible mould spots on the ceiling. One area of mould is located above the WC in the corner, and another above the bath in the left-hand corner.</p> <p>Moisture readings of 10.6%, 11.1%, and 12% were recorded on the wall surrounding the heated towel rail.</p> <p>These levels are generally considered to be within a low to normal range for internal plastered walls and do not, in isolation, indicate significant damp. However, the slight variation in readings may suggest localised moisture influence in this area, potentially due to regular humidity from bathroom use and limited ventilation, particularly given the extractor fan does not appear to be operational.</p> <p>This area should be monitored, especially if any deterioration in decoration or visible damp-related issues develop.</p> <p>One bulb was not in working order.</p>

8.2	Cleanliness	<p>The bathroom is in a poor condition of cleanliness. Significant dirt and build-up are evident throughout the space. A considerable amount of limescale is present on the chrome fittings, and some areas of rust are also visible.</p> <p>Orange staining and dirt deposits can be seen in the corner areas of the flooring on either side of the WC. Overall, the room would benefit from a thorough deep clean and descaling throughout.</p> <p><b>Needs Cleaning - Tenant</b></p>

8.3	Information To Note	<p>The bathroom extractor fan does not appear to be in working order and requires inspection, with repair or replacement recommended.</p> <p>The seal on the shower door shows signs of rust and deterioration. It would benefit from replacement in the near future in order to maintain a proper seal and help prevent potential water leaks and associated damage.</p> <p><b>Needs Maintenance - Landlord</b></p>

8.4	Information to Note	<p>The presence of mould may be associated with inadequate ventilation, particularly if the window is not consistently opened during and after bathing or showering. It is the tenant's responsibility to remove the mould growth where present and to ensure the area is properly maintained throughout the tenancy.</p> <p><b>Needs Cleaning - Tenant</b></p>

<a href="#">8.2</a> Bathroom » Cleanliness	Needs Cleaning	Tenant	<p>The bathroom is in a poor condition of cleanliness. Significant dirt and build-up are evident throughout the space. A considerable amount of limescale is present on the chrome fittings, and some areas of rust are also visible.</p> <p>Orange staining and dirt deposits can be seen in the corner areas of the flooring on either side of the WC. Overall, the room would benefit from a thorough deep clean and descaling throughout.</p>

Actions Required			
<a href="#">8.3 Bathroom » Information To Note</a>	Needs Maintenance	Landlord	<p>The bathroom extractor fan does not appear to be in working order and requires inspection, with repair or replacement recommended.</p> <p>The seal on the shower door shows signs of rust and deterioration. It would benefit from replacement in the near future in order to maintain a proper seal and help prevent potential water leaks and associated damage.</p>
<a href="#">8.4 Bathroom » Information to Note</a>	Needs Cleaning	Tenant	<p>The presence of mould may be associated with inadequate ventilation, particularly if the window is not consistently opened during and after bathing or showering. It is the tenant's responsibility to remove the mould growth where present and to ensure the area is properly maintained throughout the tenancy.</p>
<a href="#">13.1 Exterior Areas / Gardens » Front</a>	Needs Maintenance	Tenant	<p>The front garden is overgrown, with long grass and a build-up of weeds, and would benefit from general maintenance and tidying.</p>

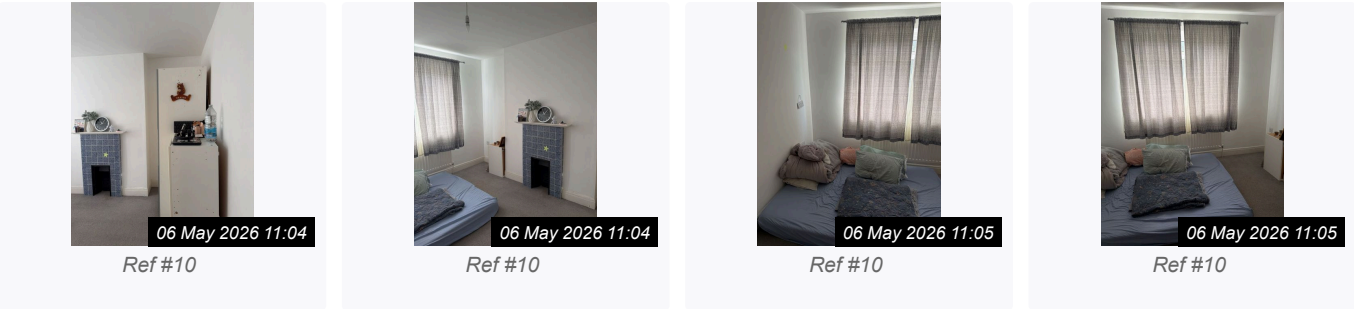
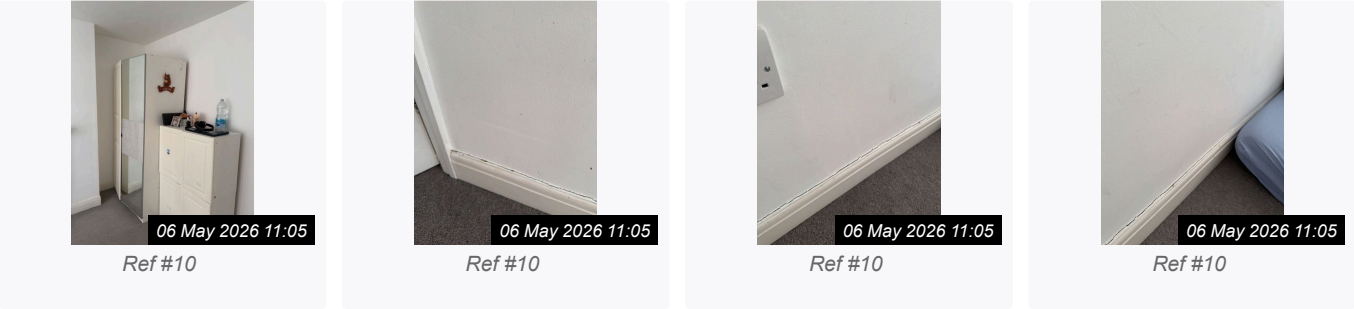
Ref	Name	Condition
10.1	Decoration / General Condition	<p>Bedroom Two shows general signs of wear and tear, with marks visible in places across the walls. Cracks are present along the skirting board behind the door.</p> <p>A moisture test was carried out below and to the right-hand side of the window, which recorded a reading of 10.1%. This is generally considered a low and normal moisture level, indicating no immediate cause for concern in relation to damp at the time of inspection.</p>
10.2	Cleanliness	The bedroom is in an acceptable condition of cleanliness, appearing generally tidy with no significant issues noted.
10.3	Information To Note	Tenant did not report any maintenance issues.

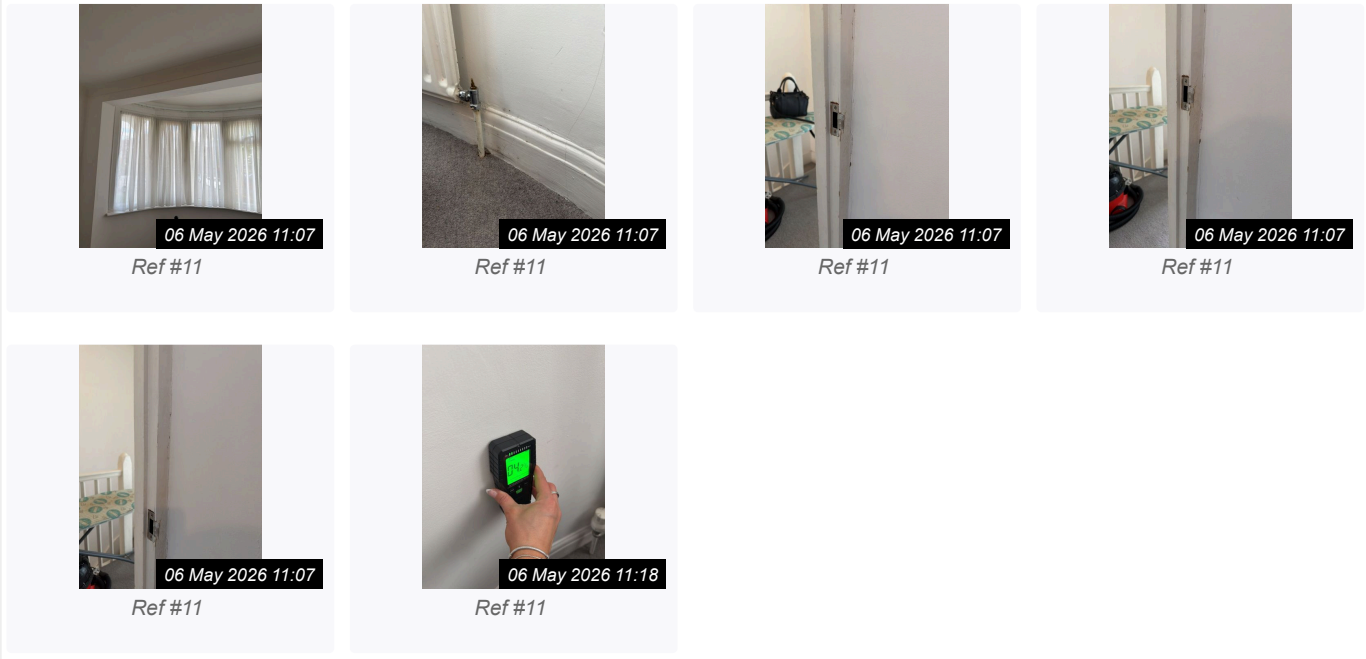
Ref	Name	Condition
11.1	Decoration / General Condition	<p>Bedroom Three shows general signs of wear and tear, with marks visible in multiple areas across the walls. Crack seen to wall under the window.</p> <p>A moisture test was carried out within the room, which recorded a reading of 4.2%. This is considered a low reading and typically indicates a dry surface with no immediate signs of elevated moisture.</p>
11.2	Cleanliness	<p>The room is in a fair condition of cleanliness, appearing neither particularly clean nor heavily soiled, though some general untidiness is evident. There is also a degree of clutter present. Staining is visible in places on the carpet.</p>
11.3	Information To Note	<p>Tenant did not report any maintenance issues.</p>
