Title: Static water penetration testing of the Barracuda brick slip system

Report No: N950-22-18406

**Issue date:** 7 February 2024

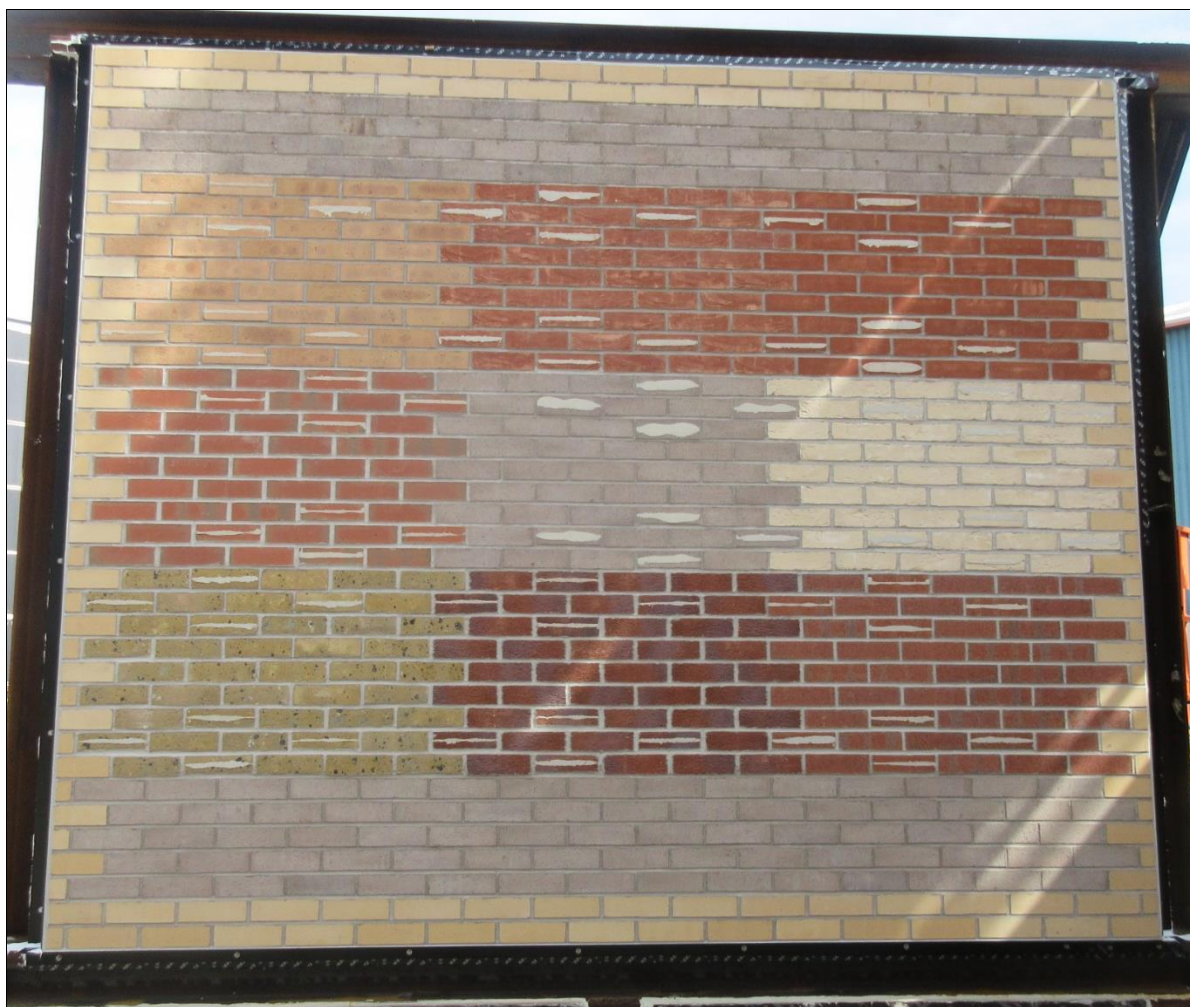
PHOTO 45141

The test sample comprised 9 different brick slip types.

TEST SAMPLE ELEVATION

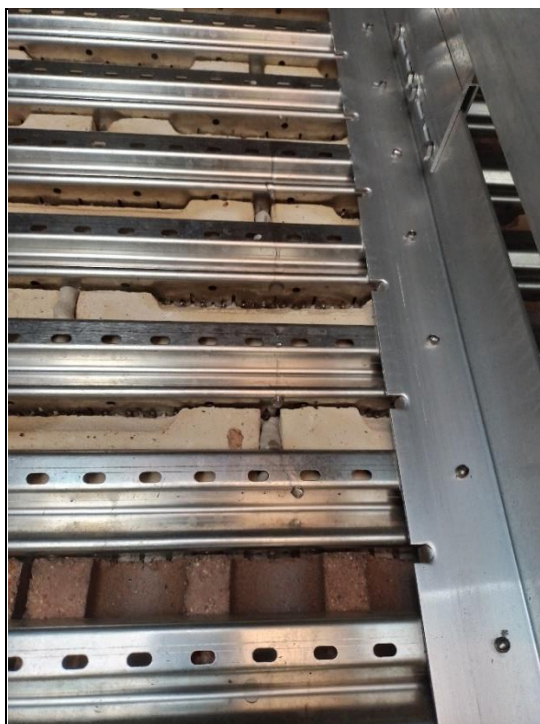
PHOTO 081302

INTERNAL VIEW DURING WATER TEST

At zero pressure minor water leakage was observed seeping through some of the brick slips and running down the rails.

The water leakage rate and area increased with increased pressure and was across all the brick types. The water was confined to the back of the bricks and rails and ran down to the base of the sample where it would drain out through a ventilated cavity.

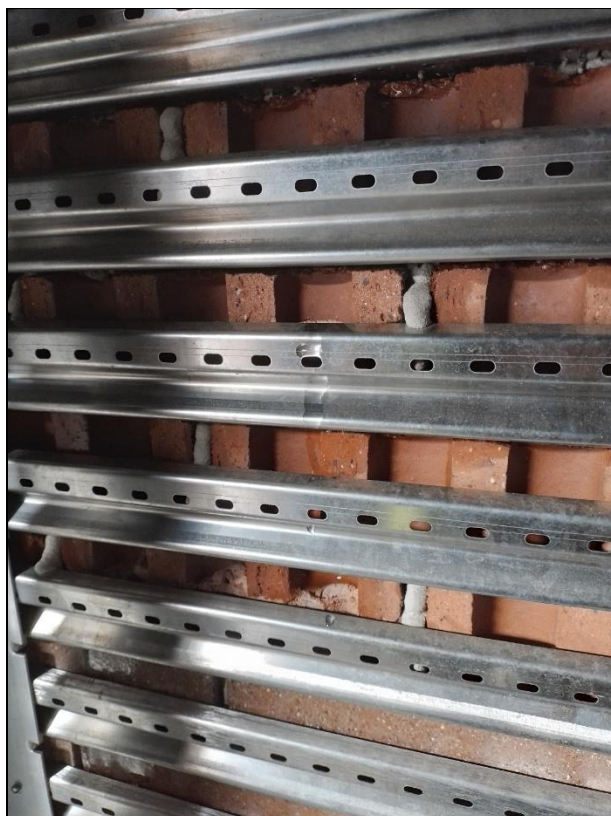
PHOTO 081411

INTERNAL VIEW DURING WATER TEST

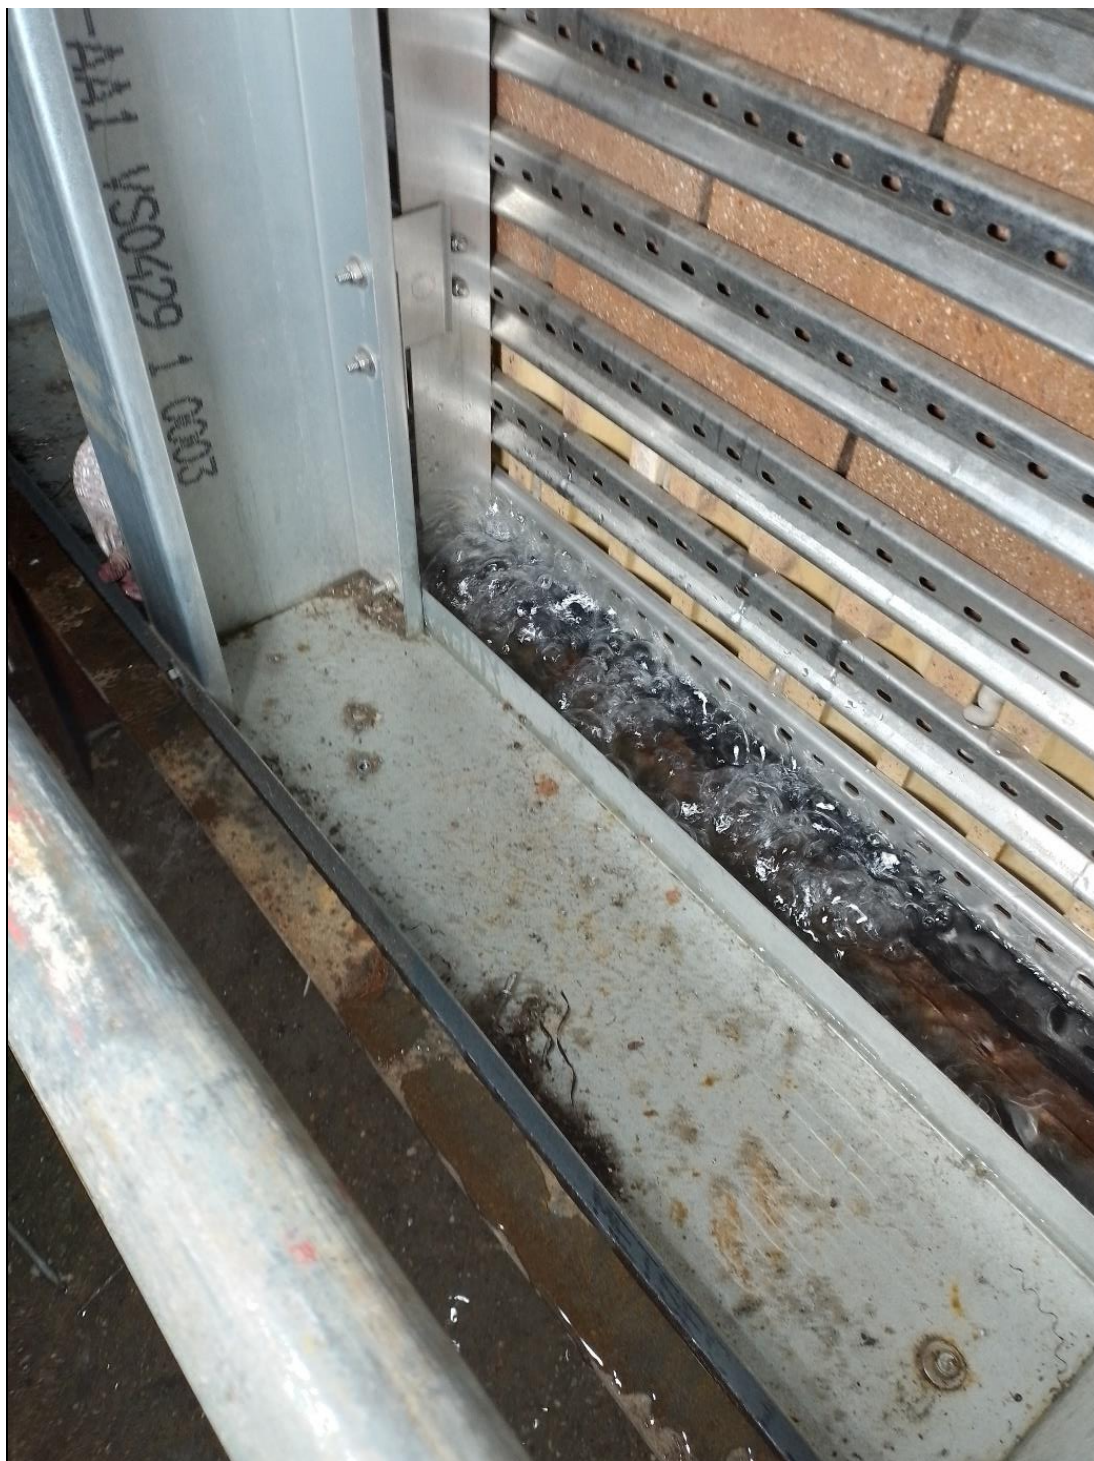
PHOTO 085845

INTERNAL VIEW DURING WATER TEST

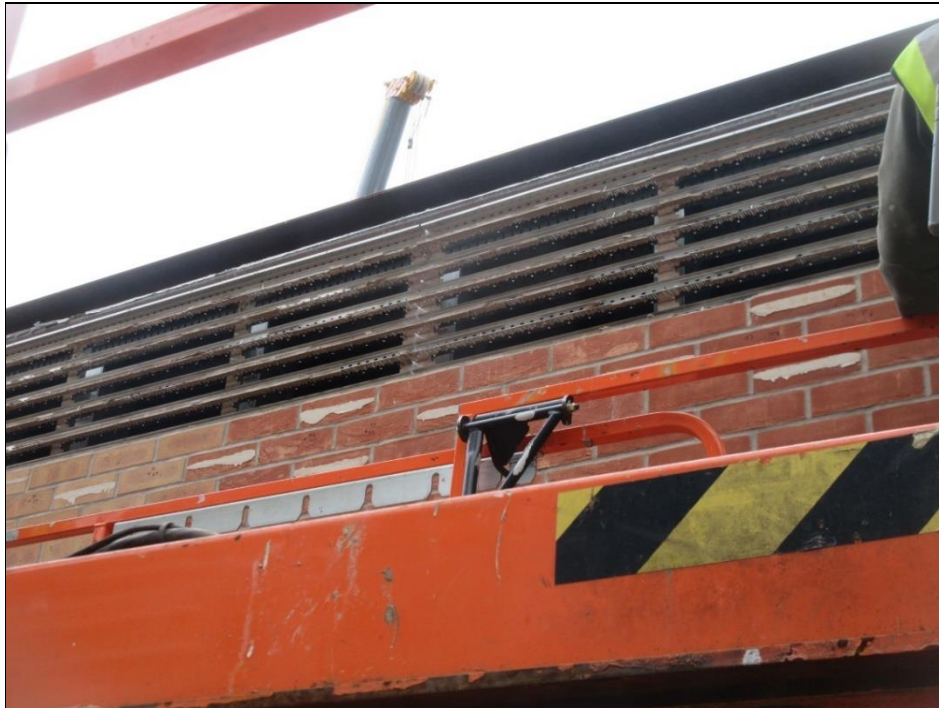
PHOTO 6137

TEST SAMPLE DURING DISMANTLE

During the dismantling of the sample no discrepancies from the drawings were found.

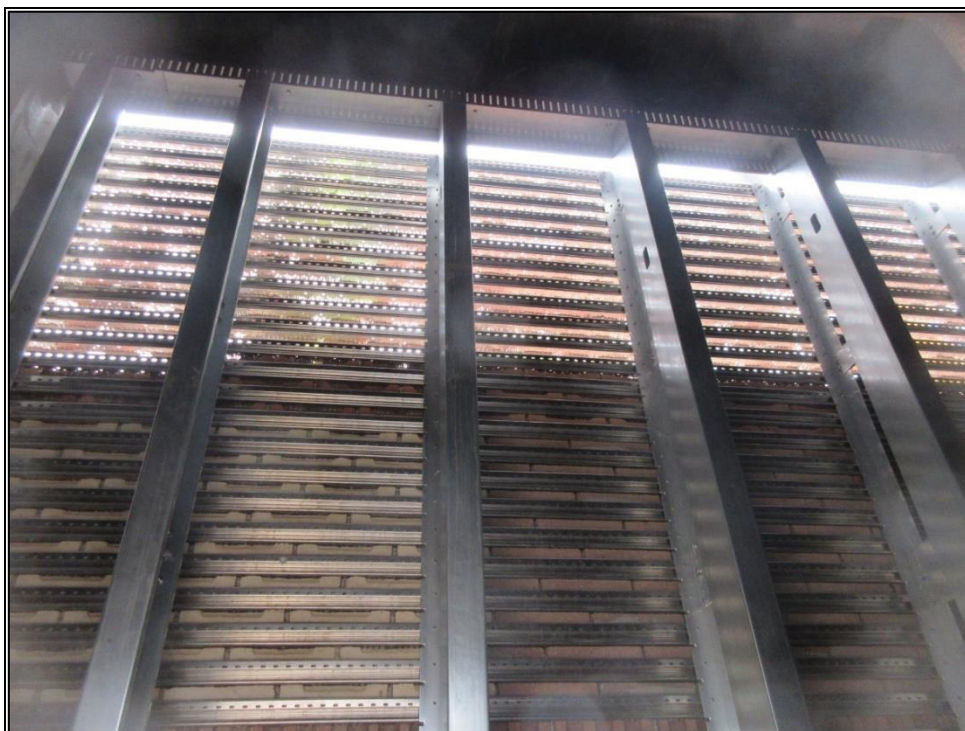
PHOTO 6145

TEST SAMPLE DURING DISMANTLE

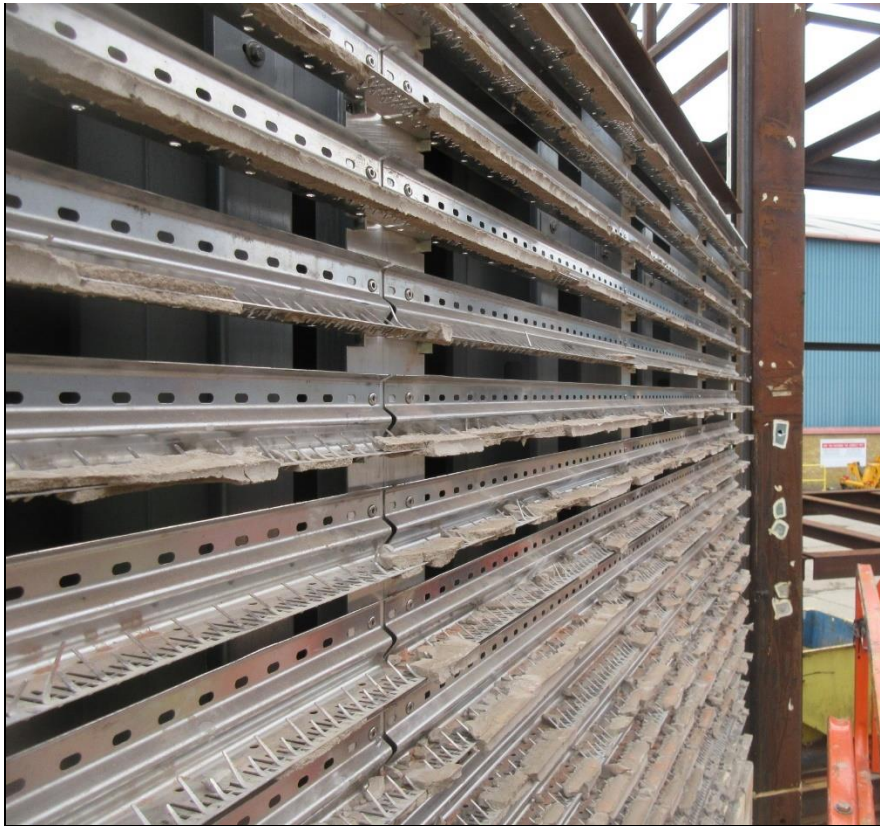
PHOTO 6156

TEST SAMPLE DURING DISMANTLE

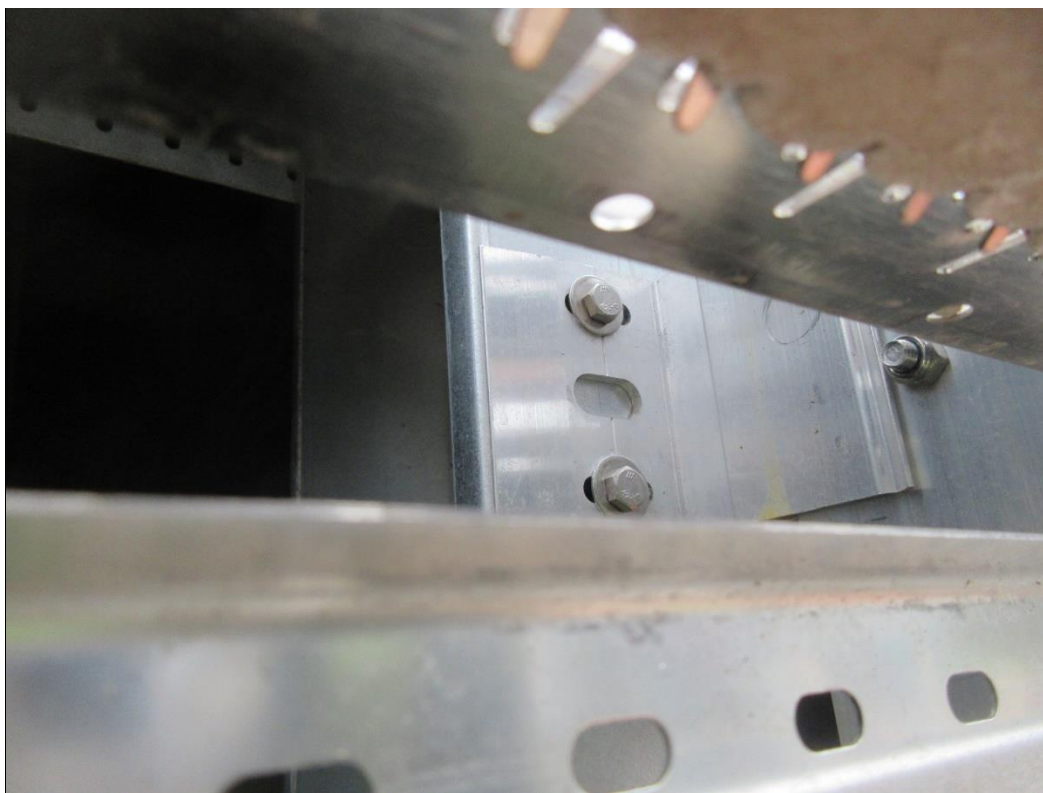
PHOTO 6158

TEST SAMPLE DURING DISMANTLE

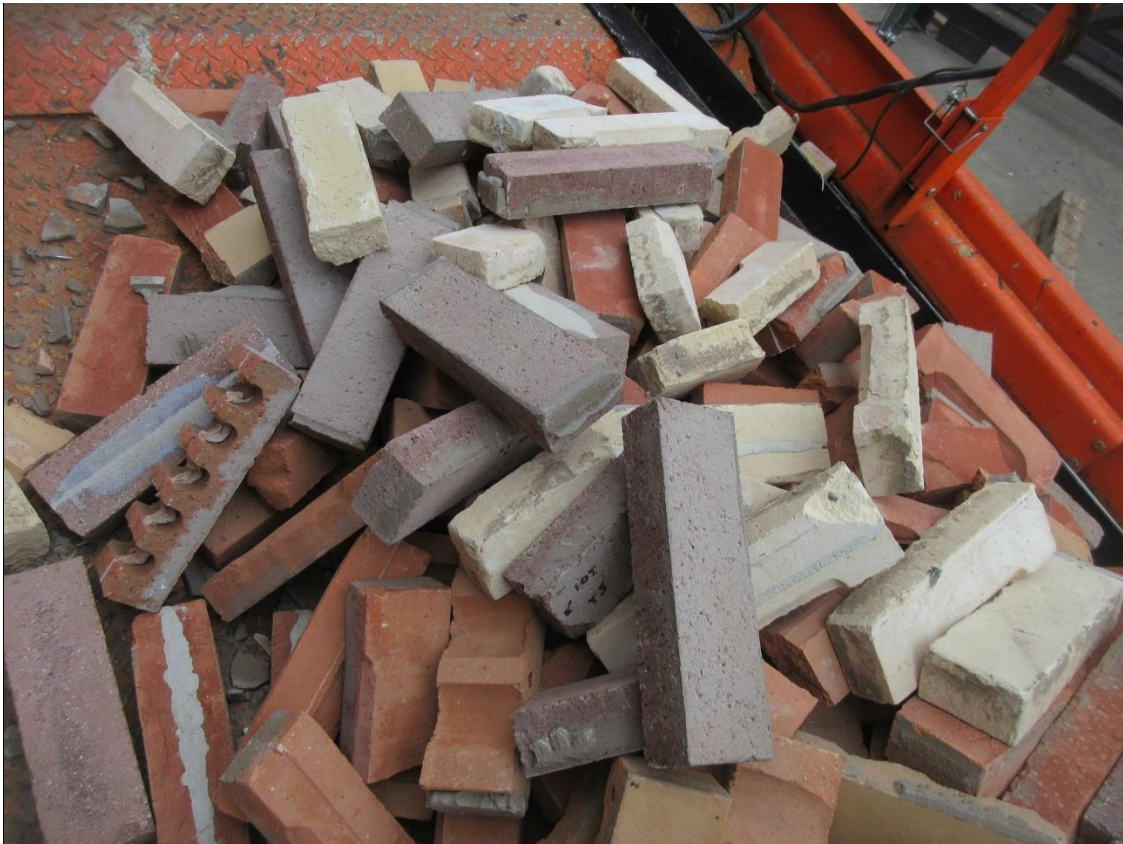
PHOTO 6160

BRICK SLIPS REMOVED FROM TEST RIG

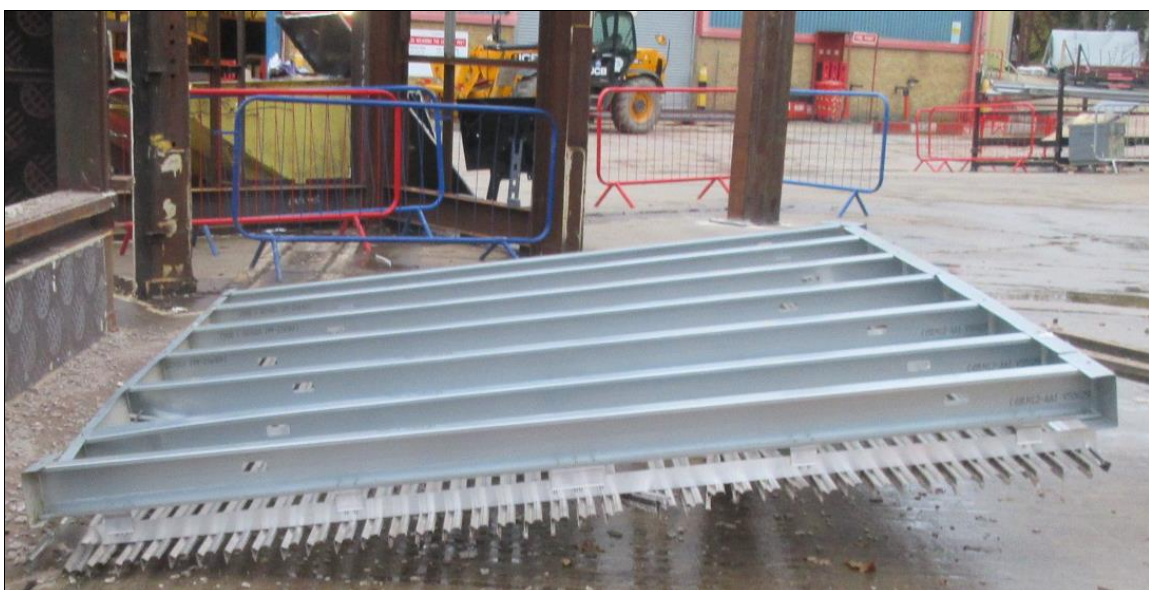
PHOTO 6181

SUPPORT FRAME REMOVED FROM TEST RIG
