Title: Wind resistance testing a Barracuda brick slip system

Report No: N950-22-18408

Customer: James & Taylor Ltd,
Sixty-Two, Barwell Business Park,
Leatherhead Road, Chessington, Surrey KT9 2NY.

Issue date: 7 February 2024

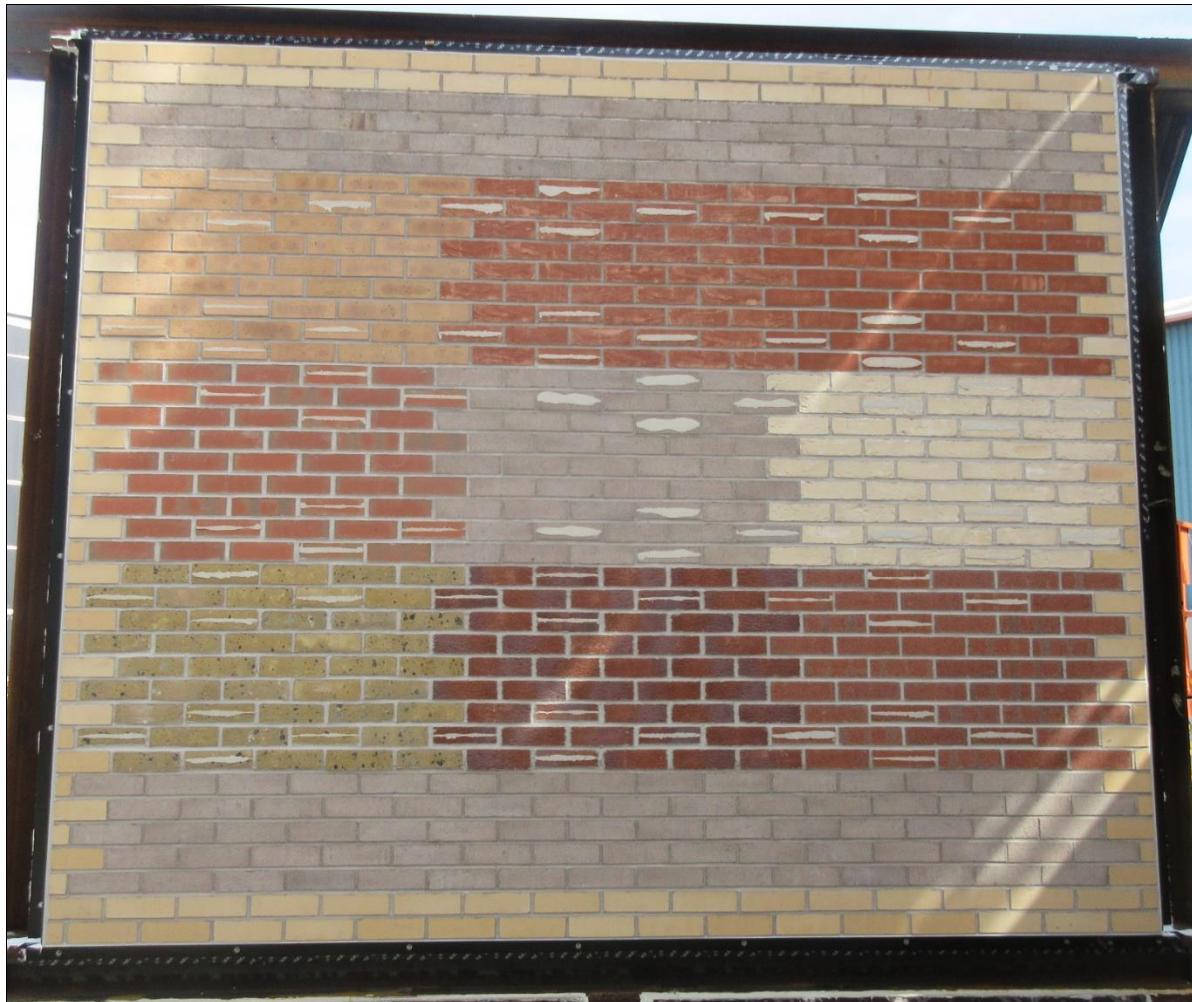
PHOTO 45141

The sample was as shown in the photo below and the drawings included as an appendix to this report.

The test sample comprised 9 different brick slip types.

TEST SAMPLE ELEVATION

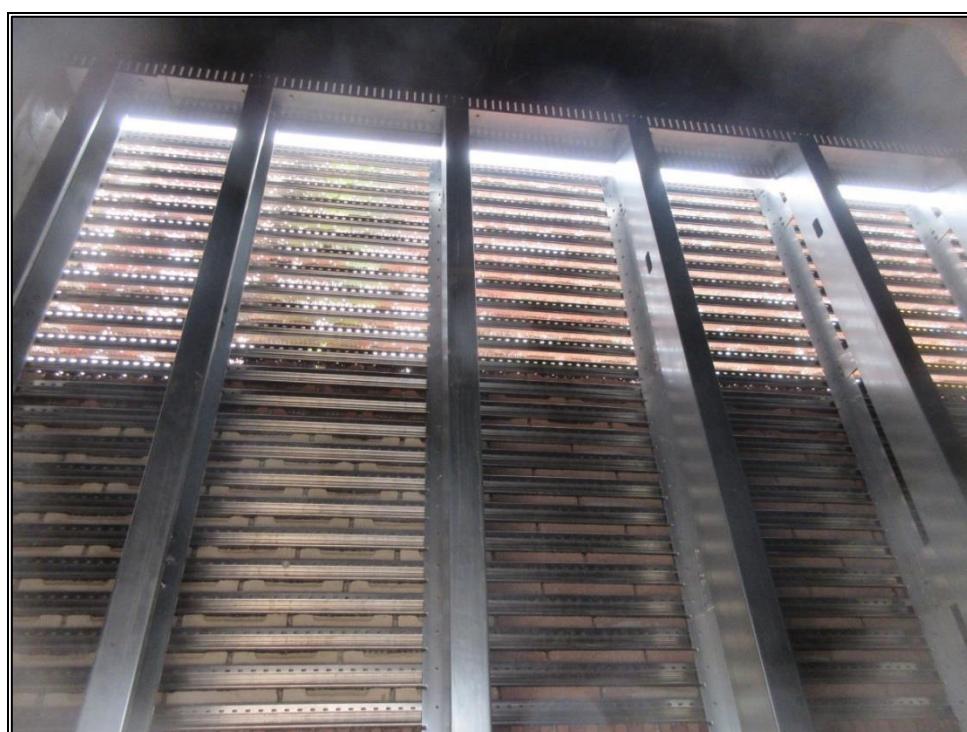
PHOTO 6145

TEST SAMPLE DURING DISMANTLE

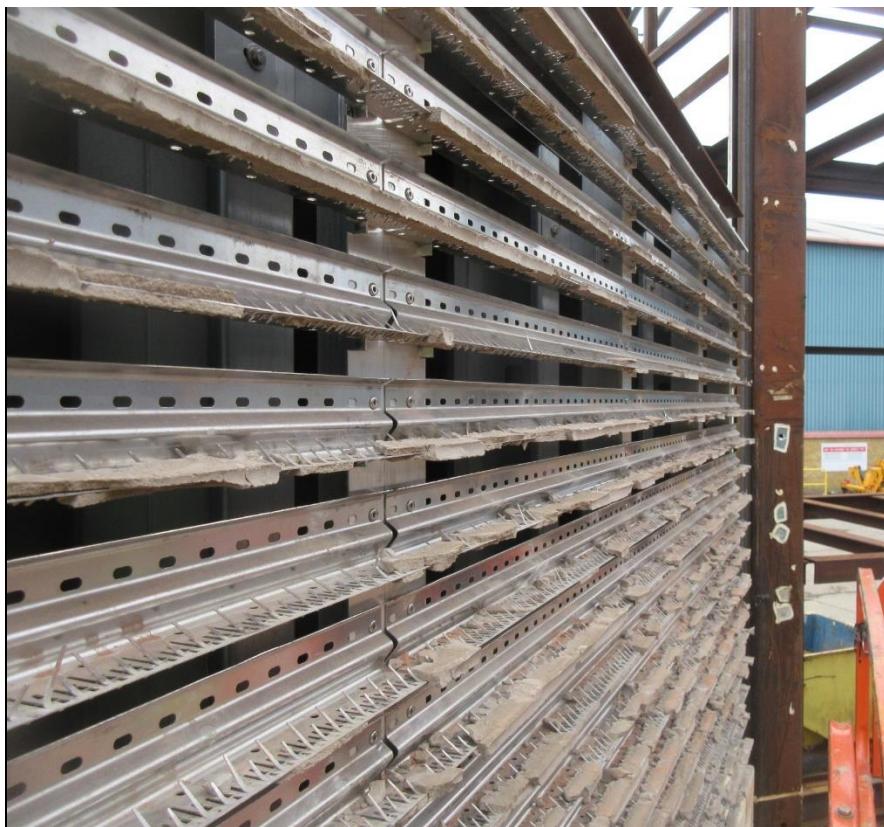
PHOTO 6156

TEST SAMPLE DURING DISMANTLE

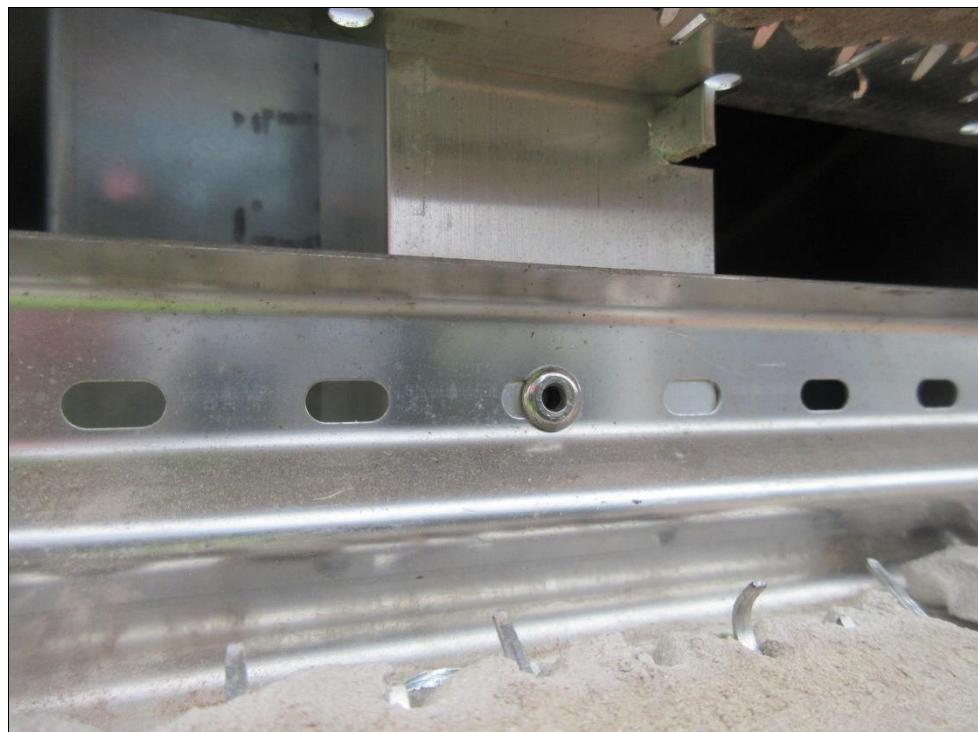
PHOTO 6157

TEST SAMPLE DURING DISMANTLE

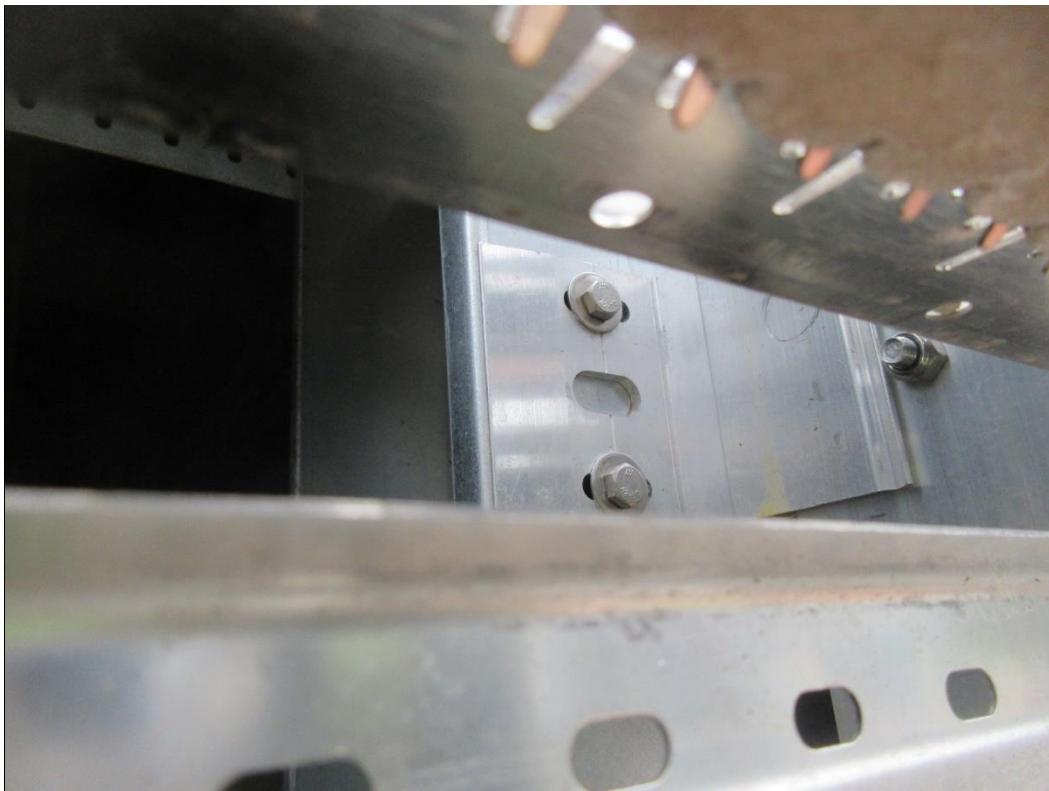
PHOTO 6158

TEST SAMPLE DURING DISMANTLE

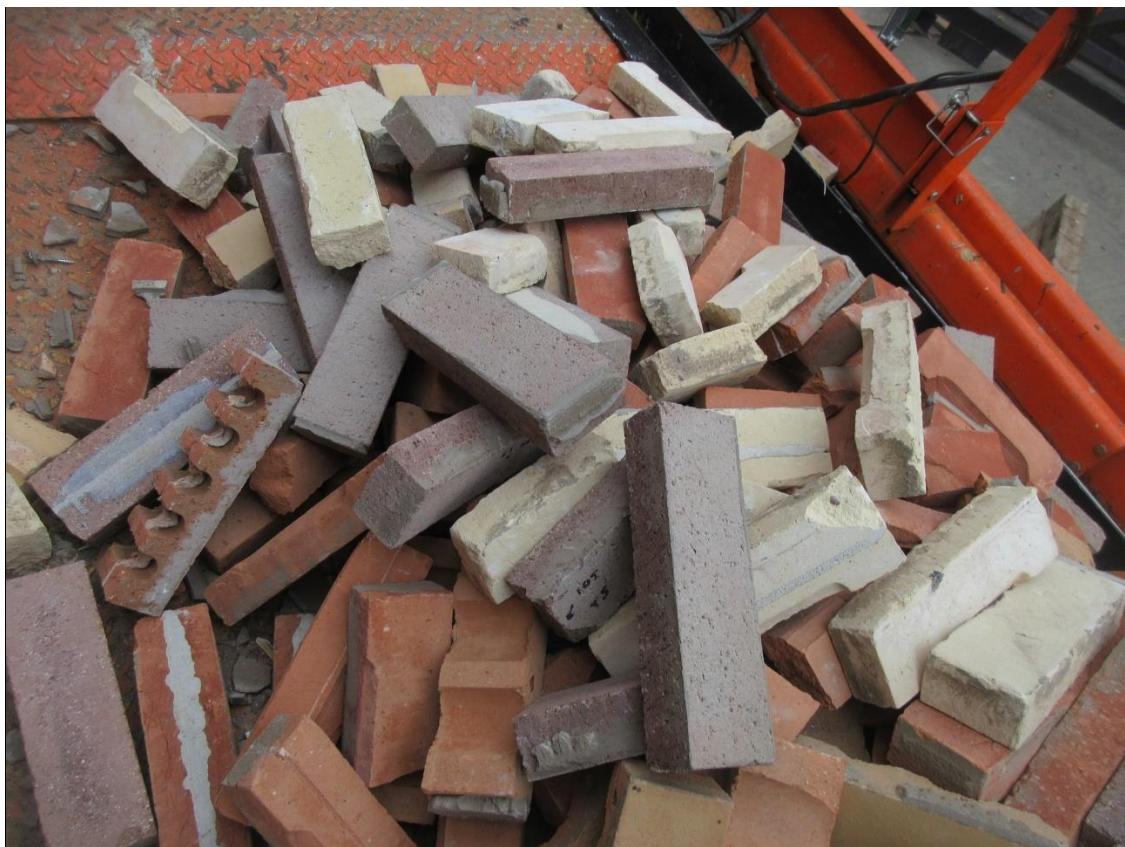
PHOTO 6160

BRICK SLIPS REMOVED FROM TEST RIG

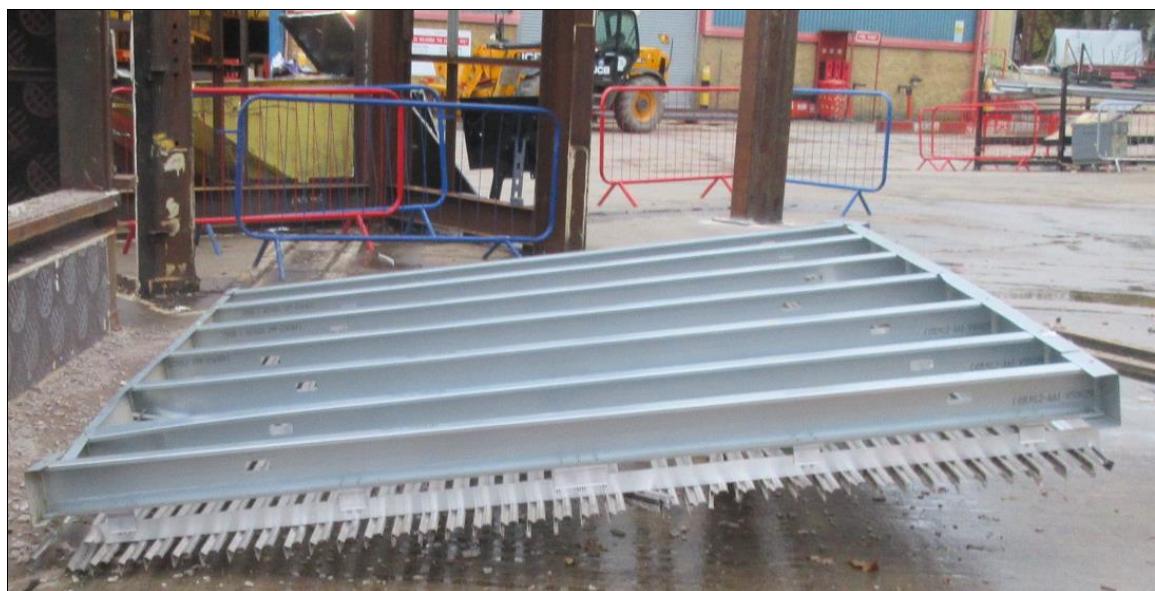
PHOTO 6181

SUPPORT FRAME REMOVED FROM TEST RIG
