Title: Impact testing of Barracuda Brick Slip System (Un-Mortared)

Report No: N950-24-18684

**Customer:** James & Taylor Ltd,  
Sixty-Two, Barwell Business Park,  
Leatherhead Road, Chessington, Surrey KT9 2NY.

The test was carried out in accordance with CWCT TN75/76.

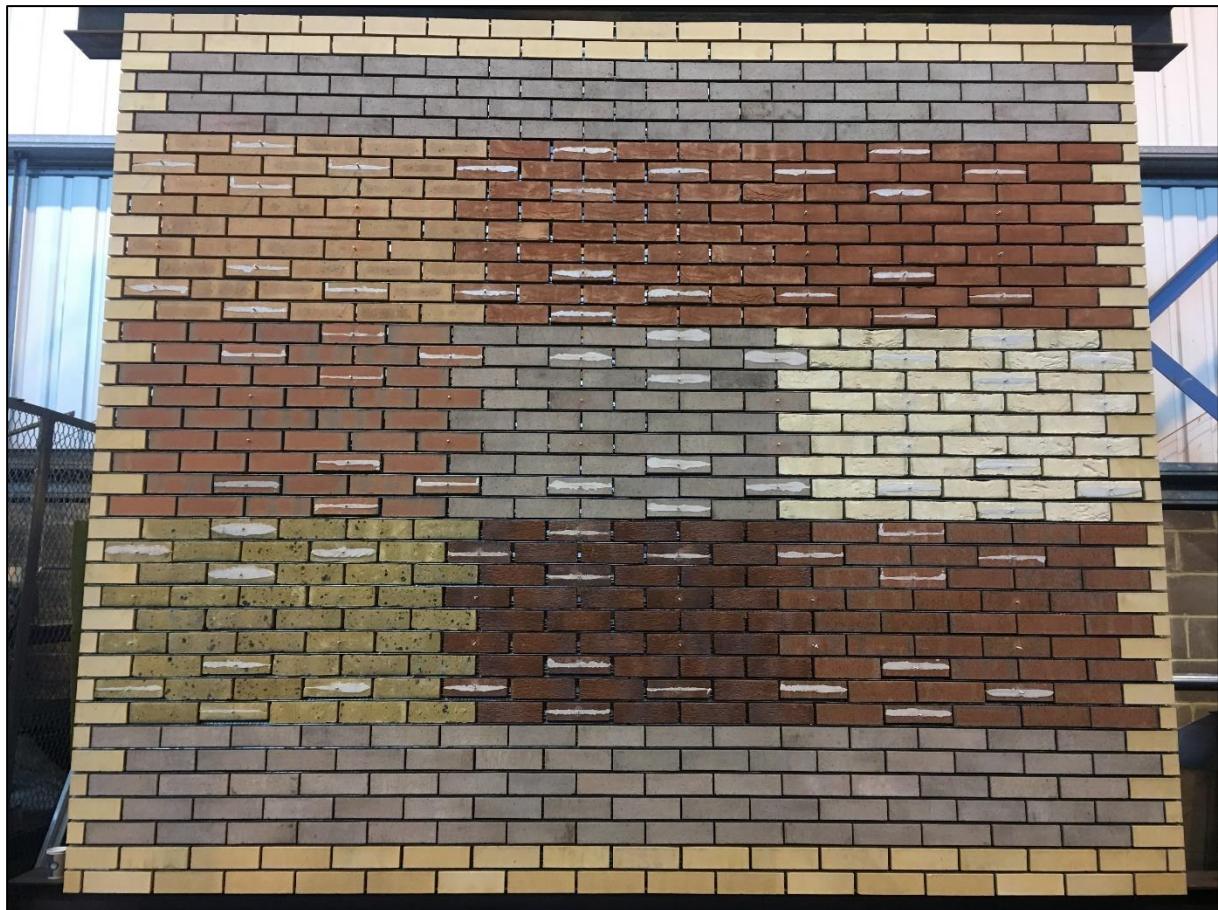
PHOTO IMG-5655

The sample was mounted to a solid steel frame which was fixed to a concrete slab as shown in the photograph below.

TEST SAMPLE

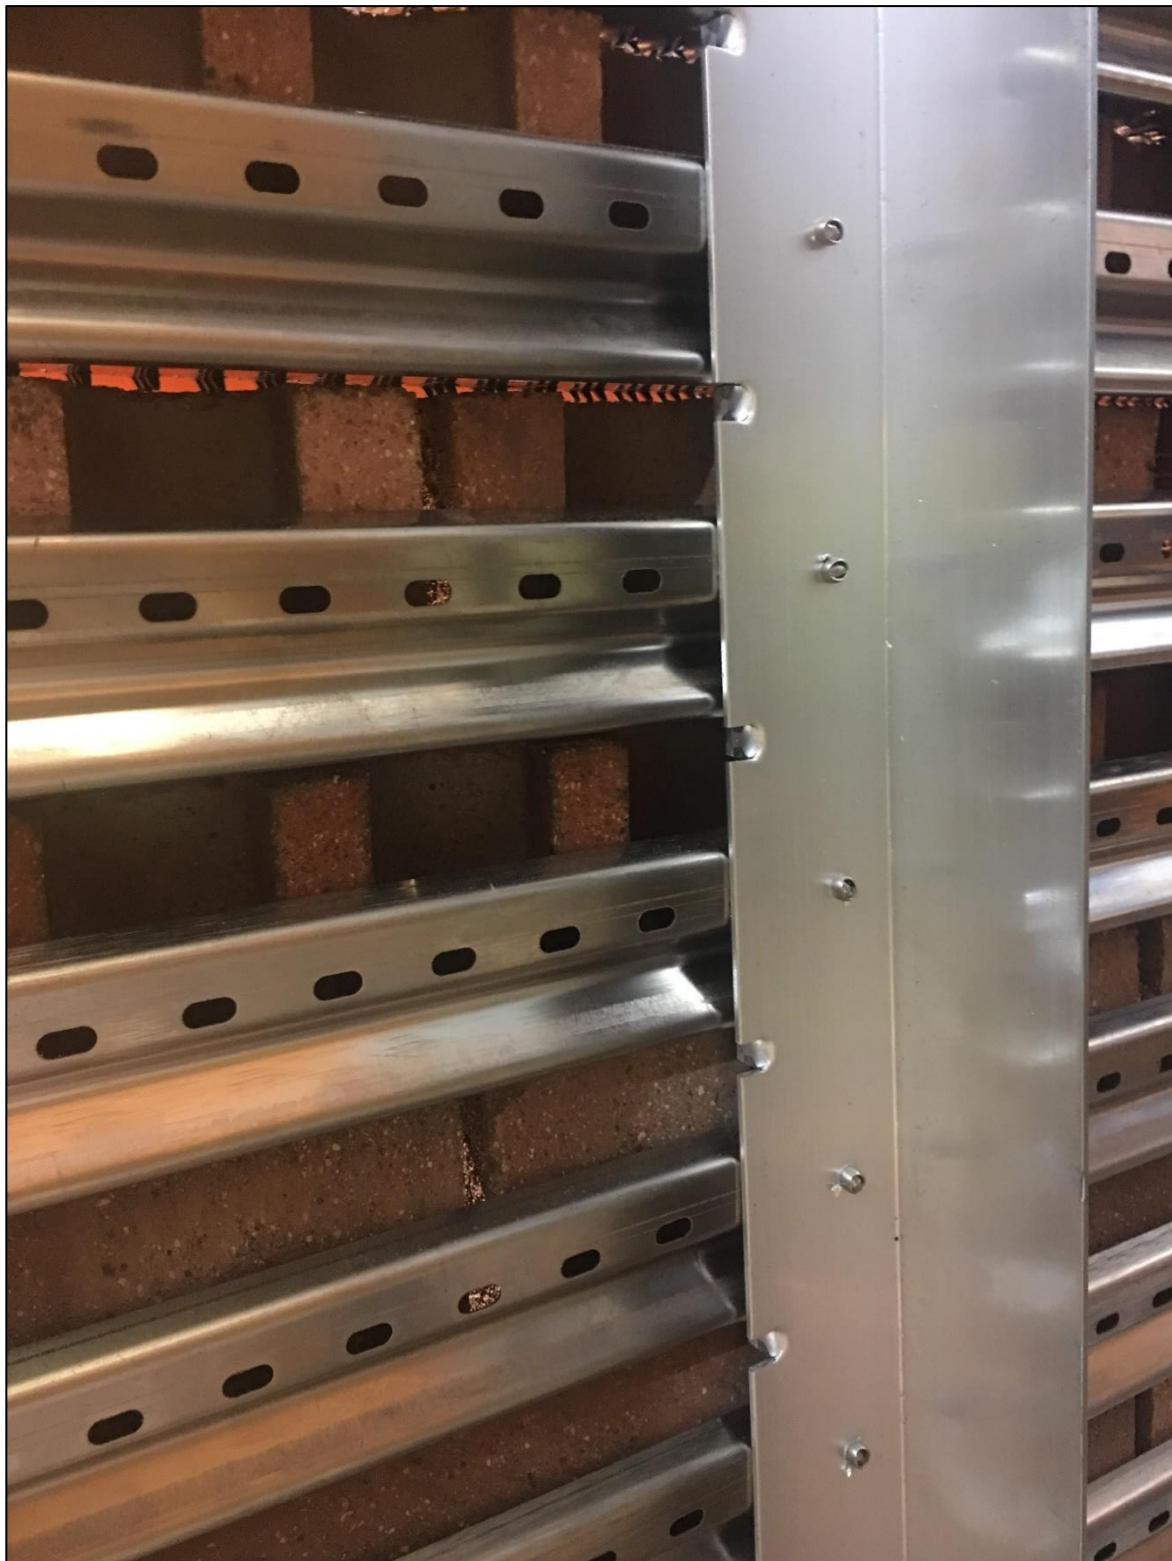
PHOTO IMG-5358

SUPPORT BRACKET

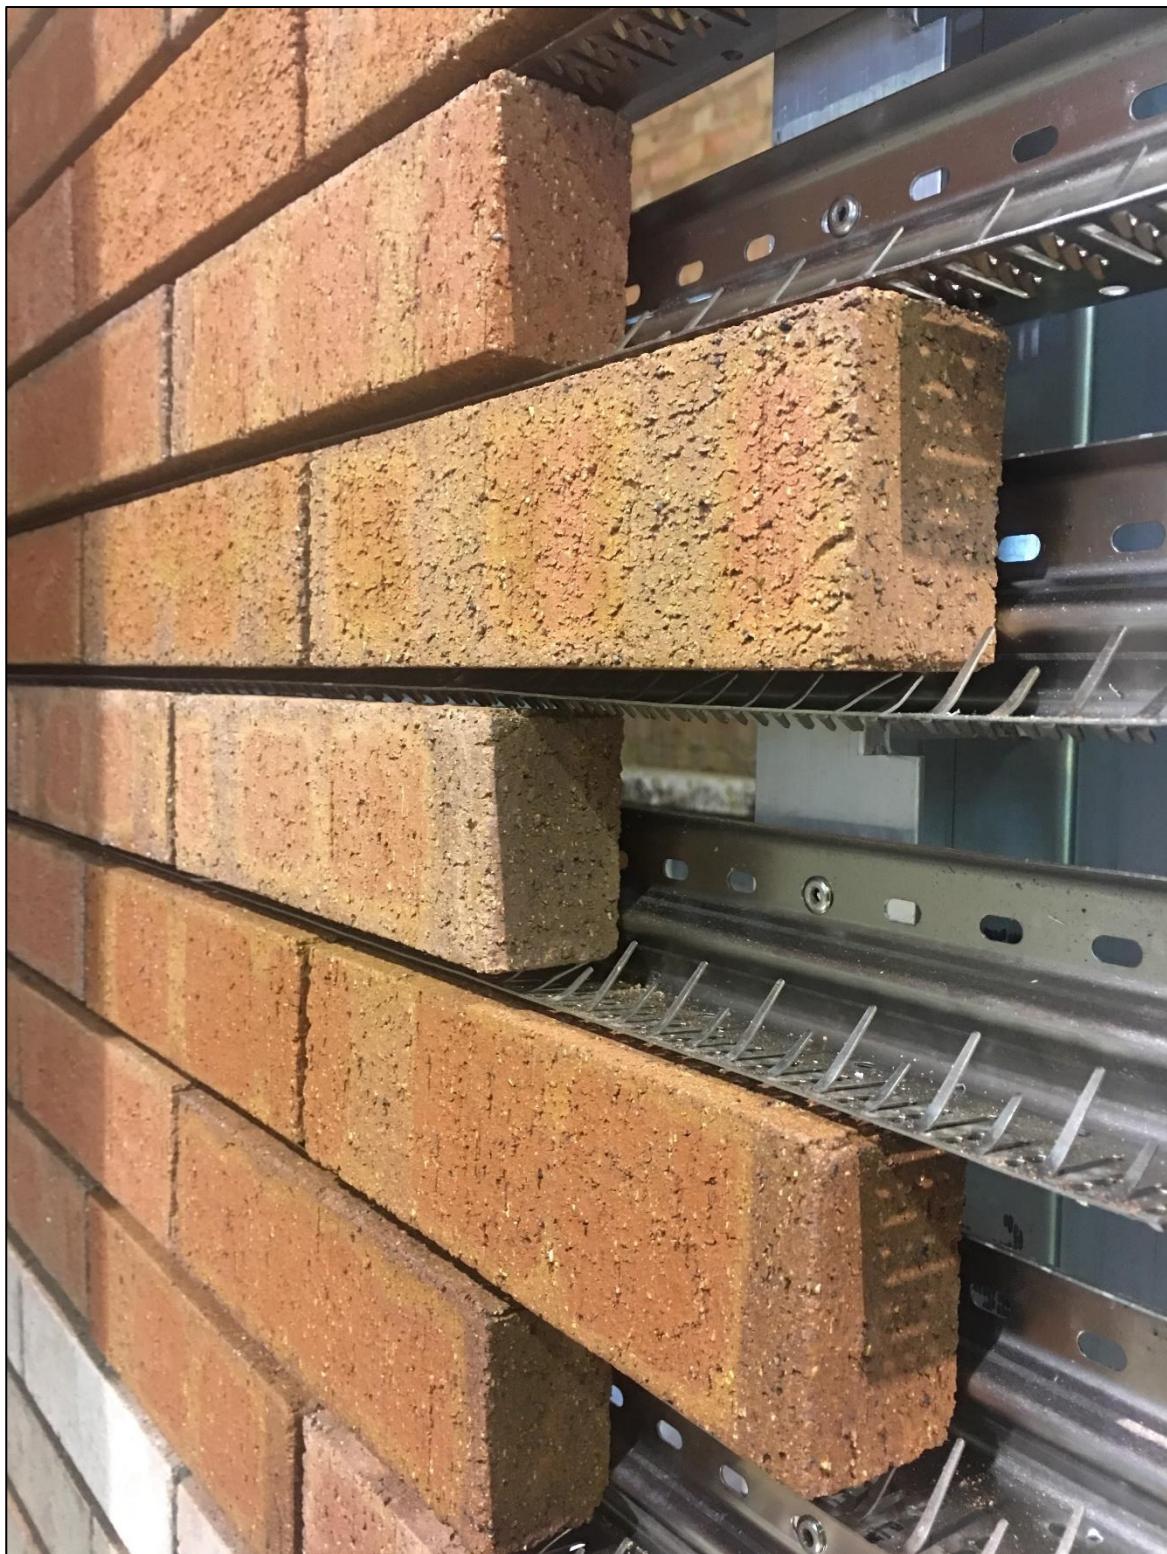
PHOTO IMG\_5352

CLOSE UP OF BRICK SLIPS

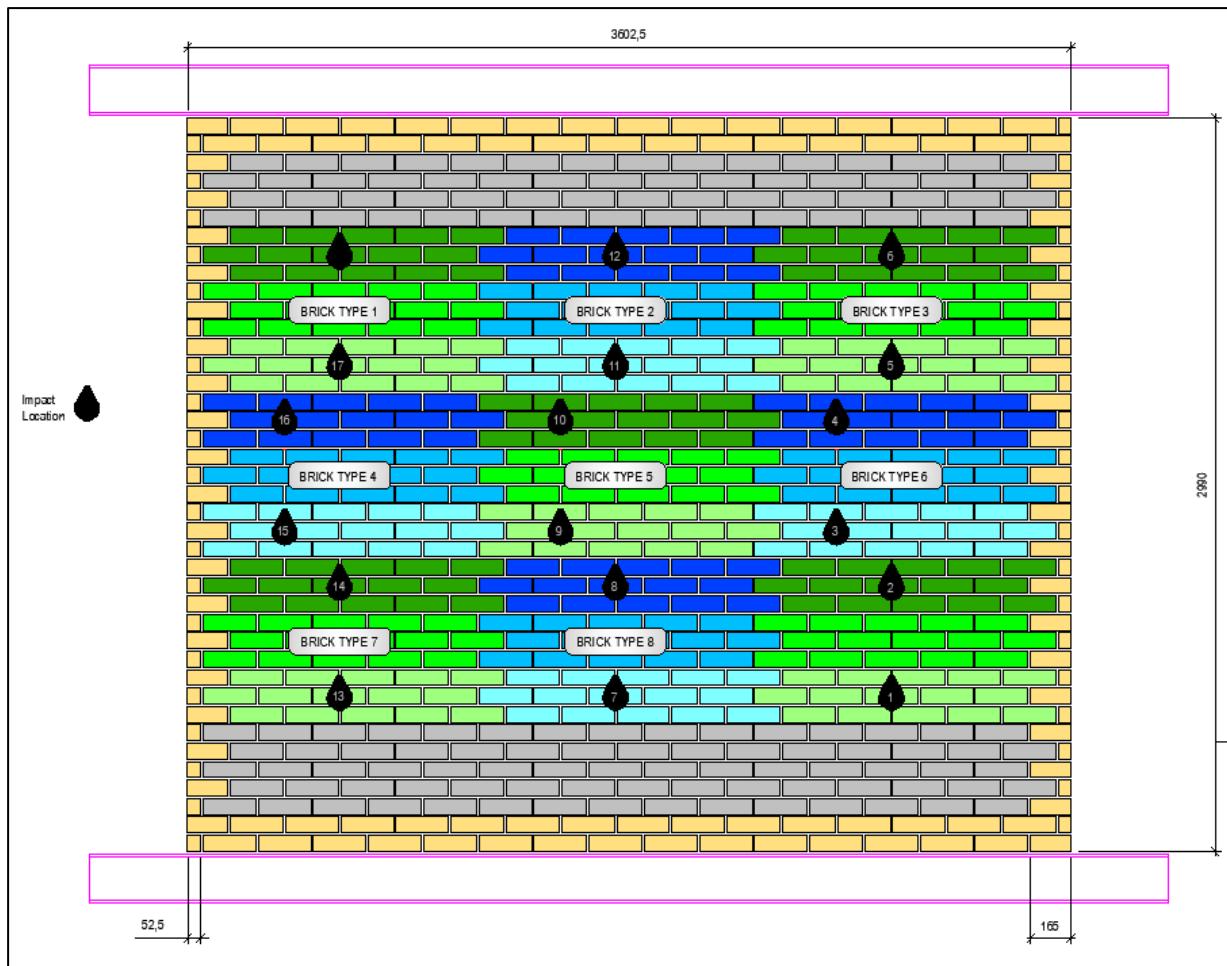
FIGURE 1

The test was performed at the locations shown in Figure 1.

SOFT BODY IMPACT LOCATIONS

TABLE 3  
SOFT BODY IMPACT TEST RESULTS

Location	Impact energy (J)	Observations	Classification
1	500	No damage observed	Negligible risk
2	500	No damage observed	Negligible risk
3	500	No damage observed	Negligible risk
4	500	No damage observed	Negligible risk
5	500	No damage observed	Negligible risk
6	500	No damage observed	Negligible risk
7	500	No damage observed	Negligible risk
8	500	No damage observed	Negligible risk
9	500	No damage observed	Negligible risk
10	500	No damage observed	Negligible risk
11	500	No damage observed	Negligible risk
12	500	No damage observed	Negligible risk
13	500	No damage observed	Negligible risk
14	500	No damage observed	Negligible risk
15	500	No damage observed	Negligible risk
16	500	No damage observed	Negligible risk
17	500	No damage observed	Negligible risk
18	500	No damage observed	Negligible risk

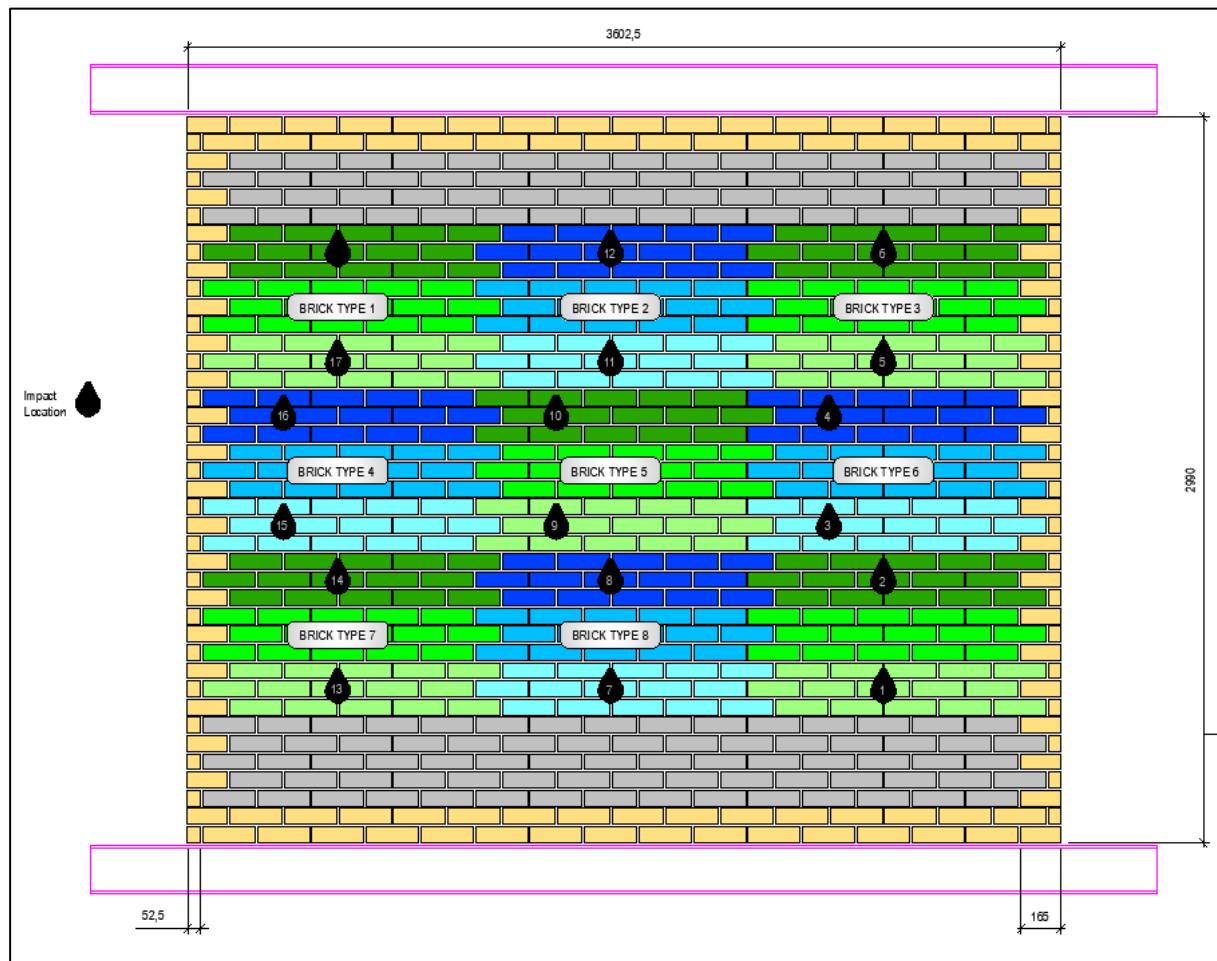
FIGURE 2

The test was performed at the locations shown in Figure 2.

HARD BODY IMPACT LOCATIONS

TABLE 4  
HARD BODY IMPACT TEST RESULTS

Location	Impact energy (J)	Observations	Classification
1	10	Crack through full height of tile	Low risk
2	10	Crack through full height of tile	Low risk
3	10	Crack through full height of tile. Small chip to corner of brick	Low risk
4	10	Minor indent	Negligible risk
5	10	Crack through full height of tile	Low risk
6	10	Crack through full height of tile	Low risk
7	10	Crack through full height of tile	Low risk
8	10	Crack through full height of tile. Small chip to corner of brick (4 g)	Low risk
9	10	Crack through full height of tile	Low risk
10	10	Minor indent	Negligible risk
11	10	Crack through full height of tile	Low risk
12	10	Crack through full height of tile	Low risk
13	10	Crack through full height of tile	Low risk
14	10	Crack through full height of tile	Low risk
15	10	Crack through full height of tile	Low risk
16	10	Crack through full height of tile	Low risk
17	10	Crack through full height of tile. Small chip to corner of brick	Low risk

18	10	Crack through full height of tile. Small chip to corner of brick (4 g)	Low risk

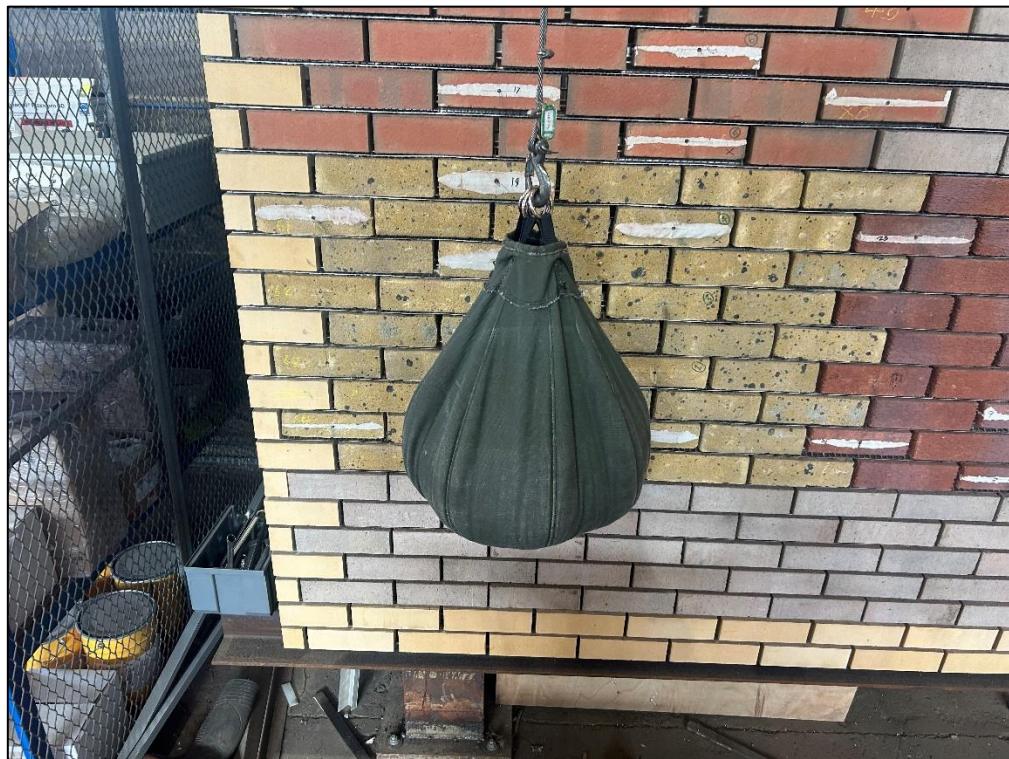
PHOTO IMG\_9288

The soft body impactor comprised a canvas spherical/conical bag 400 mm in diameter filled with 3 mm diameter glass spheres with a total mass of 50 kg suspended from a cord at least 3 m long.

SOFT BODY IMPACTOR

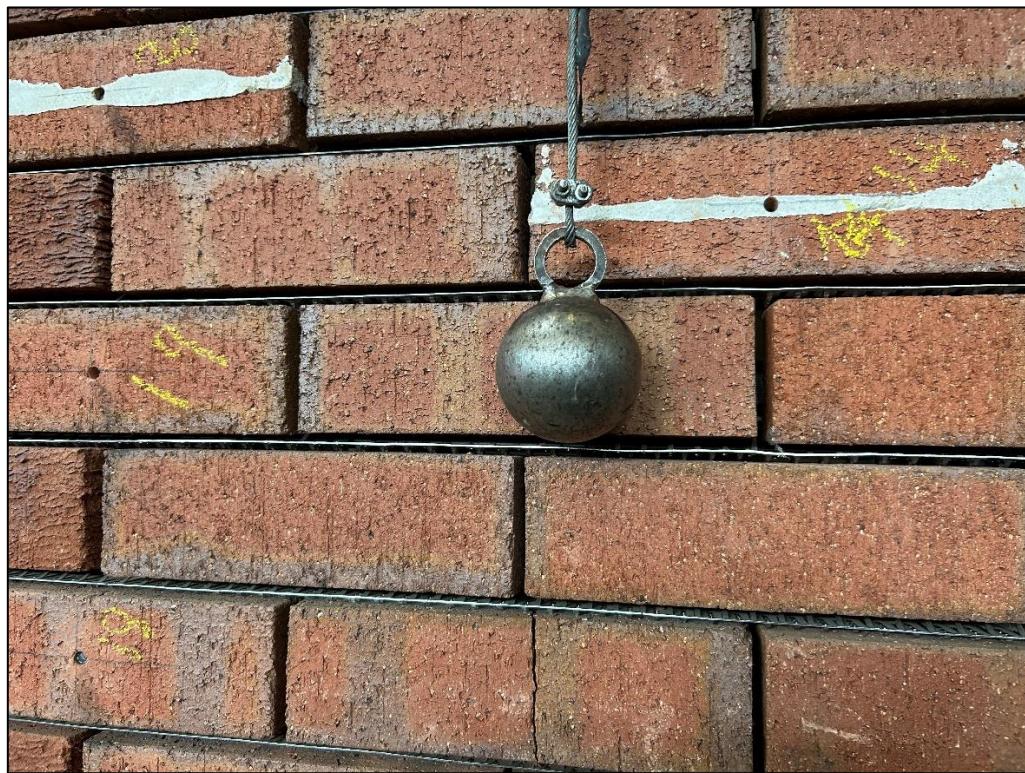
PHOTO IMG\_9311

The hard body impactor was solid steel ball of 62.5 mm diameter and mass of 1.0 kg.

HARD BODY IMPACTOR

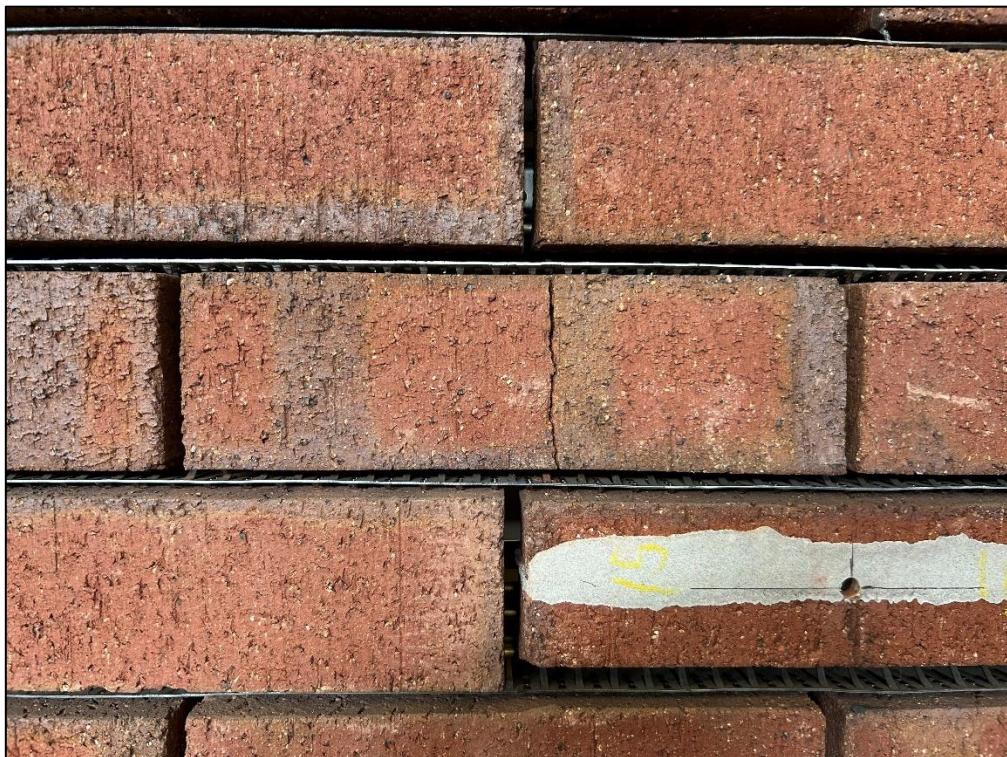
PHOTO IMG\_9310

IMPACT LOCATION 1

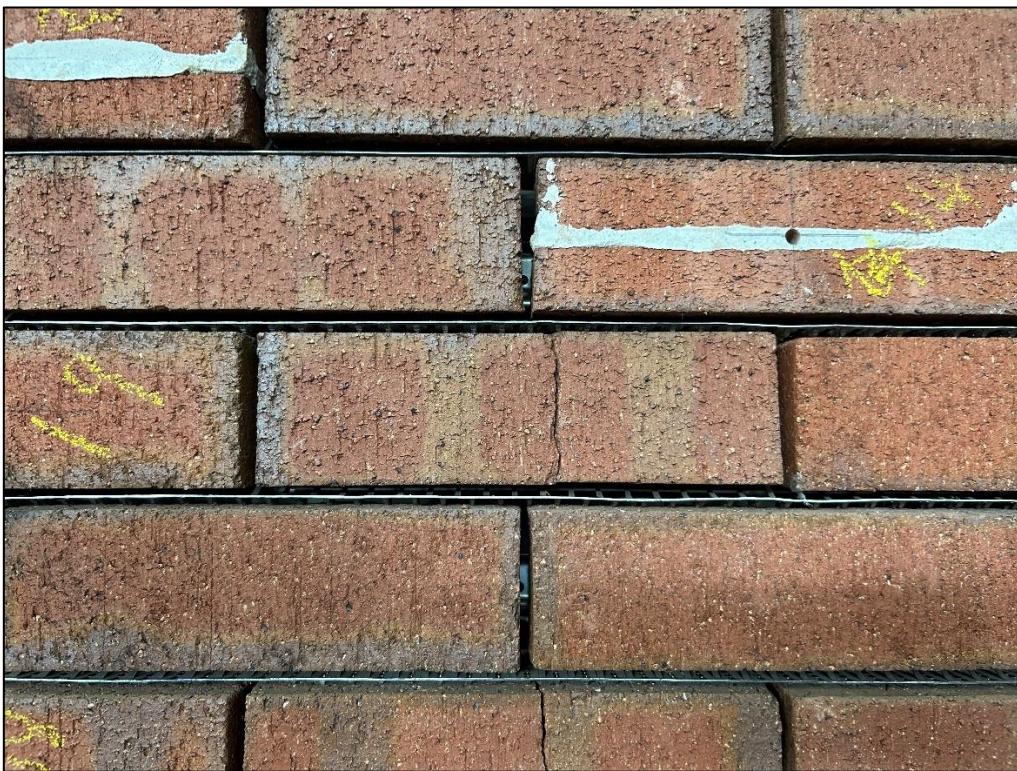
PHOTO IMG\_9312

IMPACT LOCATION 2

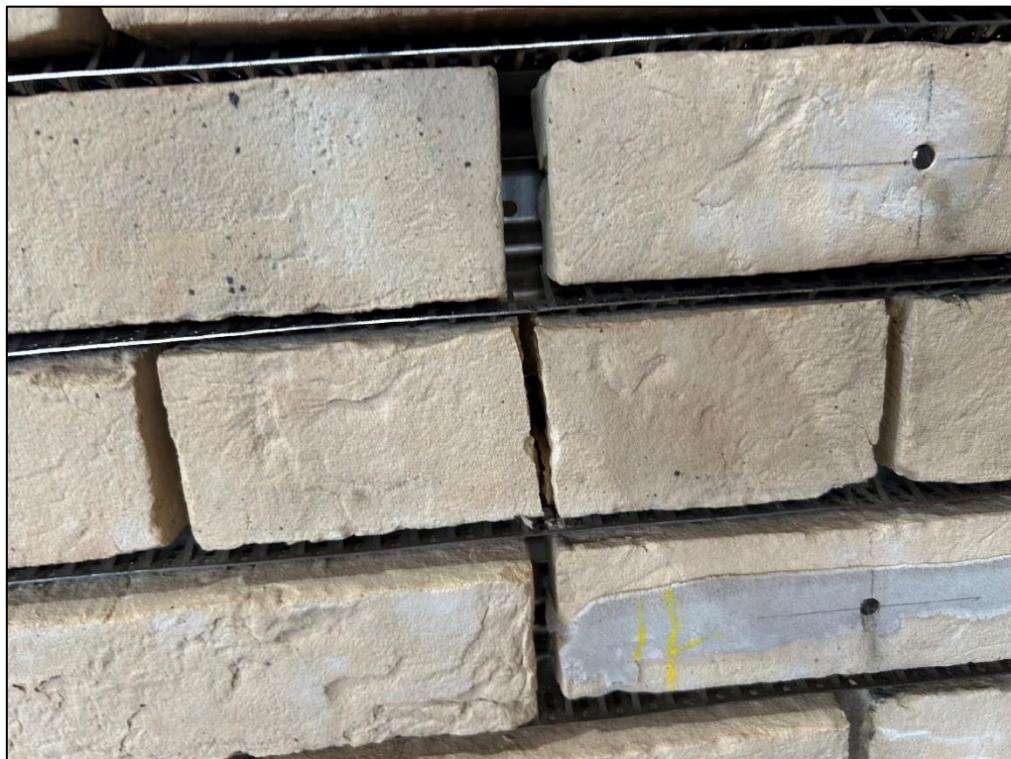
PHOTO IMG\_9314

IMPACT LOCATION 3

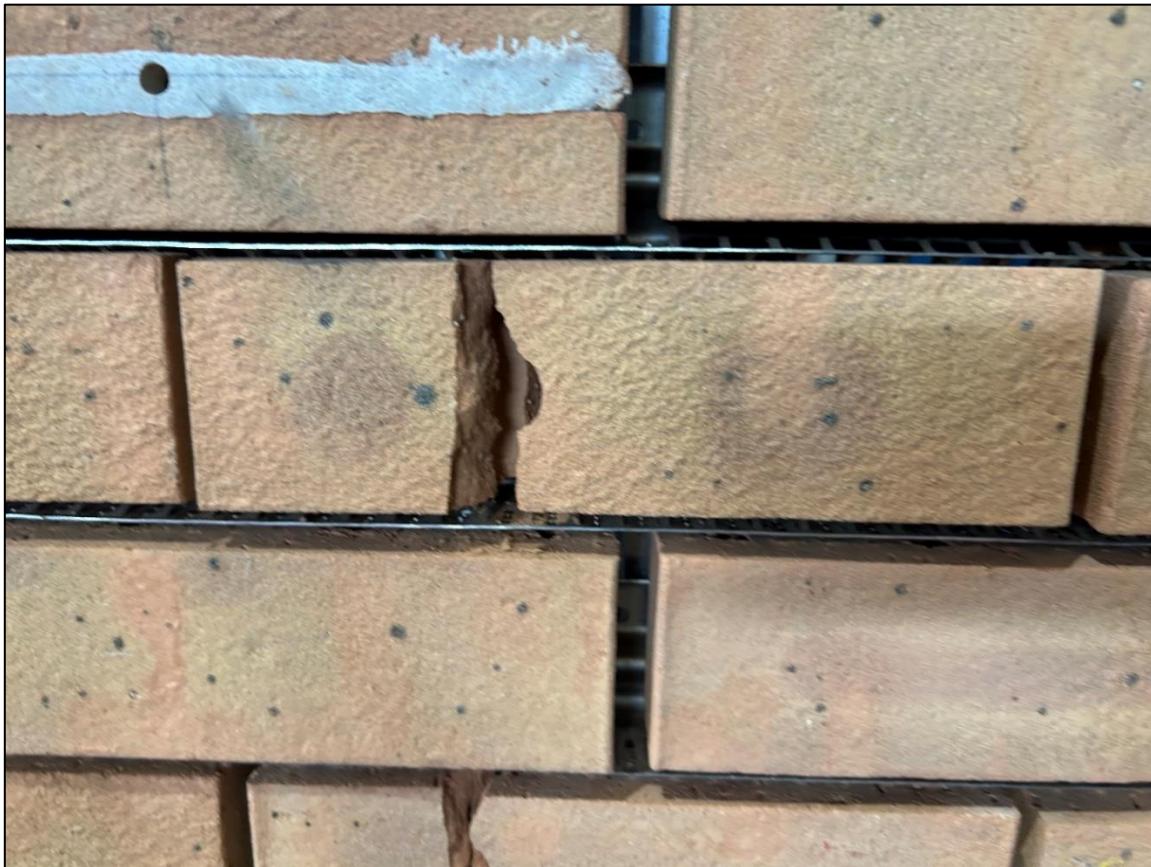
PHOTO IMG\_9354

IMPACT LOCATION 18

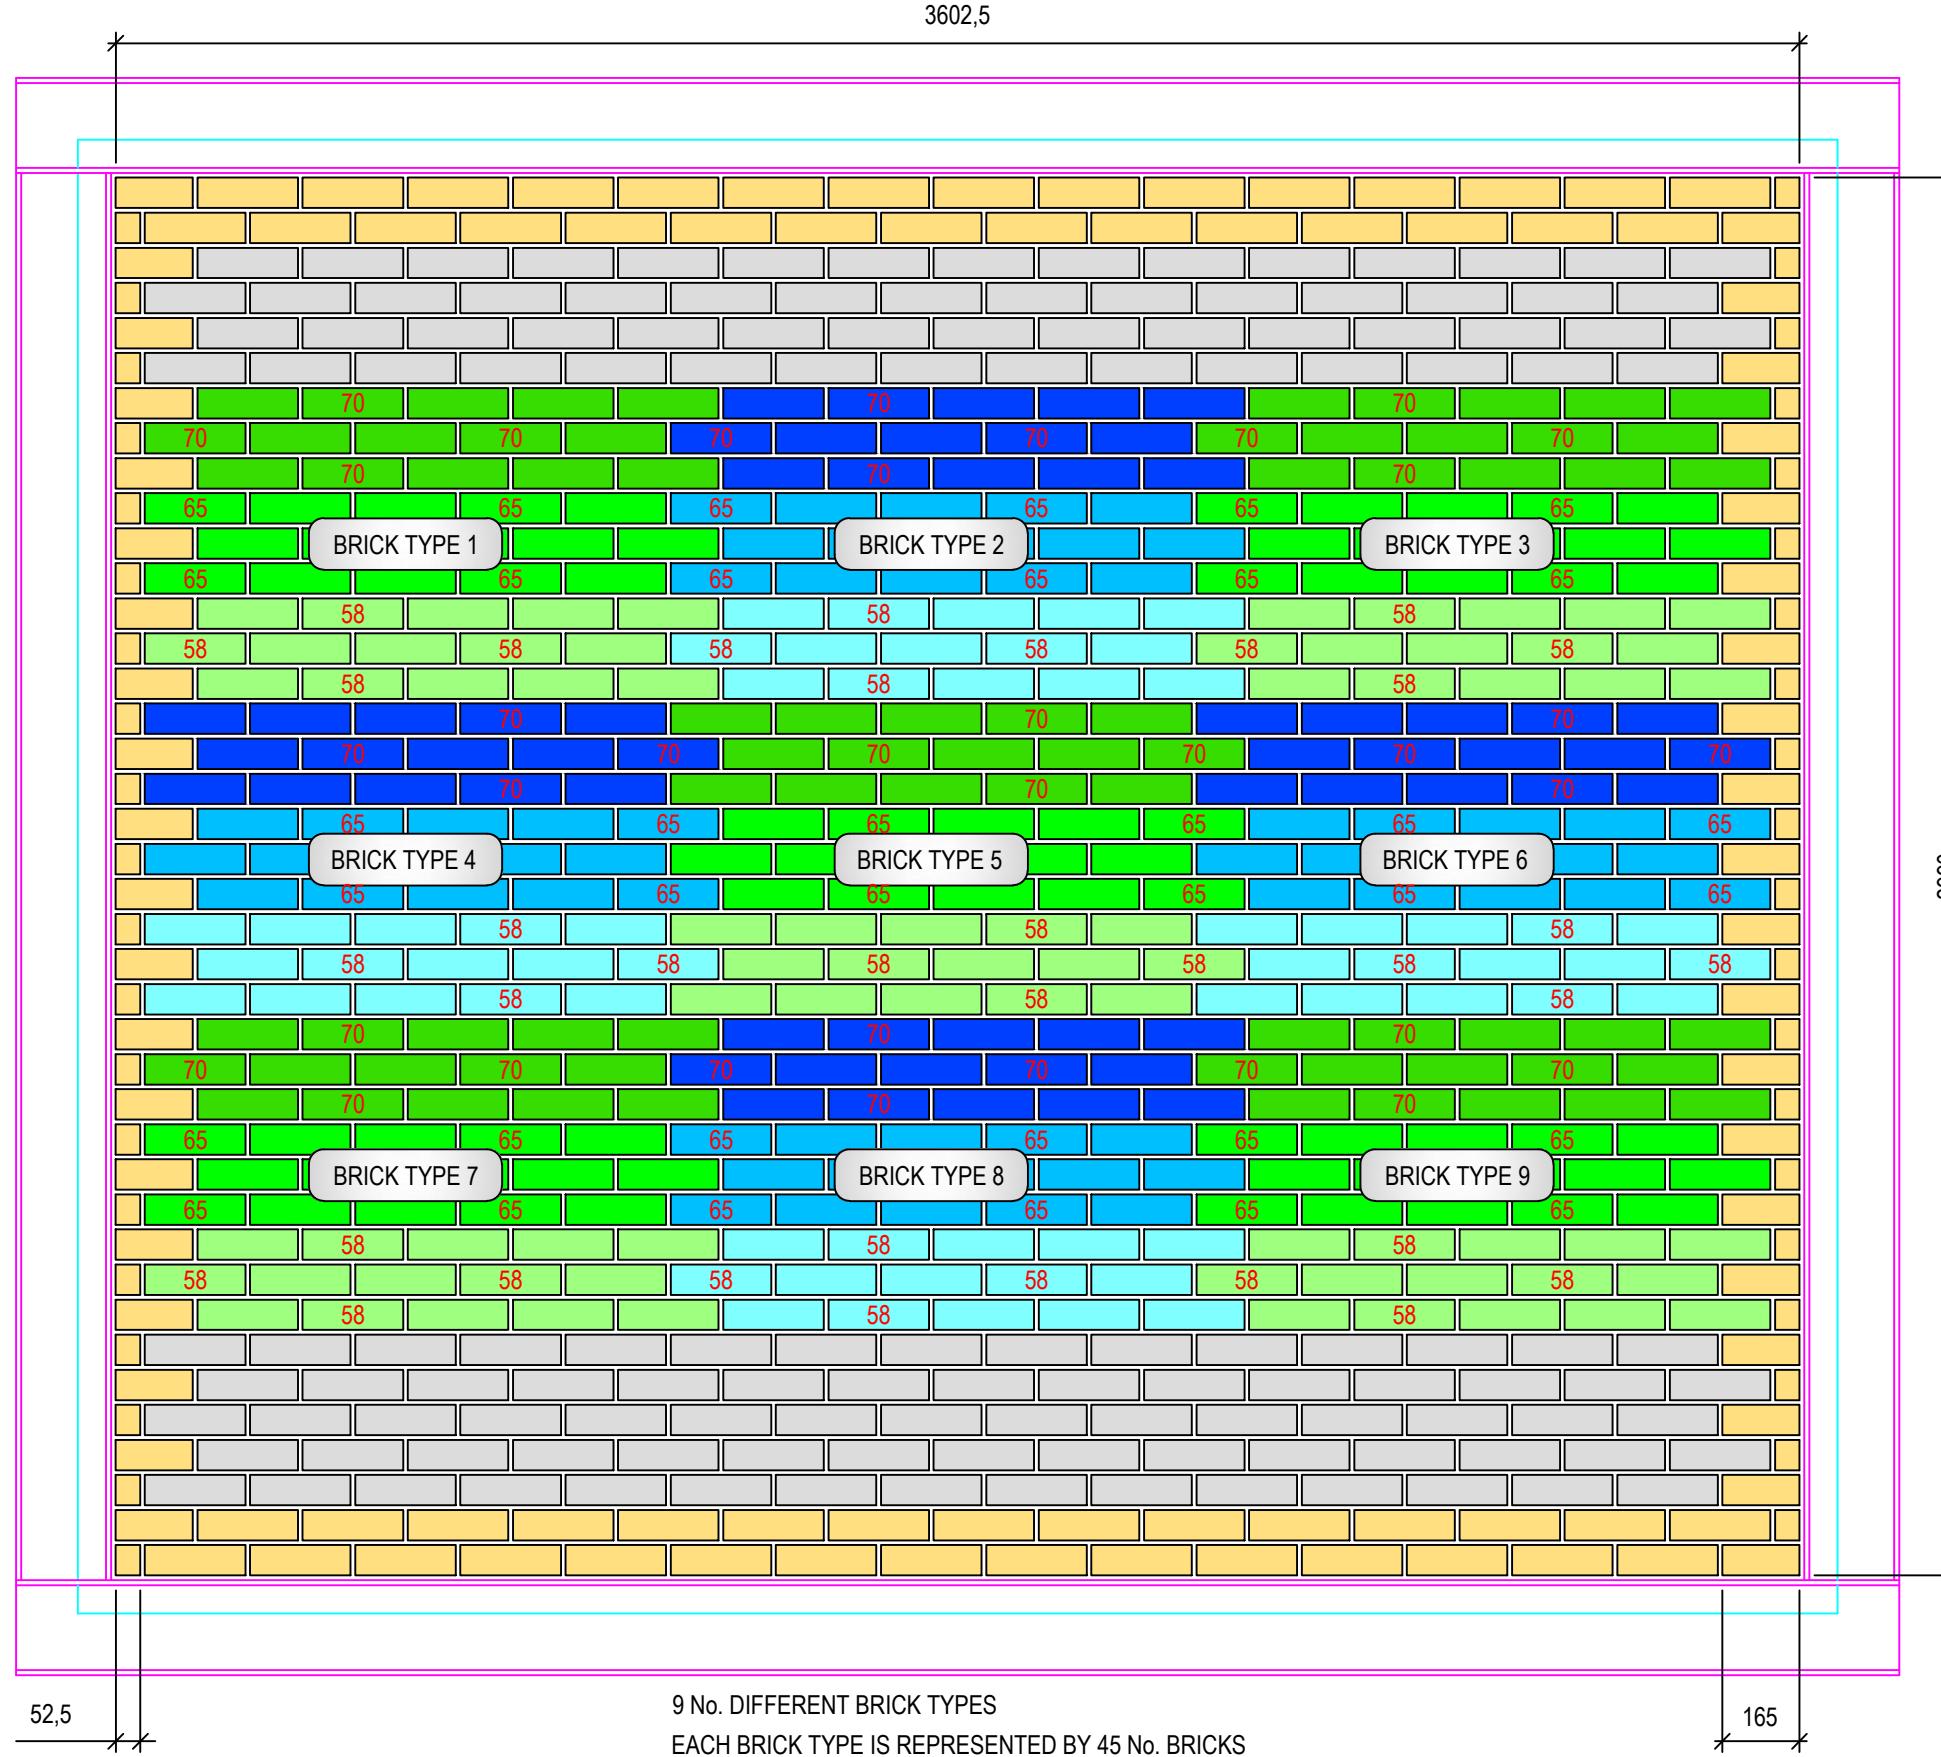
DRAWING NUMBER: REVISION:  
**BSS-TRA-T1**

# TEST RIG TYPE A - TEST 1 [UNMORTARED BRICK PULL]

TITLE:  
**TEST RIG TYPE A - TEST 1  
UNMORTARED BRICK PULL**

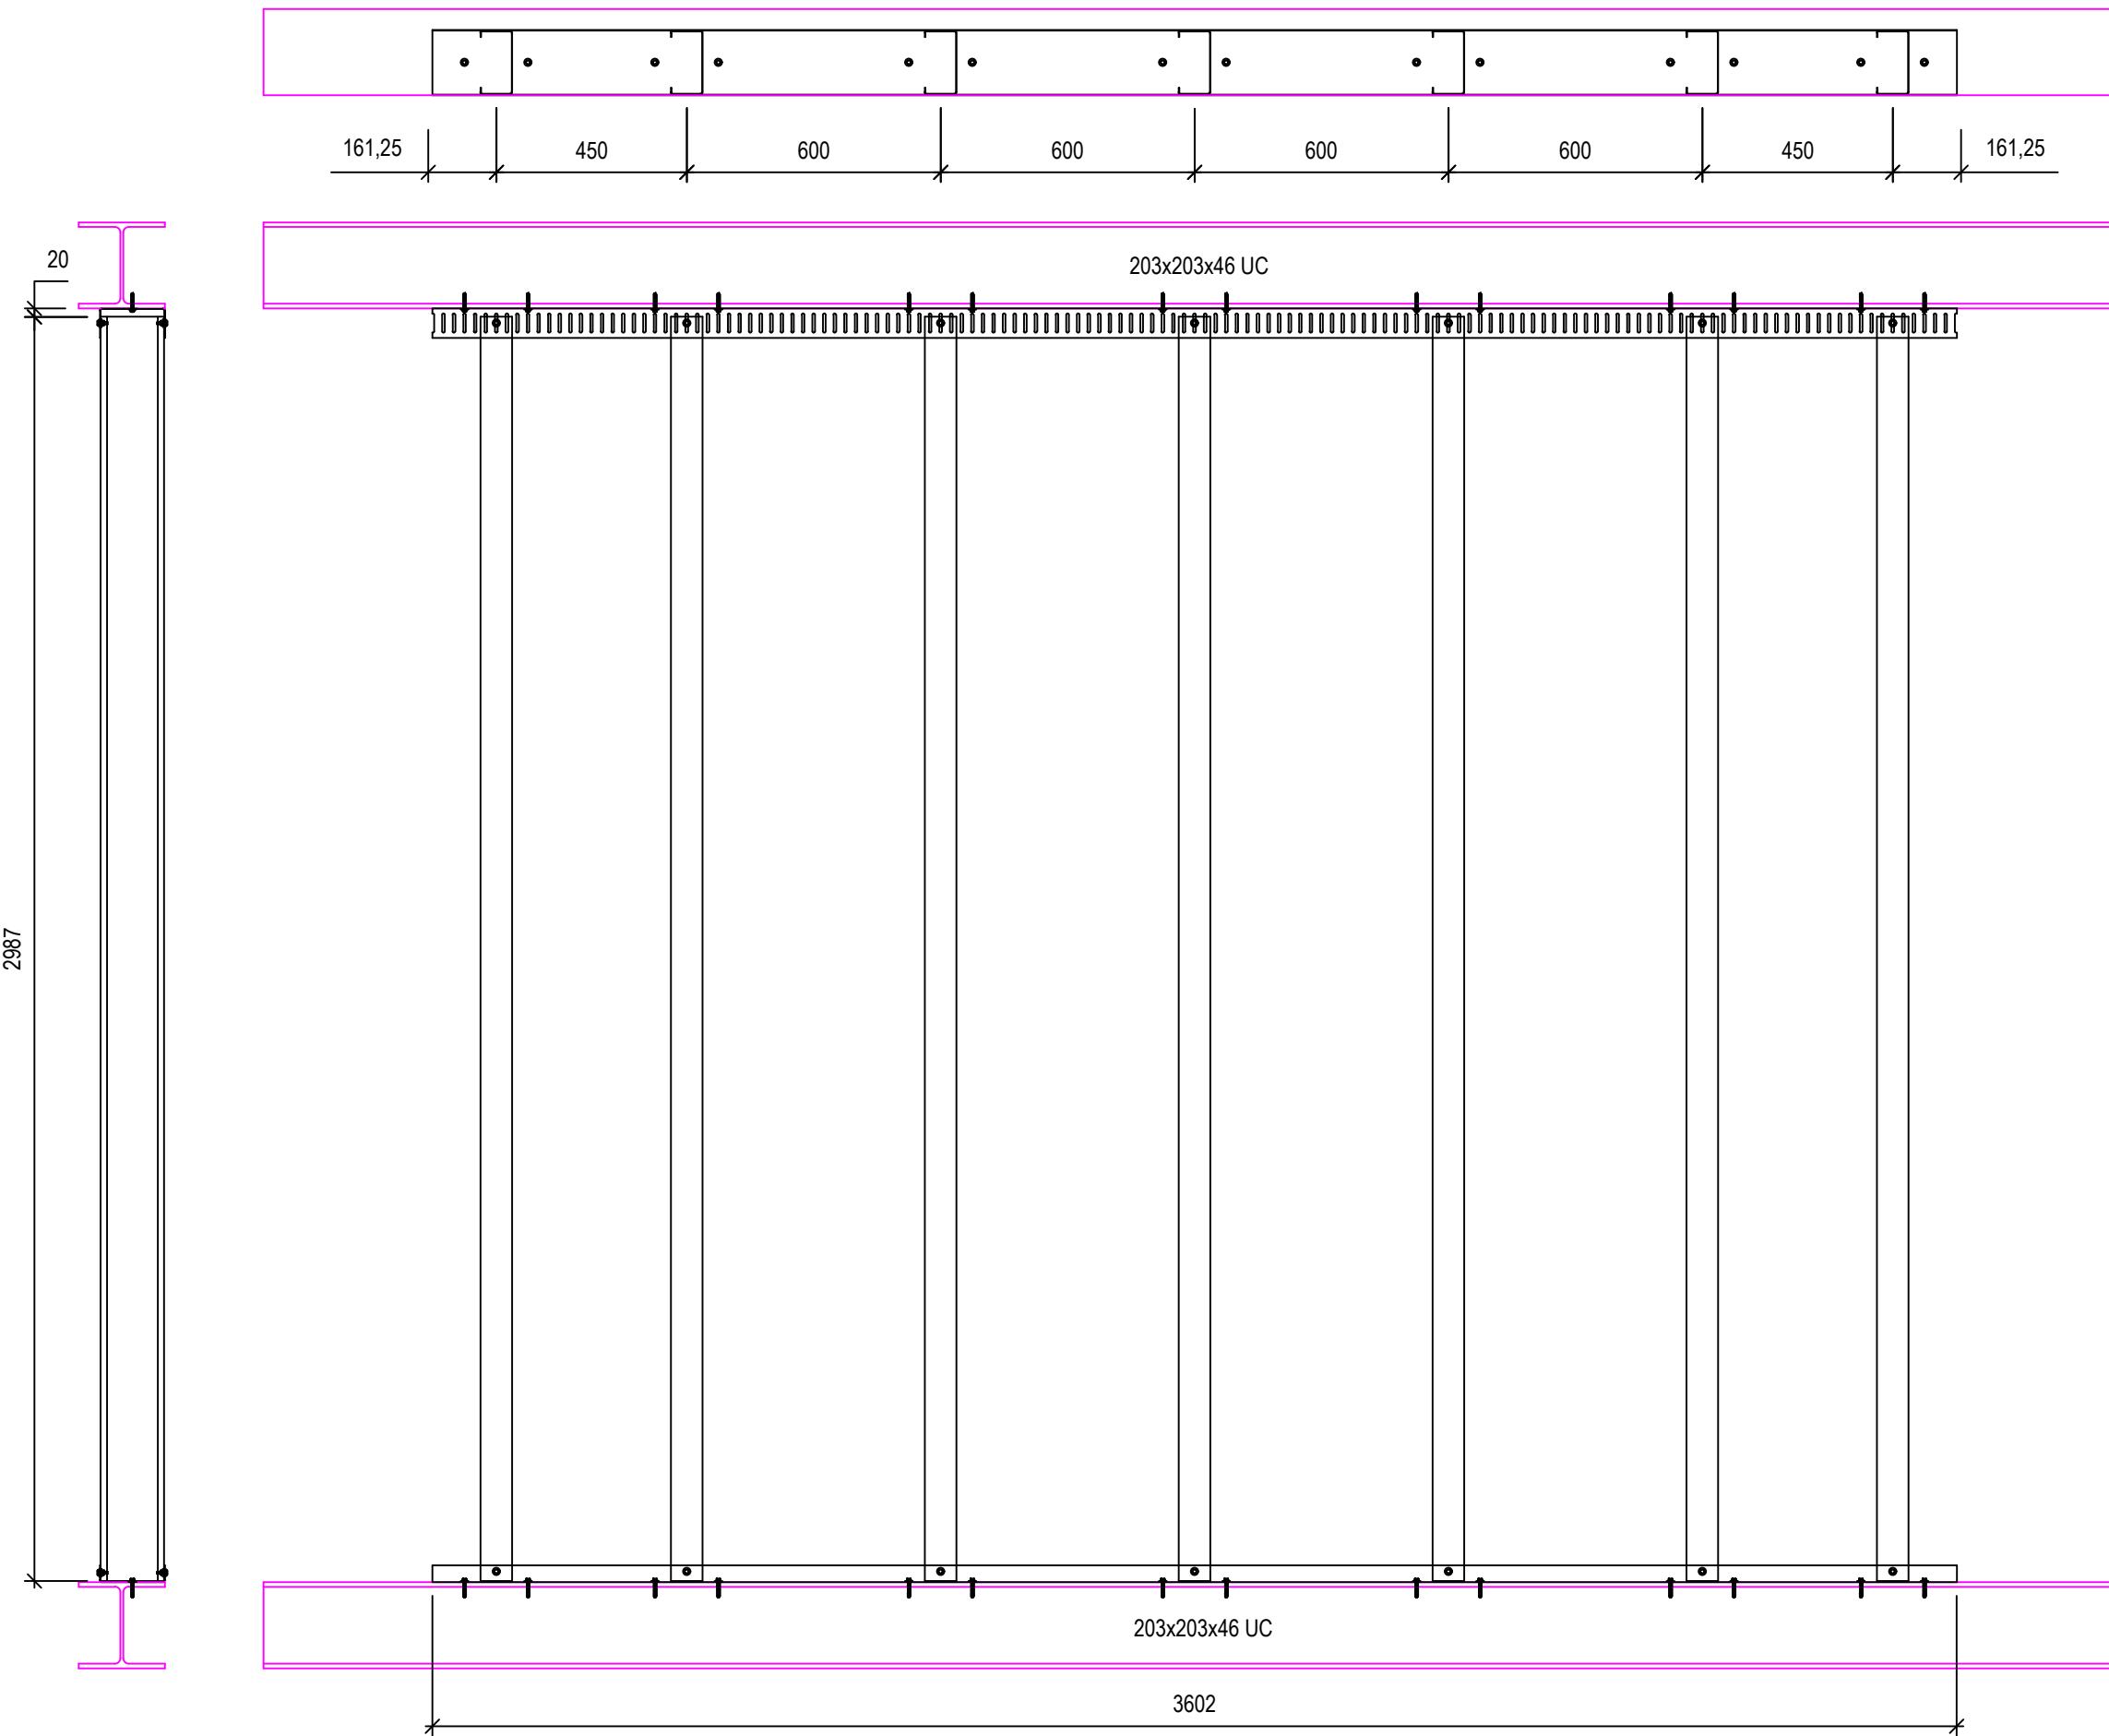
**TEST RIG TYPE B**  
**METSEC BACKING WALL; STUDWORK, BASE, AND HEAD TRACK SETTING OUT/CONFIGURATION**

METSEC REQUIREMENT  
VERTICAL STUDS  
150M12-75 (THEORETICAL LENGTH 2987mm) = 7 No.

BASE TRACK  
154M12-40 (THEORETICAL LENGTH 3602mm) = 1 No.

HEAD TRACK  
154M16-70s (THEORETICAL LENGTH 3602mm) = 1 No.
