Title: Impact testing of Barracuda Brick Slip System (Un-Mortared)

Report No: N950-24-18684

**Customer:** James & Taylor Ltd,  
Sixty-Two, Barwell Business Park,  
Leatherhead Road, Chessington, Surrey KT9 2NY.

The test was carried out in accordance with CWCT TN75/76.

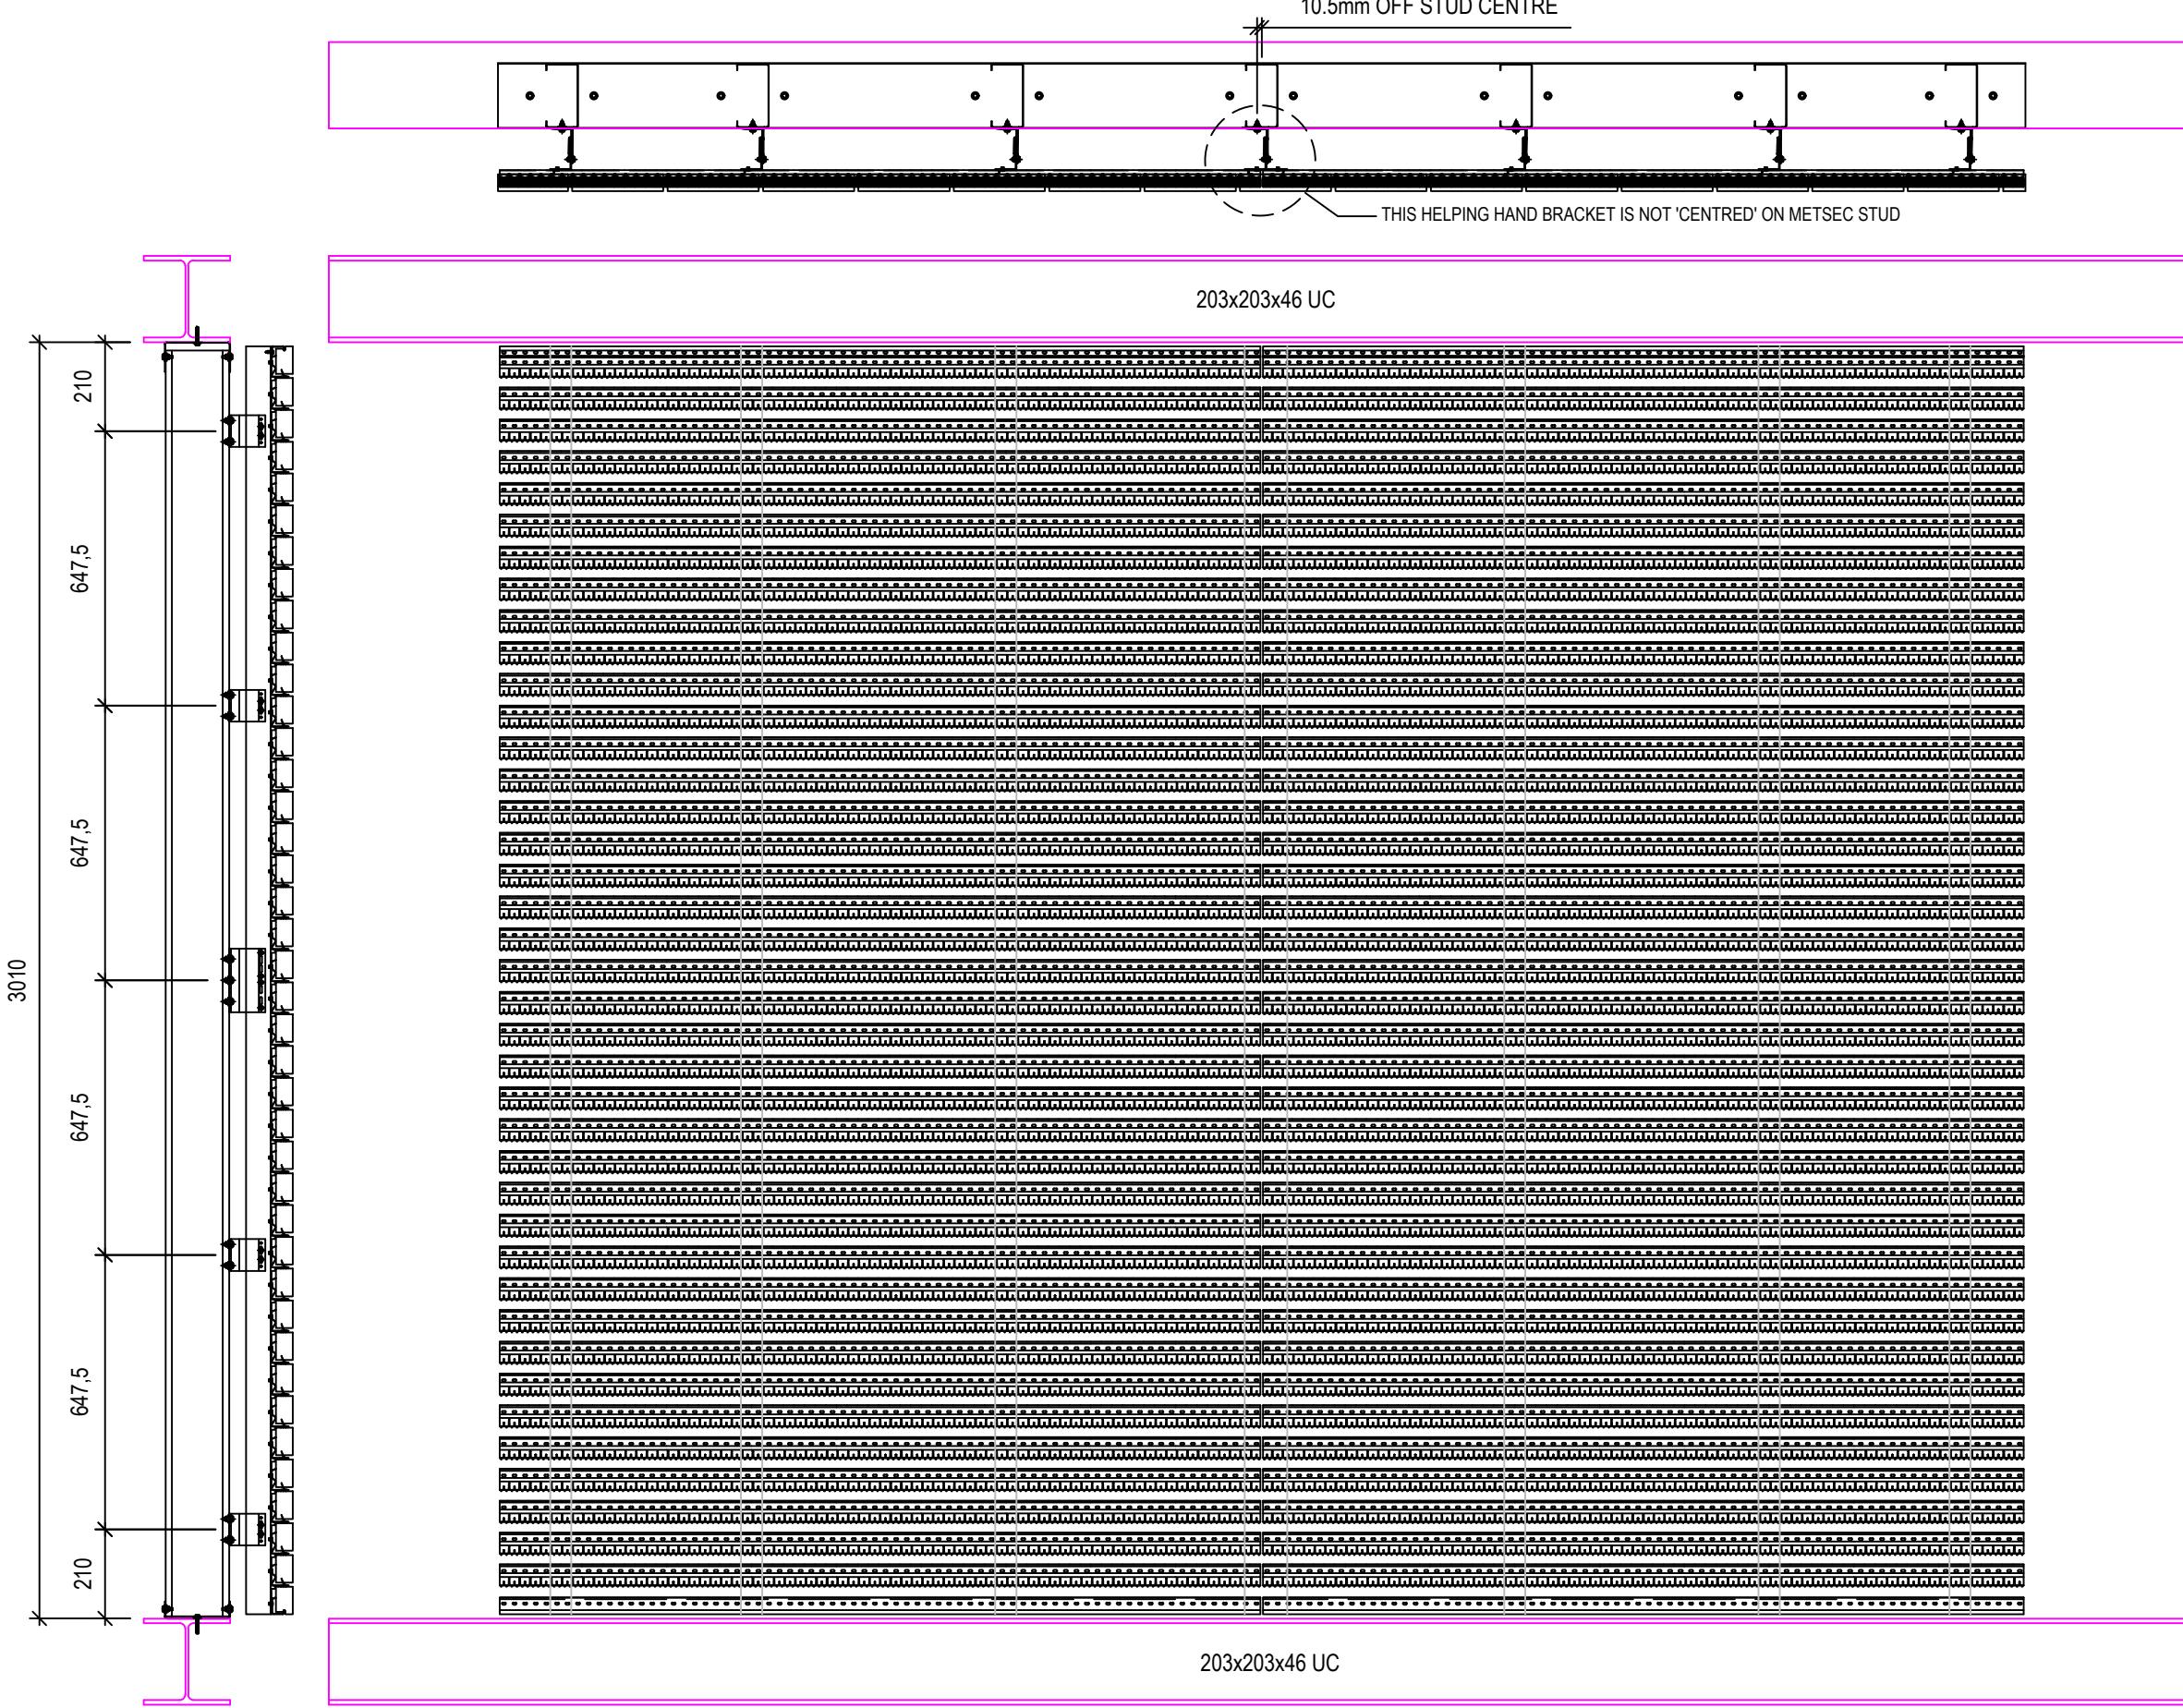
DRAWING NUMBER: REVISION:  
**BSS-TRB-GA-003**

TEST RIG TYPE B  
'HELPING HAND' BRACKET, VERTICAL SUB-STRUCTURE AND BARRACUDA RAIL SETTING OUT/CONFIGURATION

BARRACUDA HORIZONTAL RAIL REQUIREMENT

BAR-R1-1800 = 78 No.  
BAR-R2-1800 = 2 No.  
BAR-R3-1800 = 2 No.

BARRACUDA VERTICAL RAIL REQUIREMENT

BAR-VL1-2990 = 6 No.  
BAR-VT1-2990 = 1 No.

'HELPING HAND' BRACKET REQUIREMENT  
Nvelope 90 (ADJUSTMENT RANGE 92mm TO 132mm)

VERTICAL LOAD BEARING HELPING HAND = 7 No.  
RESTRAIN HELPING HAND = 28 No.
