Mosca - KCK-131-22 Service Inspection report

Hayes Packaging Service Ltd

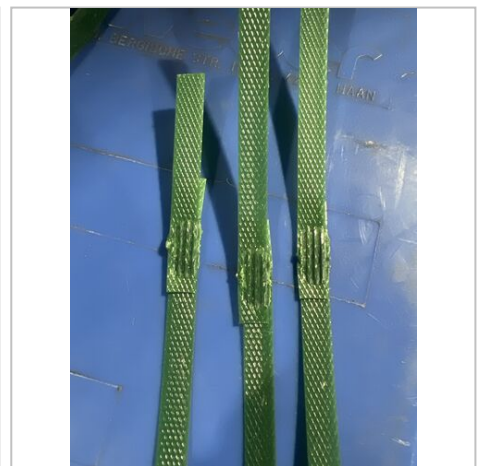
Operator reported poor welds causing strap to pop open consistently. Found loose earthing connection, braided cable starting to fray. This will need to be checked periodically to ensure sufficient welds. A contribution to poor welds was an alignment issue with the reentry chute. This has been adjusted and the welds are back to normal. Unable to change cutter due to none in stock, the cuts are poor occasionally and the mobile cutter will need replacing when this has arrived. Ran and tested all okay.

Operators fix for bad joint
