Check Out

Property inspected by A. Clerk

123 Preview Street
Sample City
London
AB1 2CD

May
29th 2026
09:00

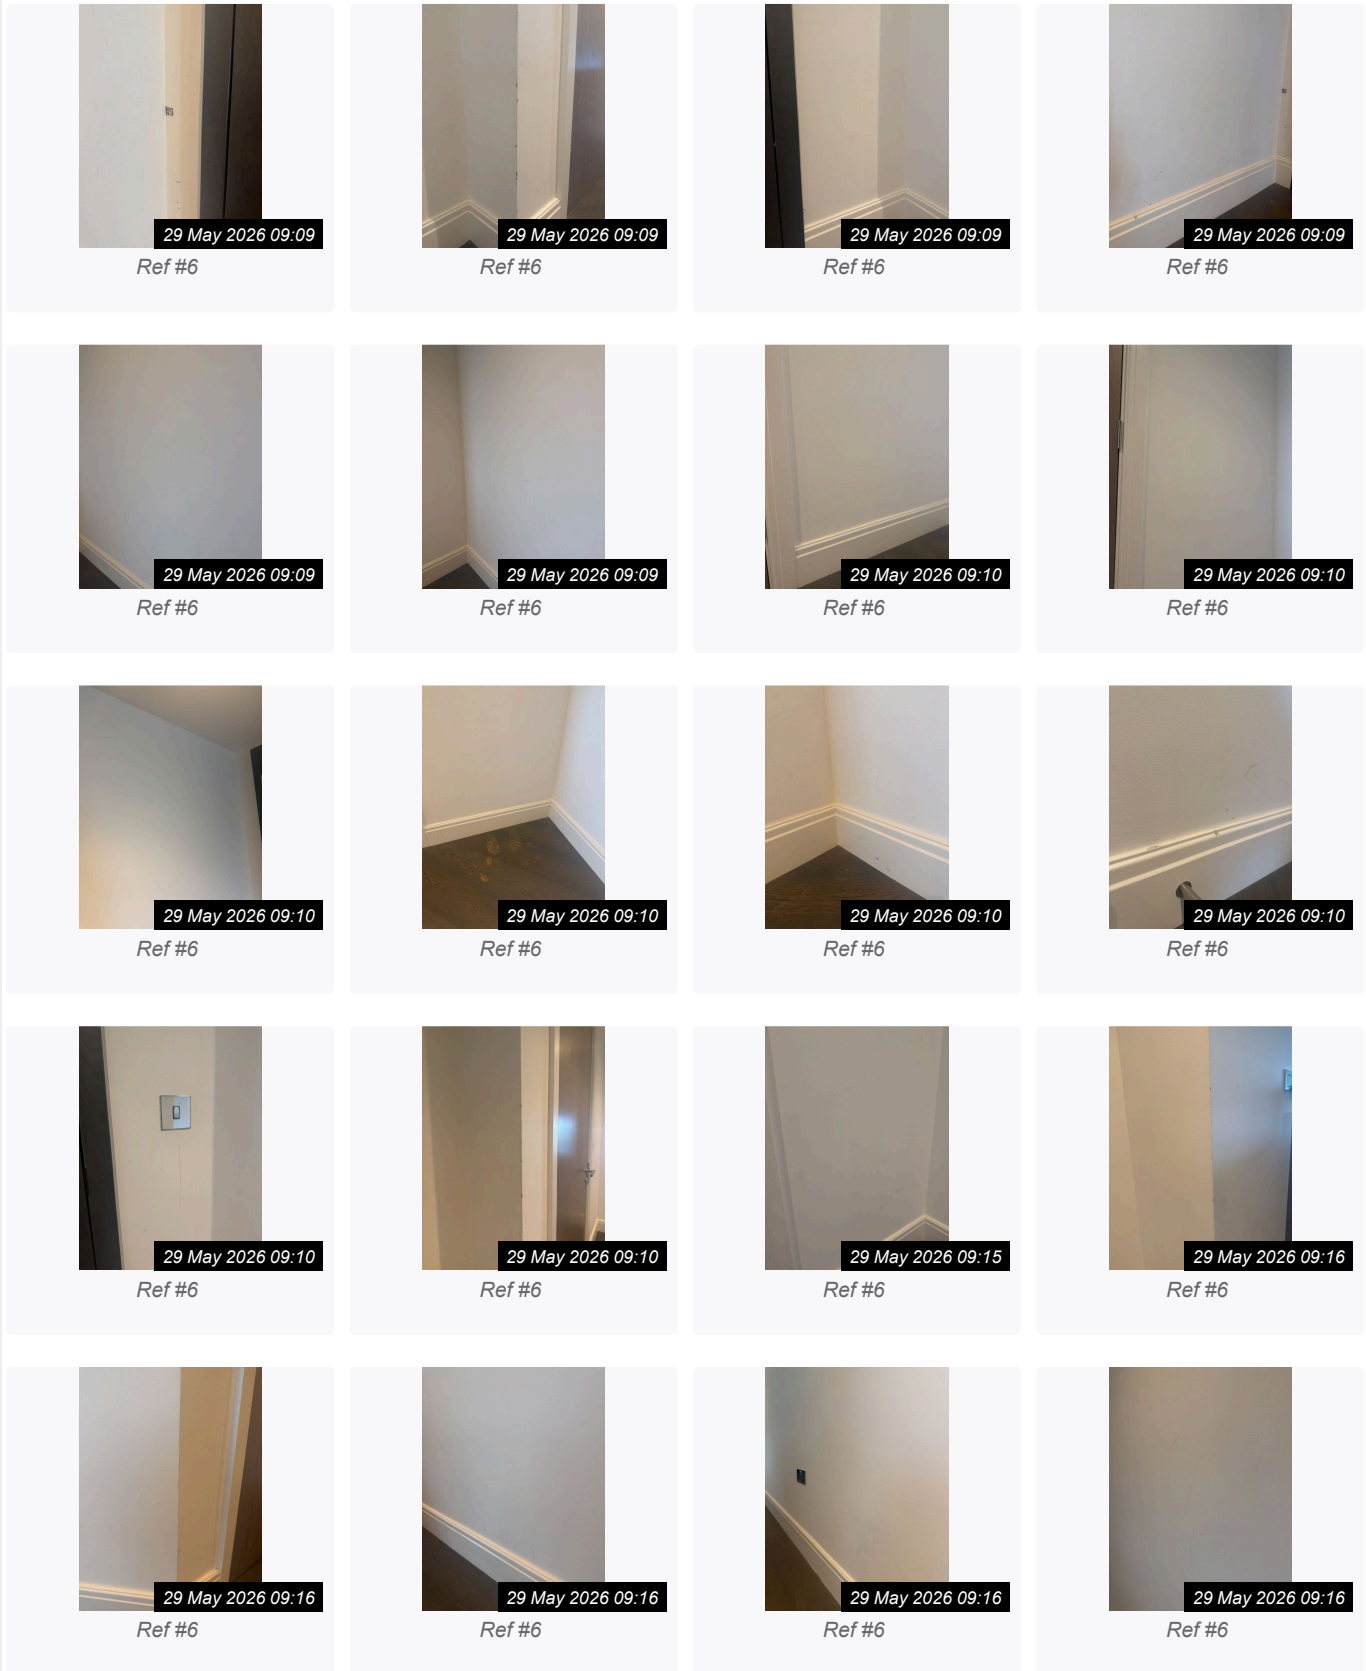
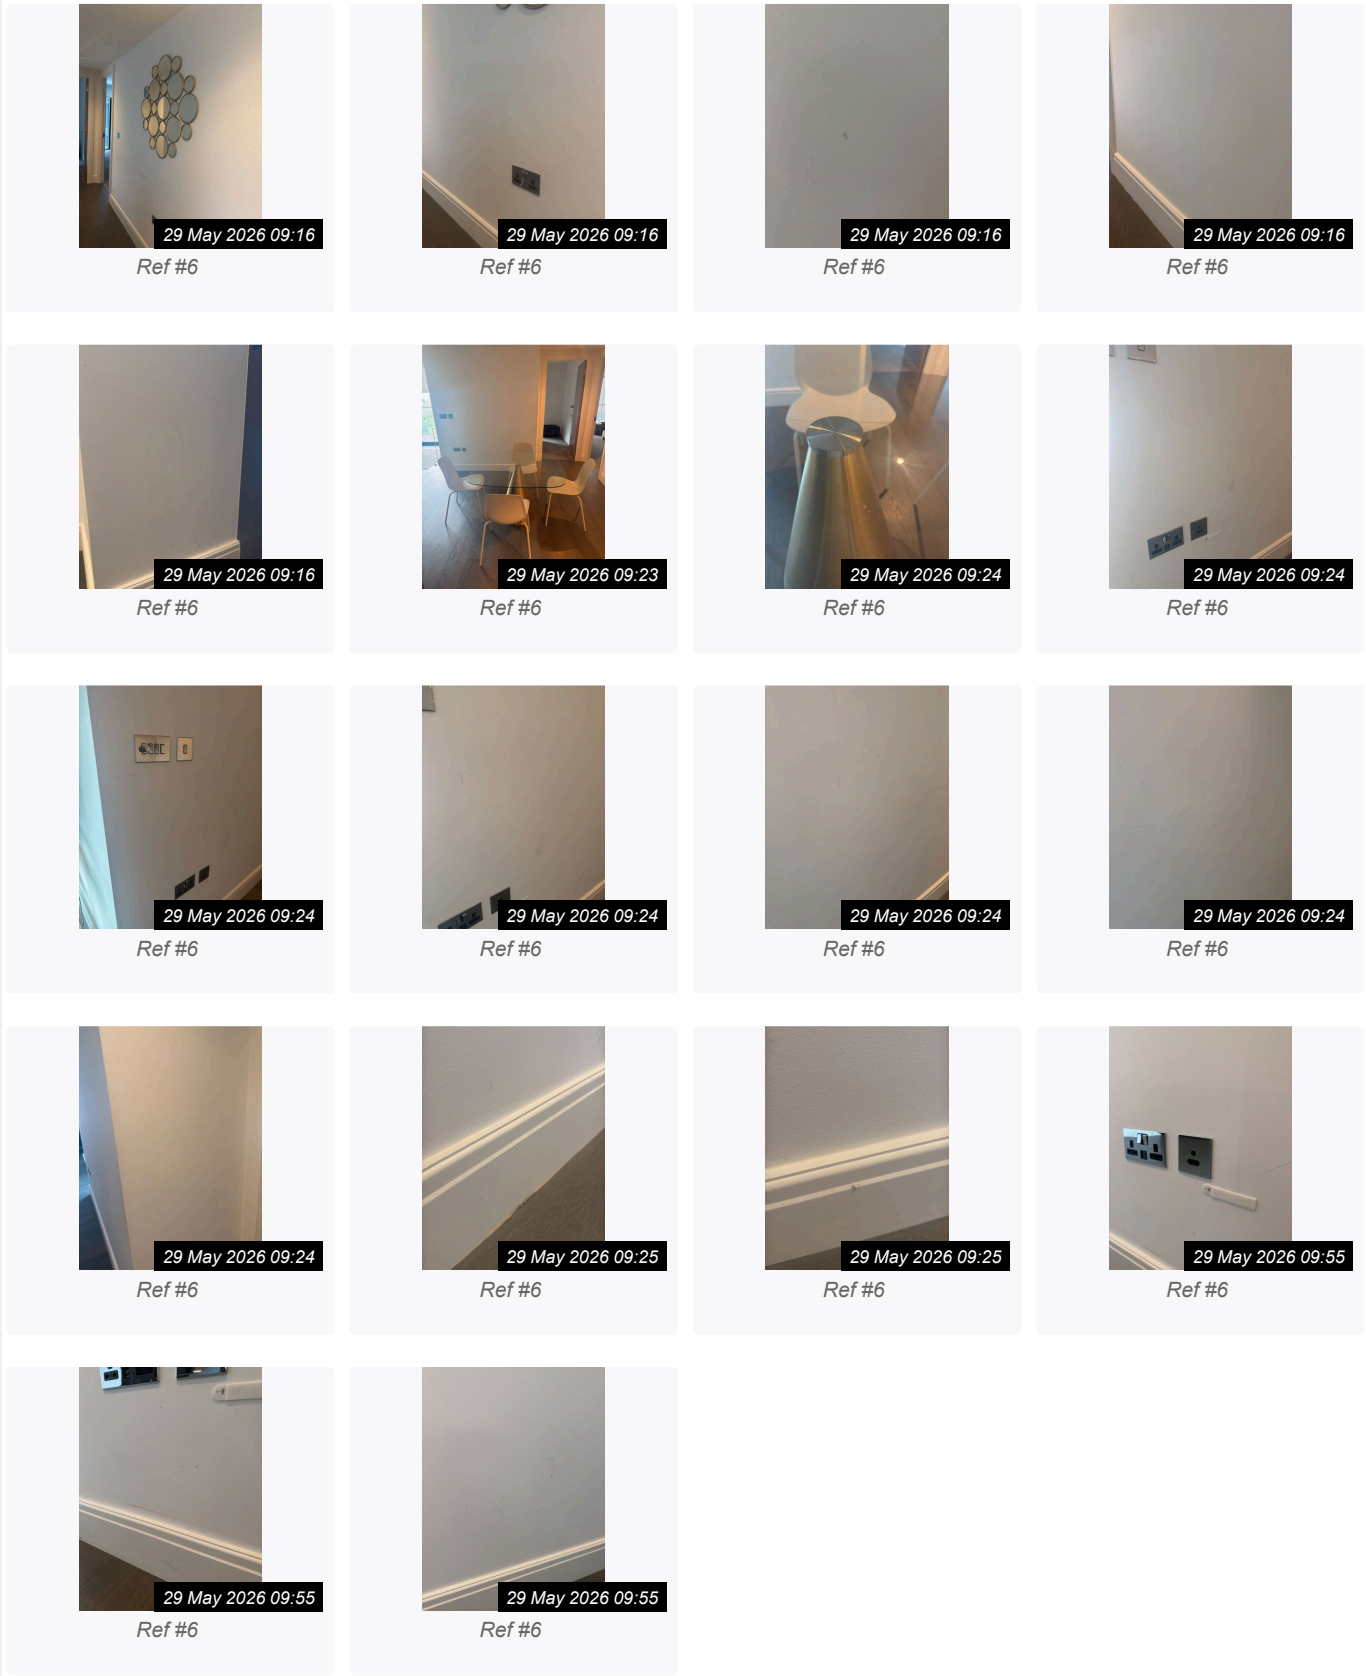
6. ENTRANCE / HALLWAY (CONT.)

Ref	Name	Description	Condition at Inventory & Check In	Condition at Check Out
6.1	General Overview			<p>The hallway was generally in good condition, with the exception of numerous scuff marks visible on the walls throughout.</p> <p>Requires professional cleaning.</p> <p>Needs Cleaning - Tenant</p>

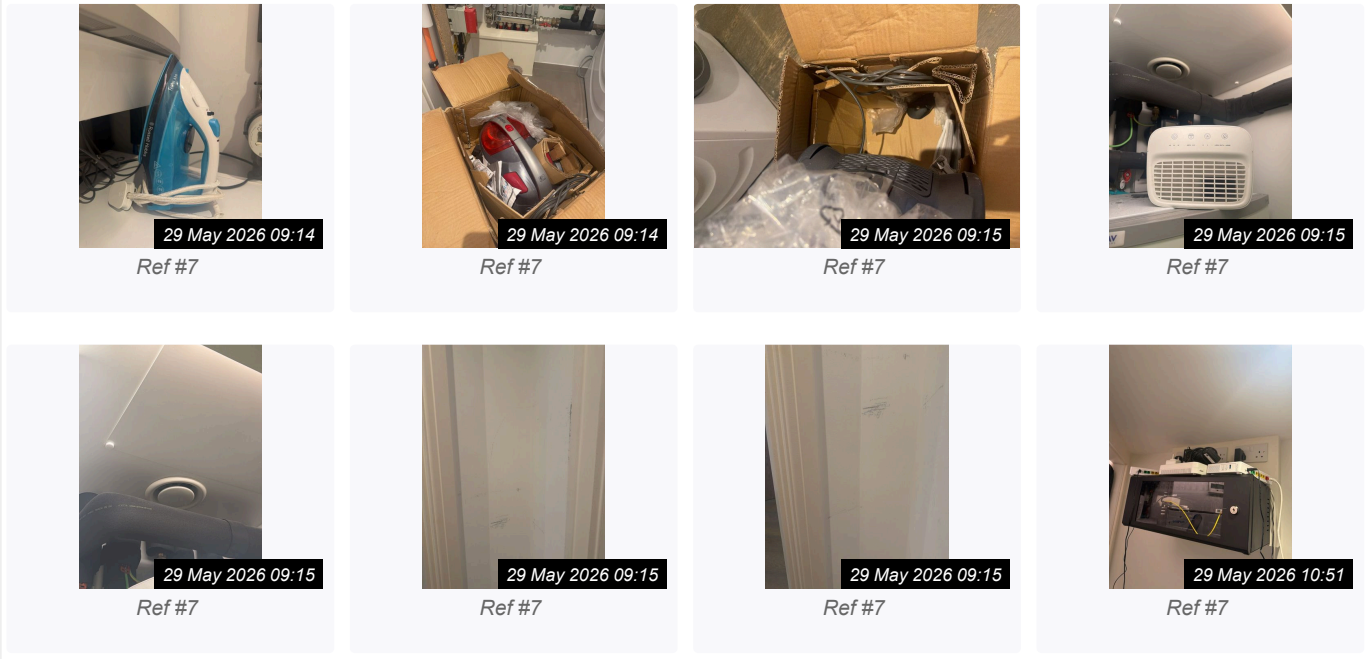
7. UTILITY ROOM / AREA (CONT.)

7. UTILITY ROOM / AREA				
Ref	Name	Description	Condition at Inventory & Check In	Condition at Check Out
7.1	General Overview			Requires professional cleaning. Needs Cleaning - Tenant

7.2	Exterior Door	1x medium wood door with - 1x chrome handle External doorframe Painted in white		In good condition - handle was in tact.
7.3	Interior Door	1x medium wood door with - 1x chrome handle Internal doorframe Painted in white		Door interior top section damaged - part of wood missing. Damage - Tenant

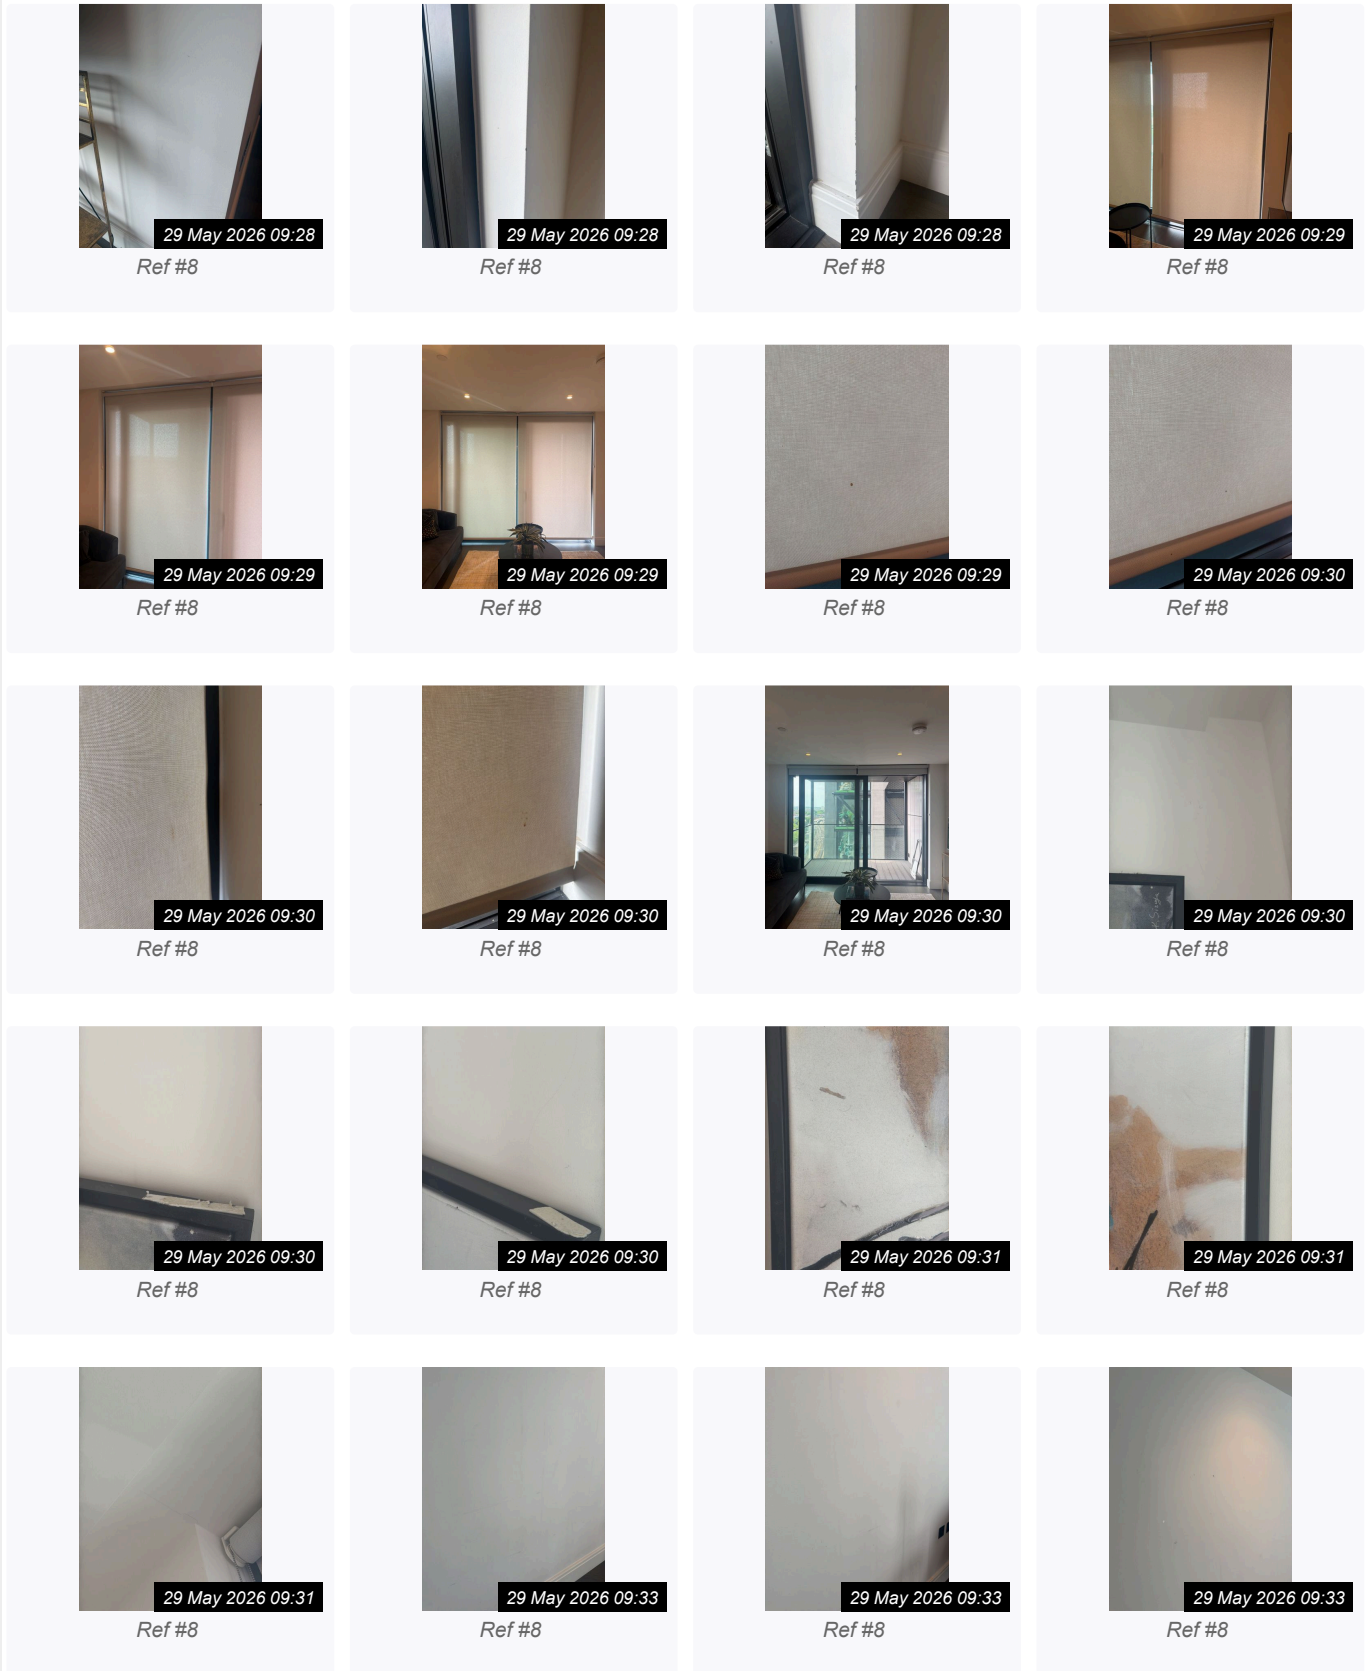
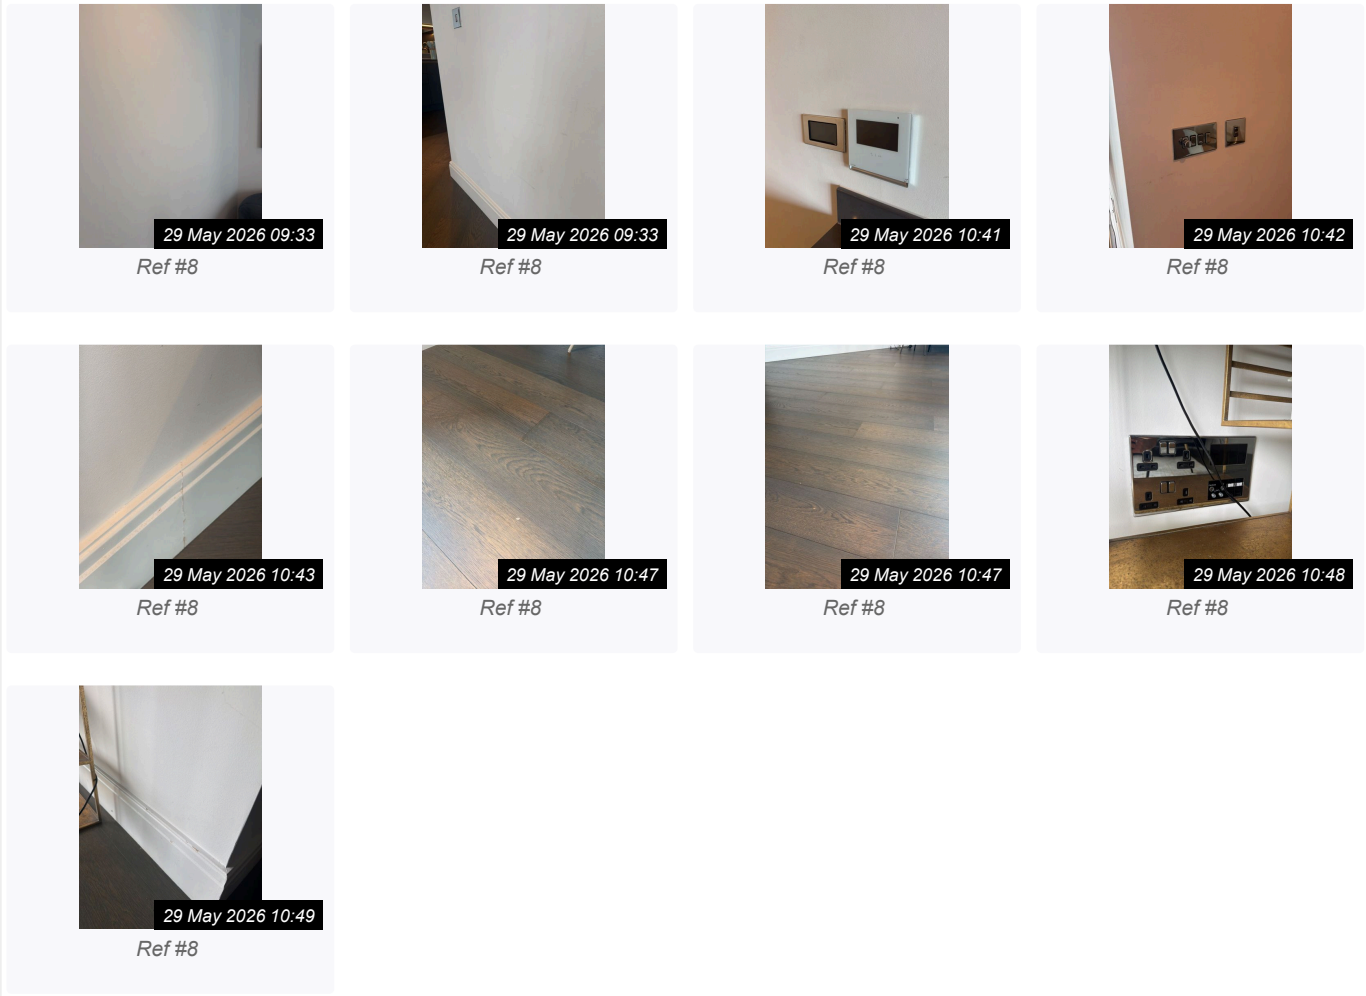
8. OPEN-PLAN RECEPTION AREA (CONT.)

Ref	Name	Description	Condition at Inventory & Check In	Condition at Check Out
8.1	General Overview			<p>Generally the reception area was in an acceptable condition though it requires professional cleaning.</p> <p>Needs Cleaning - Tenant</p>
8.2	Walls		<ul style="list-style-type: none"> - Some light shaded marks seen above the sofa - A couple of light horizontal scuff marks seen directly behind the small circular side table - Further mid to low level scuffs - Horizontal scuffs seen at low level - Numerous brown sticky residue marks seen at high-level left hand side, please see photographs - Further scuffs seen behind the TV - Left hand side wall, has glue residue mark seen at high level. 	<p><i>As Inventory & Check In</i></p> <p>+</p> <p>Scuff marks visible around light switches.</p>

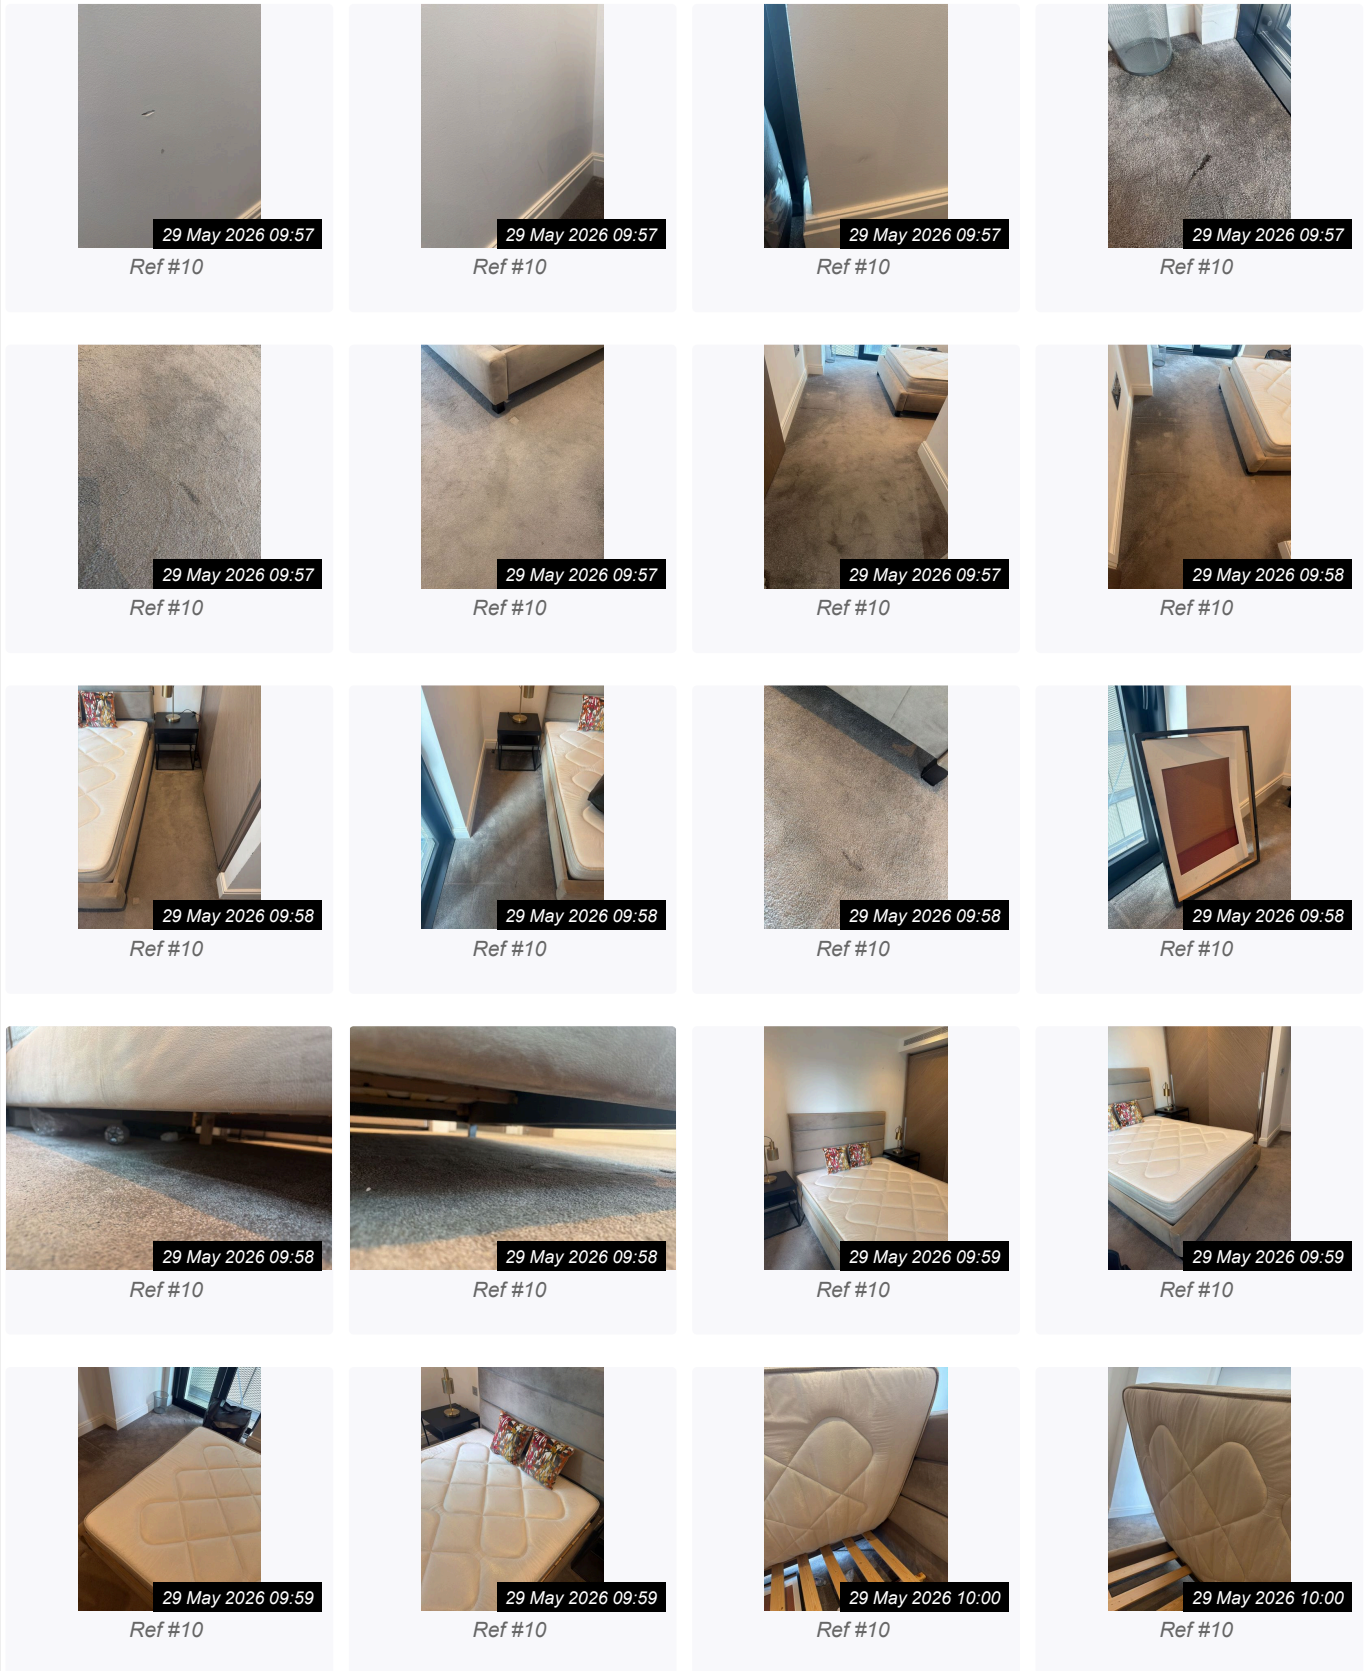
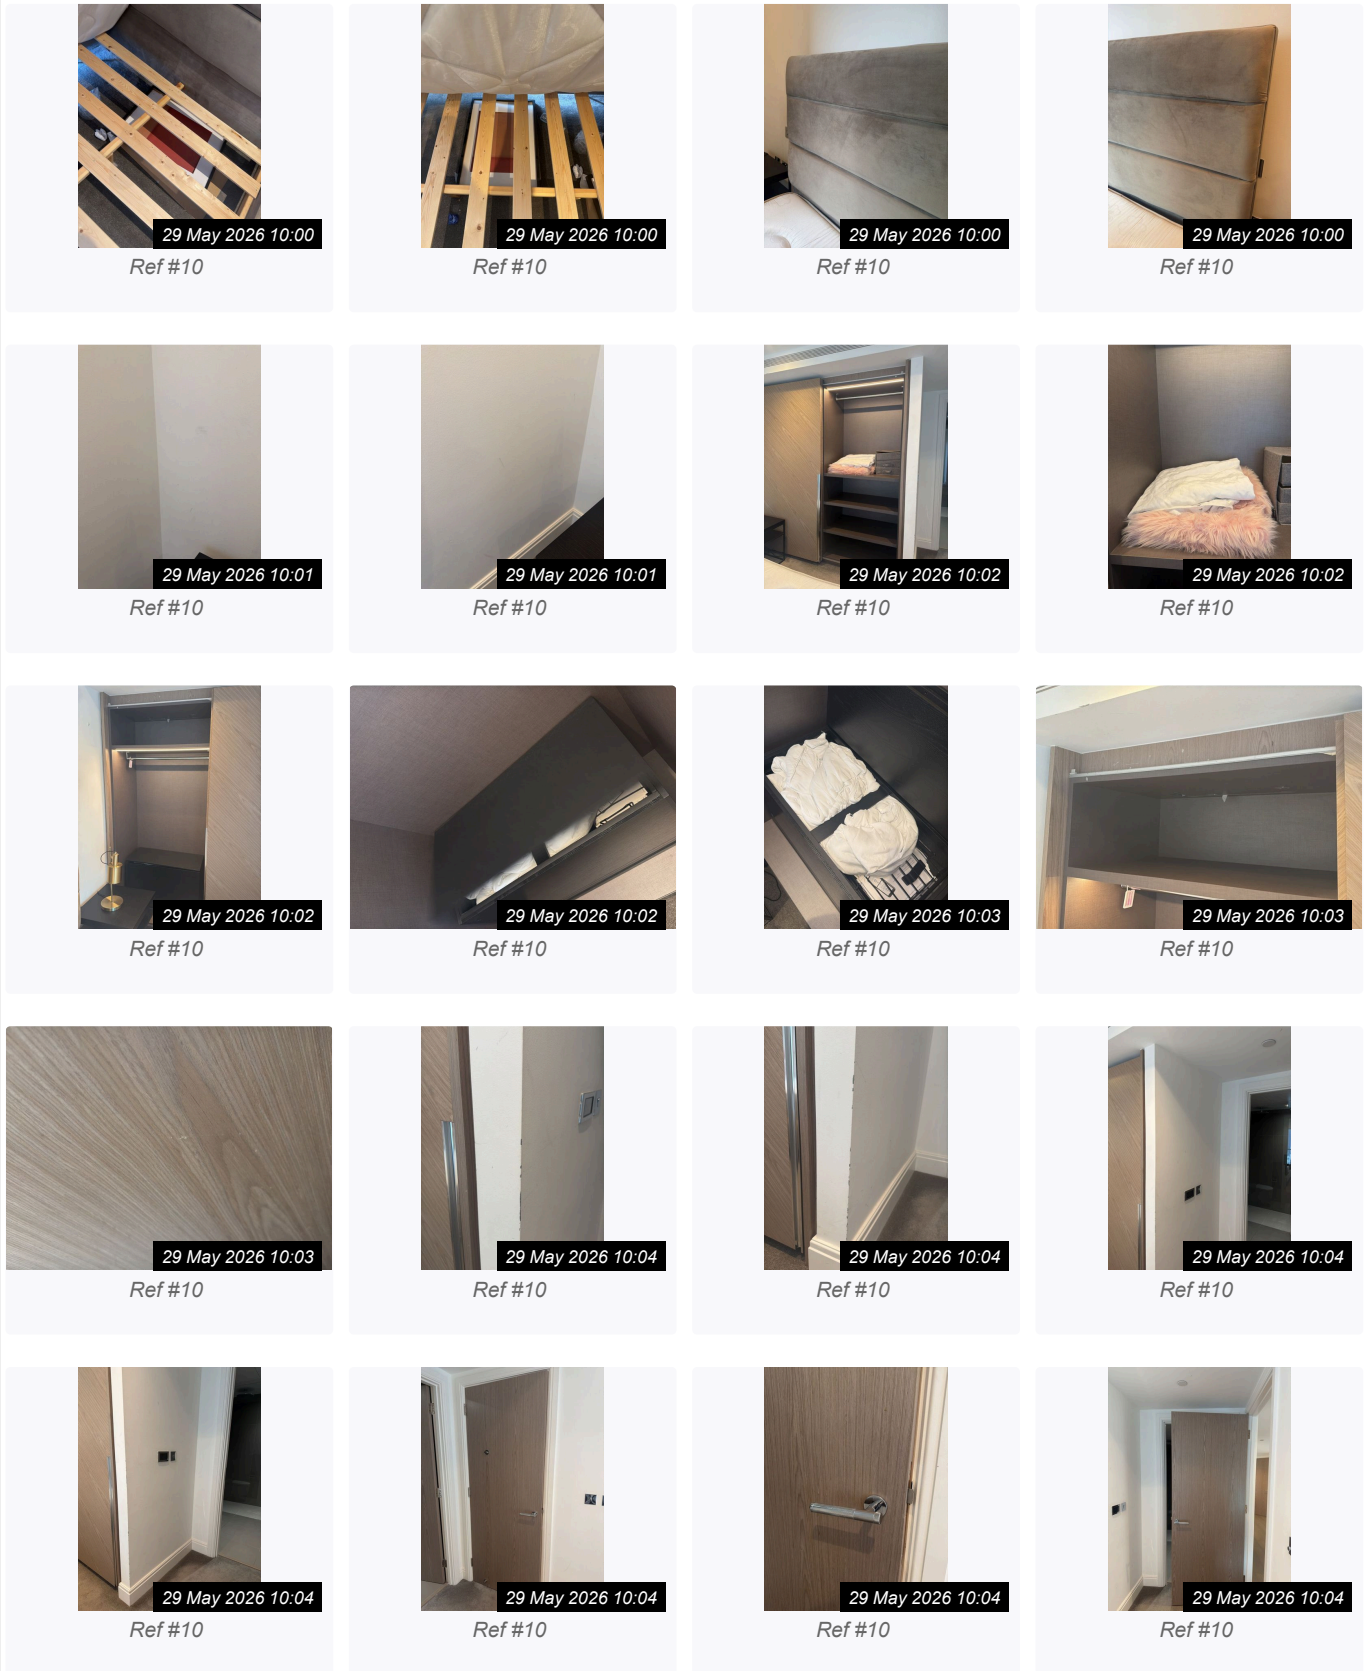
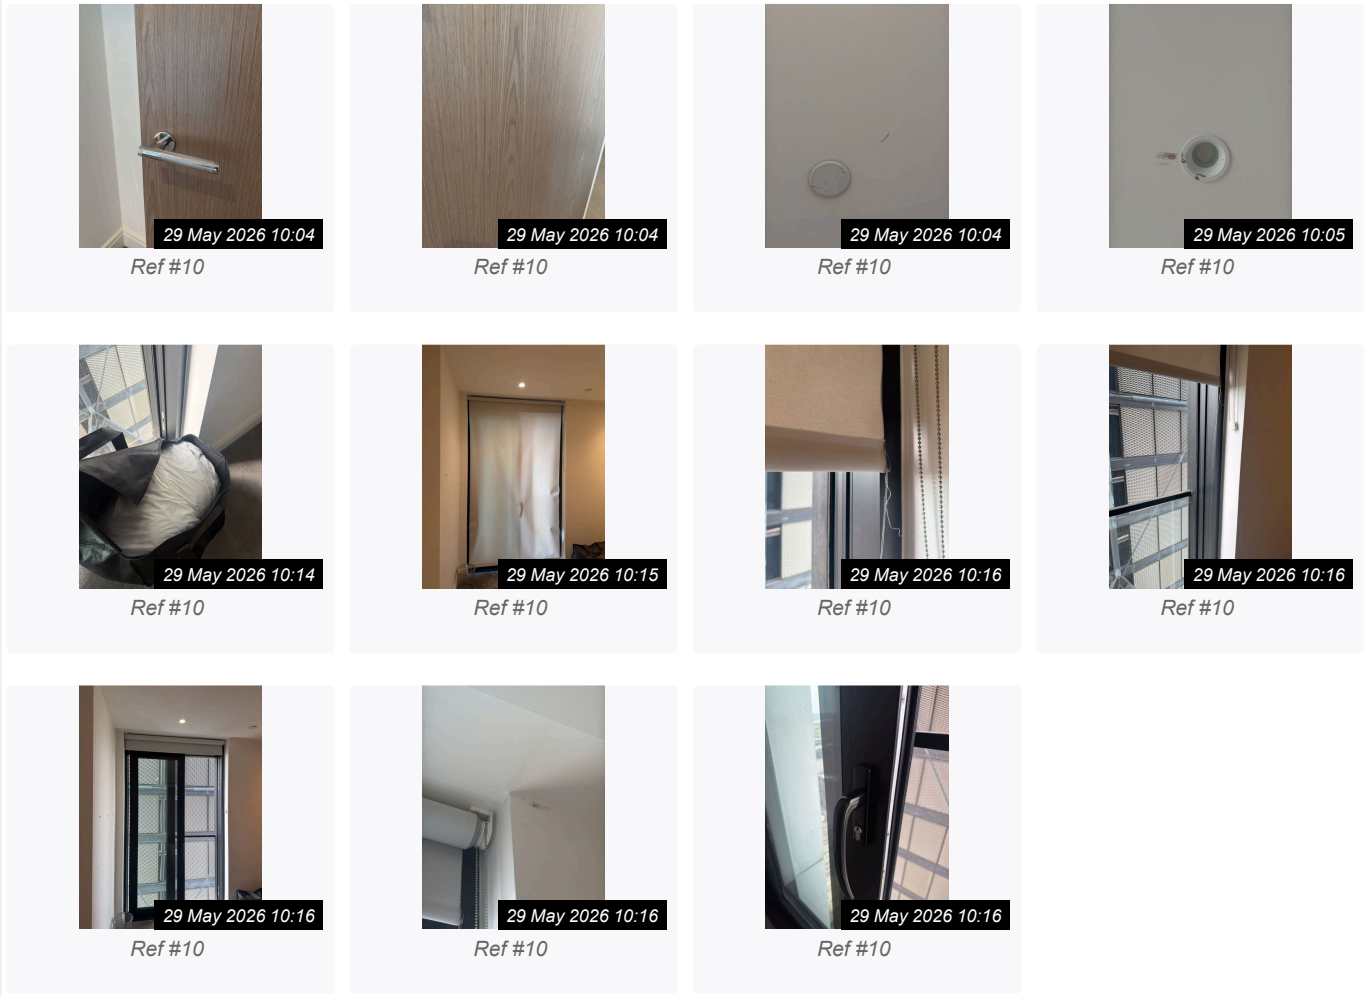
Ref #10

Ref	Name	Description	Condition at Inventory & Check In	Condition at Check Out
10.1	General Overview			<p>Generally in good condition, although dust and dirt were observed in places, including under the bed.</p> <p>Requires professional cleaning.</p> <p>Needs Cleaning - Tenant</p>
10.2	Exterior Door	<p>Medium wood finish - 1x chrome handle</p> <p>External doorframe Painted in white</p>	- Tested and working	<p><i>As Inventory & Check In</i> +</p> <p>Appears in good condition.</p>

10. BEDROOM 1 (CONT.)				
10.3	Interior Door	Consistent with external Internal doorframe Painted in white		Appears in good condition.
10.4	Walls	Painted in white	<ul style="list-style-type: none"> - Opposite the entry there are various small marks - Towards the corner there are large scuffs seen above the audio unit - Heavy indent seen at a low level to the right hand side of the window - Further scuffs seen to the leading edge - Further mid to low level scuffs - Numerous sellotape residue marks seen to the left hand side of the window - Opposite the entry there are various small marks - Towards the corner there are large scuffs seen above the audio unit - Heavy indent seen at a low level to the right hand side of the window - Further scuffs seen to the leading edge - Further mid to low level scuffs - Numerous sellotape residue marks seen to the left hand side of the window - Left hand side of window, has some sticky residue, 2x screw holes and scuffs surrounding 	<p><i>As Inventory & Check In</i> +</p> <p>Additional marks: LHS wall near entrance.</p> <p>Extra scuff marks: wall RHS of window, next to bedside unit.</p> <p>Chipping: outer corner wall opposite entry.</p>

10.5	Ceiling	Painted in white		Brown tape-like residue seen next to spotlight by wardrobe; further scuff mark visible near sprinkler.
10.6	Flooring	Dark grey fitted carpet	<ul style="list-style-type: none"> - Additional spot marks seen on the entrance, approximately 2x - Further shaded areas seen to both left and right hand sides of the bed - Spot stains seen on entrance - 4x burn marks seen in front of the window - 2x areas of small whitish marks seen to the right hand side of the bed. 	<i>As Inventory & Check In</i>

10.15.3	-	2x black picture frames, please see a photograph for the artwork internally	- Both picture frames are missing glass	<p><i>As Inventory & Check In +</i></p> <p>Both items appear damaged.</p>
10.15.4	-	2x gold based lamps withhold shades	- Tested and working	<p>Left-hand lamp not working; bulb present but non-functional.</p> <p>Needs Replacing - Tenant</p>

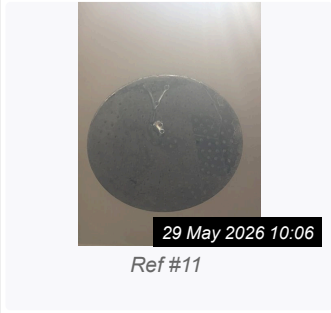
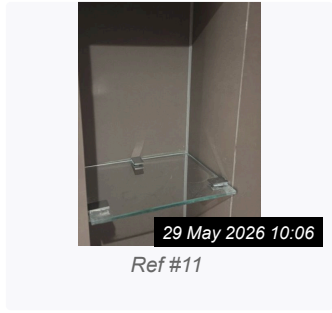
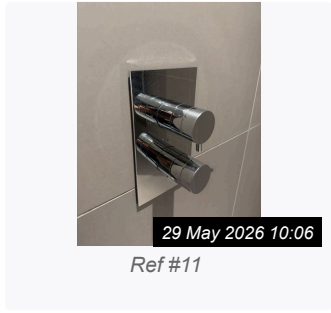
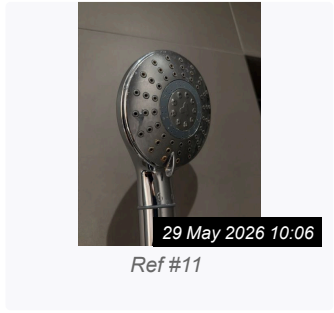
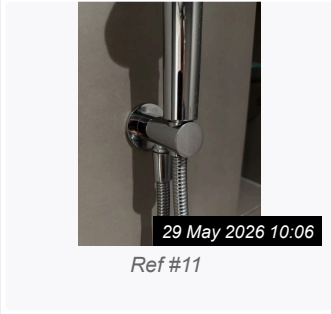
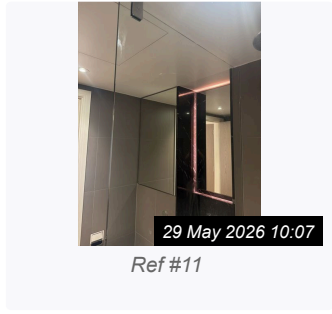
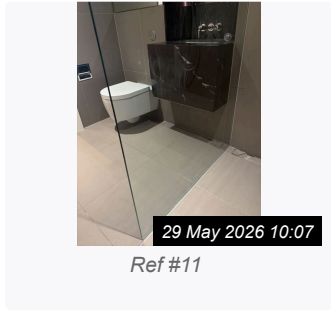
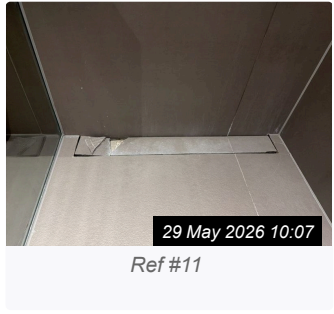
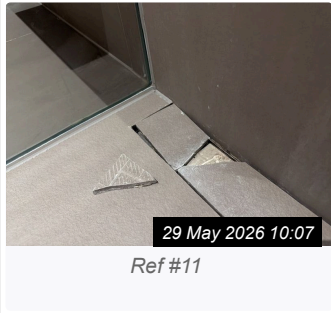
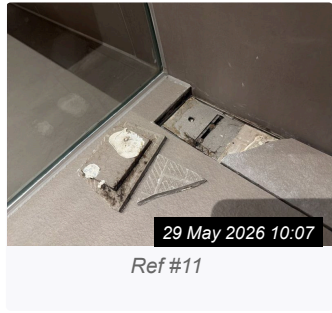
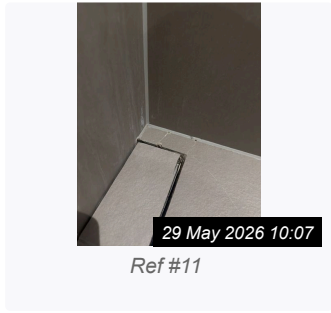
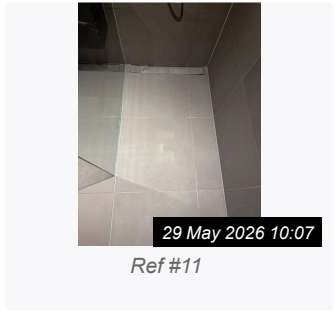
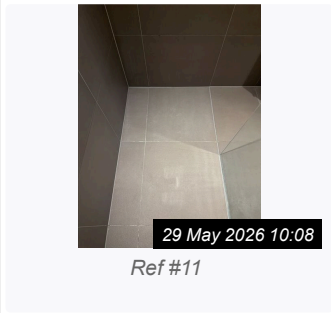
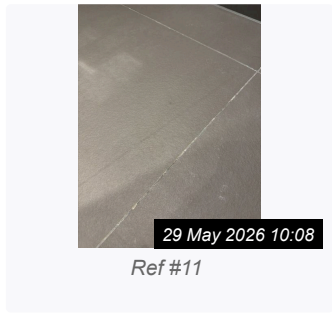
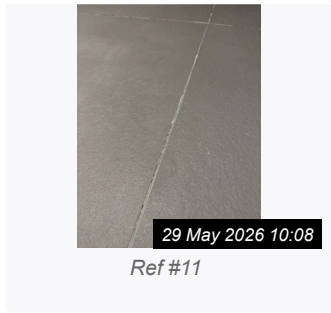
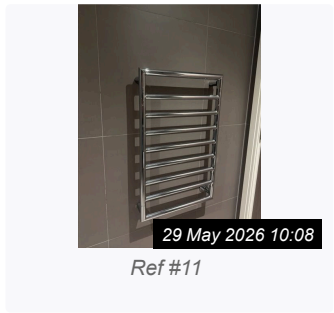
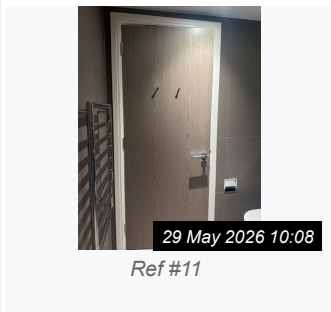
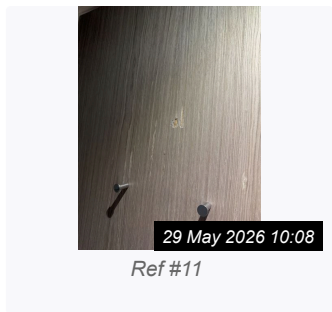
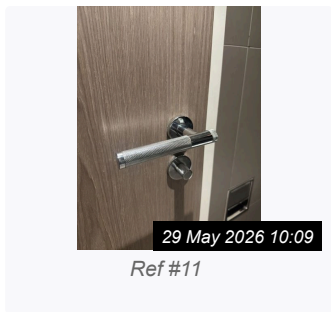
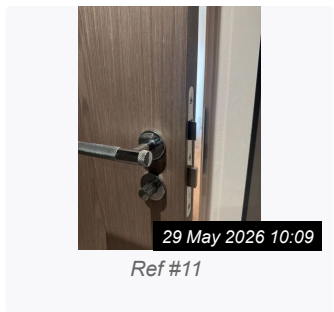
Ref #11

Ref	Name	Description	Condition at Inventory & Check In	Condition at Check Out
11.1	General Overview			Requires professional cleaning throughout. Needs Cleaning - Tenant
11.2	Exterior Door	Medium wood - 1x chrome handle External doorframe Painted in white		Generally good overall condition, though slightly dirty to touch; door handle chrome ring detached. Door handle chrome ring detached. Needs Maintenance - Landlord

11.4	Walls	Grey tiled	- White discolouring seen in the shower at a low level - Black marble is surrounding the sink and heavy white liquid stains are present - Light discolouring seen to the grout.	<i>As Inventory & Check In</i>

11.5	Ceiling	Painted white		Appears in good condition.
11.6	Flooring	Grey tiled floor	- Heavy discolouring seen to the grout - Further discolouring seen to the grout - Discolouring seen to the grout	<i>As Inventory & Check In</i>

11.8	Switches			All in good, working order.
11.9	Heating	1x chrome towel rail		Appears in good condition - clean, no rust visible.
11.10	Extractor Fan			Air vent: cover is missing. Needs Maintenance - Investigate

11. EN SUITE (CONT.)				
11.12	Basin / Tap	<ul style="list-style-type: none"> - 1x white ceramic sink - Chrome mixer tap - 1x chrome pop-up waste <p>Sink is mounted on a black marble surround</p>	<ul style="list-style-type: none"> - Tested and working - Tested and working - Heavy white staining seen throughout - Heavy white stain seen to the mould on top. 	<p><i>As Inventory & Check In +</i></p> <p>Drain blocked/restricted; water drained very slowly when tap run.</p> <p>Needs Maintenance - Investigate</p>

11.13	Shower Unit / Cubicle	<ul style="list-style-type: none"> - Shower tray, a continuation of the floor tiles - 1x glass shower screen on a partial chrome frame - 1x chrome mixer tap - 1x chrome handheld showerhead with a flexi hose and a wall mount - 1x circular chrome showerhead ceiling mounted 	<ul style="list-style-type: none"> - Chrome plate of the mixer tap is coming away from the wall slightly - Shower tray waste is cracked 	<p><i>As Inventory & Check In +</i></p> <p>Additional triangular crack to shower drain section; floor grouting damaged in places.</p> <p>Needs Maintenance - Investigate + Landlord</p>

11.16.2	-	1x black plunger		<p>Not seen.</p> <p>Missing Item/s - Tenant</p>

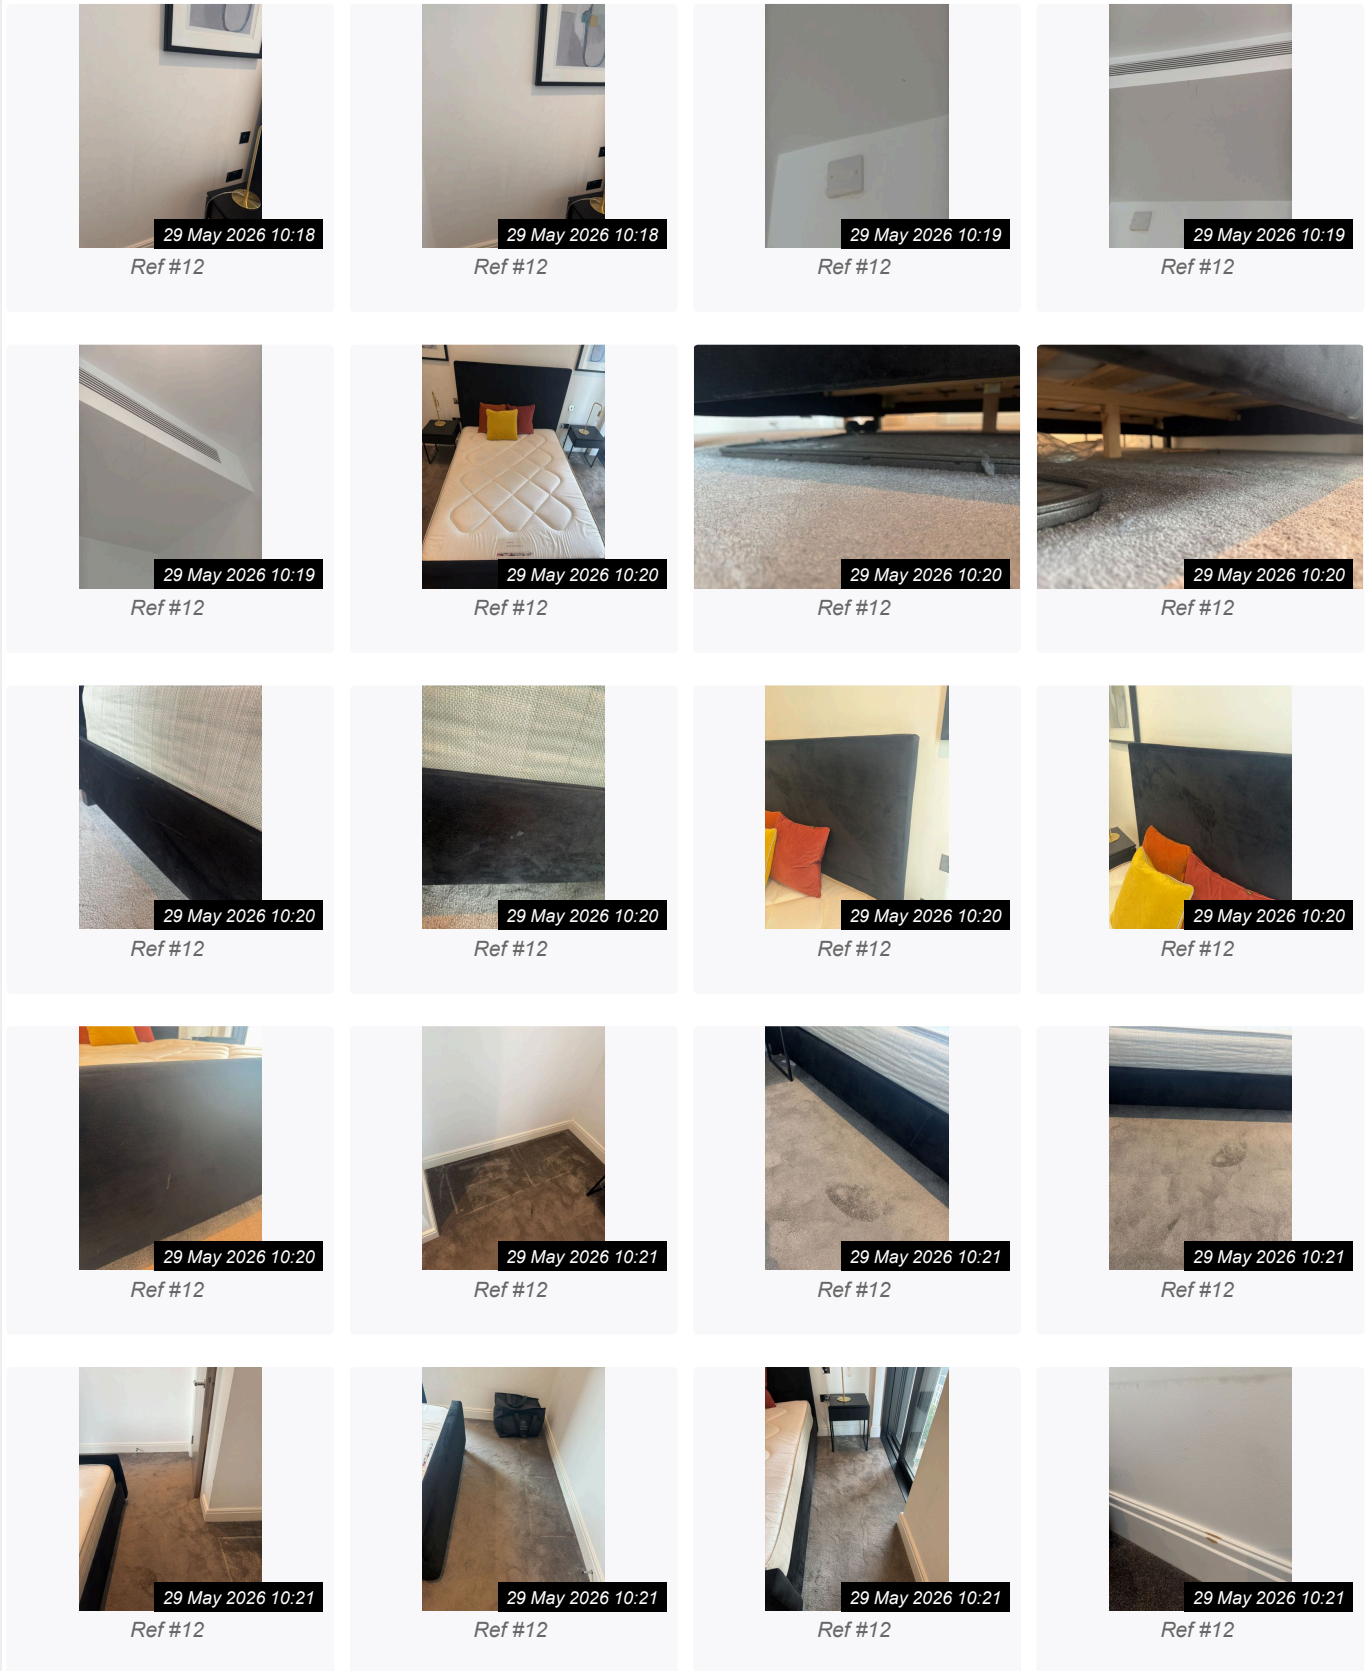
Ref	Name	Description	Condition at Inventory & Check In	Condition at Check Out
12.1	General Overview			<p>Generally good condition; dust present, dirt found under bed.</p> <p>Requires professional cleaning.</p> <p>Needs Cleaning - Tenant</p>
12.2	Exterior Door	<p>Medium wood finish - 1x chrome handle</p> <p>External doorframe Painted in white</p>	- Tested and working	<i>As Inventory & Check In</i>
12.3	Interior Door	<p>Internal door Consistent with external</p> <p>Internal doorframe Painted in white</p>		In good condition.

12. BEDROOM 2 (CONT.)				
12.4	Walls	Painted in white	<ul style="list-style-type: none"> - Left hand side on the entry, has multiple chips seen to the angle - Right hand side of the wall, at a low level, has a cluster of scuff marks towards the corner of the same wall - Below the mirror, there are large- scuffed areas - Some additional mid to low level scuffs seen - Further scuffs seen to the right hand side of the window - Black sellotape residue marks seen below the mirror - Additional chip seen to the edges. 	<p><i>As Inventory & Check In</i> +</p> <p>Brown stains visible high level on right-hand side wall by window.</p>

12.5	Ceiling	Painted in white		<p>In good condition generally.</p> <p>Scuffs visible on ceiling below air vent grill.</p> <p>Damage - Tenant</p>
12.6	Flooring	Dark grey fitted carpet	<ul style="list-style-type: none"> - On the entrance there is a faint white spot mark, which appears to be a paint mark. Also, at the base of the bed, there is the same spot marking seen, which appears to be a paint mark. - 2x brown stains are seen on entry - 1x black spot stain seen to the left hand side of the bed - Shaded area seen on entrance - Burn mark seen to the left hand side of the bed - Further brown stain seen below the bedside cabinet - Left hand side of the bed has an iron burn mark - Directly on entrance there are scattered spot stains. 	<p><i>As Inventory & Check In</i> +</p> <p>Furniture indentations visible on carpet - both right and left sides on entry.</p>

12.13	Fixtures & Fittings & Furniture			
12.13.1	-	1x chrome digital thermostat	- Light is seen - Tested and working	<i>As Inventory & Check In</i>
12.13.2	-	2x black picture frames, please see the photographs for the artwork internally		These are present, in good condition - but dusty. Needs Cleaning - Tenant

12.13.3	-	1x metal framed mirror		Not seen. Missing Item/s - Tenant
12.13.4	-	1x gold and black framed mirror	- Sellotape seen to the edges and appears to be broken	Not seen. Missing Item/s - Tenant

12.15	Bed	1x black material double base bed with a matching headboard - 1x white mattress by Kingsley	- Mattress brand new	<i>As Inventory & Check In</i> + Bed frame end: small light stains present; mattress in good condition, no stains on either side. Needs Cleaning - Tenant

12.16	Armchair	1x orange accent fabric chair	<ul style="list-style-type: none"> - Light stained area seen to the base - Further stained area seen to the left hand side edge - Slightly wobbly - One of the legs is loose - Left hand side leg is wobbly, needs attention 	<p>Not seen.</p> <p>Missing Item/s - Tenant</p>
12.16.1	-	Duvet stored in black bag	<i>Item added after Check In</i>	<p>Requires Disposal - Tenant</p>
12.16.2	-	2x orange pillows 1x yellow pillow	<i>Item added after Check In</i>	In good condition.

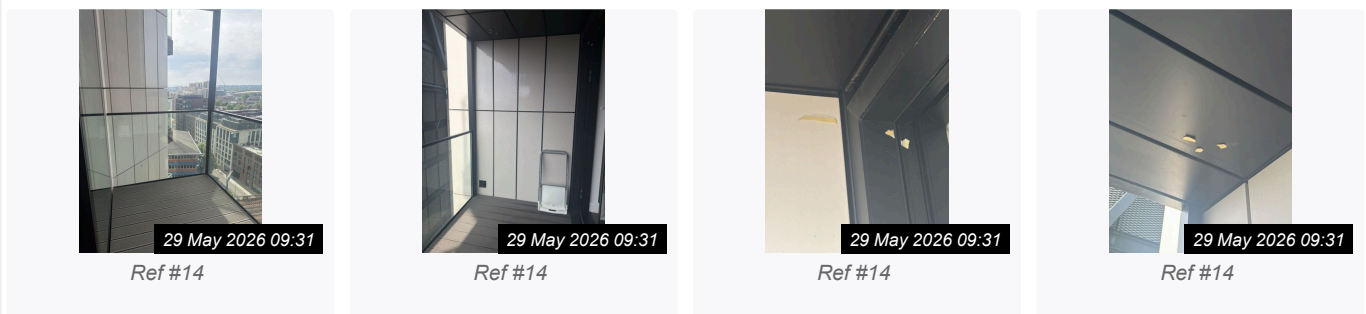
14. OUTSIDE SPACE / BALCONY

Ref	Name	Description	Condition at Inventory & Check In	Condition at Check Out
14.1	Floor	A composite decking	- All glass is intact	As Inventory & Check In + Localised weathering is visible to sections of the decking, with some areas more affected than others. Requires further cleaning.
14.2	Wall	Large white tiled panels	- All tiles are intact	As Inventory & Check In
14.3	Additional Items / Information			
14.3.1	-	A range of glass panels with a black metal handrail	- All glass is intact	Needs Cleaning - Tenant
14.3.2	-	1x plastic chair		This is present.
