Check Out

Property inspected by A. Clerk

123 Preview Street
Sample City
London
AB1 2CD

May
29th 2026
09:00

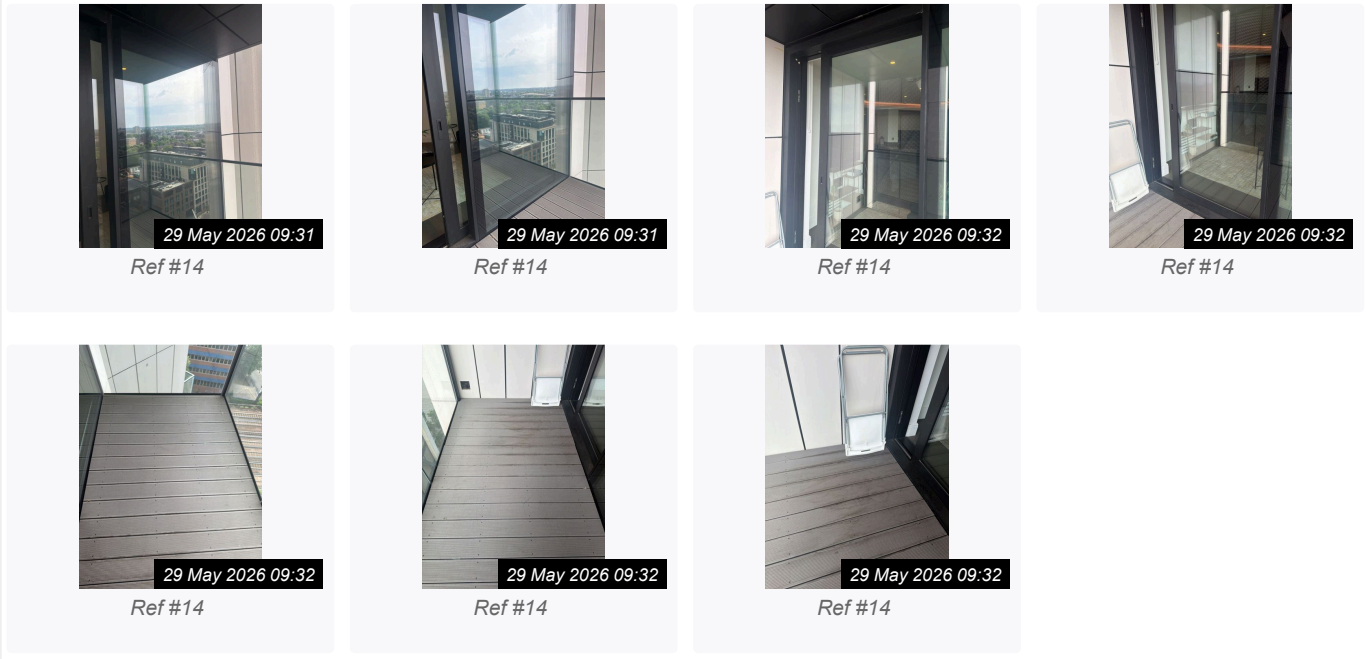
14. OUTSIDE SPACE / BALCONY (CONT.)

Ref	Name	Description	Condition at Inventory & Check In	Condition at Check Out
14.1	Floor	A composite decking	- All glass is intact	As Inventory & Check In + Localised weathering is visible to sections of the decking, with some areas more affected than others. Requires further cleaning.
14.2	Wall	Large white tiled panels	- All tiles are intact	As Inventory & Check In
14.3	Additional Items / Information			
14.3.1	-	A range of glass panels with a black metal handrail	- All glass is intact	Needs Cleaning - Tenant
14.3.2	-	1x plastic chair		This is present.
