Inventory & Check In

Address

123 Preview Street
Sample City
London
AB1 2CD

May
30th 2026
17:00

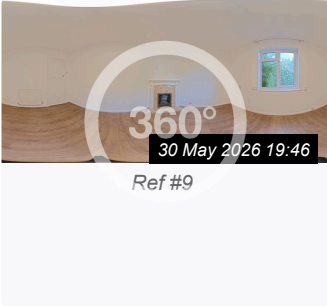
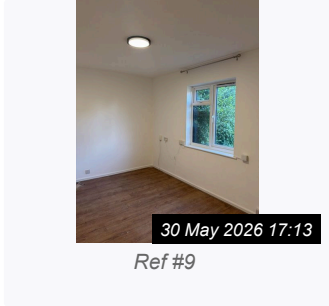
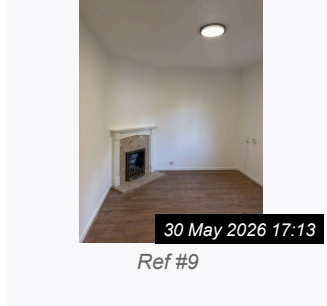
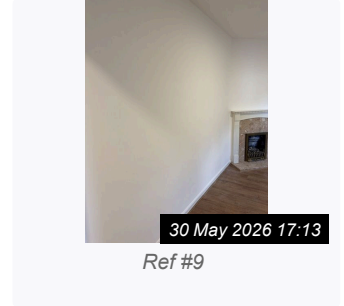
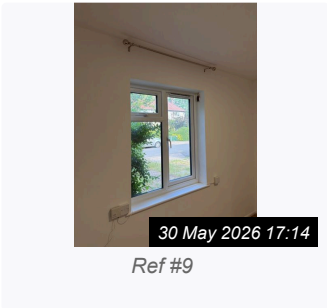
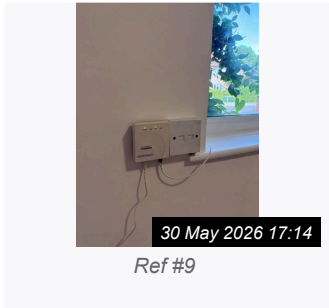
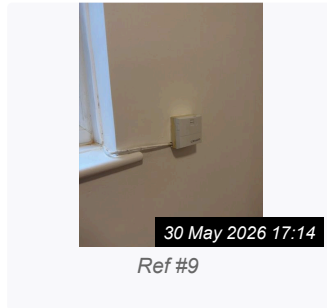
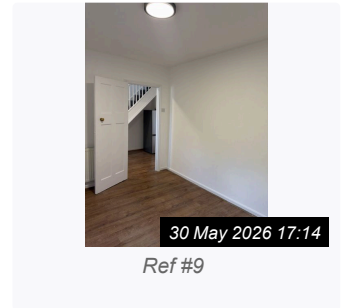
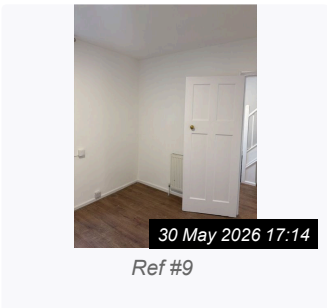
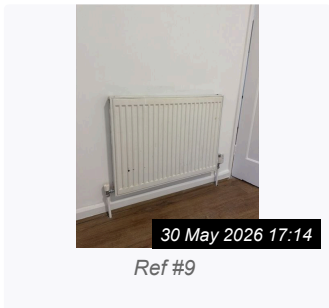
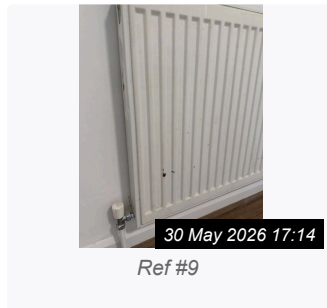
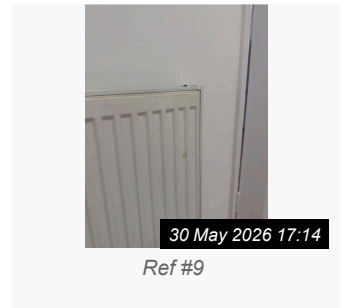
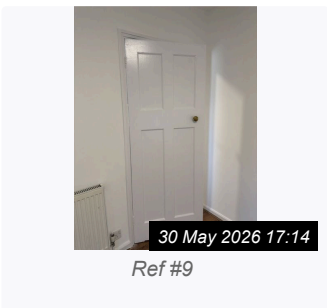
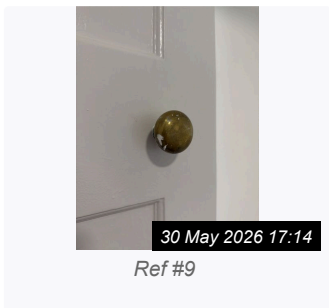
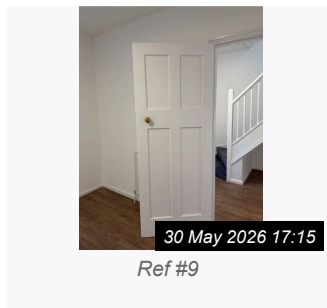
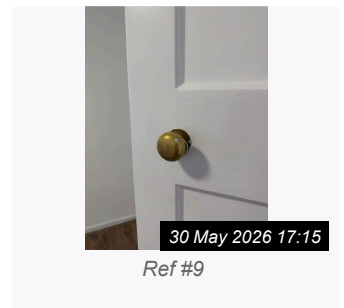
White cables (internet/TV/aerial) run along walls/units; loose/trailing.

Fittings secure, intact; minor dust/marks, no damage.

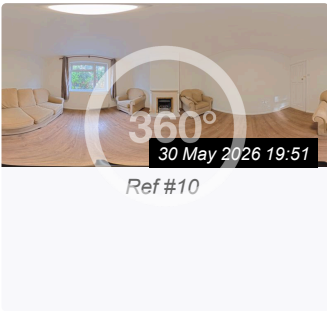
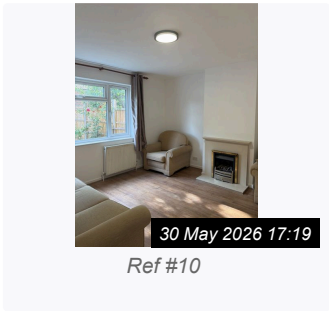
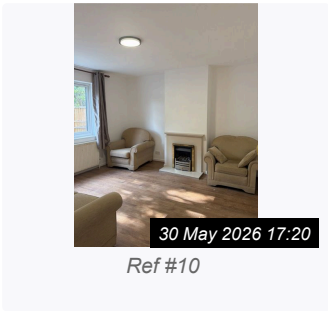
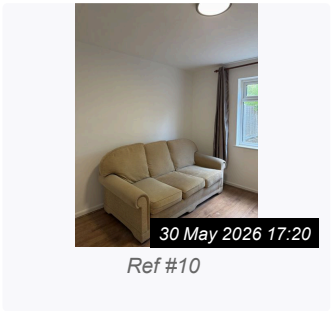
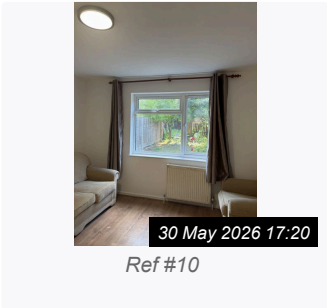
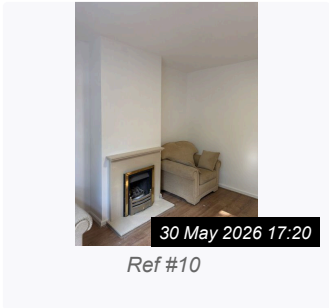
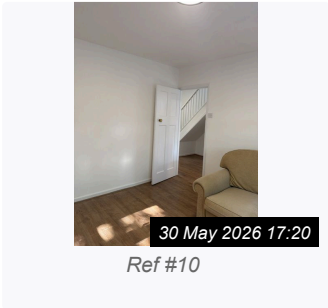
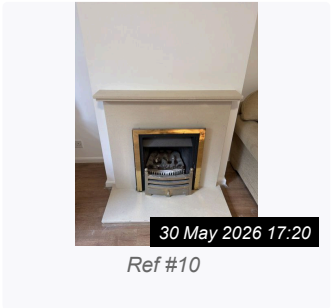
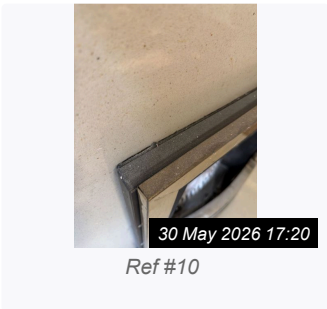
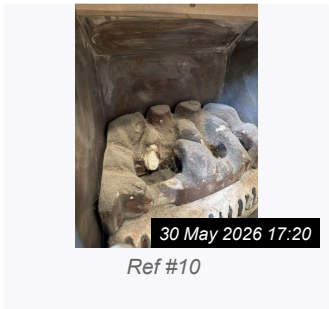
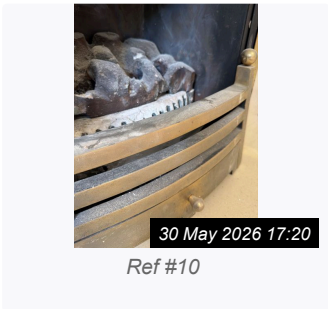
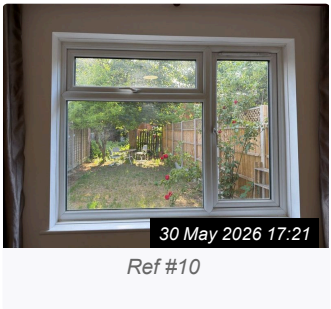
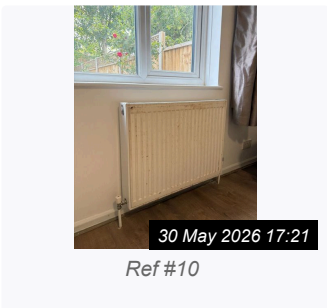
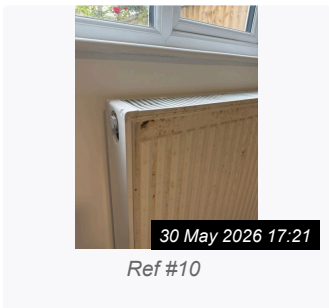
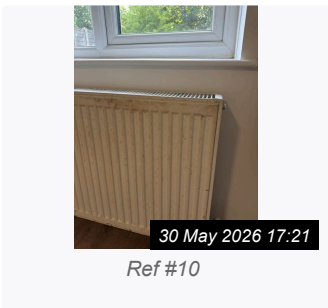
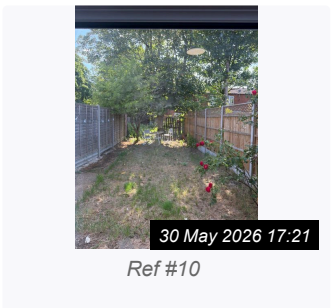
Stains and dirt marks throughout; discolouration and heavy shading, especially on right-hand armrest.

Left armchair: lighter shading, small red stain on left armrest side; further stains on seat cushion and both armrests.

General discolouration and marks consistent with use.

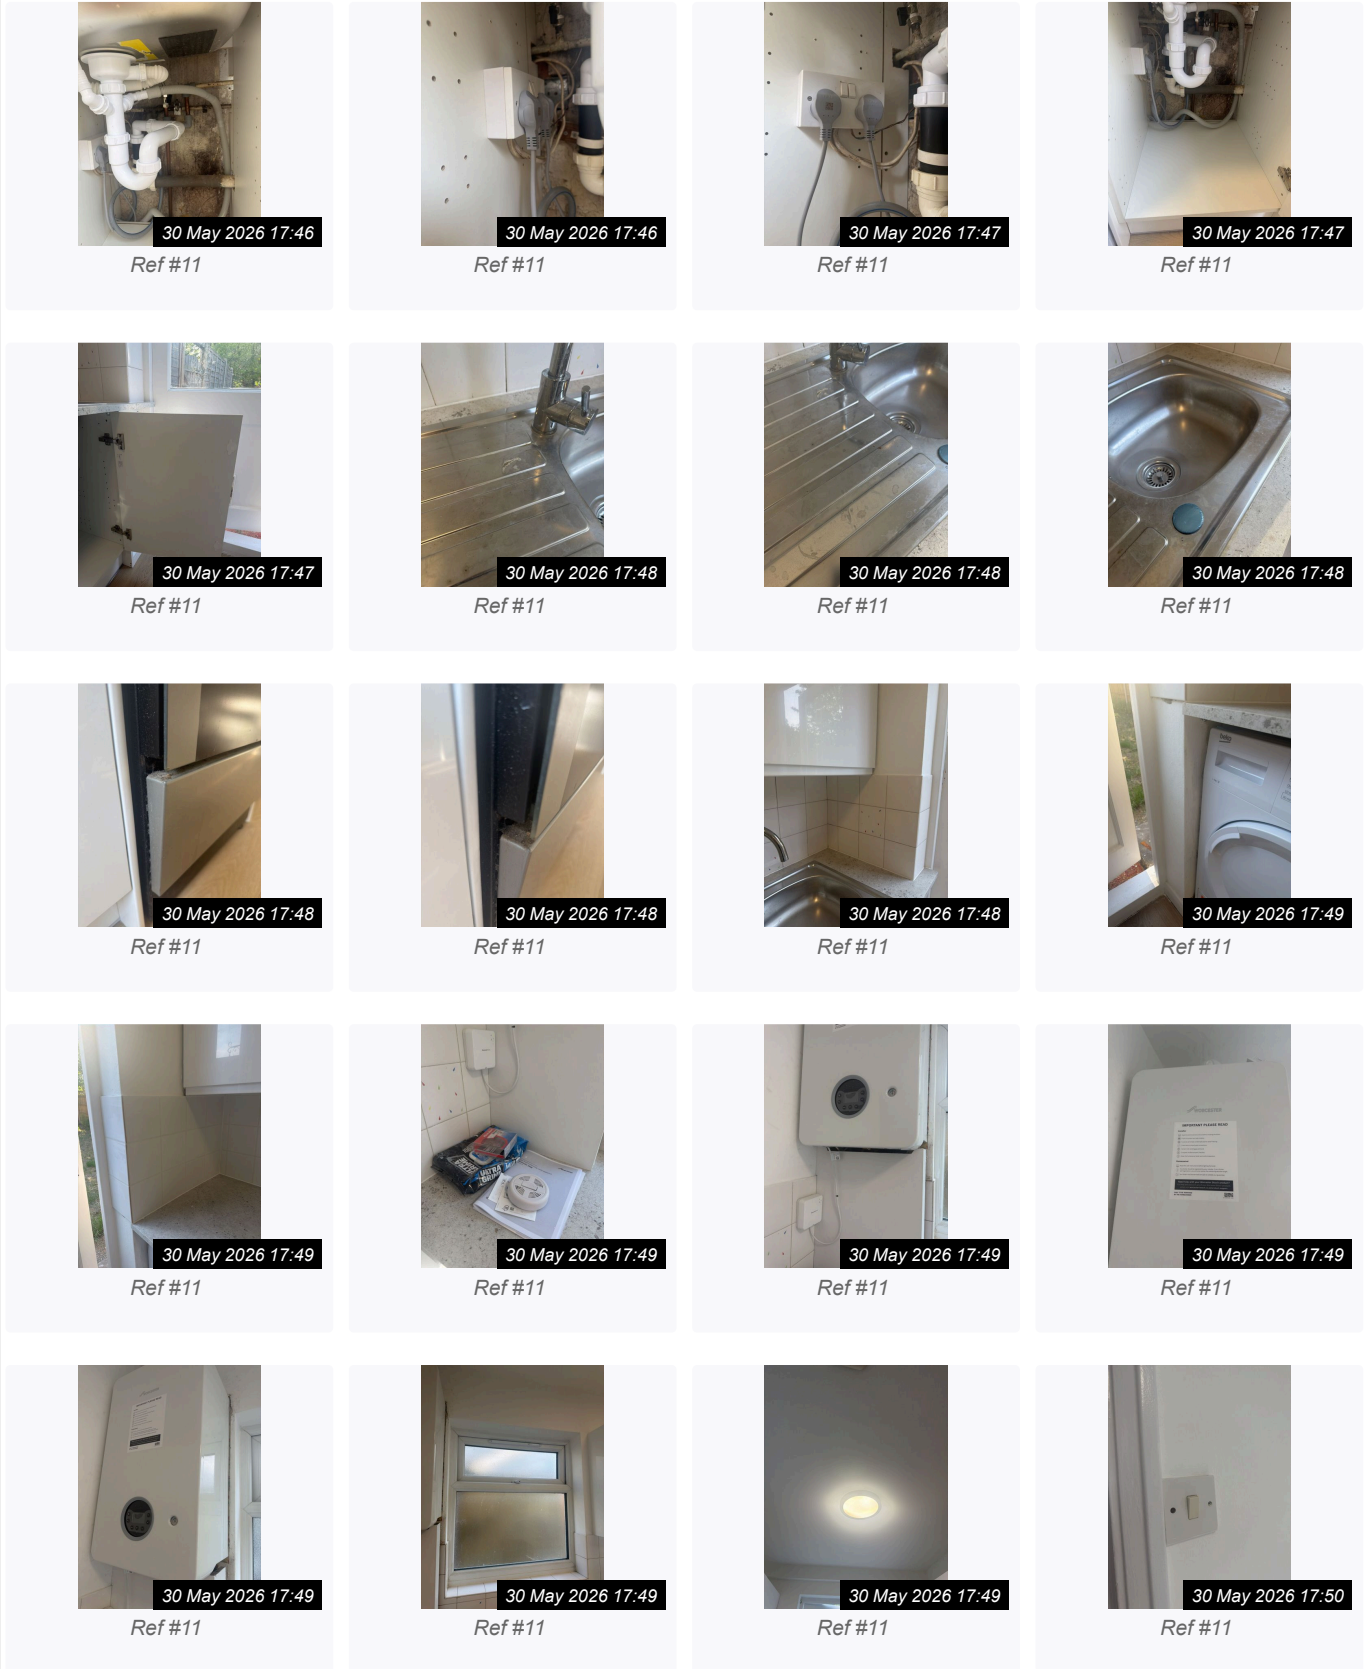
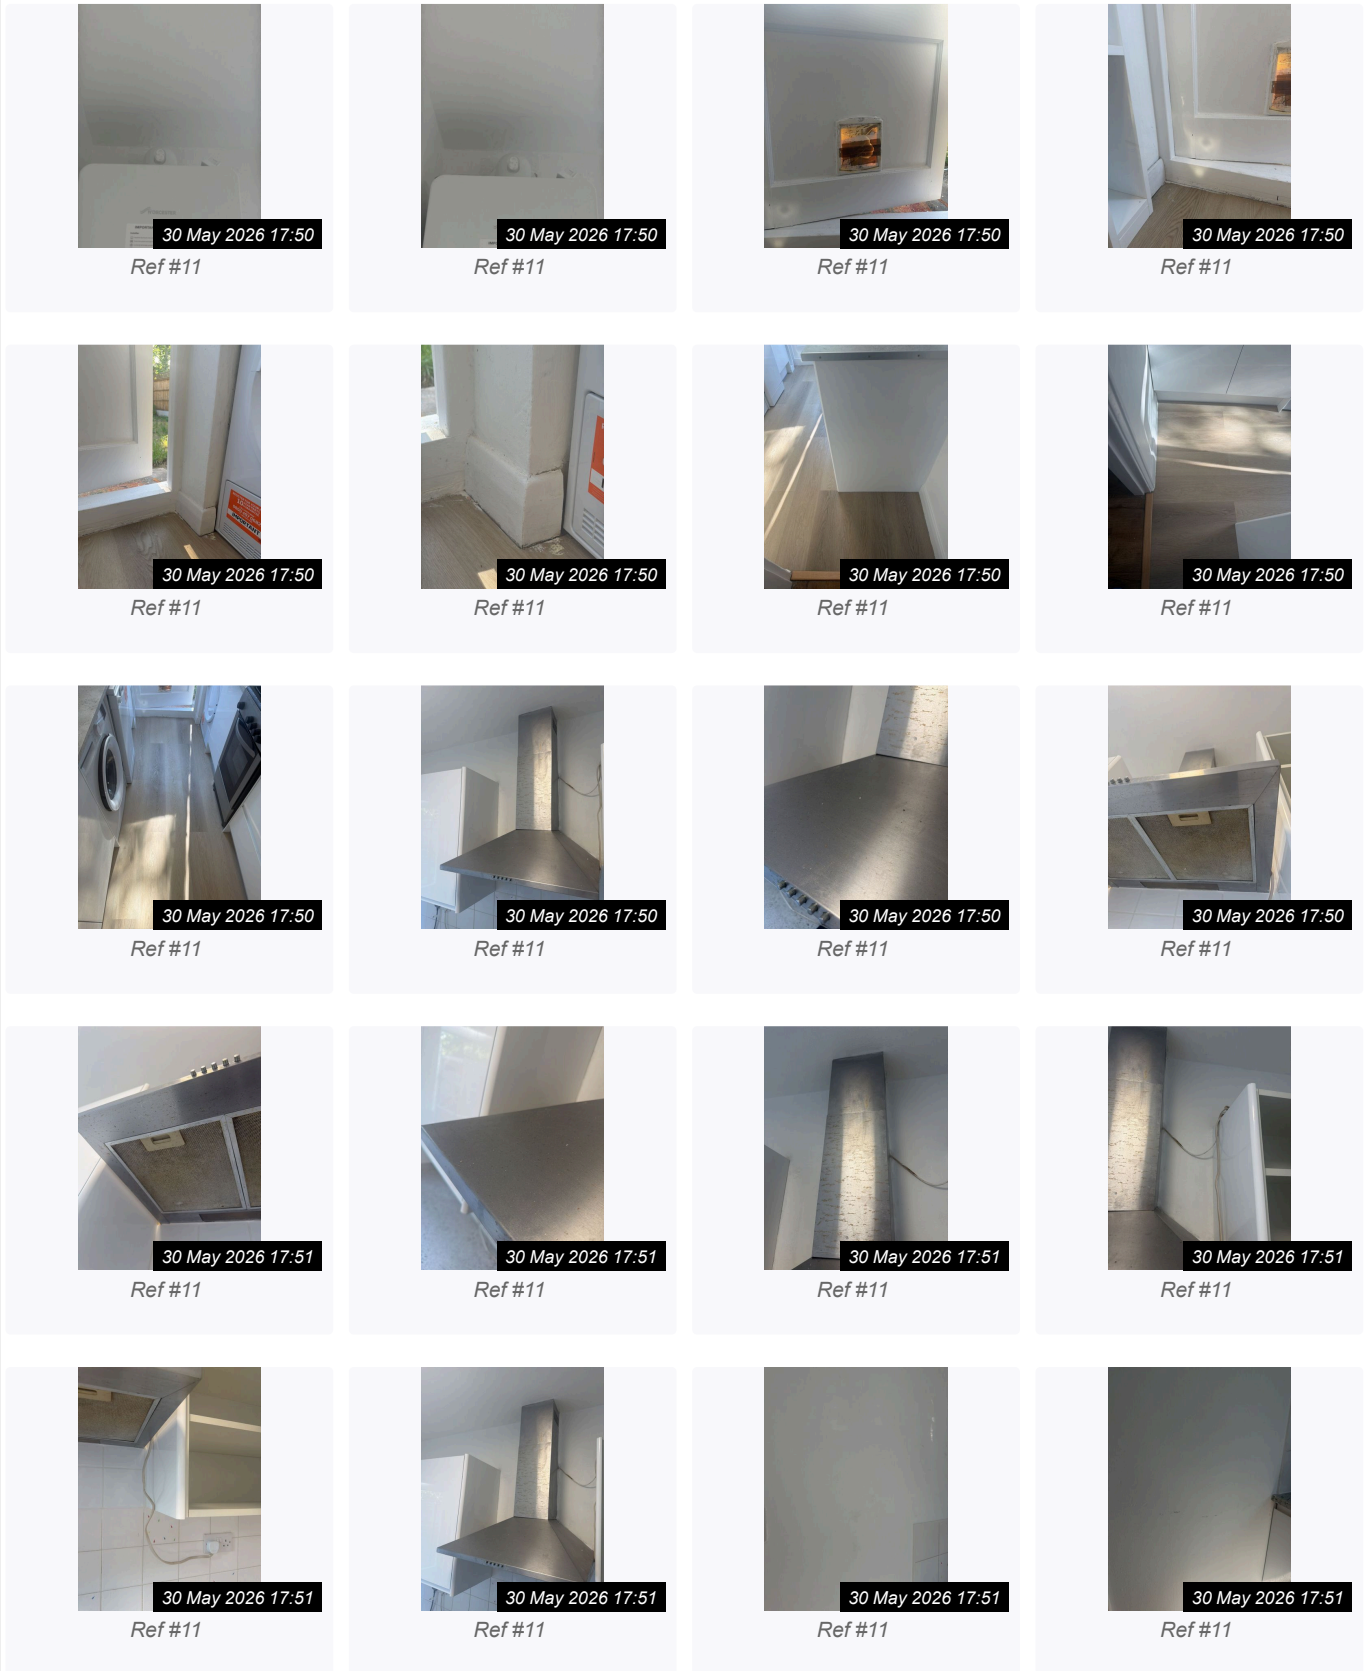
Ref #11

Ref	Name	Description	Condition
11.1	General Overview		Generally unclean throughout, with visible dust, grime and accumulated dirt on surfaces.
11.2	Door	White-painted external door with large glazed upper panel and solid lower section; fitted with metal lever handle and lock mechanism. Rectangular opening/panel visible on lower part of door.	Kitchen doorway is open with no door installed. Back door: Kitchen door lock mechanism is stiff and appears aged; adhesive tape and plastic wrapping material are present along the bottom edge of the door. Needs Maintenance - Landlord

11.11	Sockets	A range of white double sockets.	In good, working order.
11.12	Heating	N/A.	No radiators or heaters visible within the kitchen area.
11.13	Flooring	Light wood-effect laminate, smooth finish.	Surfaces have visible dust, light stains, paint marks/dried paint spots to multiple places. Unclean throughout.

11.15	Extractor Hood	Older style unit with metal canopy and chimney stack - no brand name visible.	<p>The chimney section shows clear signs of age, including rust-like discolouration and staining.</p> <p>Heavy layers of grease, dust and grime cover all surfaces, which feel sticky to the touch; both internal filters are heavily saturated with grease.</p> <p>All control buttons and functions work correctly.</p>

11. KITCHEN (CONT.)			
11.18	Cooker	<p>Freestanding gas cooker with stainless steel and black finish, featuring a black four-burner hob unit.</p> <p>1x wire shelf/grill tray positioned in the upper runner position.</p> <p>1x solid flat tray/baking sheet fitted in the middle runner position.</p> <p>Essentials brand, Model CFSGSV18; Type: YG56E4022E3408.</p>	<p>Signs of age and heavy use; very unclean and deteriorated throughout.</p> <p>Surfaces sticky, greasy and grimy; 5 discoloured, grime-coated knobs hard to read.</p> <p>Interior dirty with baked-on residue; 2 shelves and 1 tray heavily soiled.</p> <p>4-burner section heavily soiled; caps, bases and supports discoloured, dirty and worn.</p> <p>Needs Maintenance - Landlord</p>

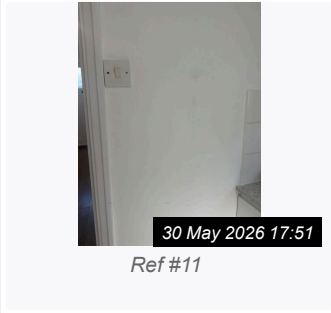
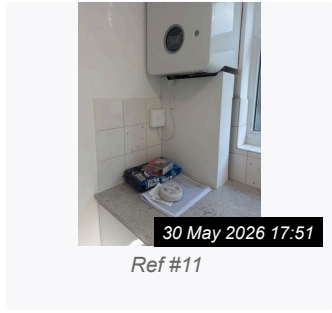
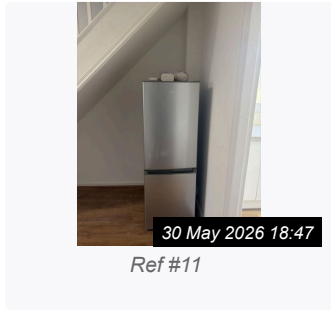
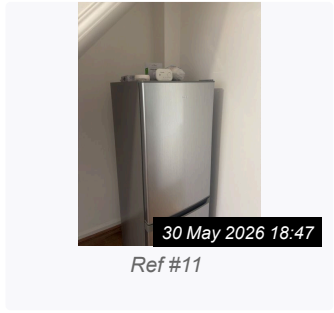
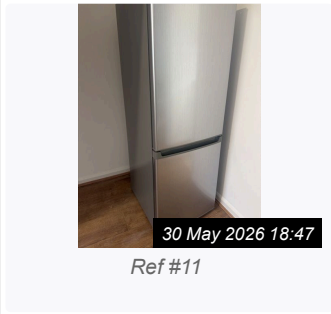
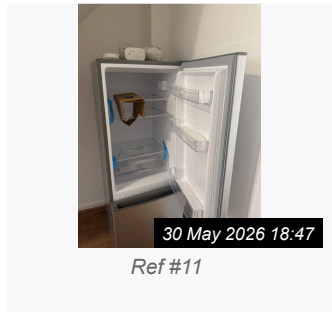
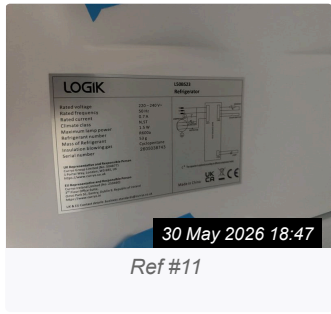
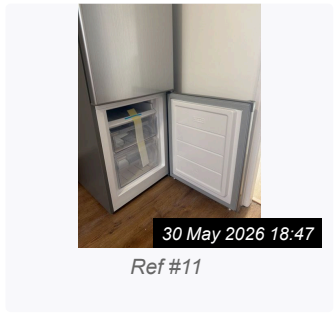
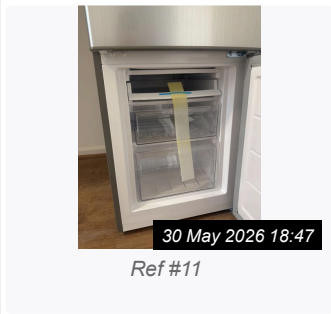
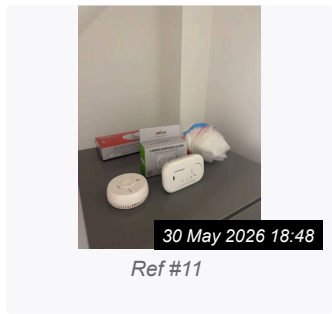
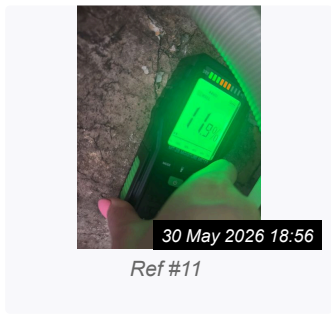
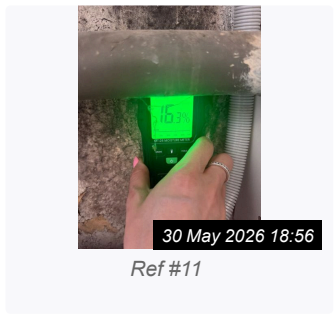
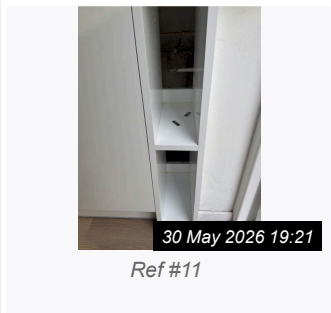
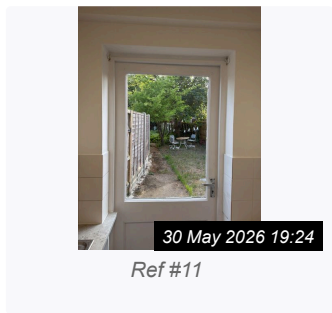
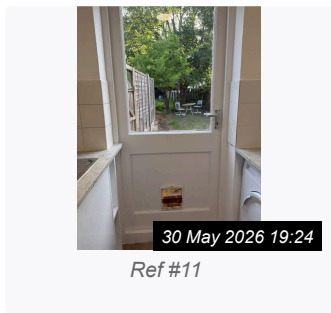
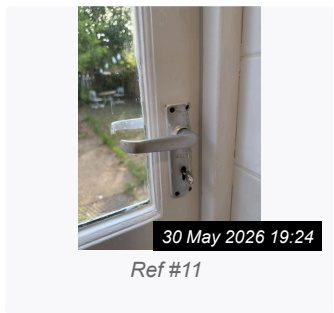
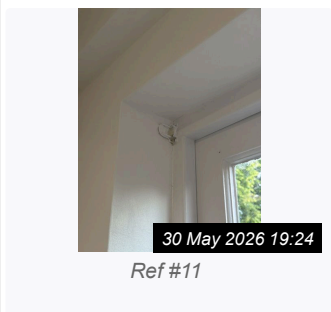
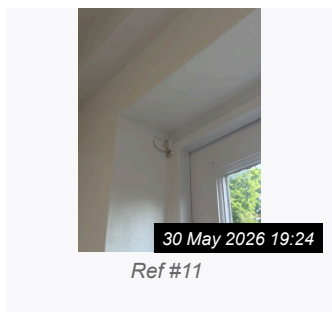
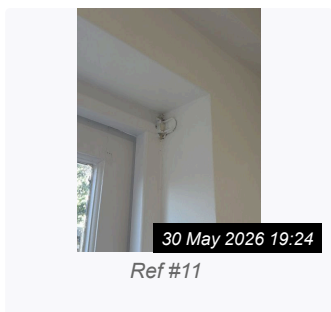
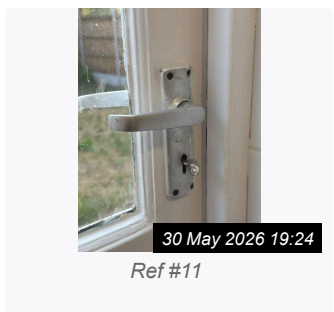
11. KITCHEN (CONT.)			
11.8	Window(s) / Sill	White PVC window with frosted/obscure double glazing.	<p>Minor scuffs and marks visible.</p> <p>Upper section is an opening light; operates smoothly, handle is intact and fully functional.</p> <p>Glass is frosted/obscured; tiled sill below in place.</p> <p>Minor gaps and wear noted to surrounding plasterwork and trim.</p>

11.9	Curtains / Blinds	N/A.	Blind is missing from the garden door; top fixings are still in place, confirming a blind was previously installed.
11.10	Switch	White single double switch plate, standard design and appearance.	In good, working order.

11.16	Worktop(s)	Light grey/white speckled laminate finish, smooth texture.	Surface has faint marks, minor discolouration and light dust/grease residue, especially near the sink edge; generally intact with no chips, cracks or damage.

11.17	Sink	Stainless steel single-bowl sink with integrated drainer, set into a speckled worktop.	<p>Surface shows dulling, water marks and light grime, not thoroughly cleaned.</p> <p>Modern curved chrome mixer tap fitted centrally; finish has minor spots and slight discolouration, securely mounted and fully functional.</p> <p>No damage or leaks noted.</p>

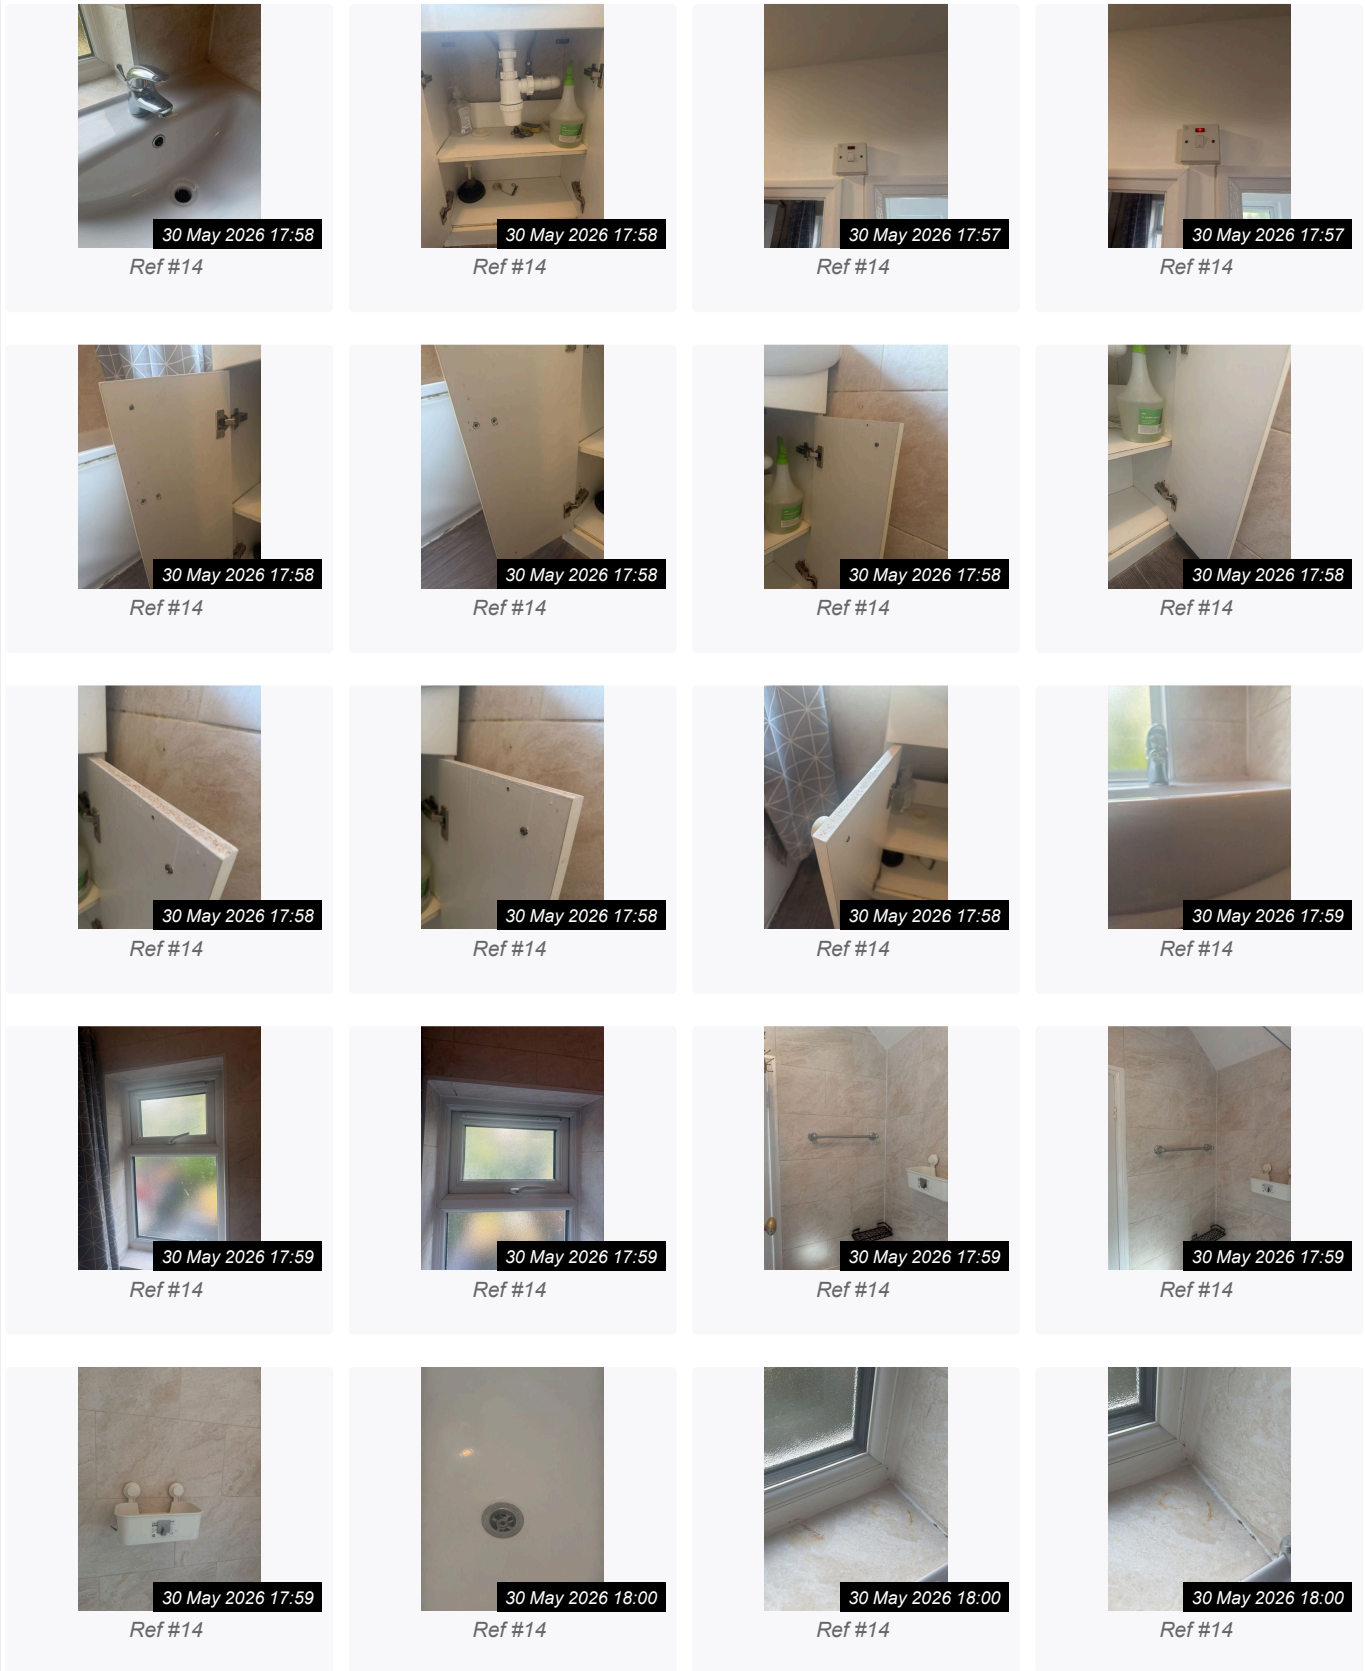
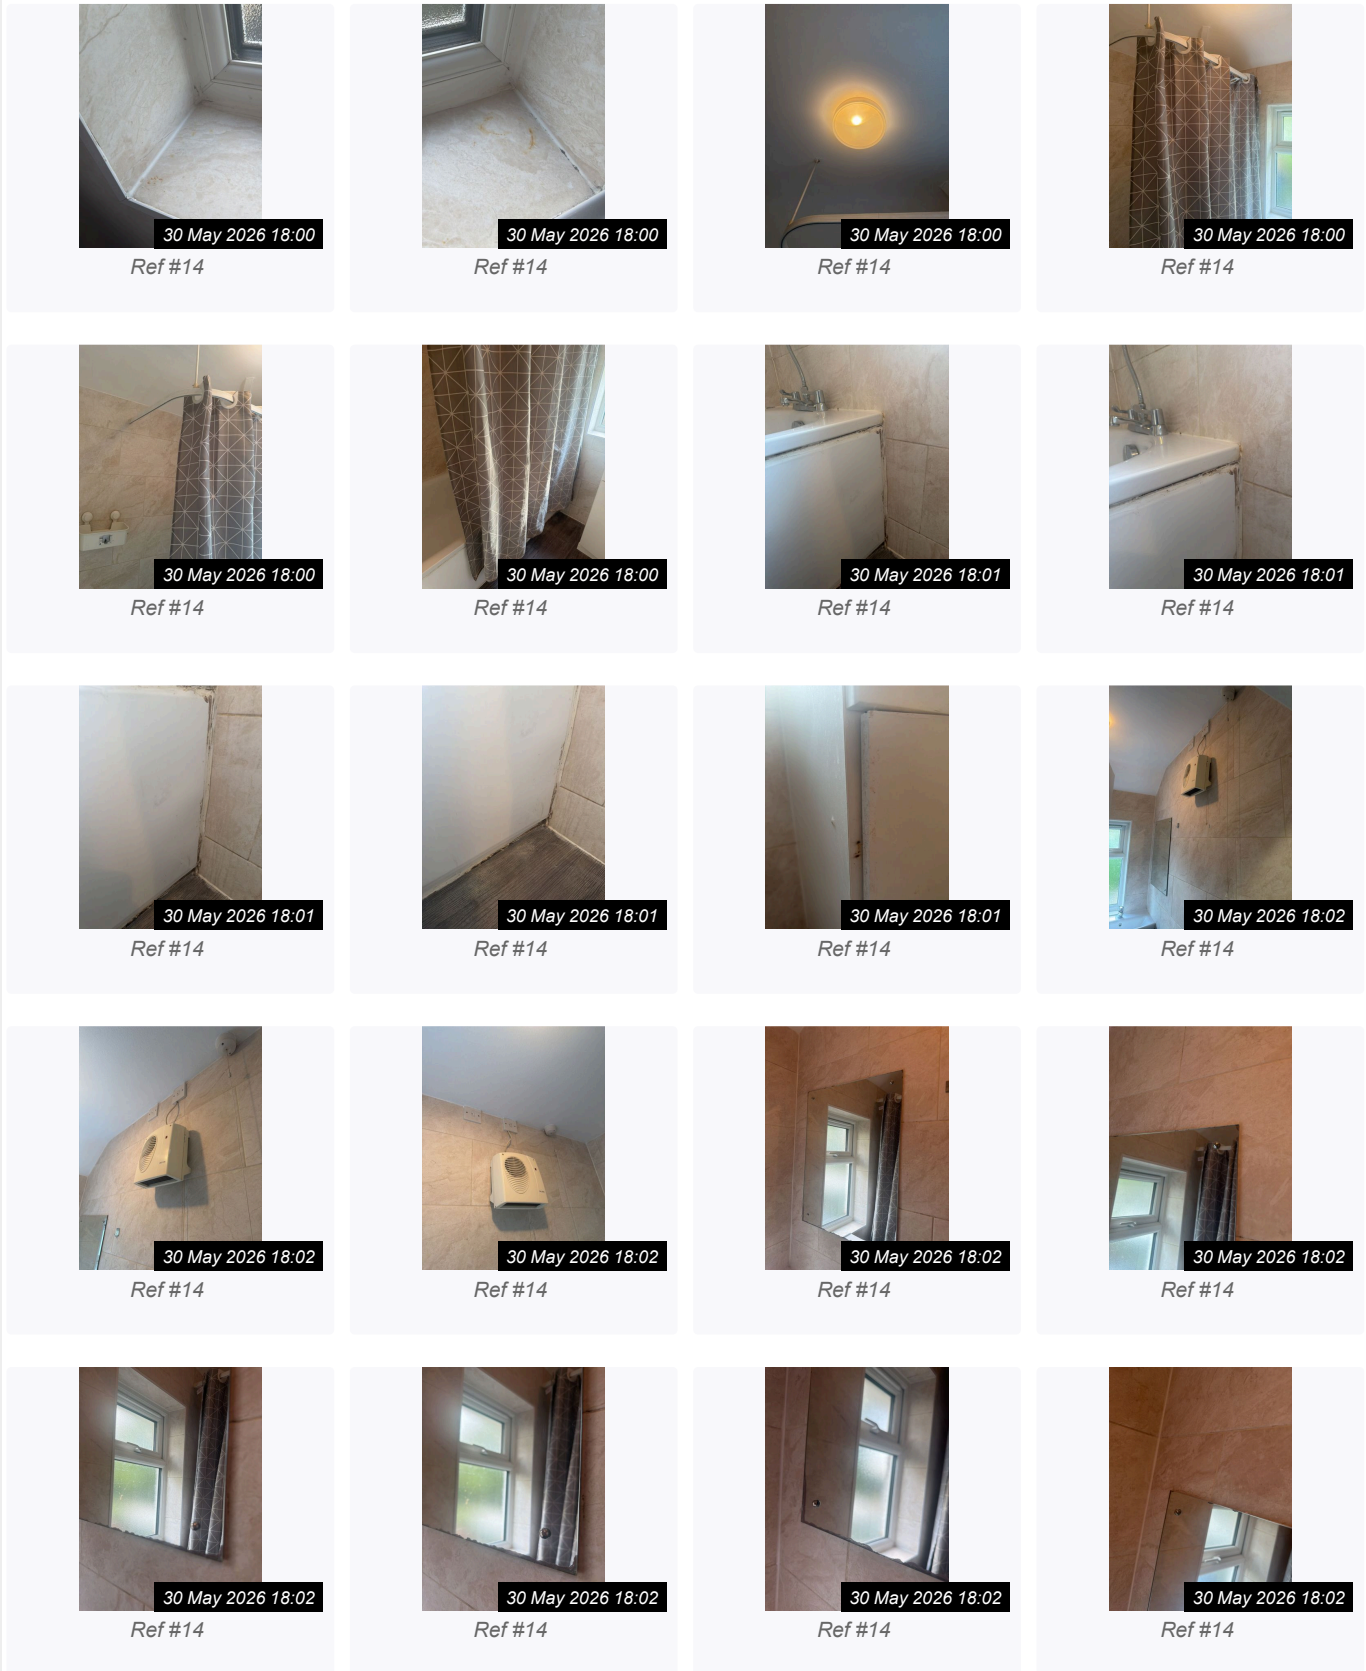
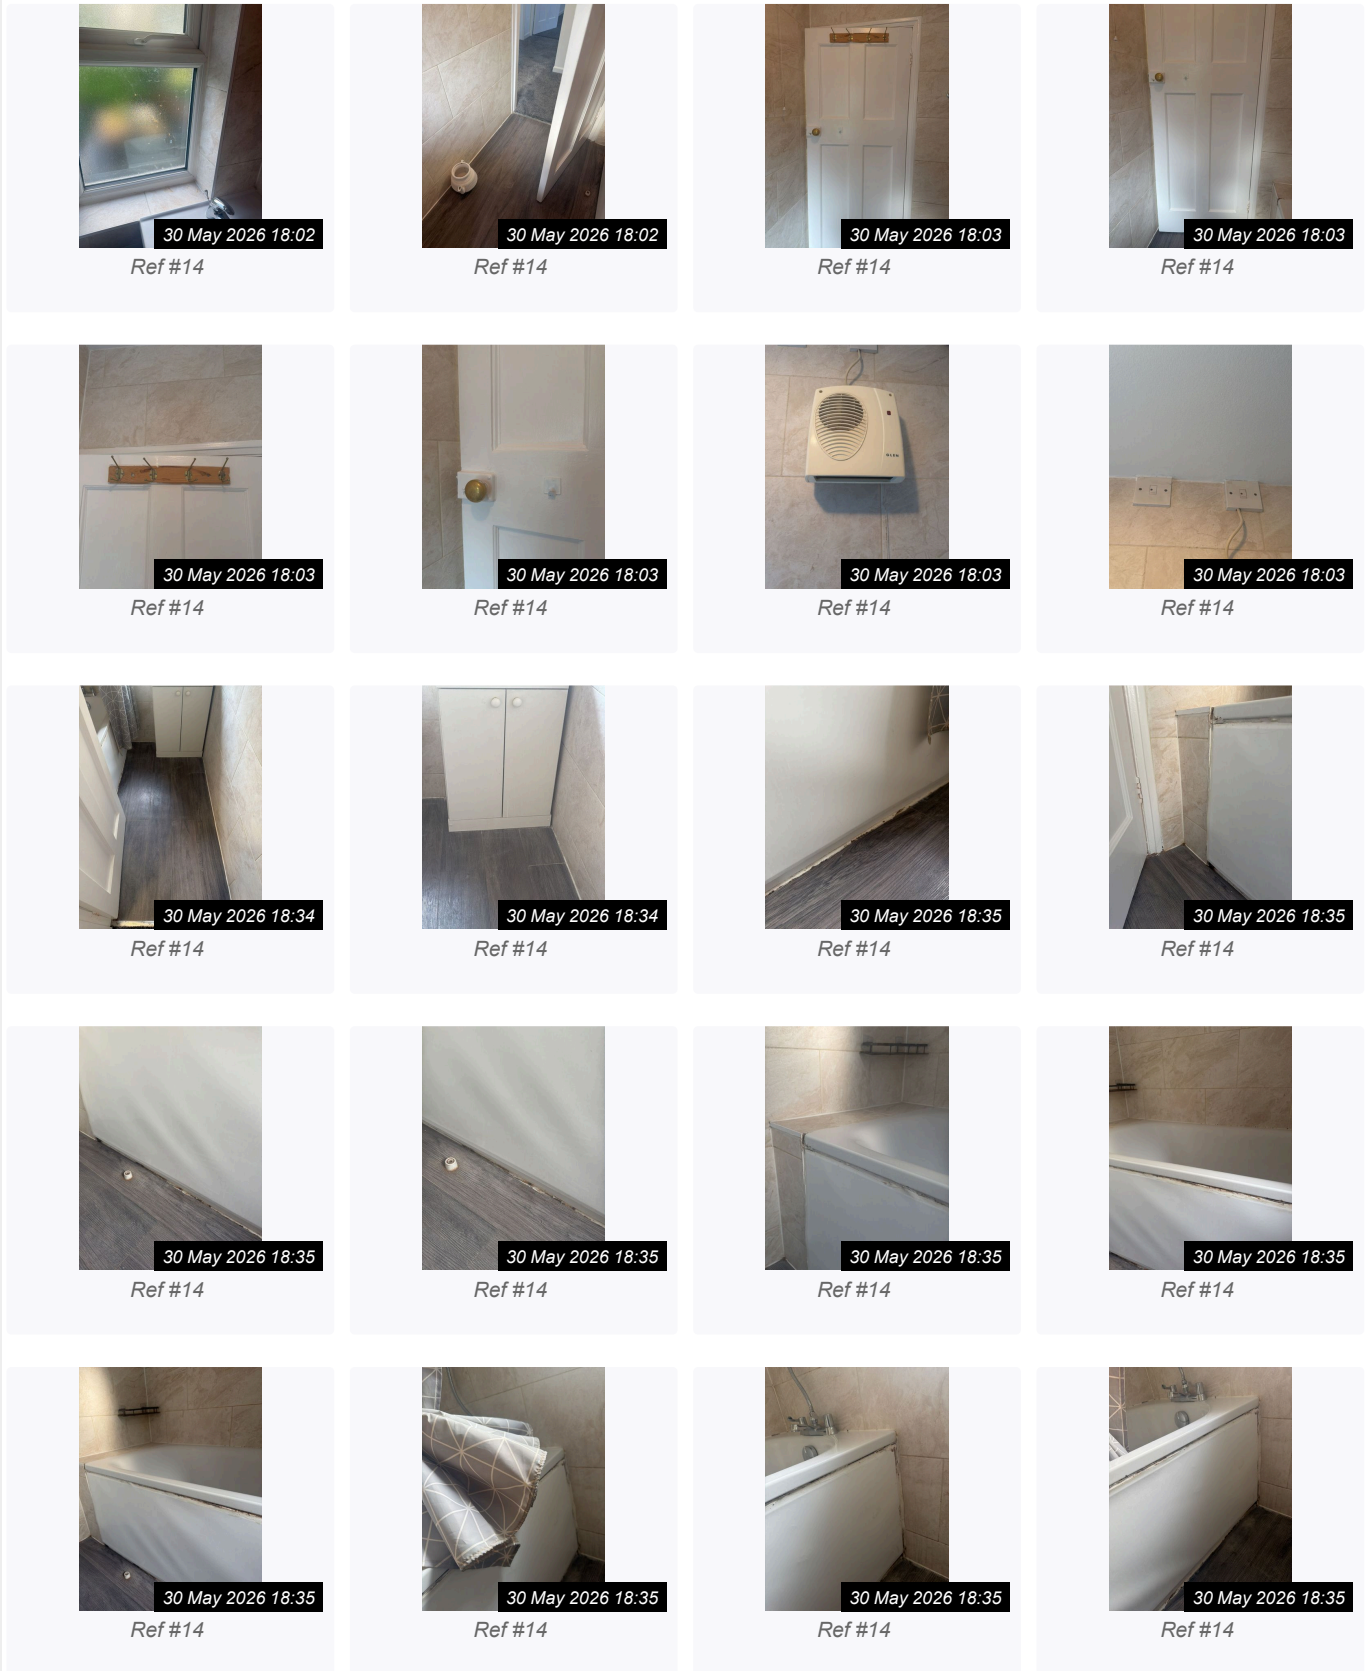
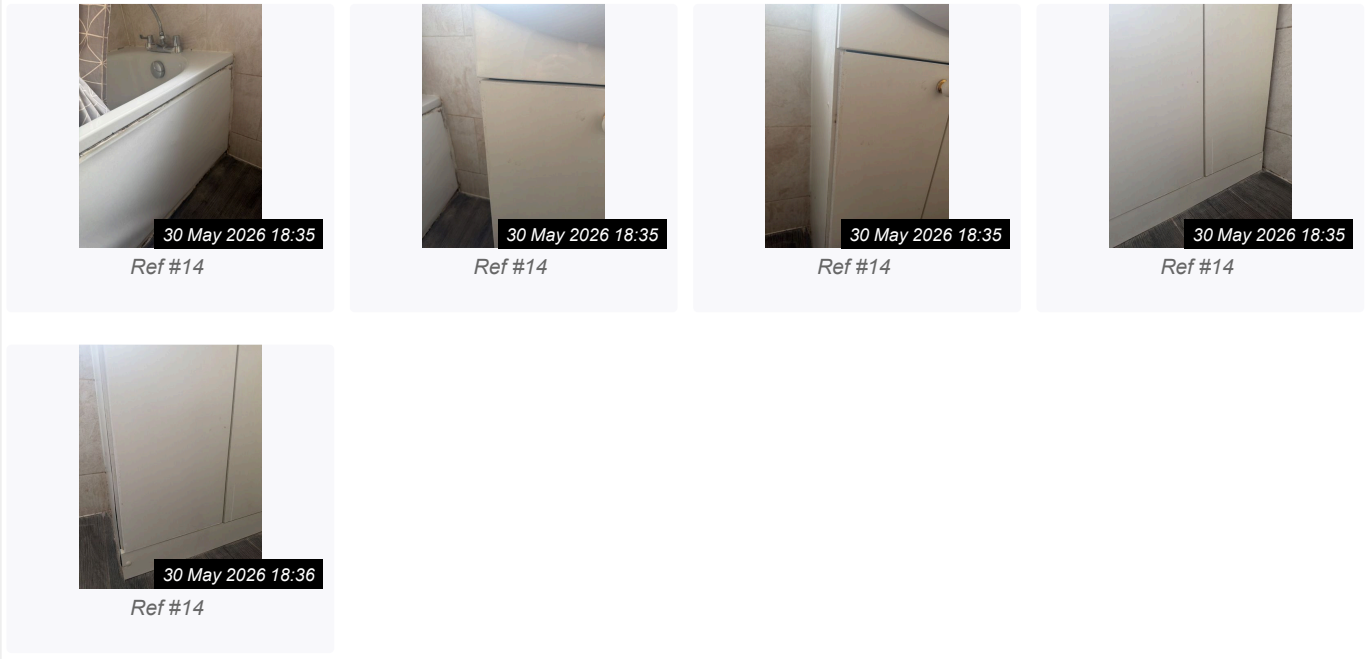
Ref #14

14. BATHROOM (CONT.)			
14.3	Door Frame	White-painted.	Signs of age; light indentations and scuff marks present.
14.4	Ceiling	Painted white.; White-painted.	Appears in good condition.

14.9	Basin	White ceramic sink with single chrome mixer tap. Basin waste & pipework.	Single mixer tap: Fitted. No pop-up plug present. Sink: No blockage noted. Basin waste & pipework: Complete, no leaks or blockages noted.

14. BATHROOM (CONT.)			
14.12	Switch	1x white plastic light switch fitted.	In good, working order.
14.13	Heating	White Glen wall-mounted heater.	Dust/grime to grille; pull-cord intact; appears functional, operated via cord and external switch.
14.14	Flooring	Dark wood-effect flooring.	Laid throughout; acceptable condition; light surface scratches and minor marks seen in places; sealant at edges discoloured / soiled.
14.15	Accessories		
14.15.1	-	Metal shelf.	Fitted to wall; rust/heavy discolouration visible.
14.15.2	-	Chrome towel rail.	Wall-mounted, secure, clean, no damage.
14.15.3	-	White plastic suction storage caddy.	Fitted, secure, intact.

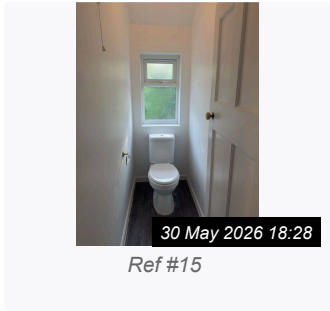
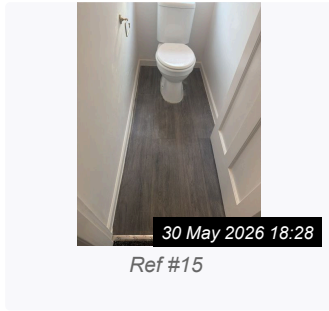
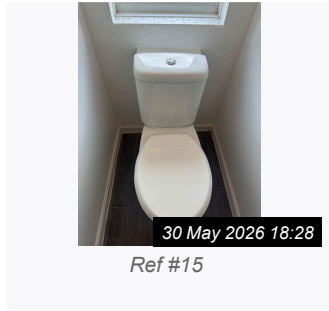
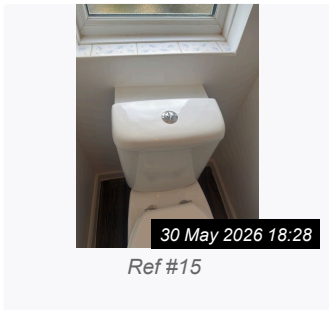
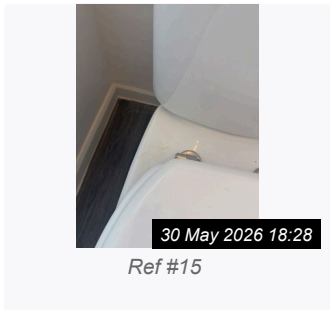
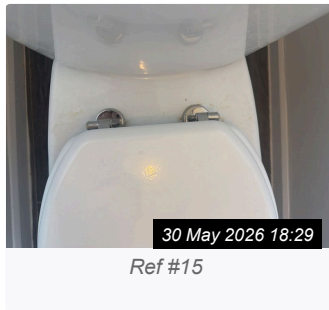
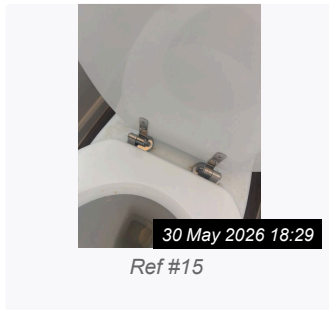
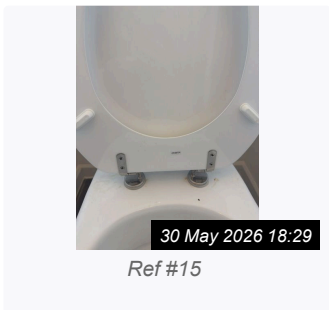
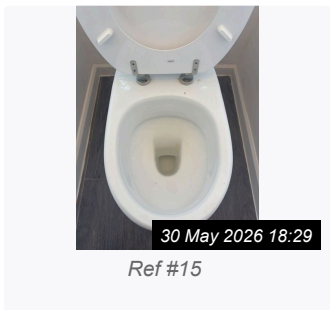
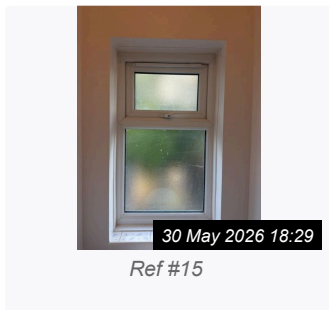
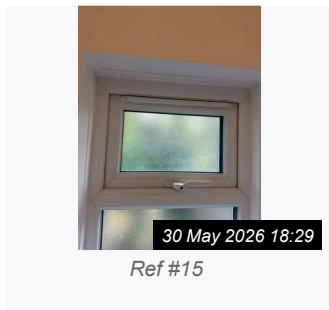
Ref	Name	Description	Condition
15.1	General Overview		In good condition.
15.2	Door	White-painted.	Appears in good overall condition, with some minor scuff marks consistent with normal use.

15.3	Door Frame	White-painted wooden door frame.	Light scuffs and minor wear consistent with use.
15.4	Ceiling	White-painted.	In good condition.
15.5	Lighting	Spherical, clear glass shade with a textured diamond-cut pattern. Pull-cord switch: white plastic base mounted on the ceiling with a hanging cord.	Bulb is in good working order. Cord fitting shows minor signs of wear/ discolouration, otherwise intact and functional.

15.8	Window(s) / Sill	Window: uPVC framed, double-glazed, with upper frosted section and lower obscured glass. Door handle: round design, white finish matching uPVC window.	Appears intact and in good condition. Handle securely fitted and functional. Small square tiles, white with blue detail; neat, clean and undamaged.

15. WC (CONT.)			
15.9	Toilet	White ceramic toilet.	Toilet seat is loose. Top-mounted flush button visible; no defects noted. Needs Maintenance - Landlord
15.10	Switch	White plastic single switch plate, standard design and appearance.	In good working order.
15.11	Flooring	Dark wood-effect flooring.	Minor wear. Metal threshold strip at doorway.
15.12	Additional Items / Information		
15.12.1	-	Metal toilet roll holder.	Securely fitted, shows minor wear and slight tarnishing.
