Inventory & Check In

Address

123 Preview Street
Sample City
London
AB1 2CD

May
30th 2026
17:00

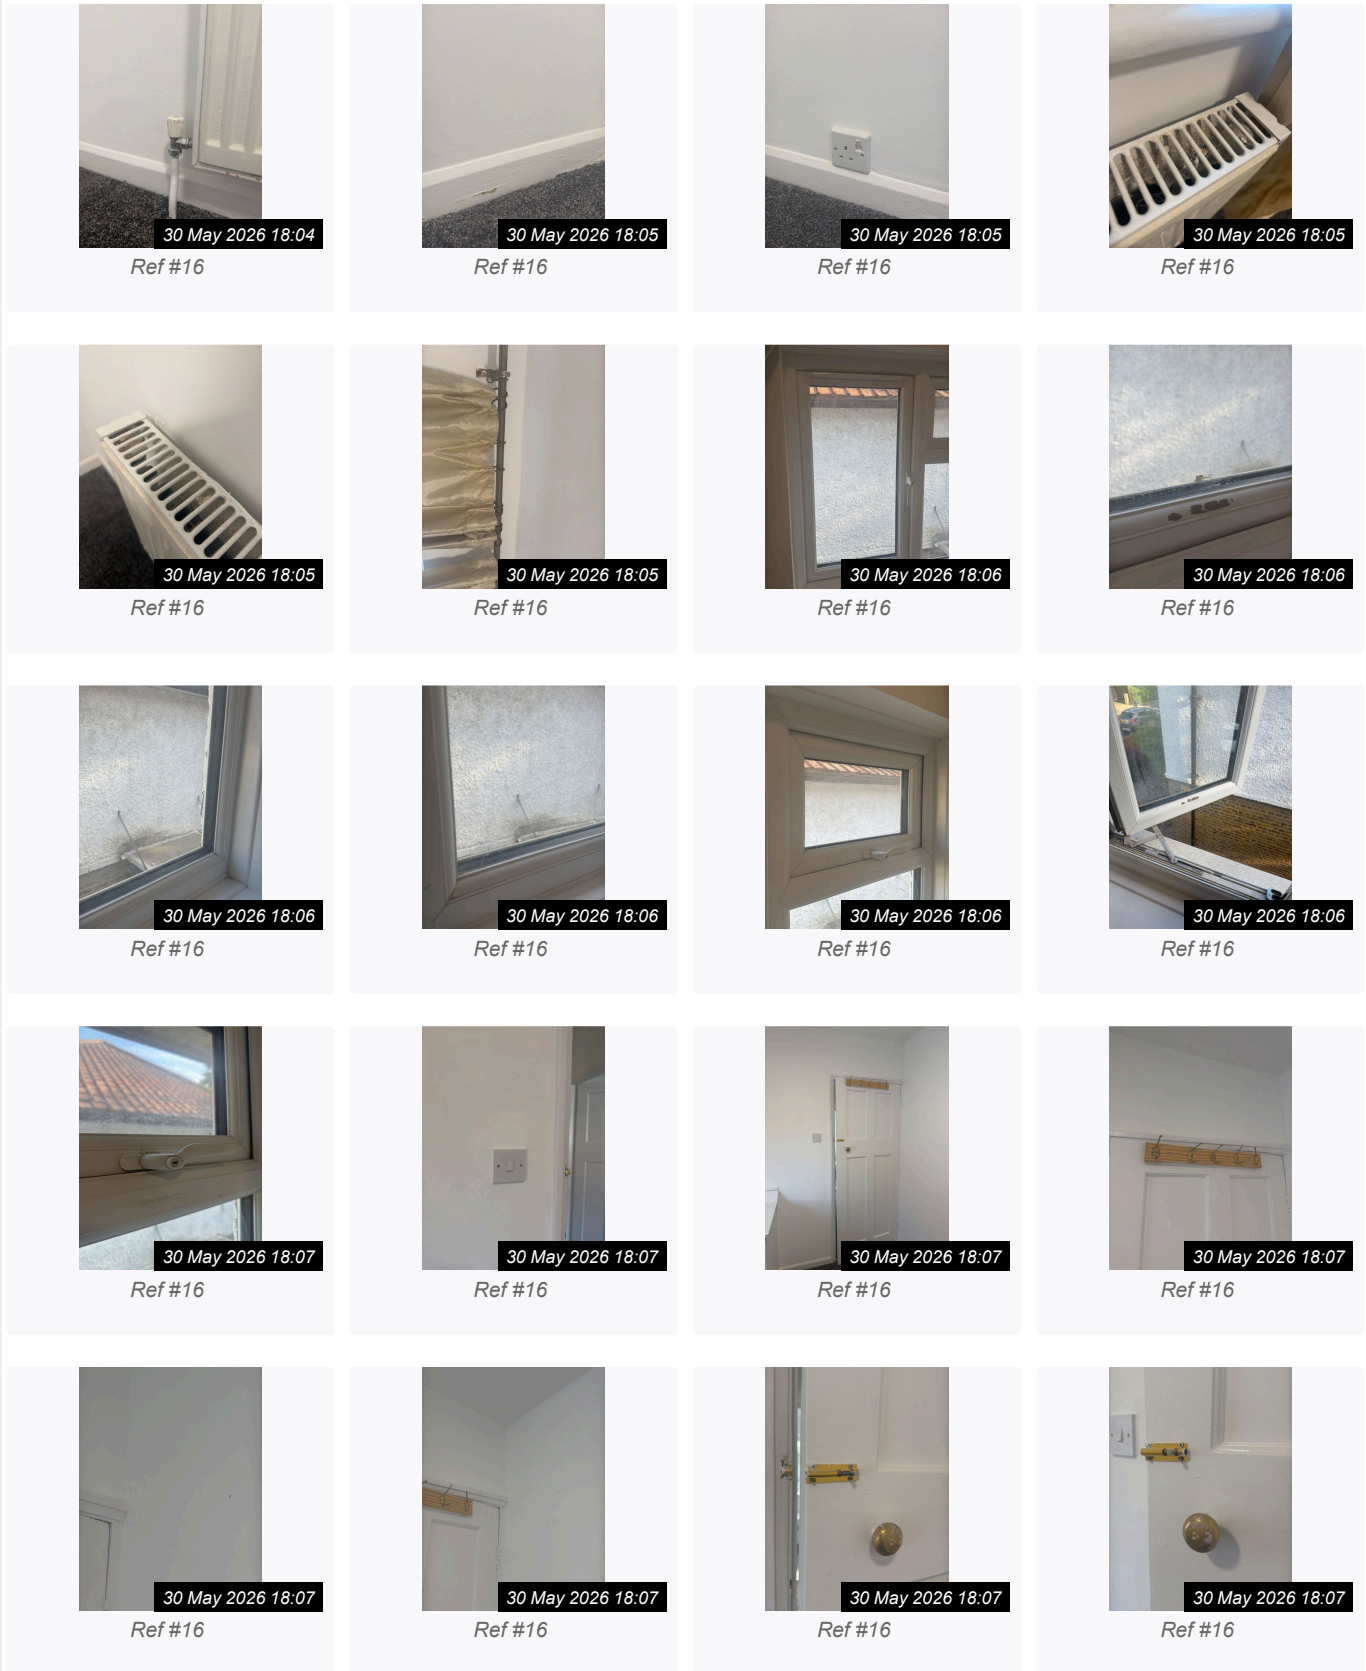
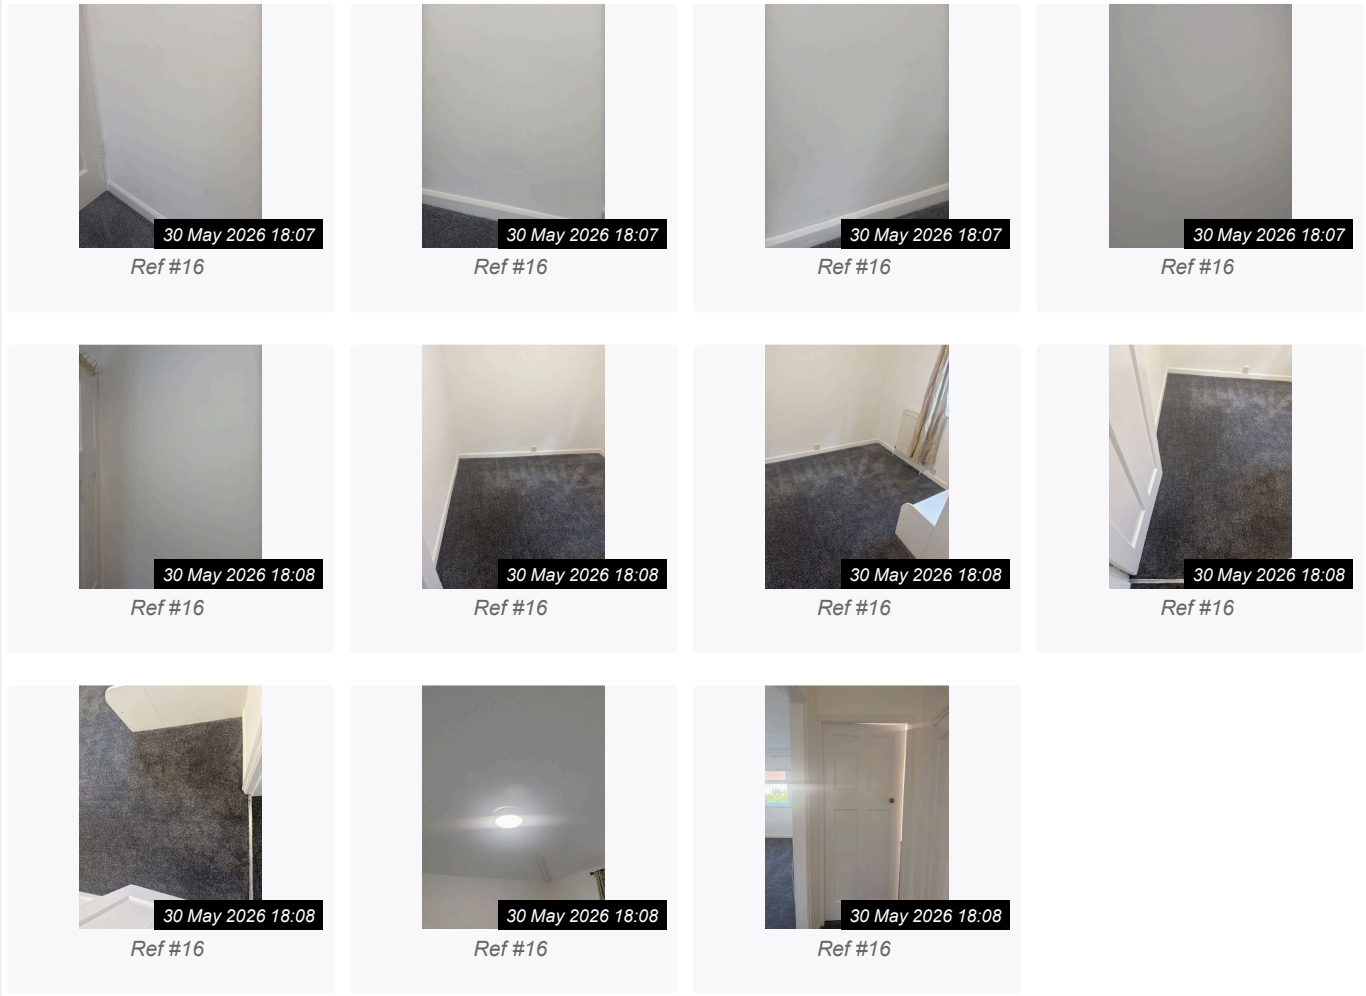
30 May 2026 18:04
Ref #16

16. BEDROOM 1 (CONT.)			
16.2	Door	<p>White panelled door, painted white.</p> <p>Round brass door knob.</p> <p>1x Fitted lock mechanism installed, finished in yellow/gold tone.</p>	<p>Significant wear, tarnish and white residue/blemishes visible.</p> <p>Both functional; aged, worn, poor cosmetic condition.</p>

16.11	Sockets	<p>2x single-gang electrical sockets fitted.</p> <p>1x double-gang electrical socket fitted.</p>	White, fitted, secure and undamaged.
16.12	Heating	White panel-type radiator, floor-mounted.	<p>Paintwork is chipped, stained and discoloured, with patches of rust visible in places.</p> <p>No thermostatic radiator valve (TRV) is fitted; no signs of leakage observed.</p> <p>The unit itself remains intact and securely fixed, though it is worn, damaged and corroded due to age.</p> <p>Accumulation of dirt and dust noted beneath the top grille.</p>

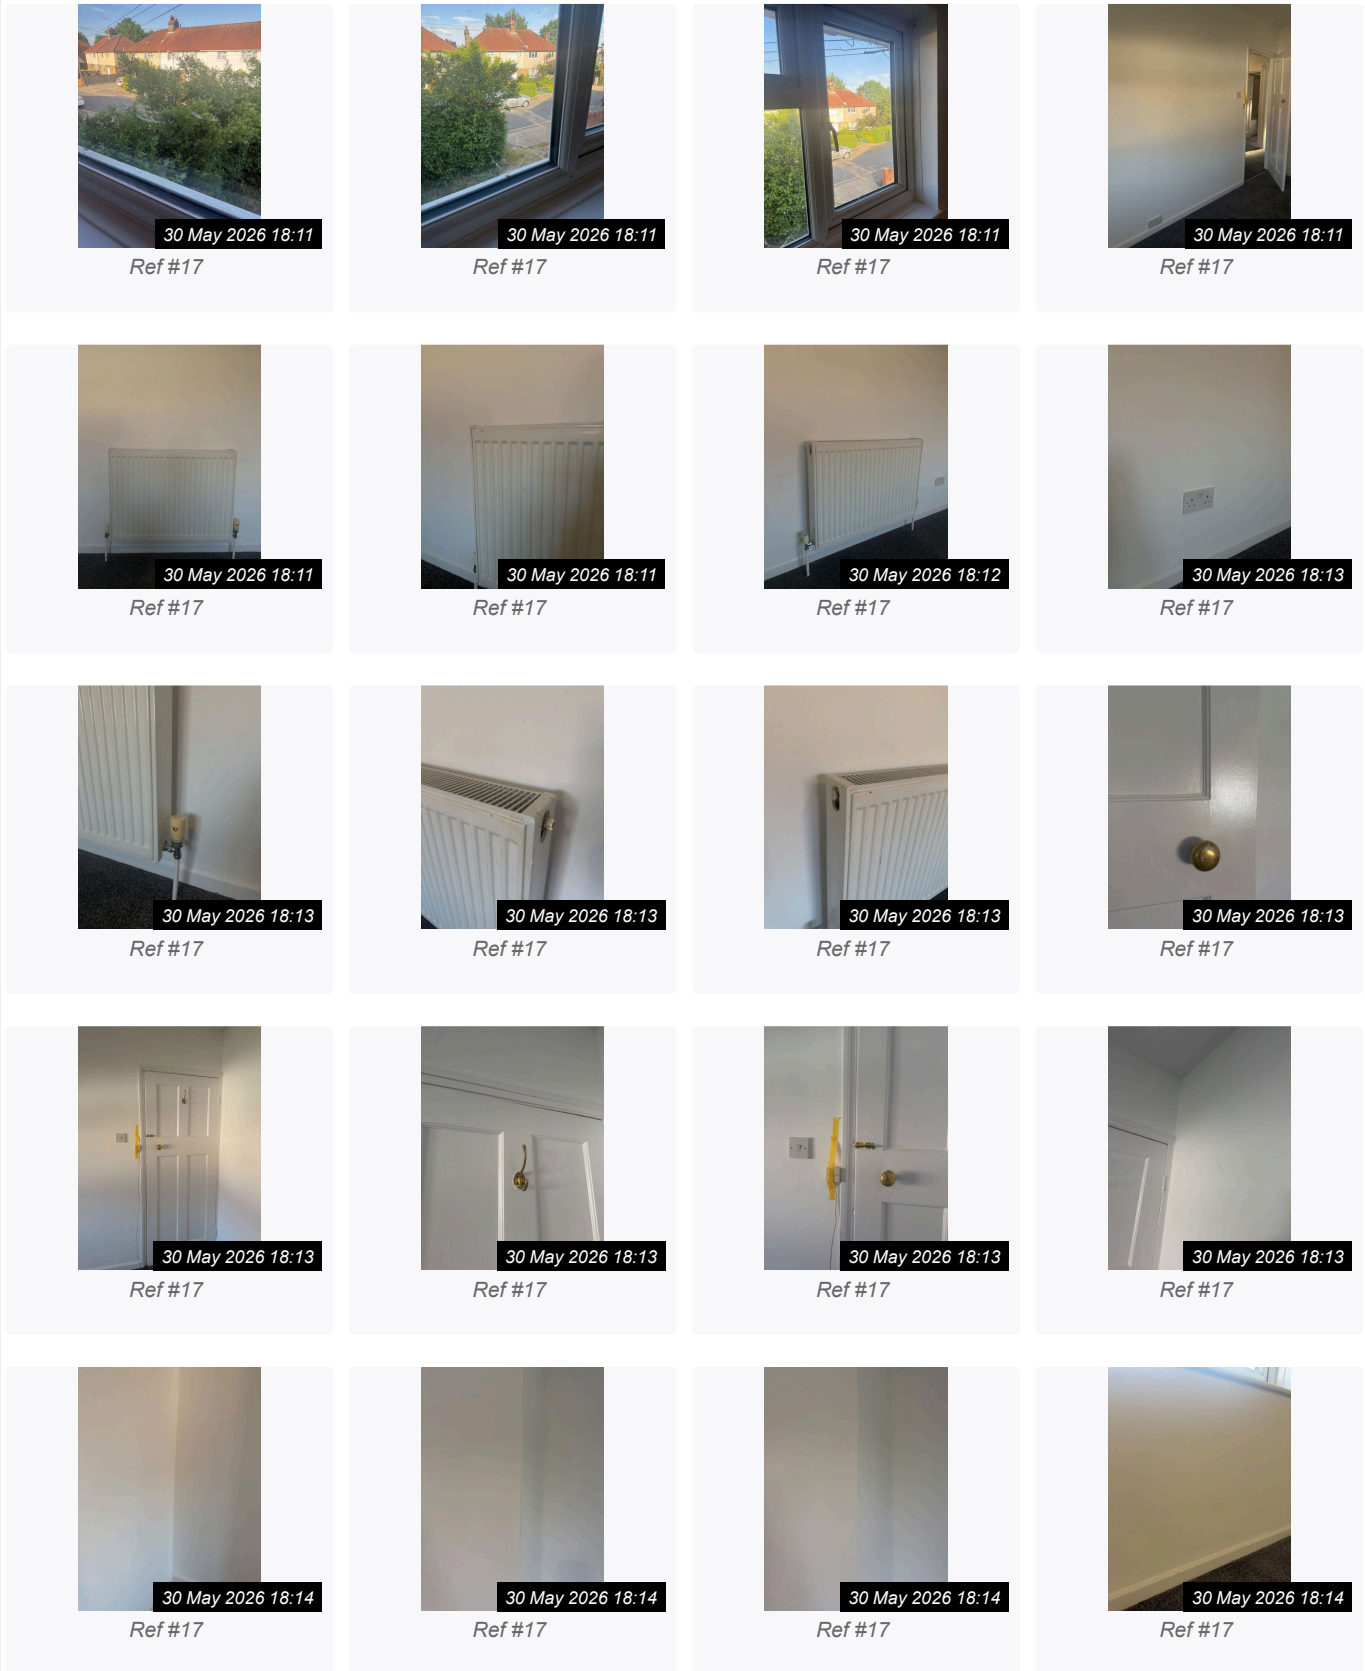
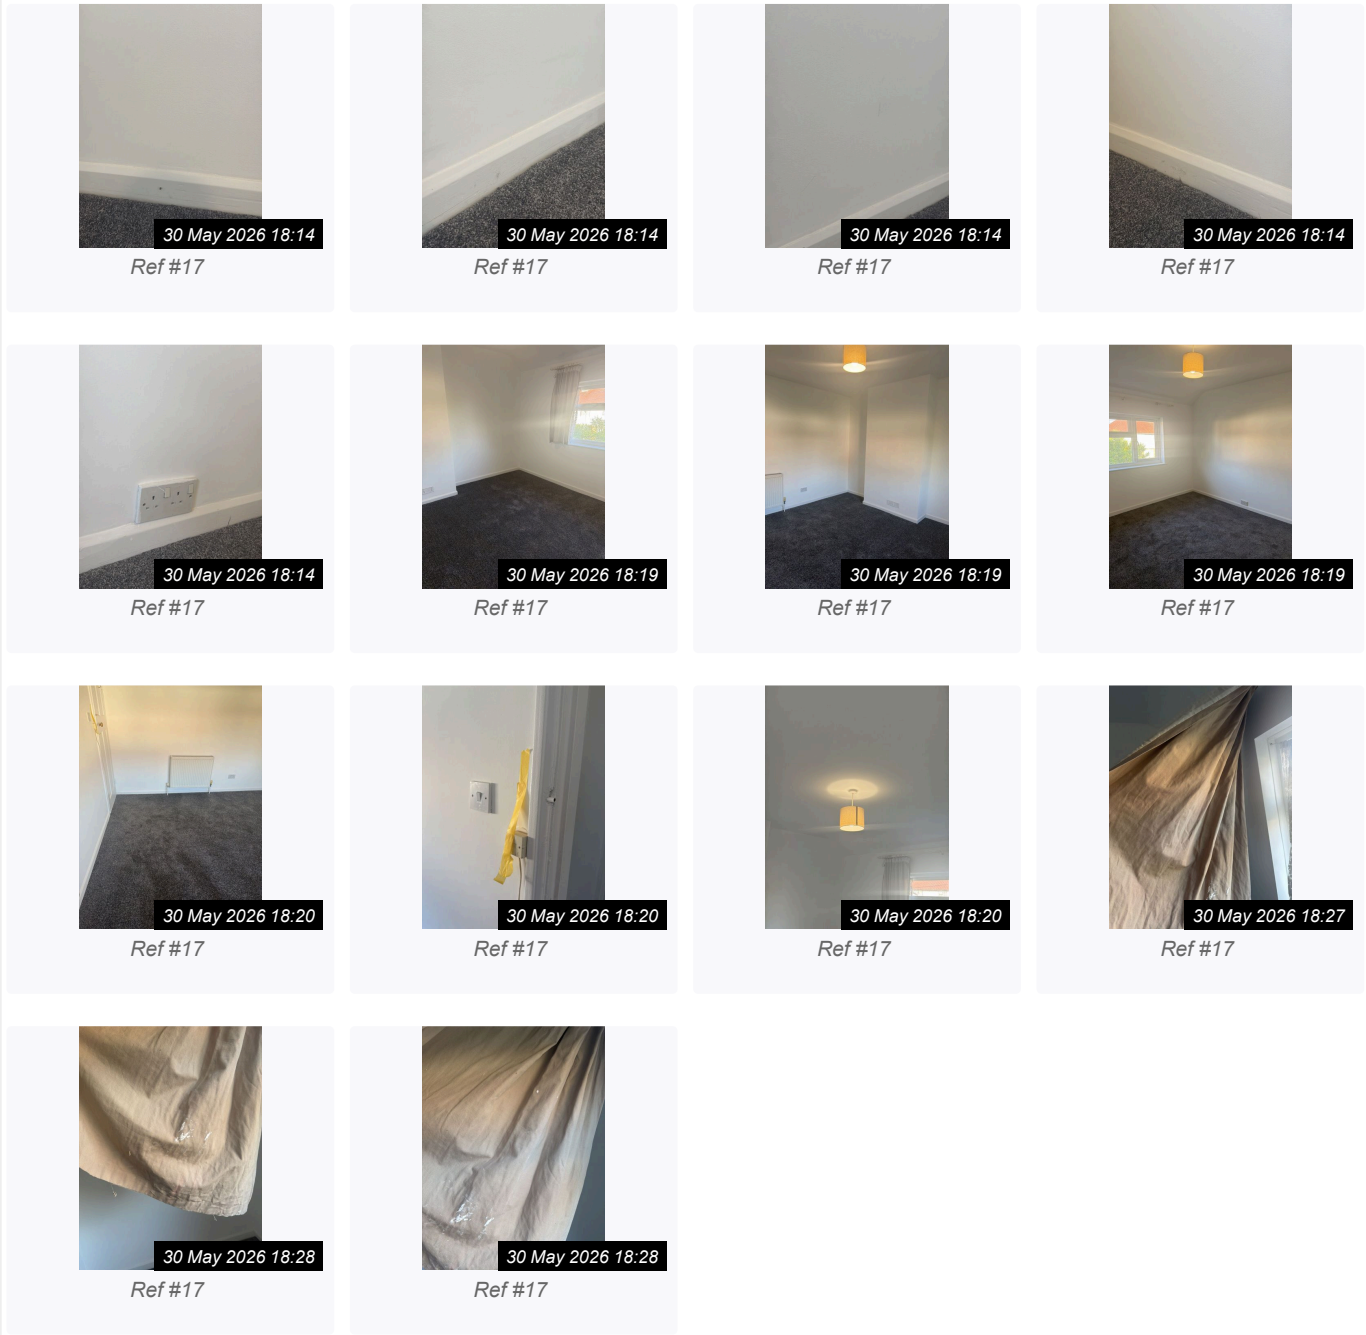
Ref #17

Ref	Name	Description	Condition
17.1	General Overview		Generally in good condition.
17.2	Door	White panelled door, painted white. Round brass round door knob. 1x brass double-ended coat hook.	Hook fitted to white panelled door: slightly worn/ tarnished, secure, no damage. Door handle: significant wear, tarnish and paint residue; finish patchy, secure and working.
17.3	Door Frame	White-painted.	Appears in good condition.
17.4	Ceiling	White-painted.	Appears in good condition.
17.5	Lighting	Single ceiling pendant light with a cylindrical natural fabric shade, suspended from a simple white ceiling rose and rod.	Fitting is secure, light is operational.

17. BEDROOM 2 (CONT.)			
17.6	Walls	White-painted.	<p>Numerous scuff marks observed on walls throughout, including at the corner edge of the wall on the chimney breast.</p> <p>Surface-mounted Ethernet port, temporarily secured with yellow tape; cabling is loose from the wall/side of the door frame.</p>

17.9	Curtains	<p>1x light brown/beige fabric curtain - with 21 rings visible.</p> <p>White painted wooden curtain pole with decorative finial.</p> <p>1x White net curtain.</p>	<p>Paint splatters/marks visible; fabric worn, loose threads, frayed lower edge.</p> <p>Light grey/beige sheer curtain: hung back-to-front; creased; brown lining showing. Second matching curtain stored upstairs cupboard, not fitted.</p> <p>White net curtain: heavily discoloured grey/black; marked/stained; very soiled throughout.</p>

17.11	Sockets	1x double-gang electrical socket fitted.	In good working order.
17.12	Heating	White panel-type radiator, floor-mounted.	<p>Paint chipped, stained and discoloured; rust in places.</p> <p>1x old TRV fitted; no leaks seen.</p> <p>Unit intact and secure; worn, damaged and corroded with age.</p> <p>Dirt/dust built up under top grille.</p>

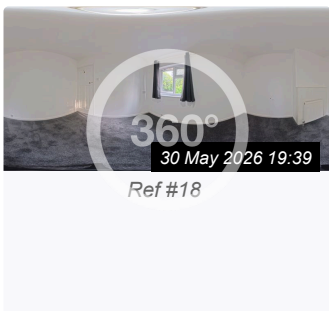
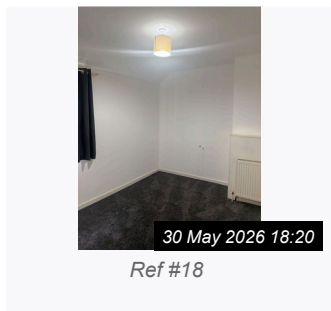
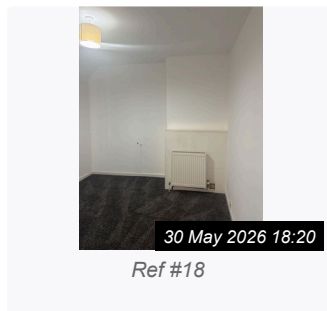
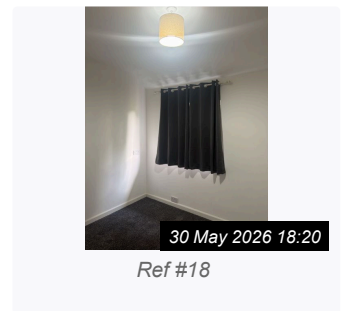
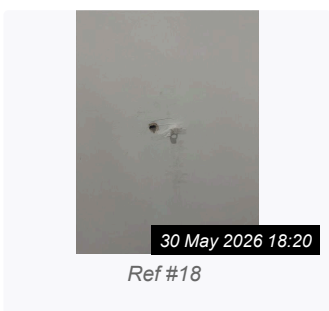
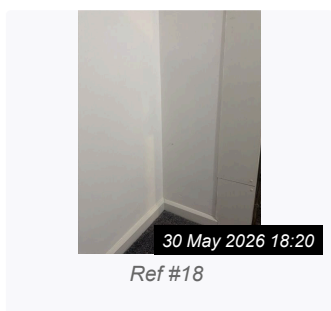
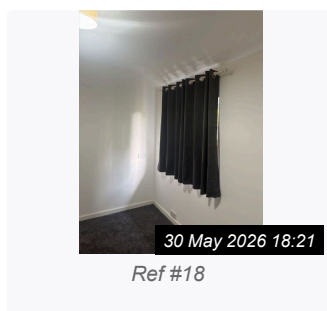
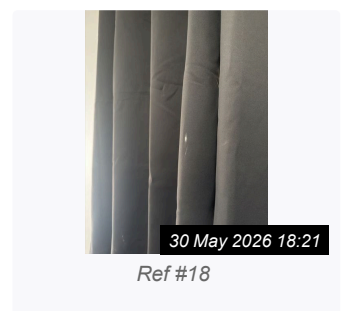
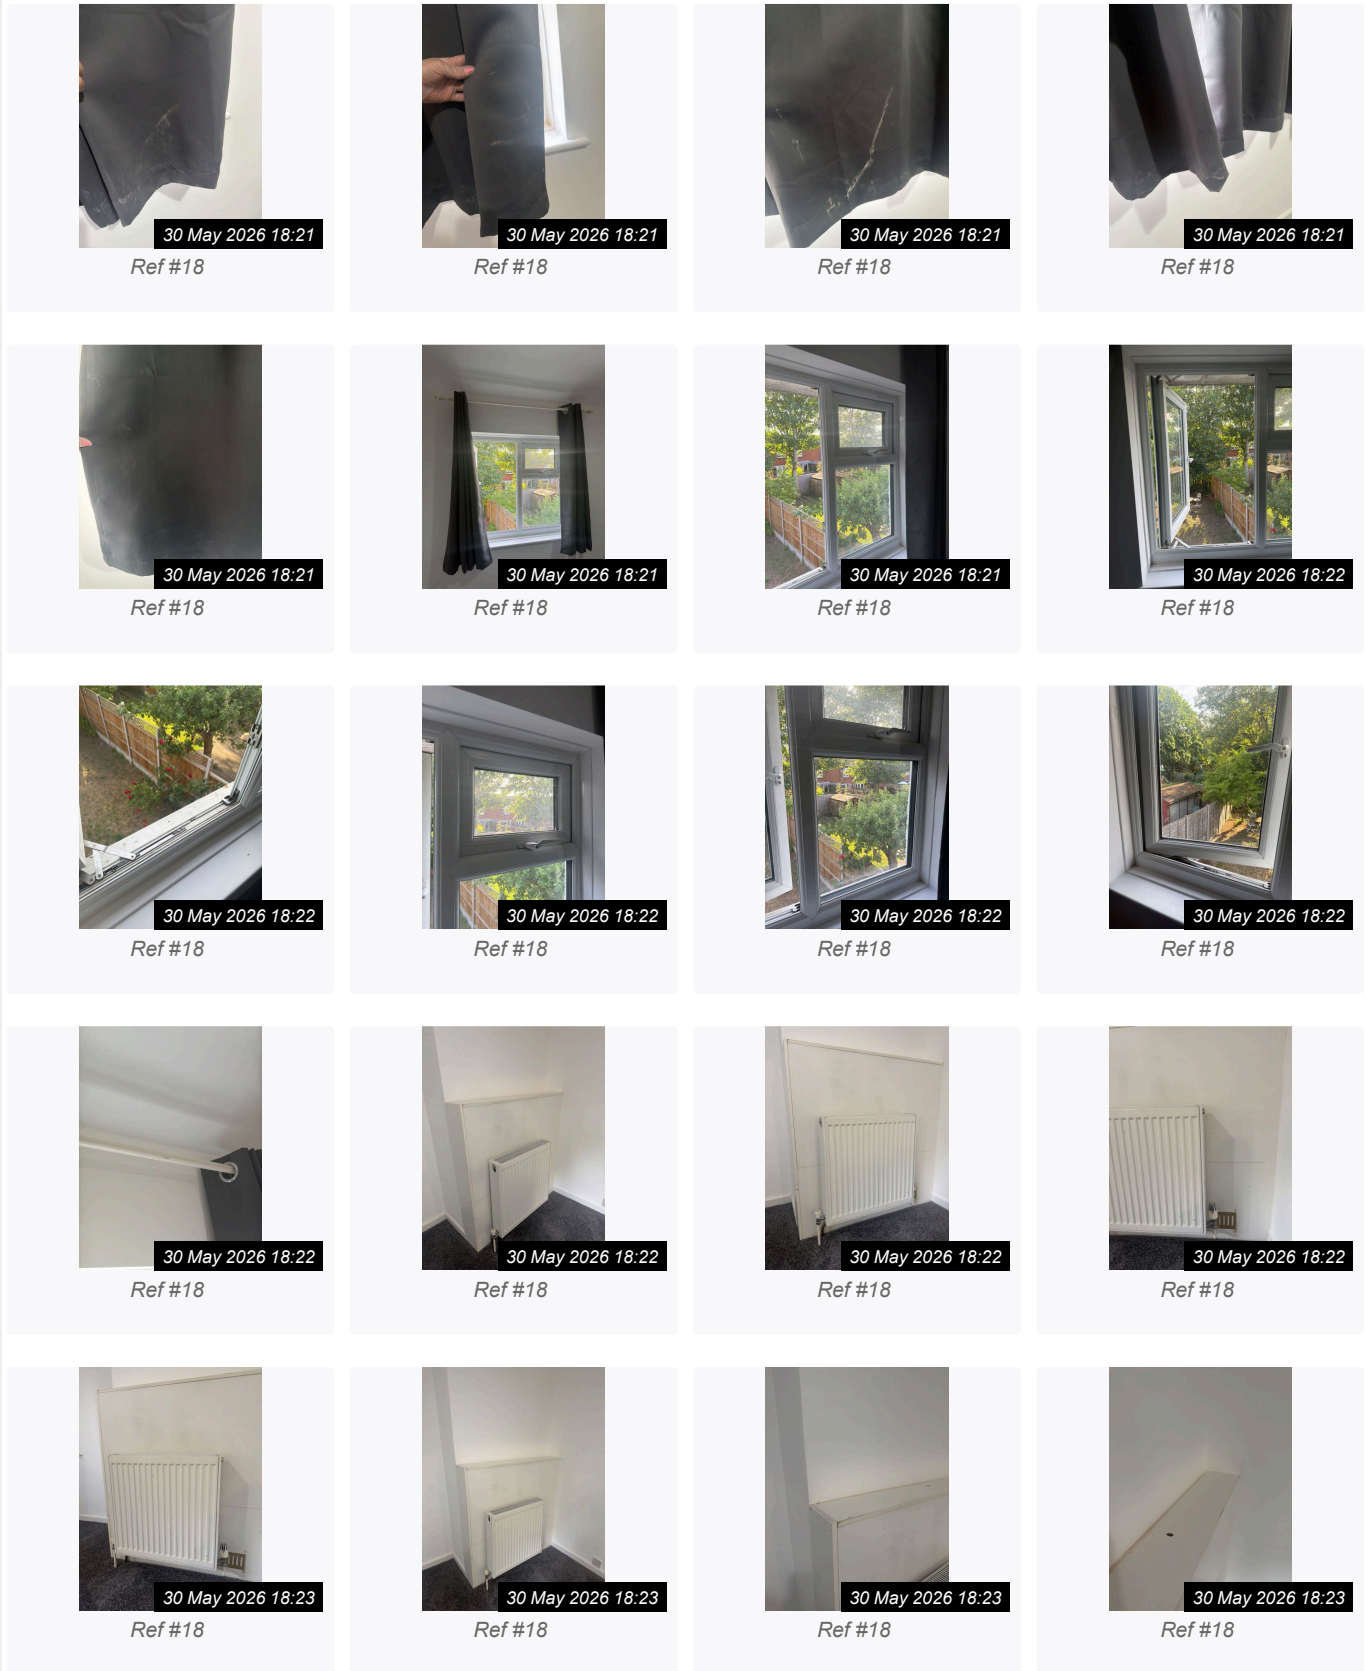
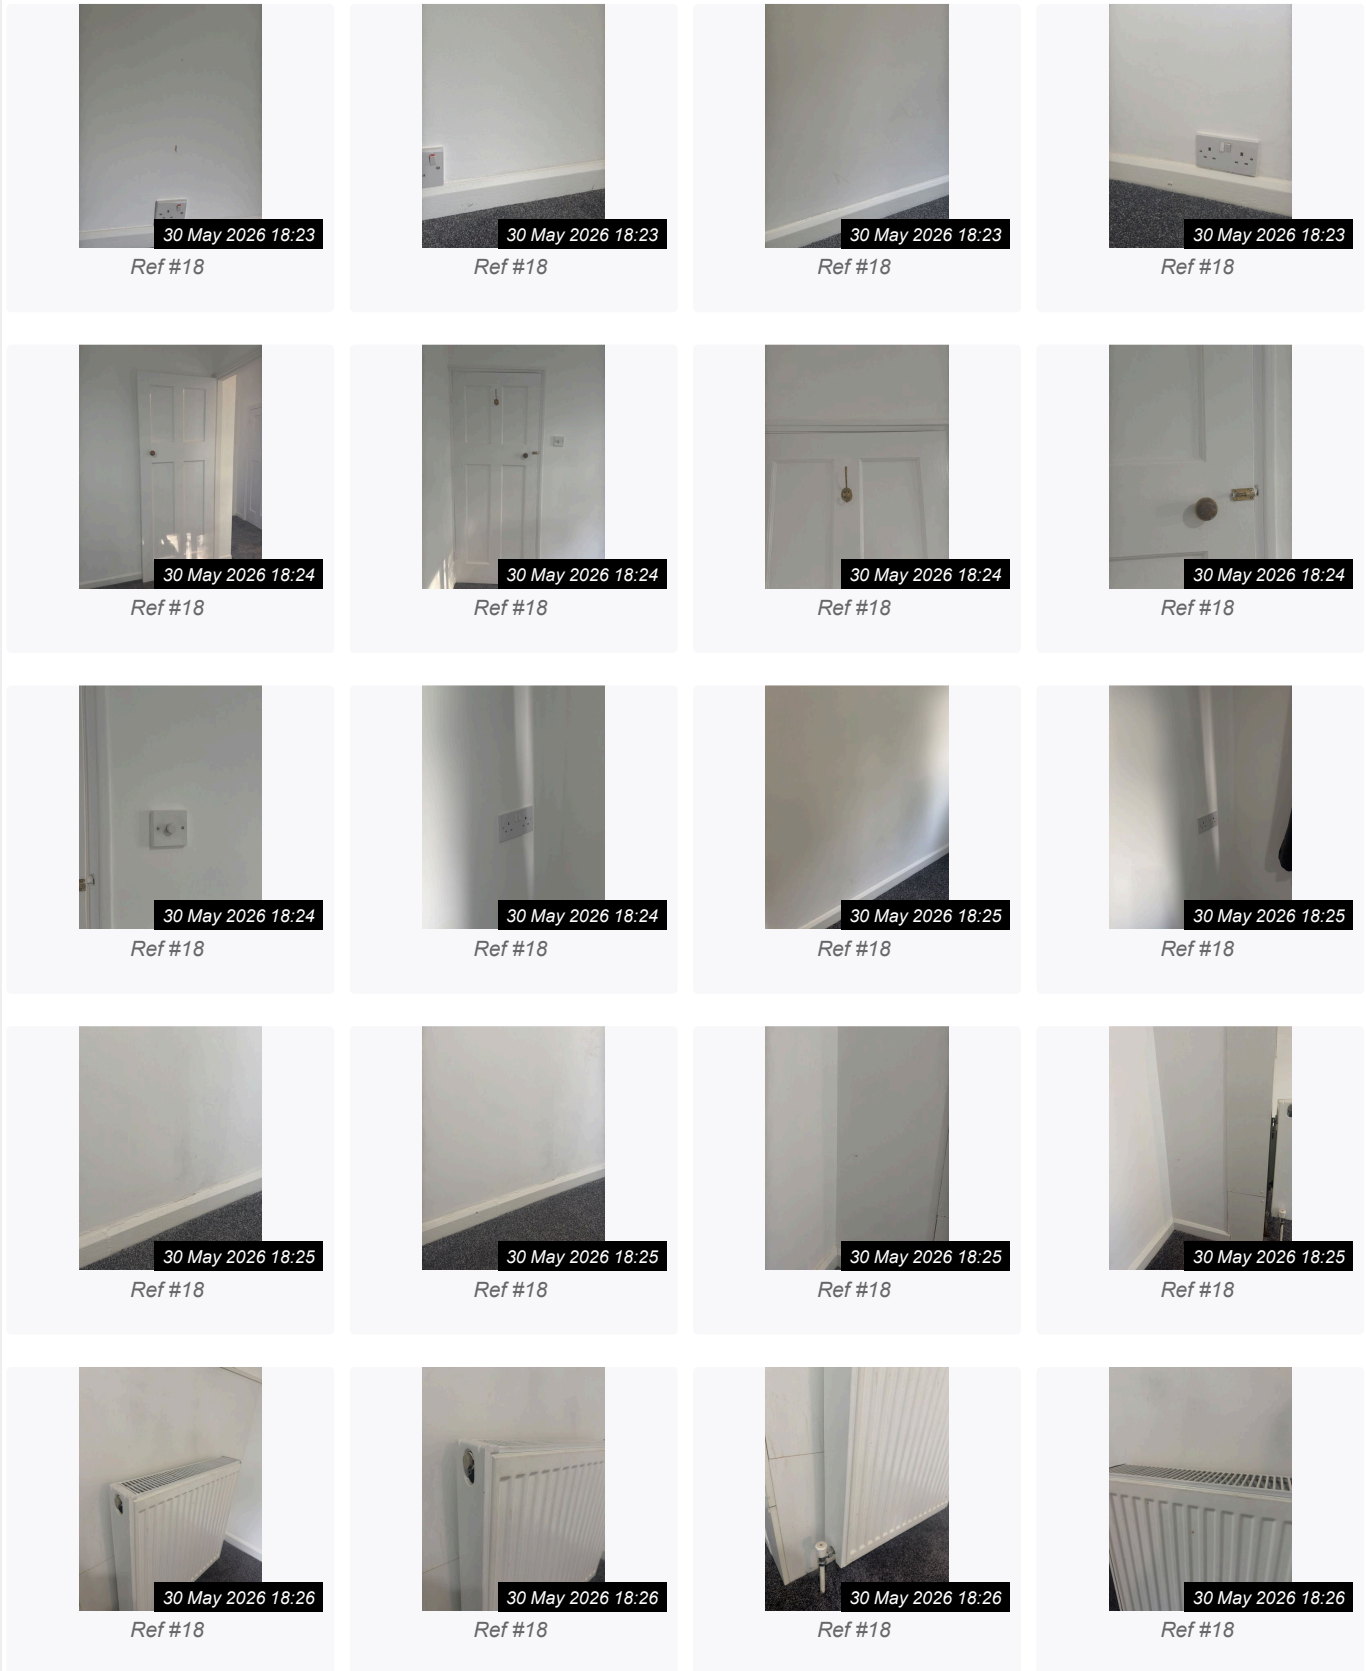
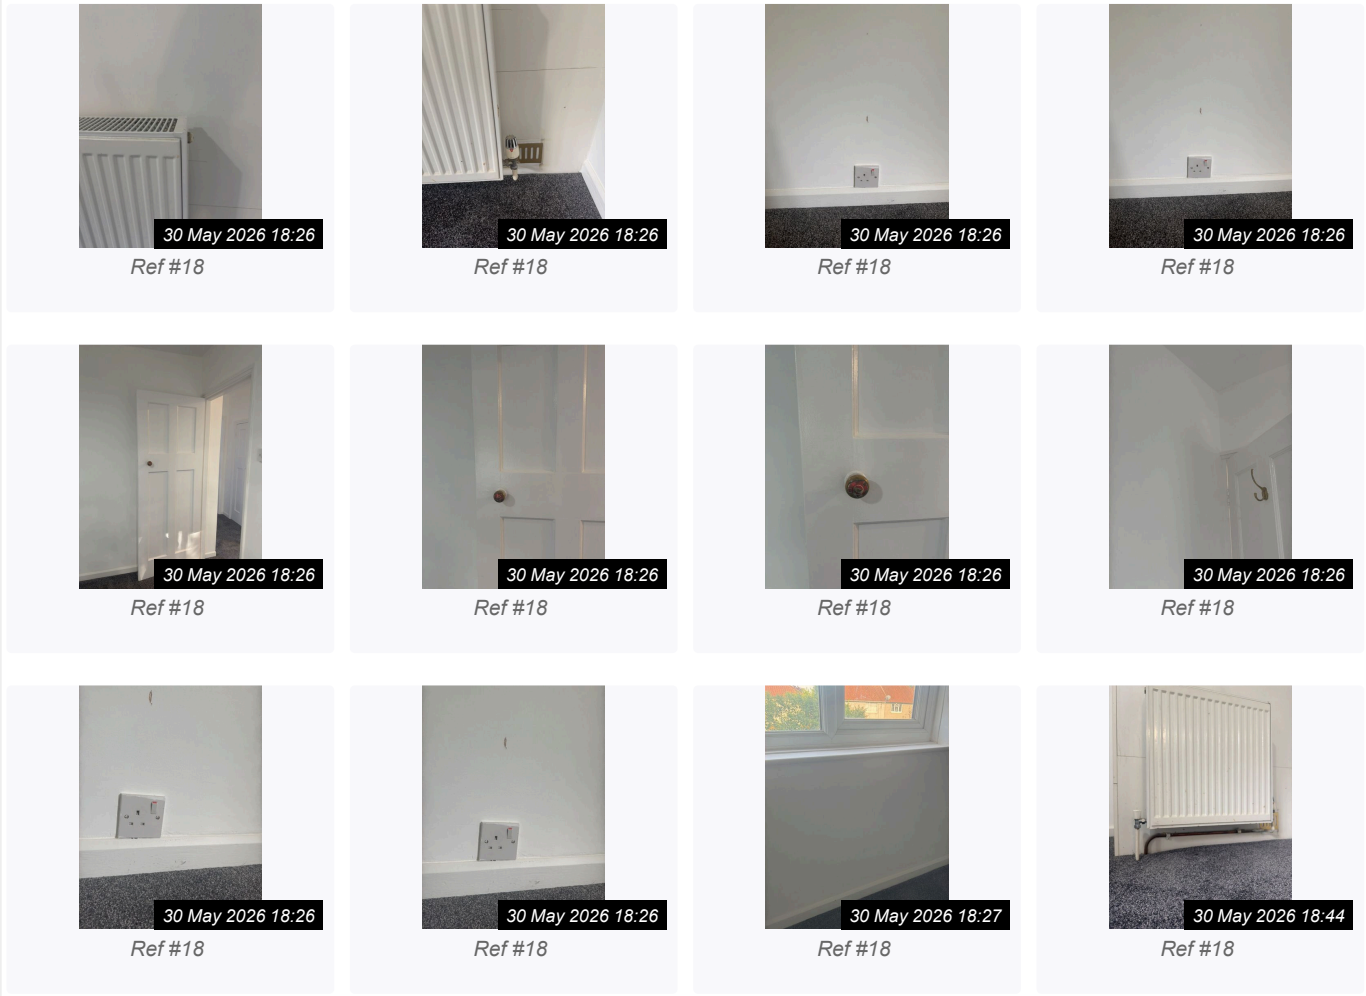
Ref	Name	Description	Condition
18.1	General Overview		Generally in good condition.
18.2	Door	White panelled door, painted white. 1x brass door knob.	Very light scuff marks seen. Brass door knob shows discolouration/tarnishing; small chrome hook fitted, slight wear visible.
18.3	Door Frame	White-painted.	Appears in good condition.
18.4	Ceiling	White-painted.	Appears in good condition.

18.7	Skirting	White-painted.	Appears in good condition with the exception of a few scuff marks and painted over indentations.
18.8	Window(s) / Sill	White UPVC frame, comprising 2x opening sections, each fitted with a handle.	Both windows operate correctly; glass and frames are soiled with dirt, grime and some sticky residue. No keys or restrictors present/visible.

18.9	Curtains	2x Heavy black fabric curtains fitted with chrome metal rings. 1x White wooden curtain pole with simple end finials.	Lower section/hem: noticeable light marks, smudges and discolouration; creased, soiled and worn.

18.12	Heating	White panel radiator, fitted with a thermostatic radiator valve (TRV).	Aged, with visible scuff marks, minor paint wear and patches of rust across the surface and edges, though remains securely fixed and shows no signs of leaks.

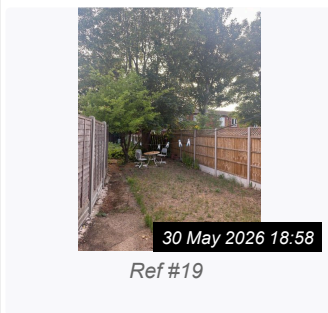
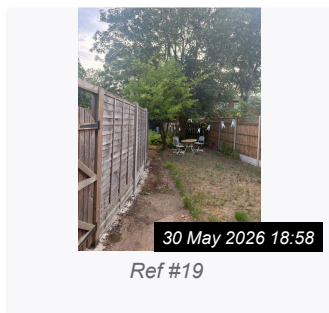
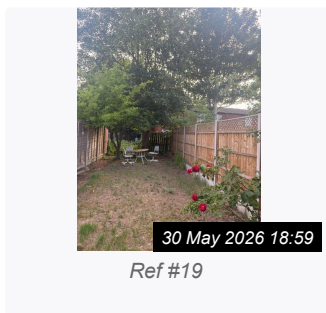
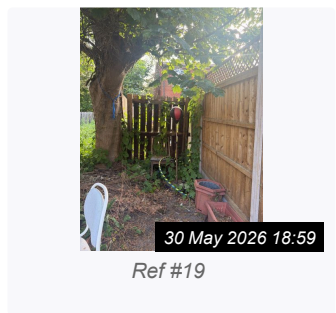
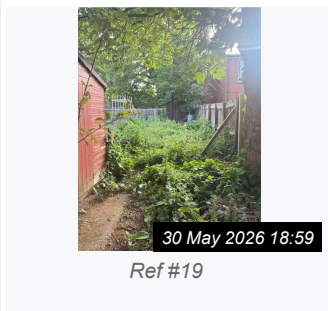
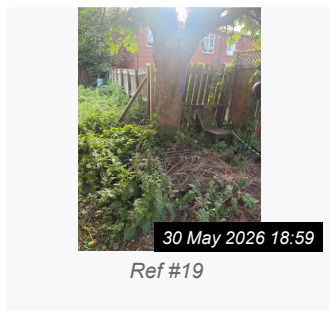
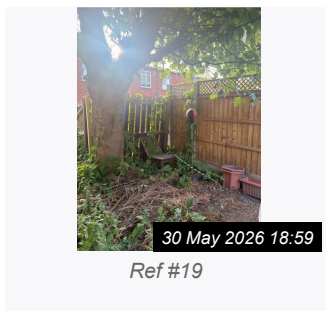
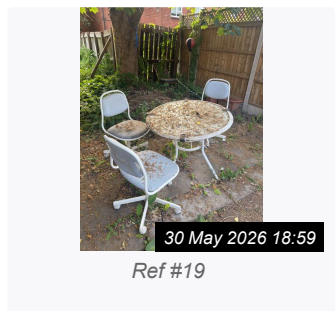
Ref	Name	Description	Condition
19.1	Garden Description		<p>Main garden area: Overgrown with unkempt grass, weeds and shrubs; includes garden furniture, washing line and established trees/ bushes; timber fencing along side boundaries is present and generally intact.</p> <p>End section of garden: Heavily overgrown.</p> <p>No fence or boundary structure visible at the rear end of the garden.</p> <p>Area around base is unclean, with weeds growing up around pipes; surrounding brickwork shows discolouration, staining and some loose or missing mortar.</p>

19. REAR GARDEN (CONT.)			
19.2	Shed(s)	Timber shed structure: red-painted finish.	<p>Visible wear and peeling paint; padlock fitted but non-functional, no key available to enable access.</p> <p>Interior contents: numerous items stored inside, arrangement is cluttered and unorganised; overall condition is very dirty, with heavy dust, grime and soiling present on all internal surfaces and contents.</p>

19.3	Guttering	External pipework and guttering.	<p>Painted finish is worn, chipped and peeling in places; metal fittings and valves show signs of corrosion, rust and age.</p> <p>Fitted with an external tap/outlet valve - connection likely links to internal kitchen plumbing.</p> <p>Concrete cover/access panel at ground level is dirty, marked and uneven; general condition of the installation is aged.</p>

19.4	Additional Items / Information		
19.4.1	-	<p>Items found in the garden:</p> <ul style="list-style-type: none"> Table with chairs Punching bag Plant pots Extra chair Wooden shelf Mop bucket Doormat positioned outside the garden door 	<p>Overused and show signs of damage, wear and deterioration throughout.</p> <p>Needs Maintenance - Landlord</p>
