Inventory & Check In

Property inspected by A. Clerk

123 Preview Street
Sample City
London
AB1 2CD

June
3rd 2026
10:00

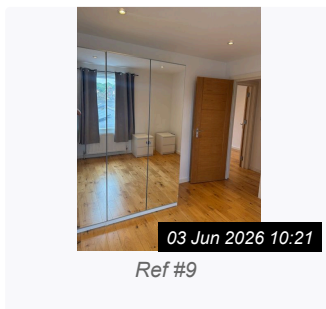
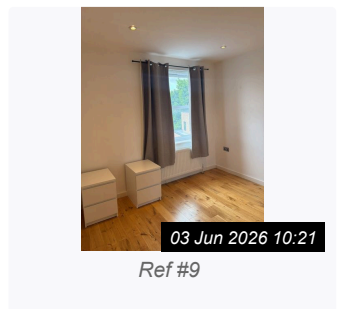
9.16	Bedside Tables	Pair of white wooden units, each with flat top and two drawers.	<p>Scuffs and marks visible on the top surface of both tables.</p> <p>Top drawer on the right-hand unit is stiff to open and close; all other drawers operate smoothly. No other damage or defects noted.</p>

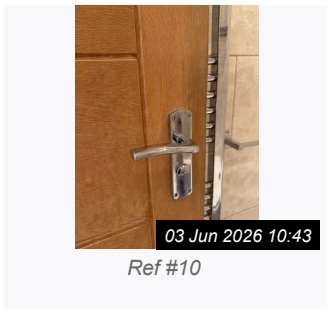
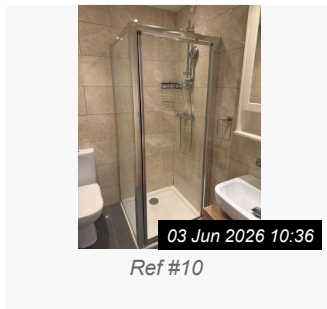
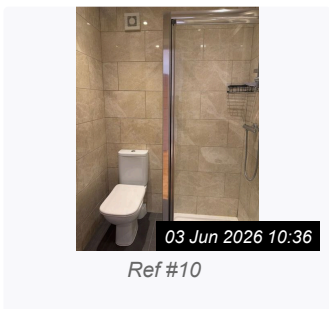
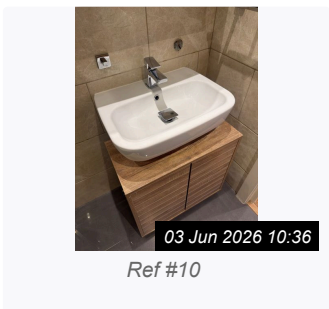
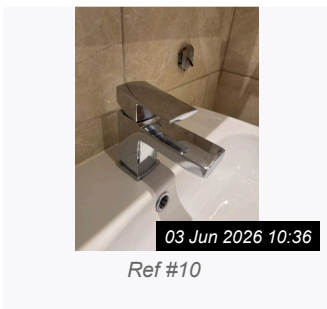
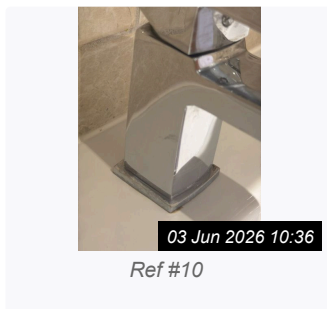
10. BATHROOM (CONT.)			
10.14.1	-	<p>Hooks: 1 small chrome hook below towel rack; 1 matching hook right of shaver socket.</p> <p>Wall fittings: 2 square fixtures; right-hand one missing.</p>	Appears in good condition.
10.15	Additional Items / Information		
10.15.1	-	White wooden wall-mounted cabinet with full-length mirror door and open lower shelf; clean, classic style.	<p>Exterior generally good with minor handwash marks.</p> <p>Bottom interior section water damaged - wood expanded and discoloured. Mirror clear and undamaged; fittings secure.</p>
10.15.2	-	Chrome square rack - right of sink.	Appears in good condition.
10.15.3	-	Square rail - left of cabinet.	Appears in good condition.
10.15.4	-		Appears in good condition.
