# Inventory & Check In

Prepared on behalf of Example Lettings Ltd

123 Preview Street  
Sample City  
London  
AB1 2CD

**October  
9th 2026**

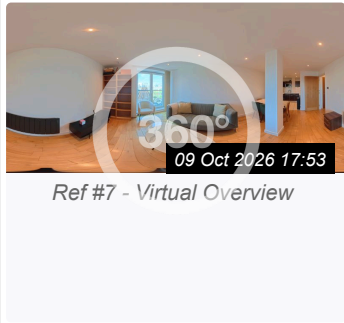
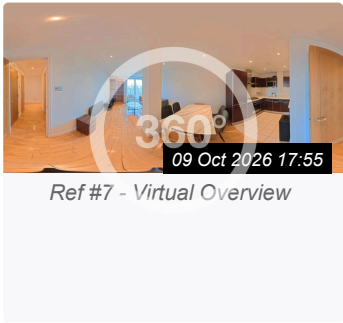
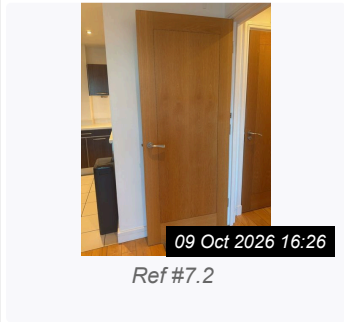
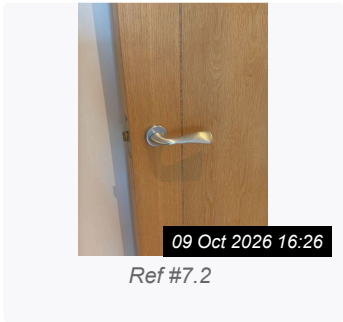
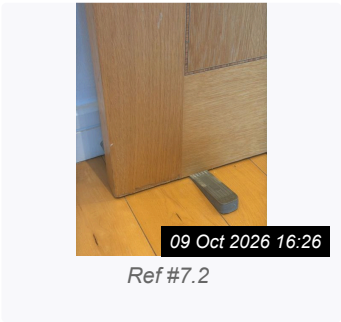
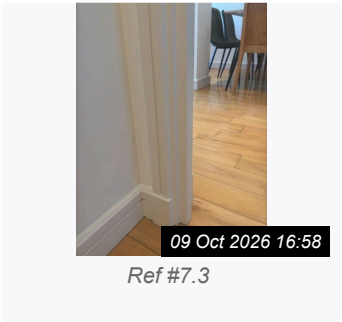
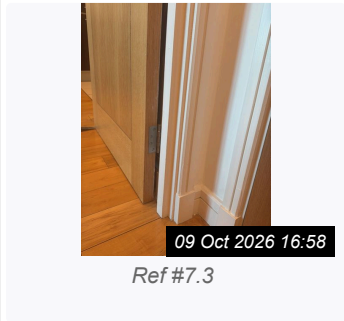
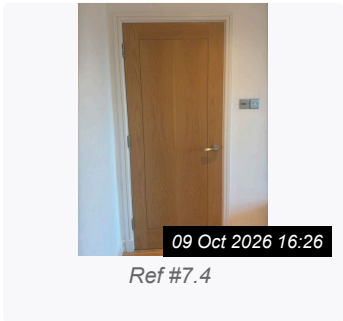
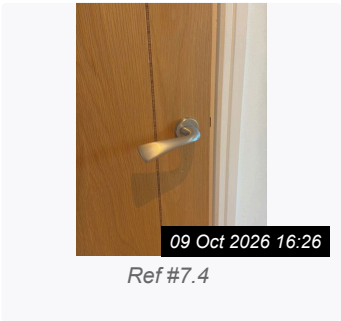
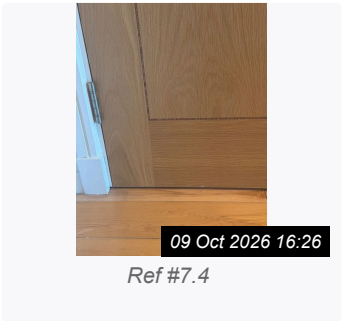
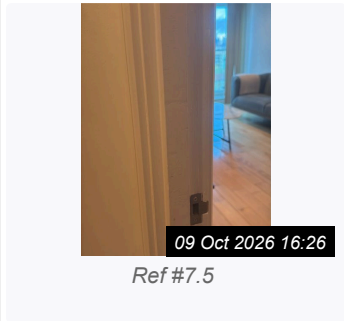
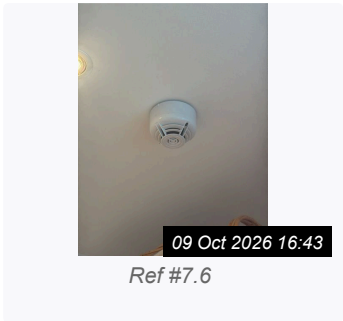
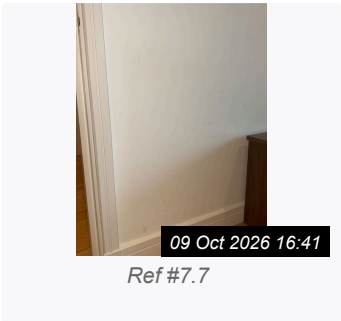
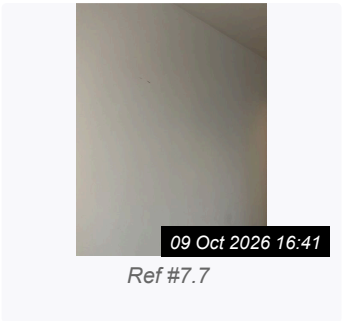
| 7.10 | Window(s) / Sill | White UPVC balcony door assembly.<br>White UPVC door handle - 1x key present.<br>2x Trickle vents fitted - one on each side. | In good overall condition and full operable.<br>Extremely loose and wobbly.<br>Sill edges (both sides): scuff marks and cracking to paint. |
| 7.11 | Blind | 1x Set beige vertical blinds. | Multiple slats missing.<br>Connecting beading loose, detached & broken in sections. |

| 7.23 | Dining Table & Chairs | Dining table: white marble-effect top, black metal legs; vinyl protective cover fitted.<br>4x Green/grey fabric/suede dining chairs.<br>2x Light wood dining chairs. | Vinyl/protective cover: A few pink scuff lines visible; small imperfections scattered in places.<br><br>Small white stains seen to suede chairs in places.<br>One seat detached from frame. |

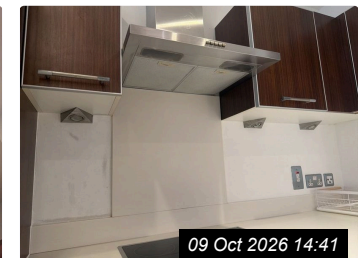
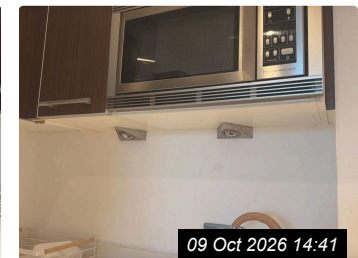
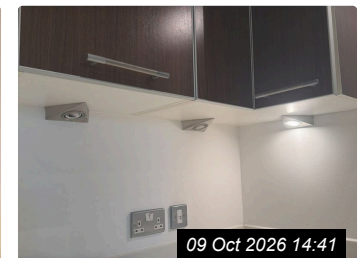
| 8.7 | Lighting | 4x Recessed spotlights.<br><br>9x Pelmet / under-cabinet lights.<br><br>1x Recessed spotlight above sink, integrated to cabinetry. | All in good, working order.<br><br>8x units: not in working order.<br>4x units: missing clear glass covers.<br>All in good, working order. |

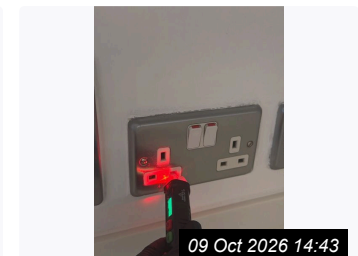
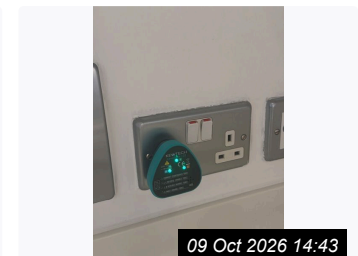
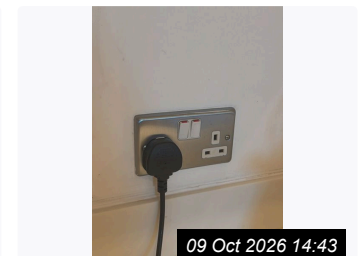
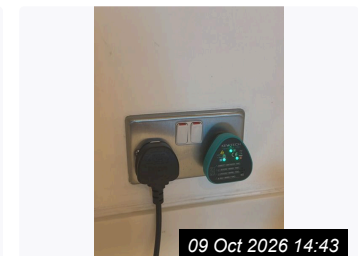
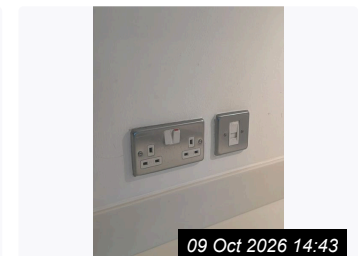
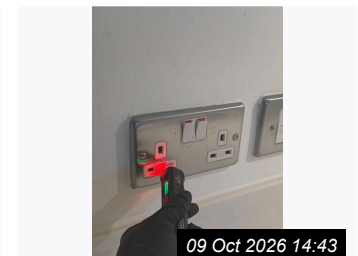
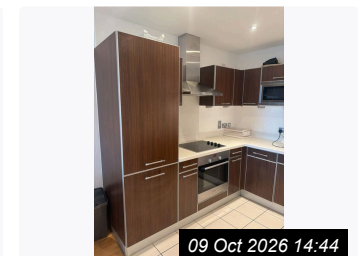
| 8.9 | Sockets | 3x Double brushed steel socket plates. | Tested for power using voltage tester; supply confirmed present and in working order.<br>Fittings appear secure; no visible damage to casing or wiring. |

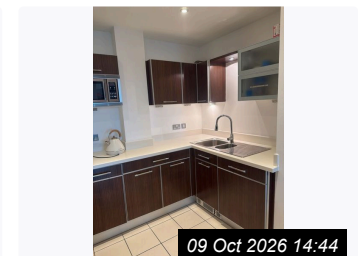
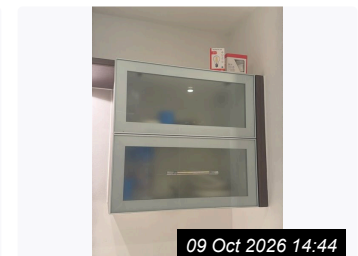
| 8.10 | Kitchen Units | Dark walnut-effect veneer finish.<br>Glazed 2-door wall unit (recessed frosted glass).<br><br>20x Chrome bar-style handles (includes fridge & dishwasher).<br><br>1x Drawer with white plastic cutlery insert.<br><br>Silver-finish kickboard/plinth.<br>Kickspace heater unit beneath cabinetry. | Top cabinet door - RHS of fridge: Handle contacts cabinetry on closing. One dent visible.<br>Corner folding top cabinet door RHS - Not aligned. Does not sit flush to frame.<br>Edges tarnished on all handles.<br><br>In good condition.<br><br>Appears in good condition.<br>Control panel intact. Grille clean. Full function not tested. |

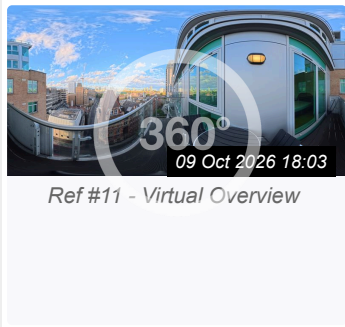
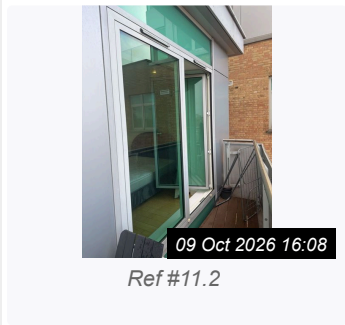
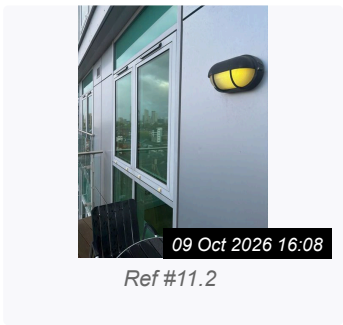
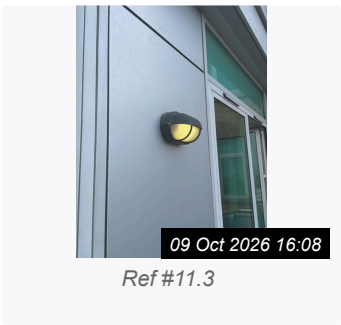
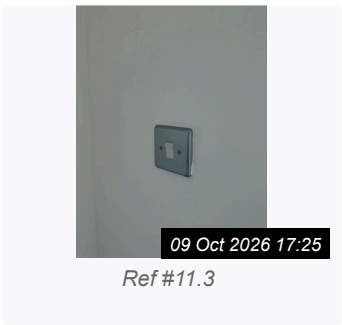
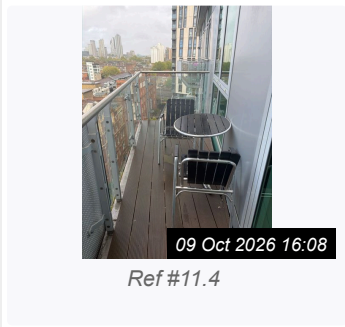
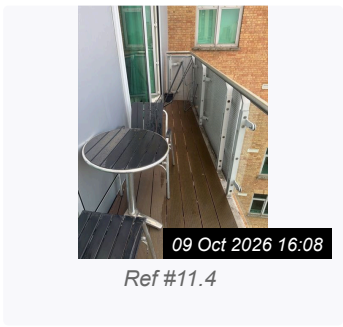
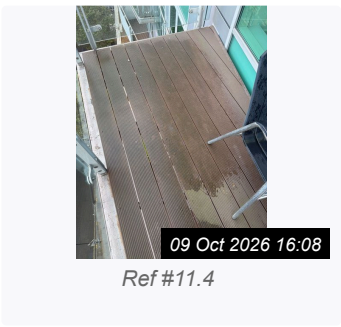
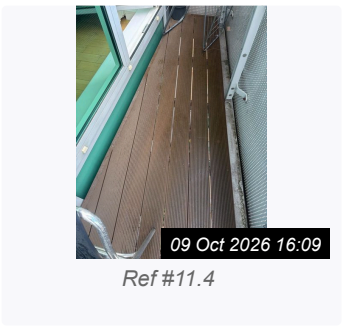
11. BALCONY (CONT.)

| 11. BALCONY (CONT.) | | | |
|---|---|---|---|
| 11.4 | Decking | Brown composite decking boards. | In weathered condition.<br>Boards generally secure; no significant lifting or damage. |
| 11.5 | Balustrade | Stainless steel top handrail.<br>Clear glass infill panels.<br>Perforated metal panel section.<br>Metal support posts and fixings. | Structure secure and intact overall.<br>Glass panels in good condition - no chips or cracks observed.<br>All fixings present and tight. |
| 11.7 | Table & Chairs | 1x Round black slatted table with metal frame.<br>2x Matching slatted chairs with metal arms and legs. | Surface weathering and some discolouration visible to all items.<br>All frames, legs and fixings secure; no damage or instability. |
| 11.10 | Plant Pots | A range of plant pots. | In old and weathered condition. |

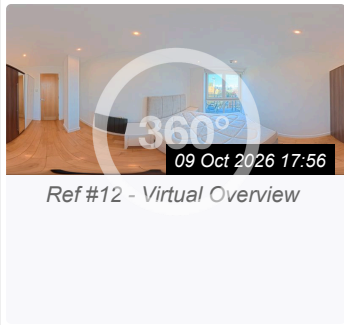
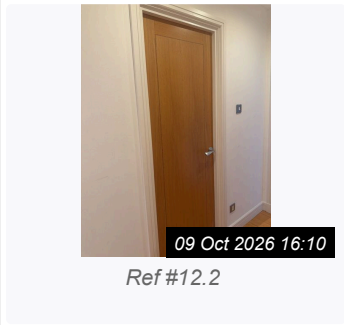
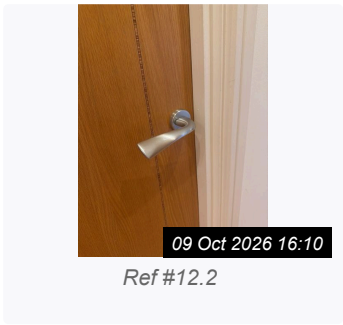
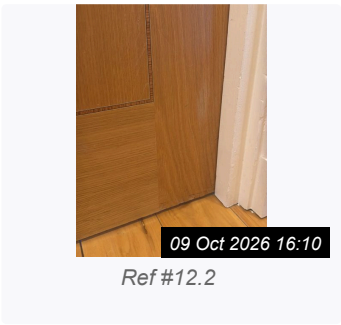
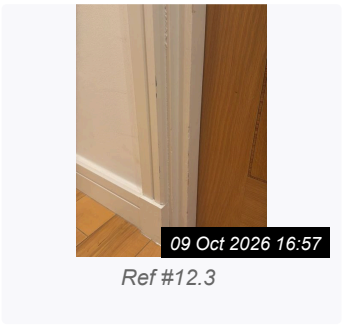
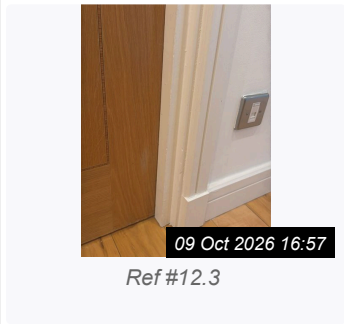
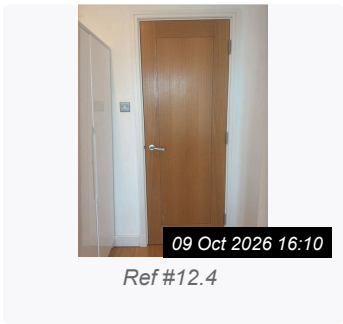
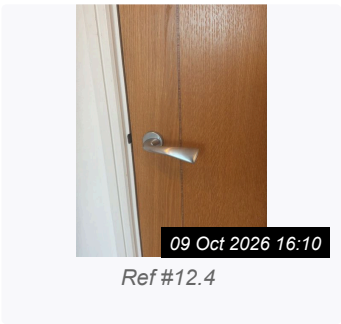
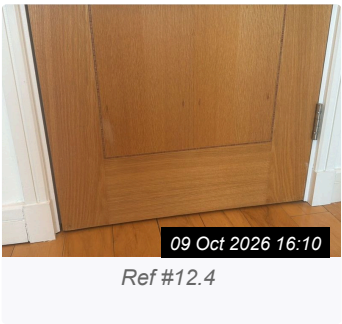
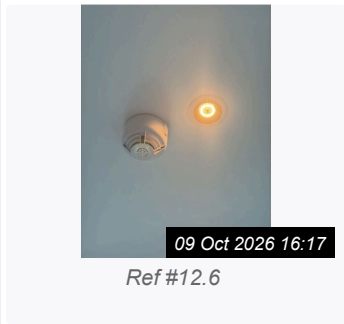
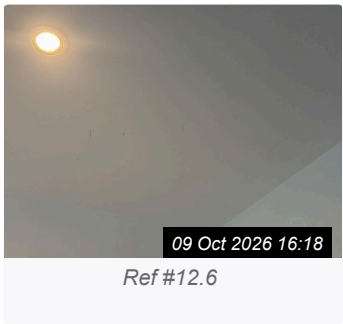
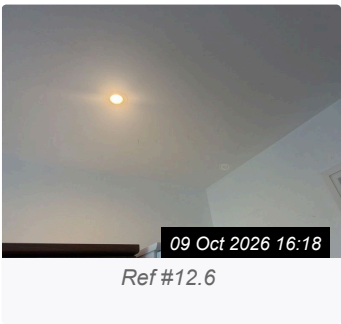
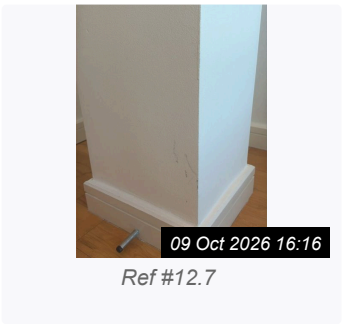
12. BEDROOM TWO (RIGHT-HAND SIDE) (CONT.)

| 12. BEDROOM TWO (RIGHT-HAND SIDE) | | | |
|---|---|---|---|
| 12.3 | Exterior Door Frame | White-painted. | Scuff marks and paint wear visible to both side sections.<br>Minor chipping and surface damage along edges. |

| 12.8 | Flooring | Light oak engineered wooden flooring. | Fine surface scratches scattered throughout.<br>Minor scuff marks and faint wear visible across planks. |
| 12.9 | Skirting Boards | White-painted.<br><br>1x Skirting-mounted doorstop with black rubber tip. | Scuff marks and paint wear visible to corner and joint sections.<br>Minor surface marks and faint scratches visible.<br>Intact and secure. |
| 12.10 | Window(s) / Sill | White UPVC window assembly.<br>2x White UPVC door handles - 2x keys present.<br>2x Trickle vents fitted - one on each side. | In good overall condition and full operable.<br>Handles intact and secure.<br>Sill edges (both sides): scuff marks and cracking to paint. |
| 12.18 | Bed & Mattress | Light grey/cream suede-effect bed frame / headboard.<br>Double mattress - measurements 135cm x 190 cm (4'6" x 6'3").<br>2x Fire resistant labels present. | White stain marks visible to headboard surface.<br>In good clean condition, no stains visible. |

| 12.20 | Freestanding Wardrobes | <p>1x Dark wood-effect wardrobe with mirrored sliding door.</p> <p><b>Contents</b><br/>Items of bedding visible to interior.</p> <p>1x White finish double-door wardrobe.</p> <p><b>Contents</b><br/>A range of cushions and pillows.</p> | Both units unstable, wobbly and leaning. |
